**Enhanced Decommissioning,  
Rehabilitation and Restoration Scheme  
(EDRRS)**

**Kellysgrove Bog Rehabilitation  
Ex-Post Report**

Client	Bord na Mona Lands and Habitats					
Project Title	Peatlands Climate Action Scheme – Kellysgrove Bog					
Document Title	Ex- Post Report					
Document No.	PCAS – Kellysgrove Bog					
This Document Comprises	DCS	TOC	Text	List of Tables	List of Figures	No. of Appendices
			10	3	4	2

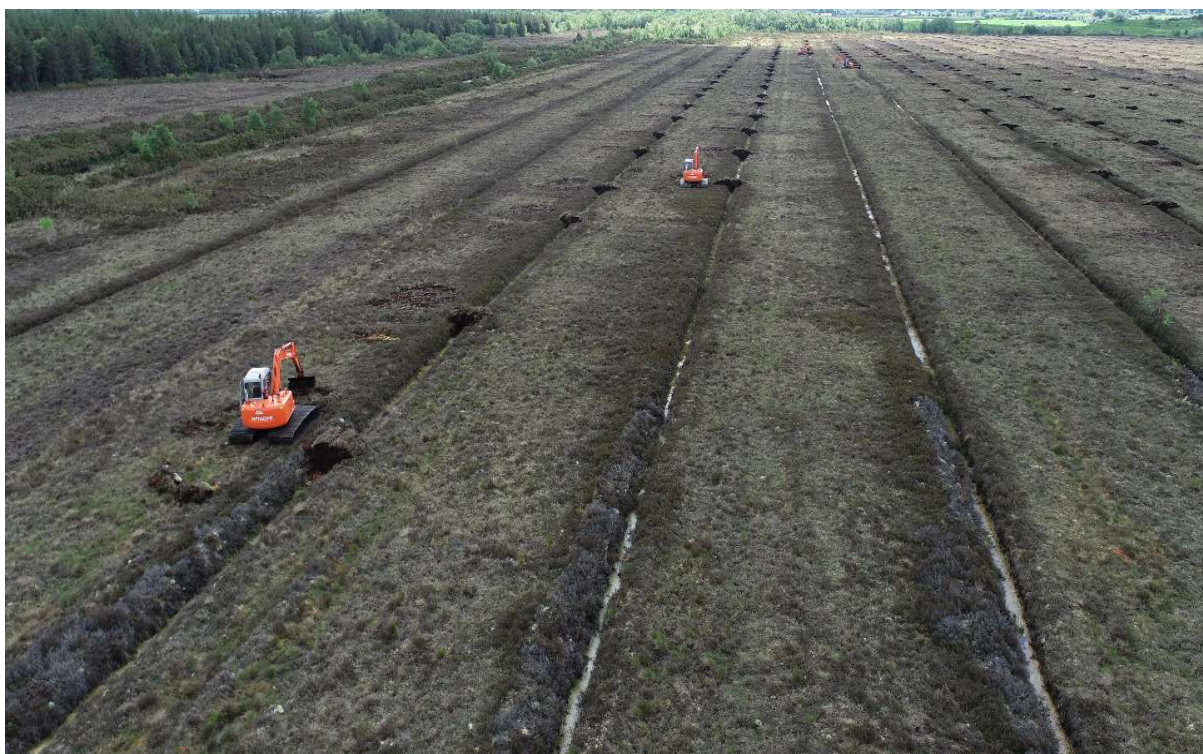
*Figure 1: Drain blocking being carried out at Kellysgrove*

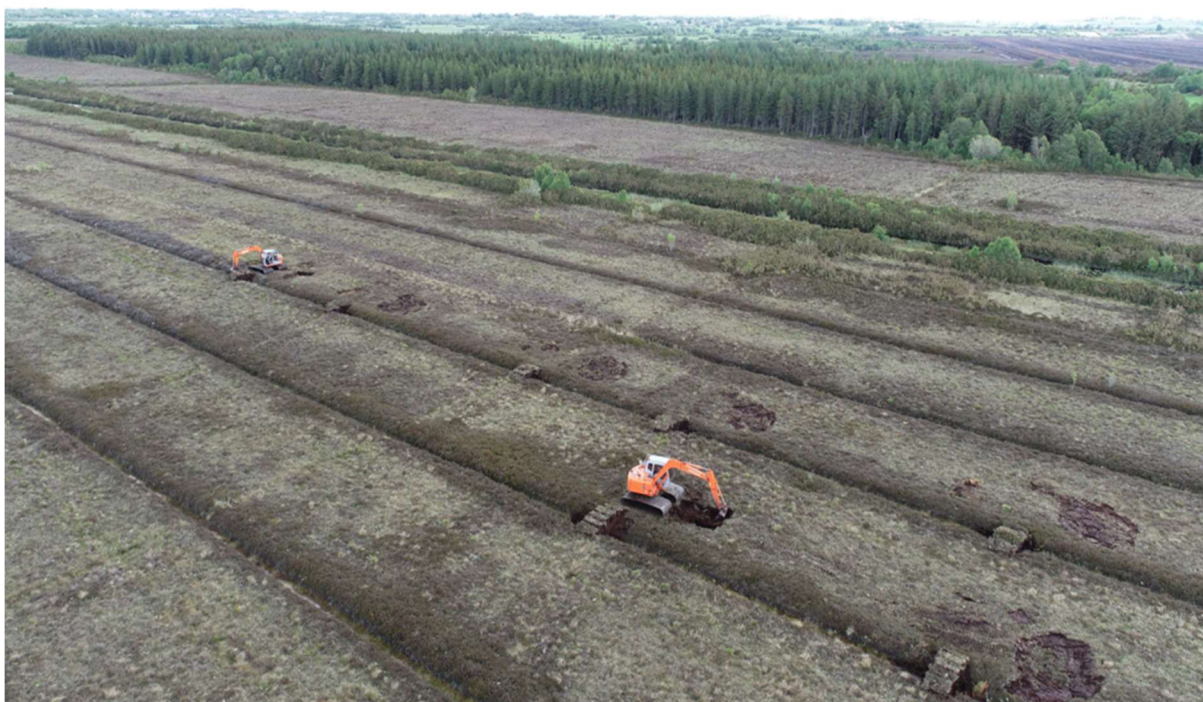
*Figure 2: Drain blocking being carried out at Kellysgrove*

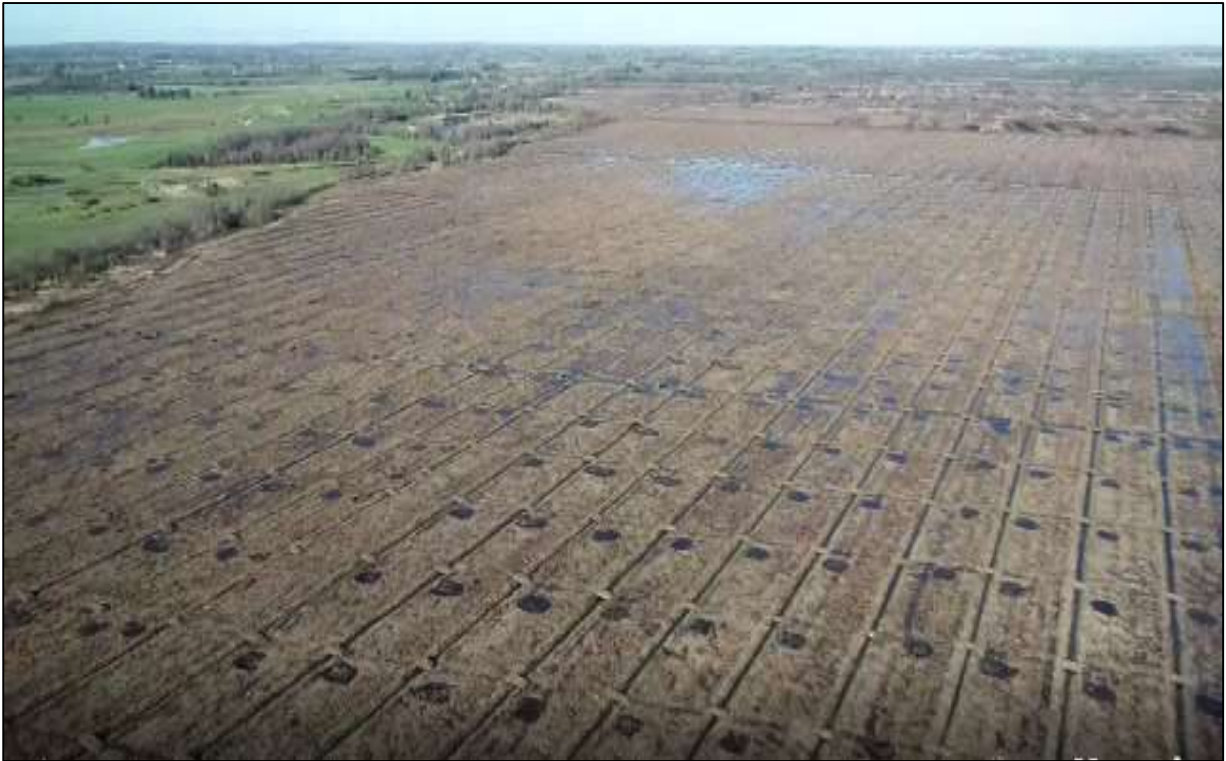
No quality or design non-conformance issues were identified during the inspection and verification process and the supervising Engineer formally signed off on the completed rehabilitation on September 30<sup>th</sup>, 2021.

*Figure 3: Aerial view of Kellysgrove Bog 4<sup>th</sup> March 2022*

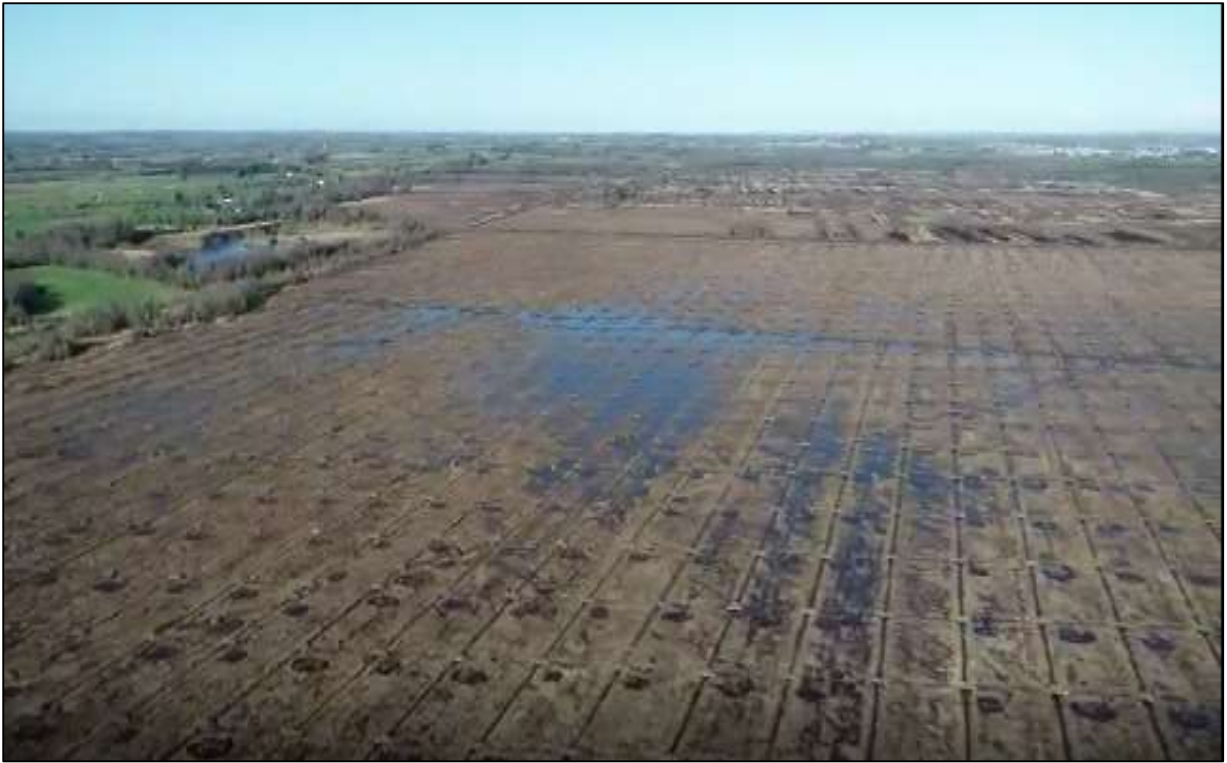
*Figure 4: Aerial view of Kellysgrove Bog taken 4<sup>th</sup> March 2022*
