# Mount Lucas Bog

## Cutaway Bog Decommissioning and Rehabilitation Plan 2021

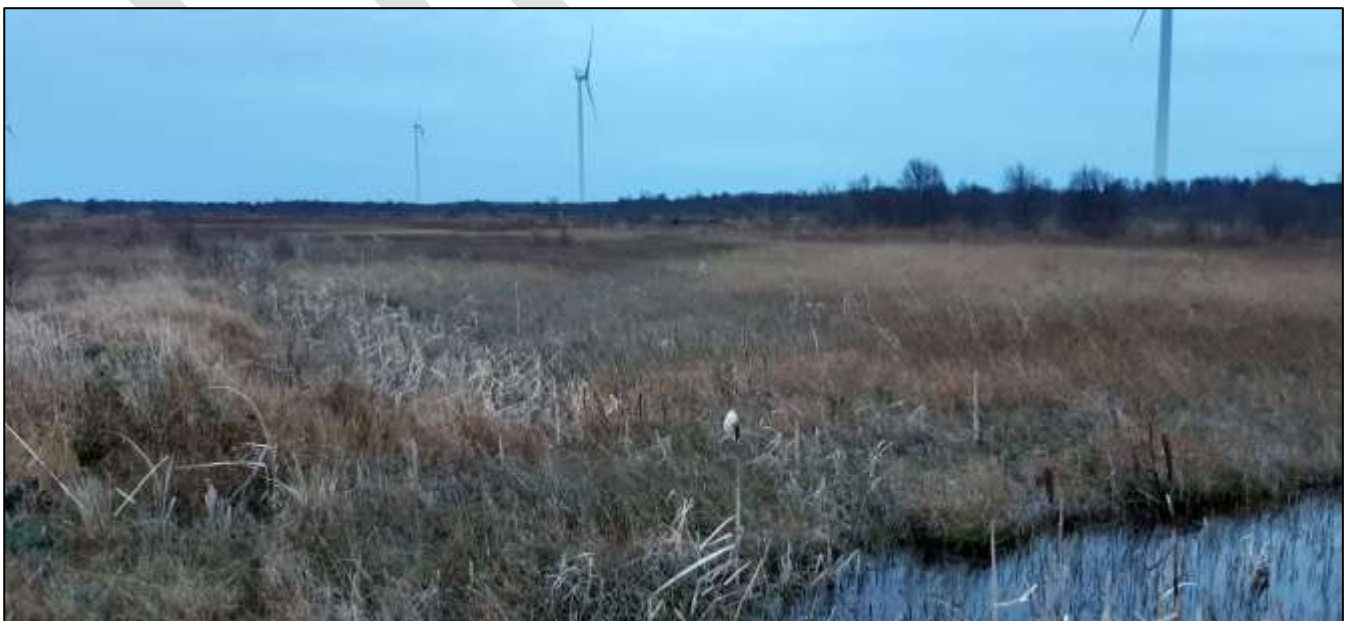
*Figure 3.3 Wetland vegetation at Mount Lucas (November 2020)*

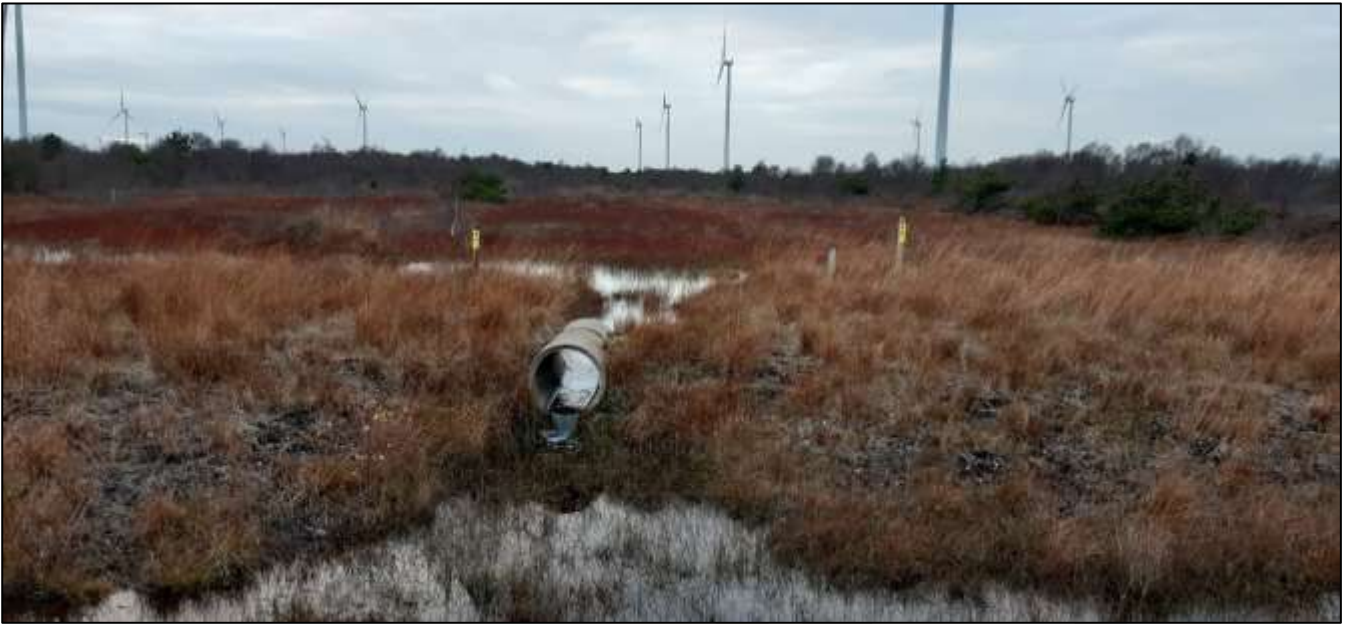
*Figure 3.4 Wetland habitats, pioneering Birch Woodland and scrub at Mount Lucas (November 2020)*

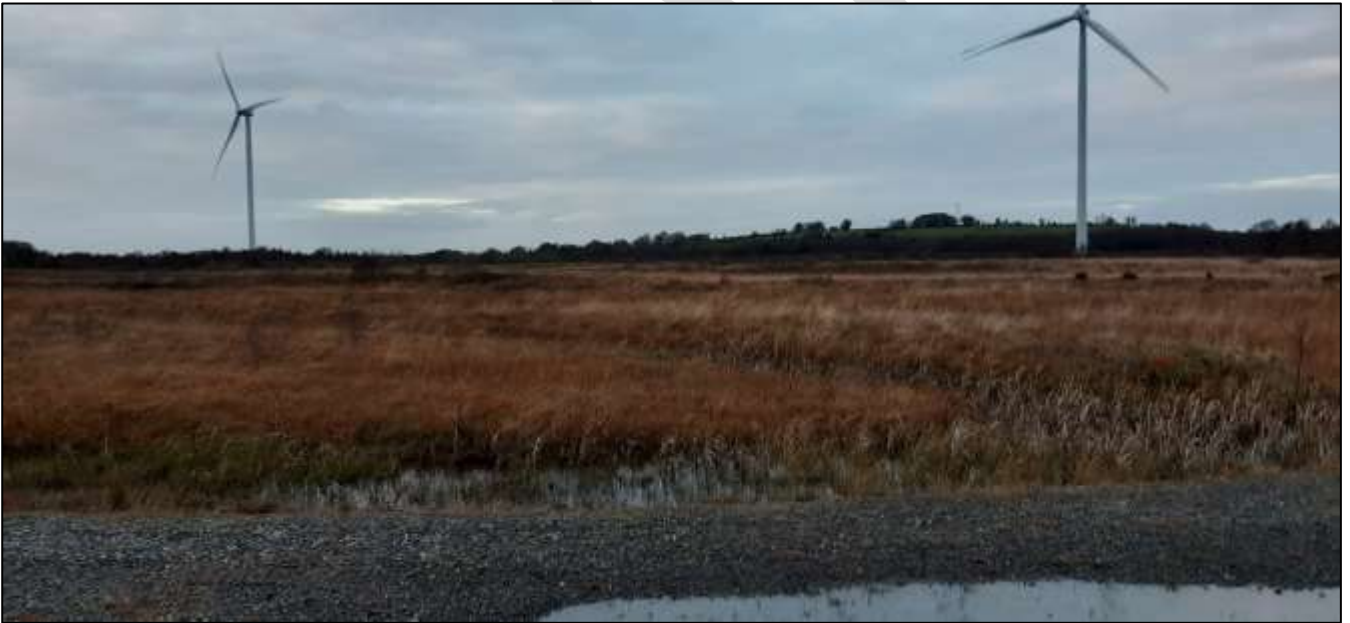
*Figure 3.5 Grassland and wetland vegetation at Mount Lucas Bog (November 2020)*

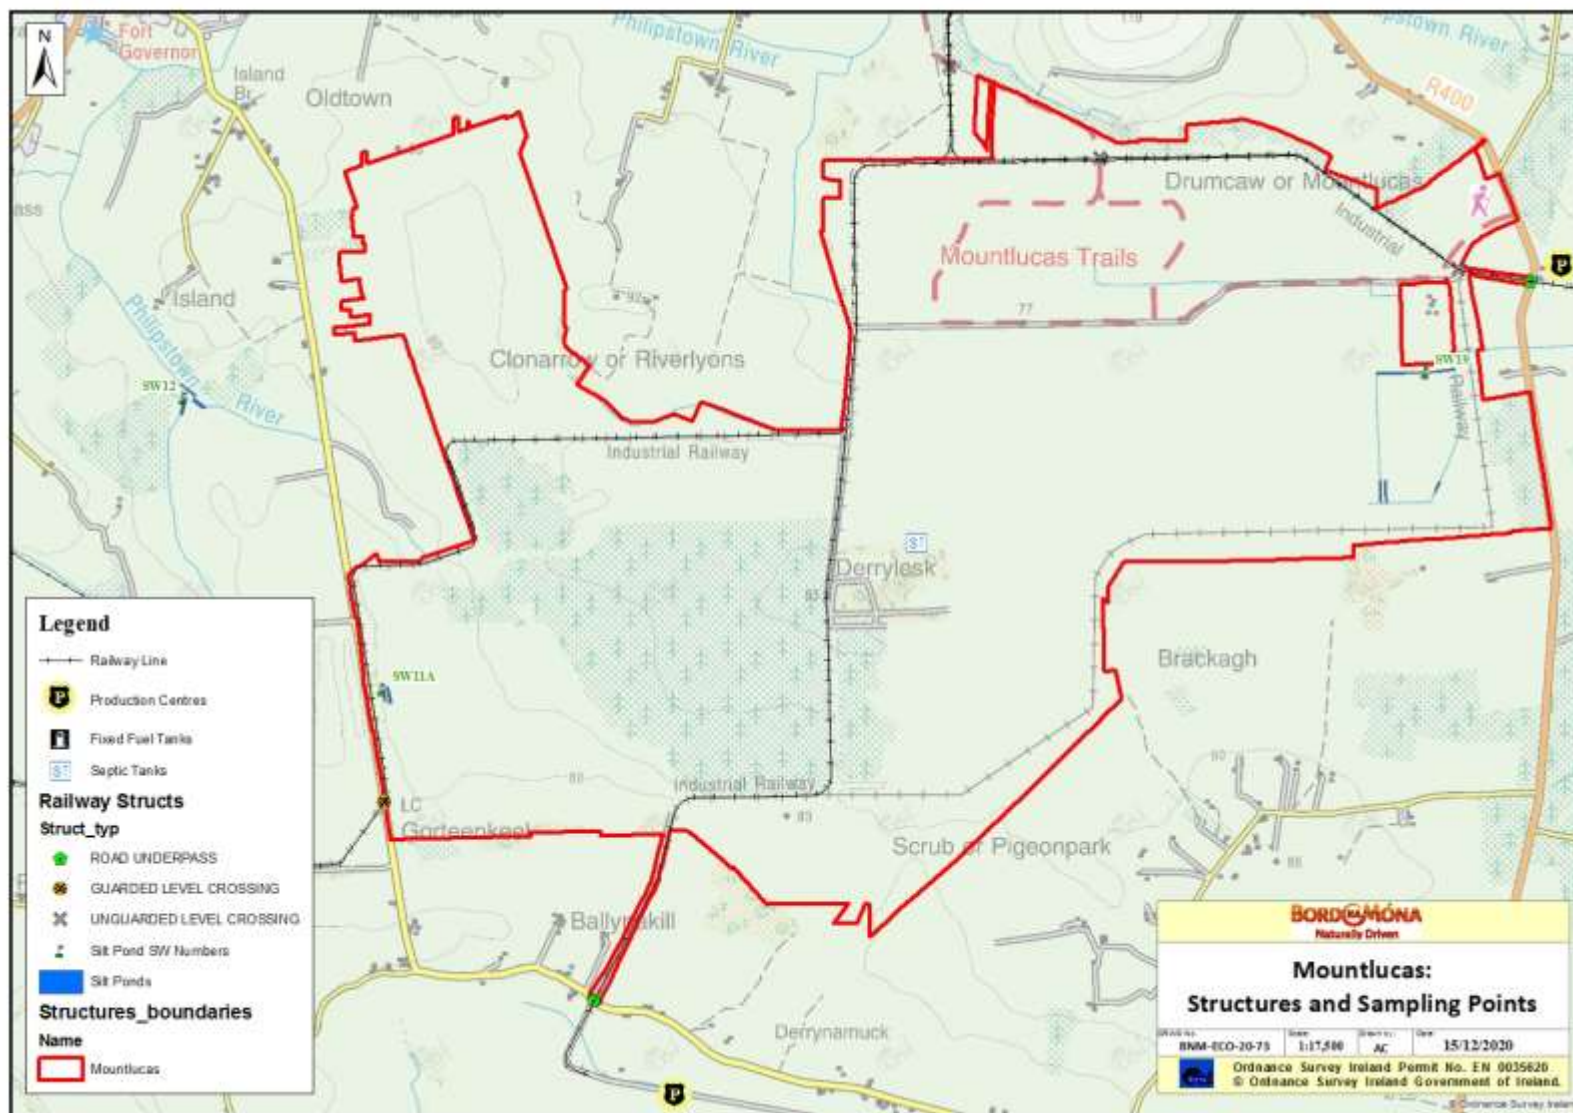
Figure 3.7. Map of Mountlucas Bog showing structures and designated emission points
