Cutaway Bog Decommissioning and Rehabilitation Plan

Natura Impact Statement

**Edera Bog,
Co. Longford**

May 2021

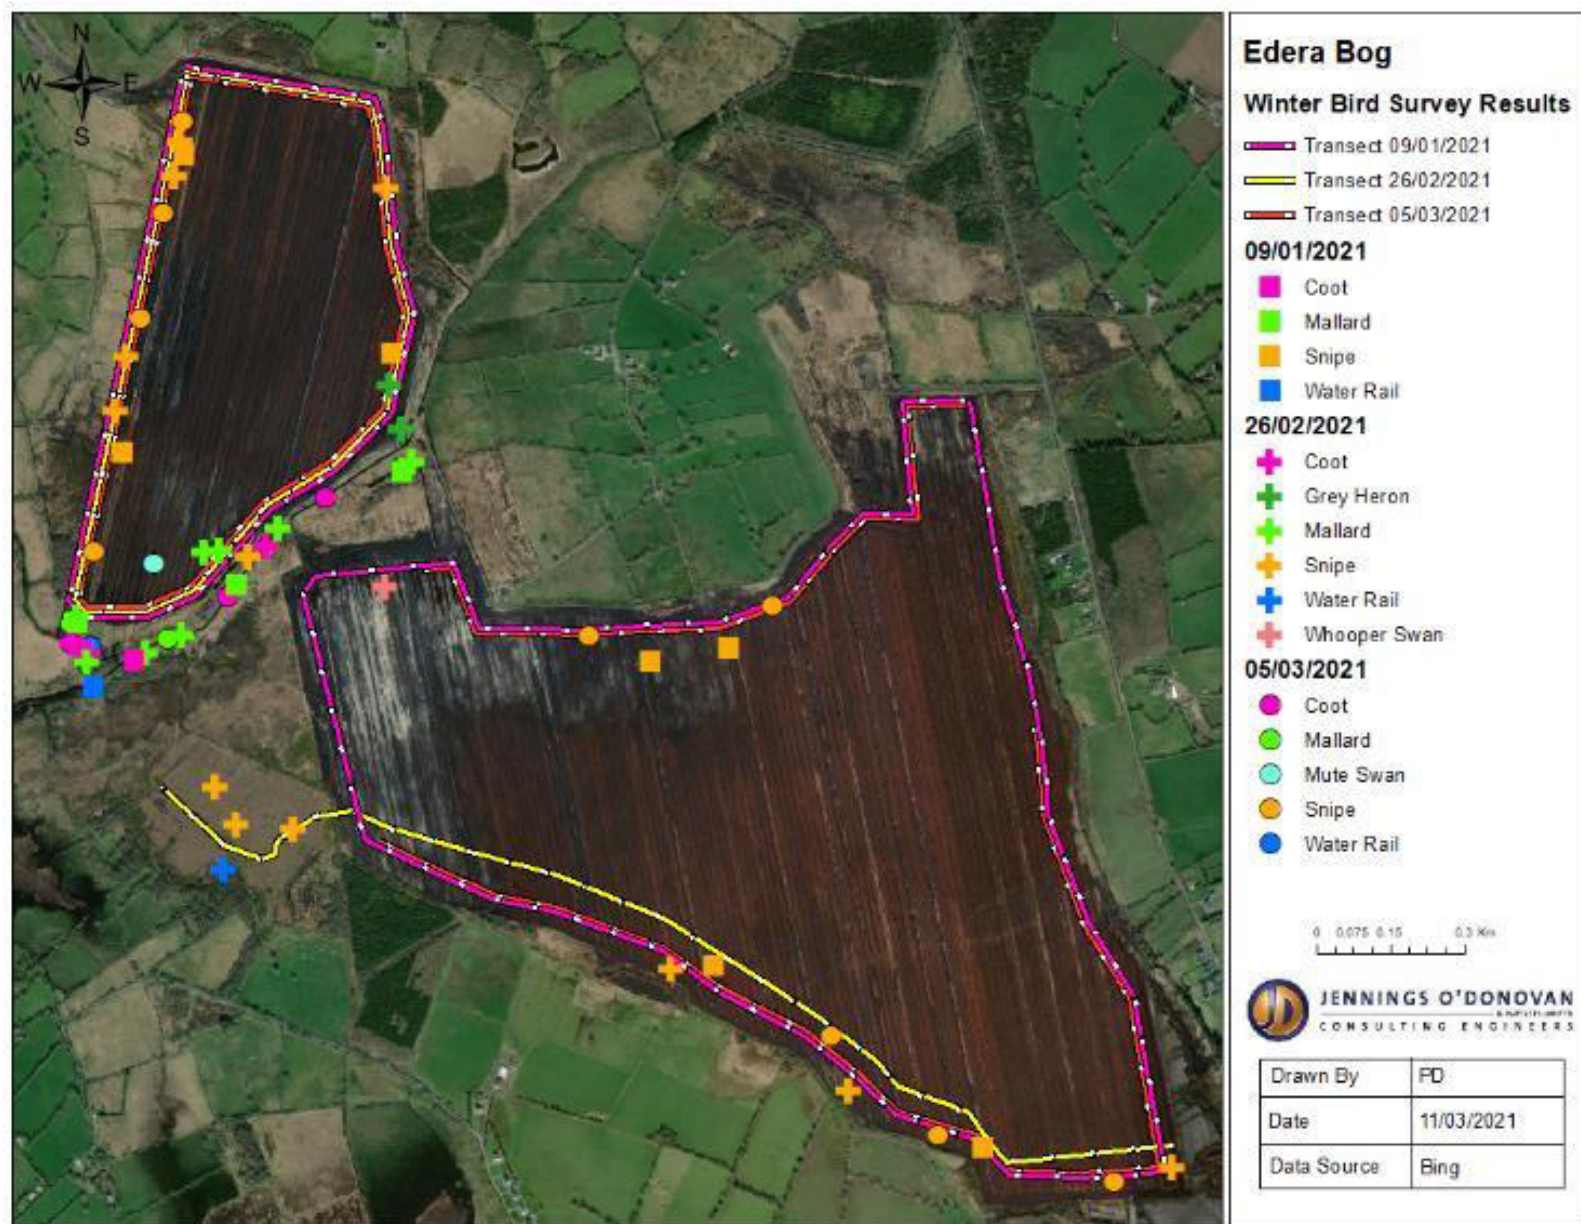
Figure 4: 2021 Winter Bird Survey Results

The locations of bird observations from the above surveys are presented in Figure 4.

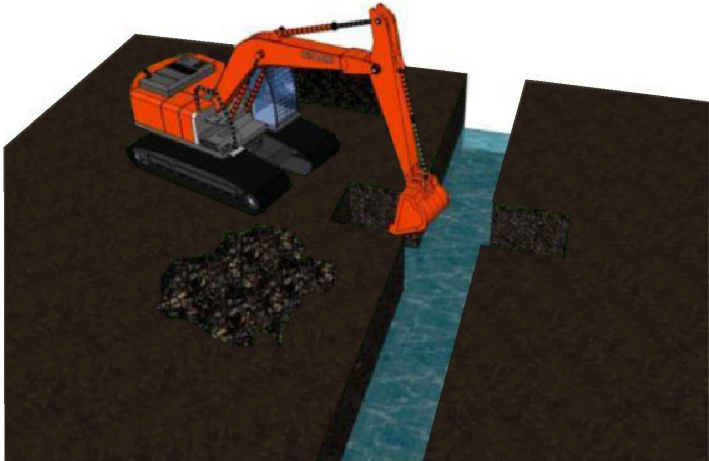
3. Open an area behind machine to be used as a borrow pit. Avoid using the surface layer of peat (top 100-200mm) which is likely to be very permeable. Only use the deeper, more compacted peat to build the drain block.
(If any vegetation present, it should be carefully removed and left aside for replacement at the end of the process.)

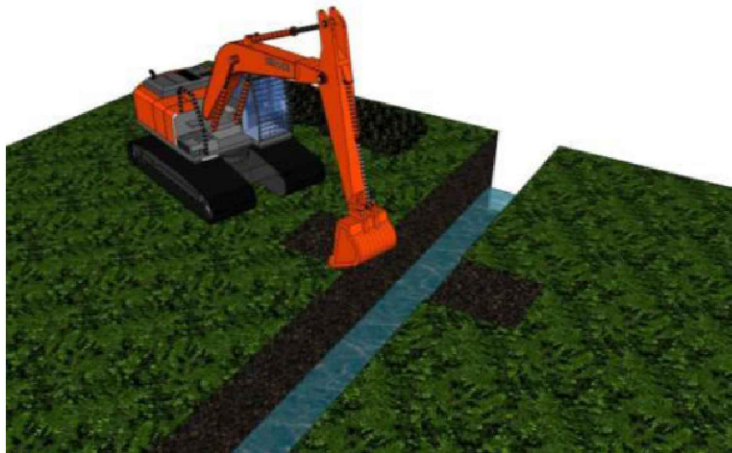
2. Cut key in either side of the drain approximately 500mm deep, and ensure that it is wider than the actual drain. Remove 500mm of peat from bottom of the drain also and place behind the machine for replacement later.

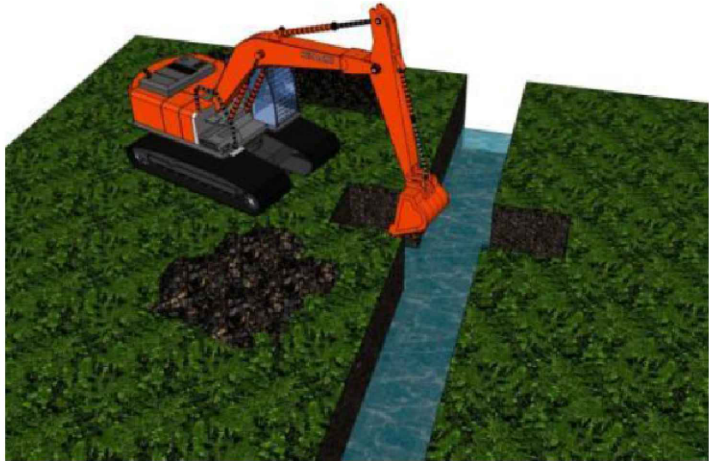
3. Open an area behind machine to be used as a borrow pit. Avoid using the surface layer of peat (top 100-200mm) which is likely to be very permeable. Only use the deeper, more compacted peat to build the drain block. Any vegetation should be carefully removed and left aside for replacement at the end of the process.

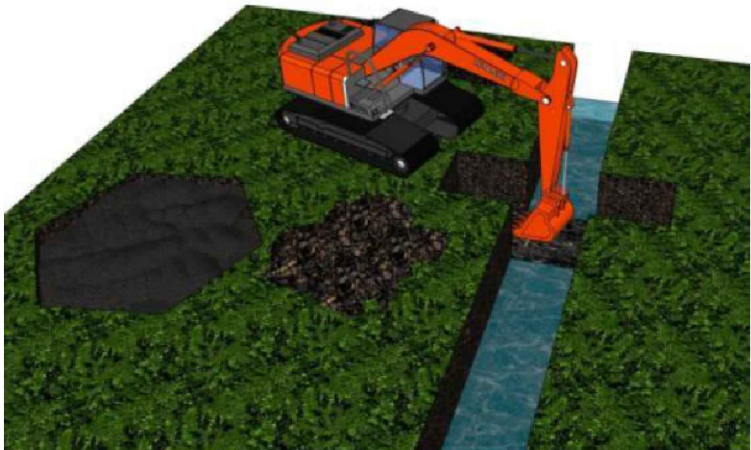
4. Dig out peat from the borrow pit and place into the drain compacting in 300mm layers. Compact the peat firmly using the excavator bucket before laying more peat from the borrow pit.

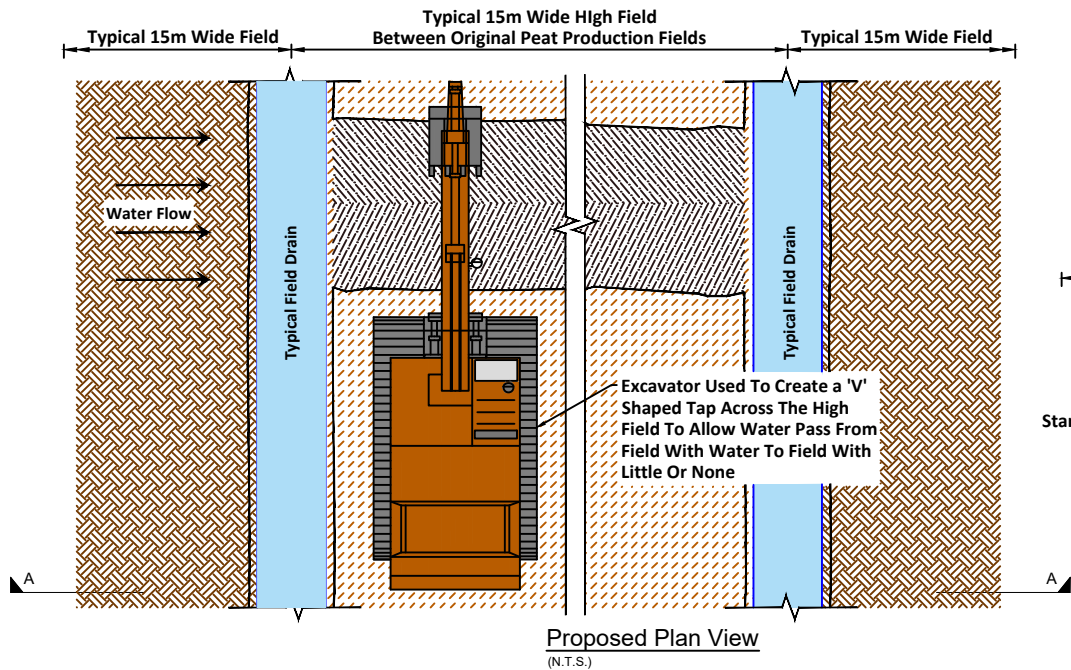
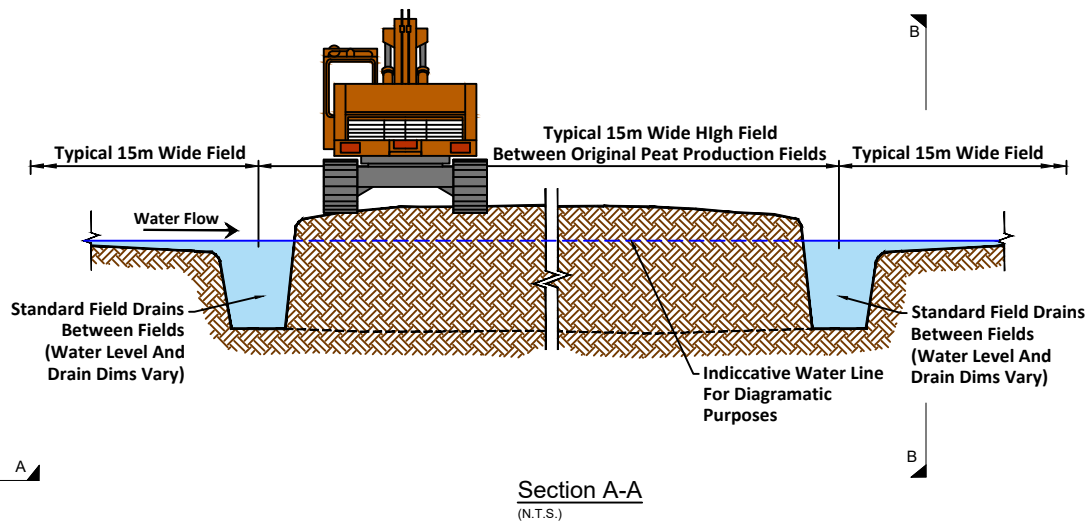
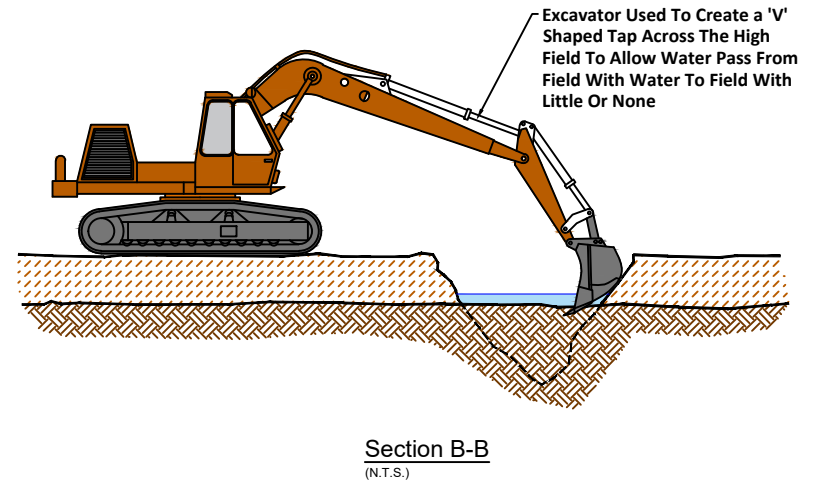
'V' Tap Across High Field To Control Water Levels

Blocking Of Outfall

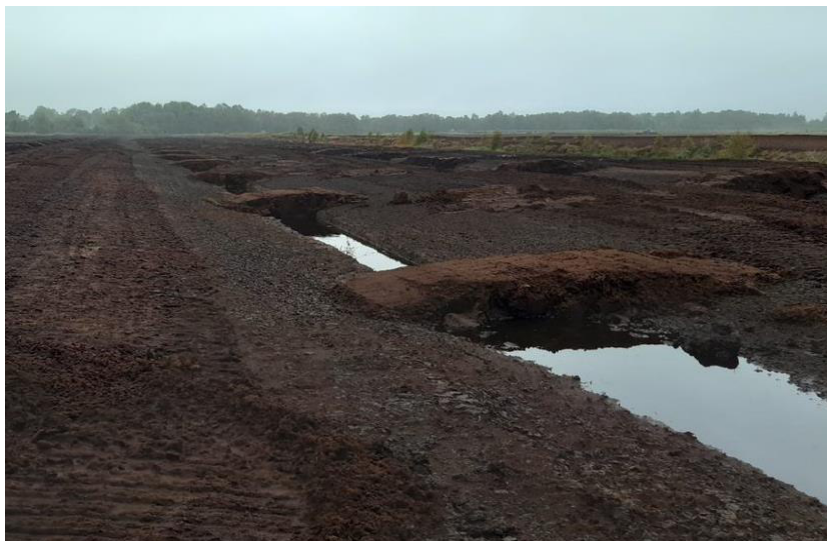
Figure 5.1.1 Peat drain block trials at Castlegar bog

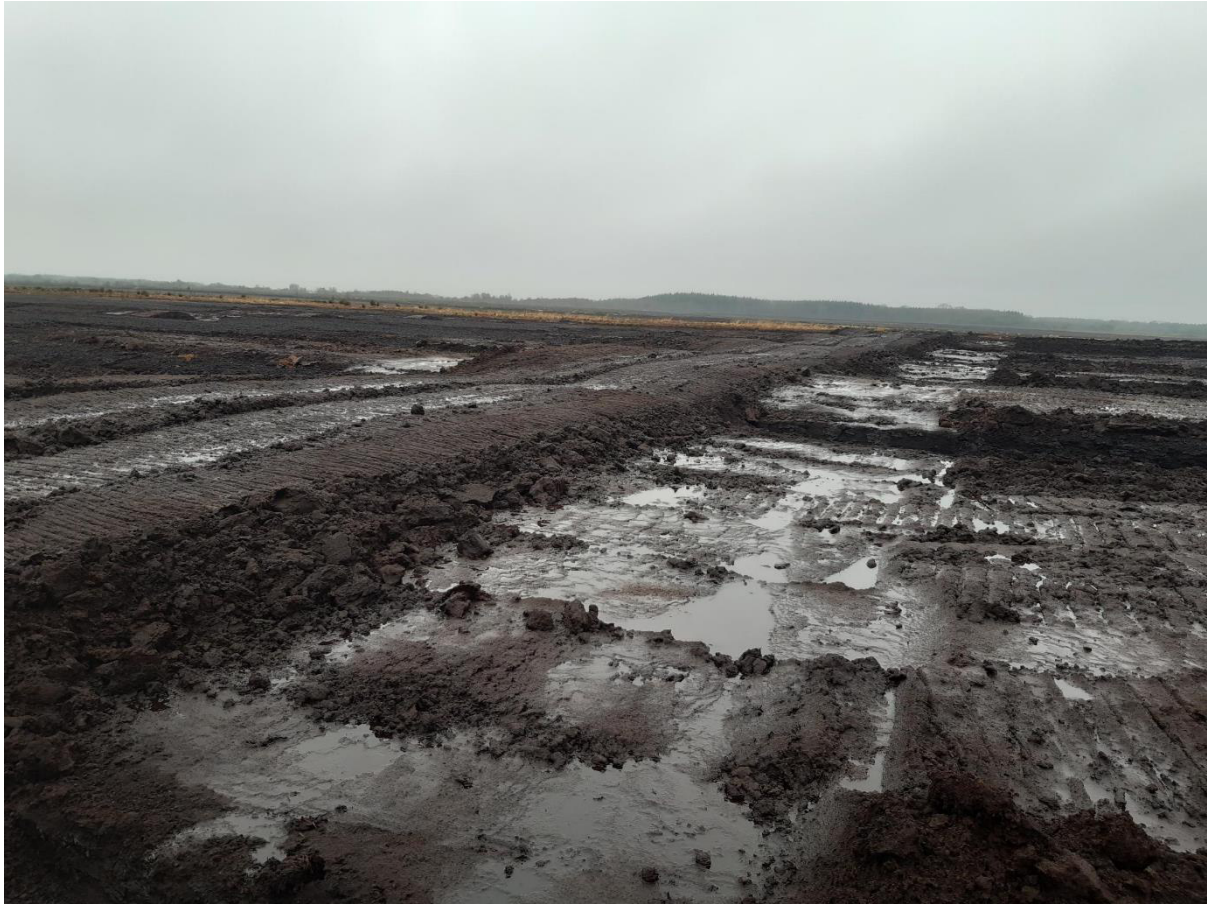
Figure 5.2.1 Peat Berm at Castlegar Bog

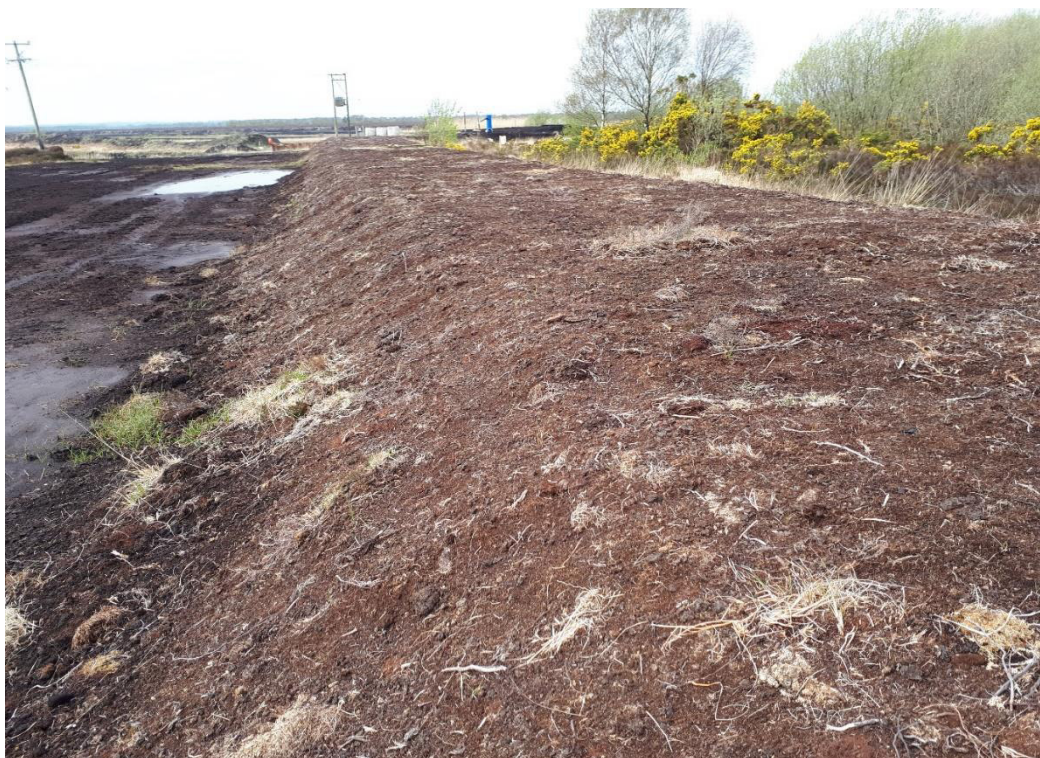
Figure 5.3.1 Garryduff 1 Flood Defence Berm,

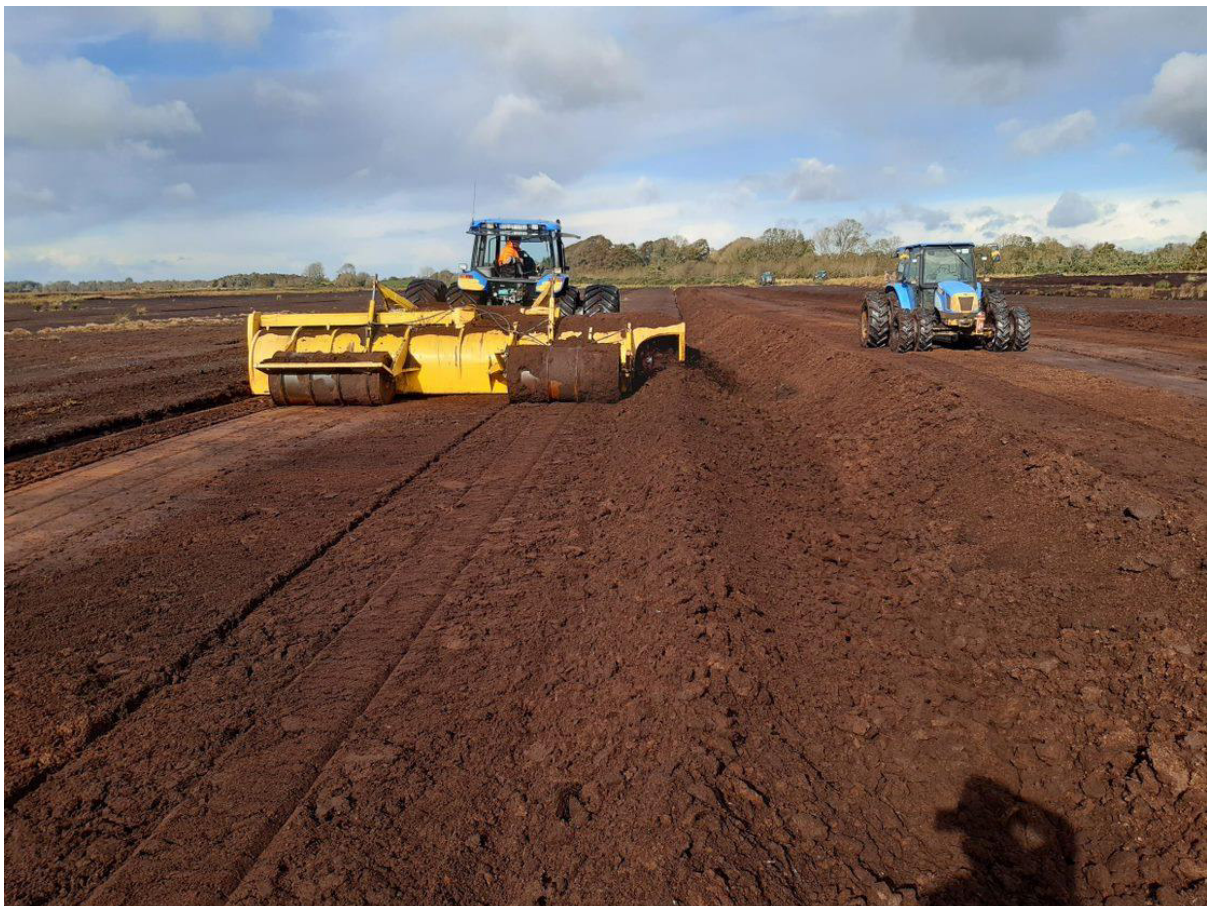
Figure 5.5.1 Field re-profiling using Screw-Leveller

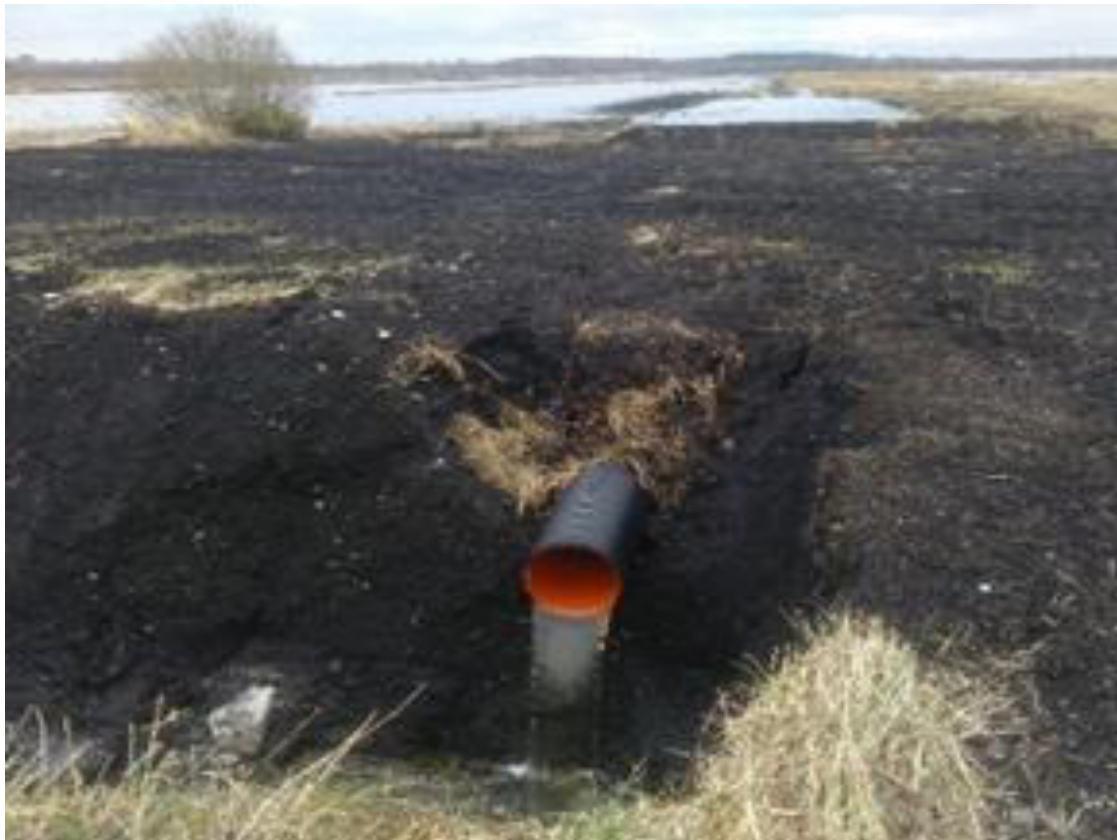
Figure 5.6.3.1 Raised water outlet at Cavemount
