Cutaway Bog Decommissioning and Rehabilitation Plan

Screening Report for Appropriate Assessment

Belmont Bog

Co. Offaly

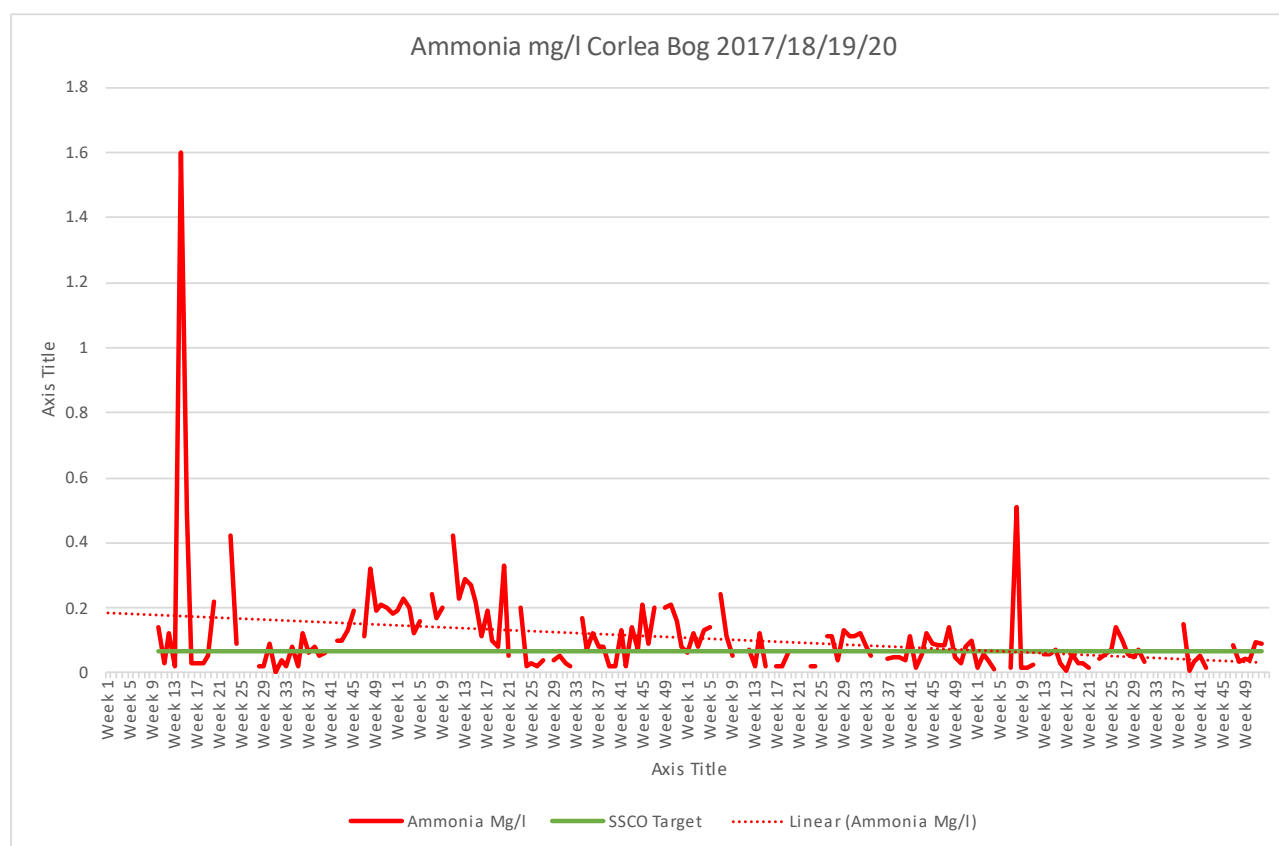
**Graph 1: Ammonia Concentrations and Trend at Corlea Bog**

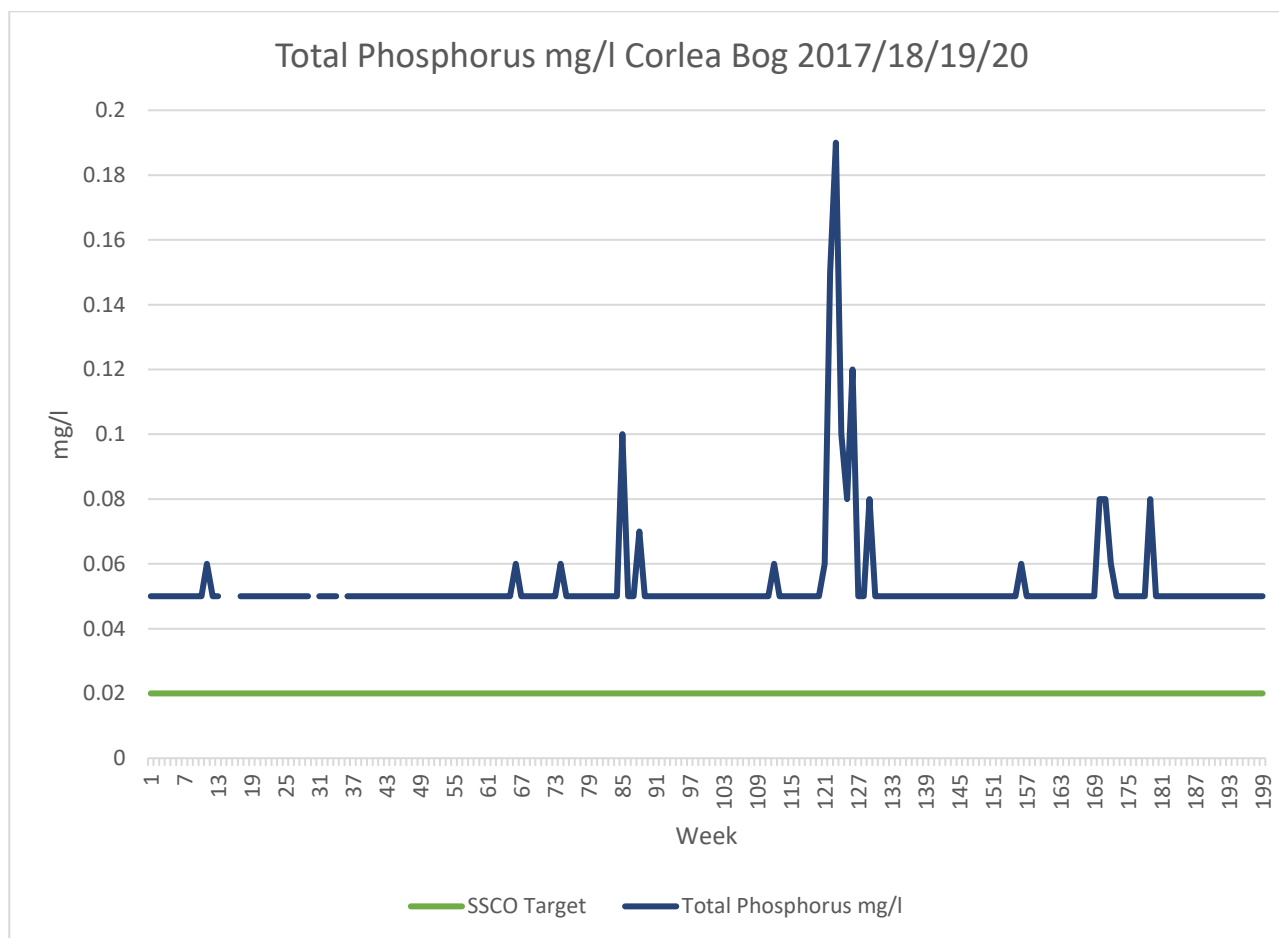
**Graph 2: TP Concentrations at Corlea Bog, showing the limit of detection at 0.05mg/l**

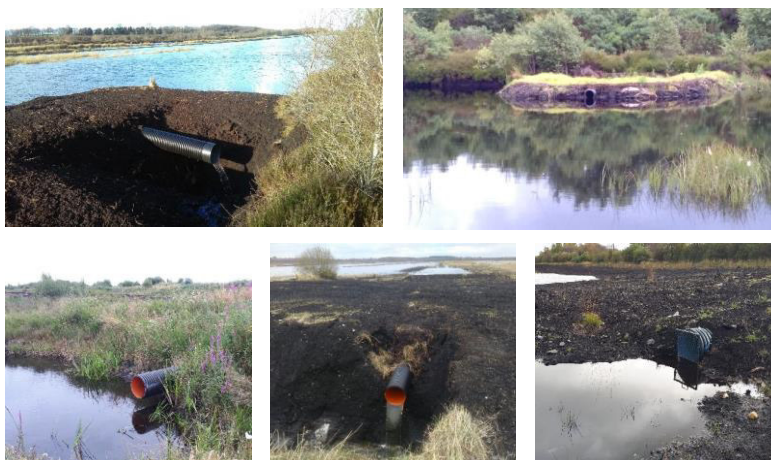
Plate 1: Examples of installed overflow pipes

Overflow pipes are installed using an excavator.

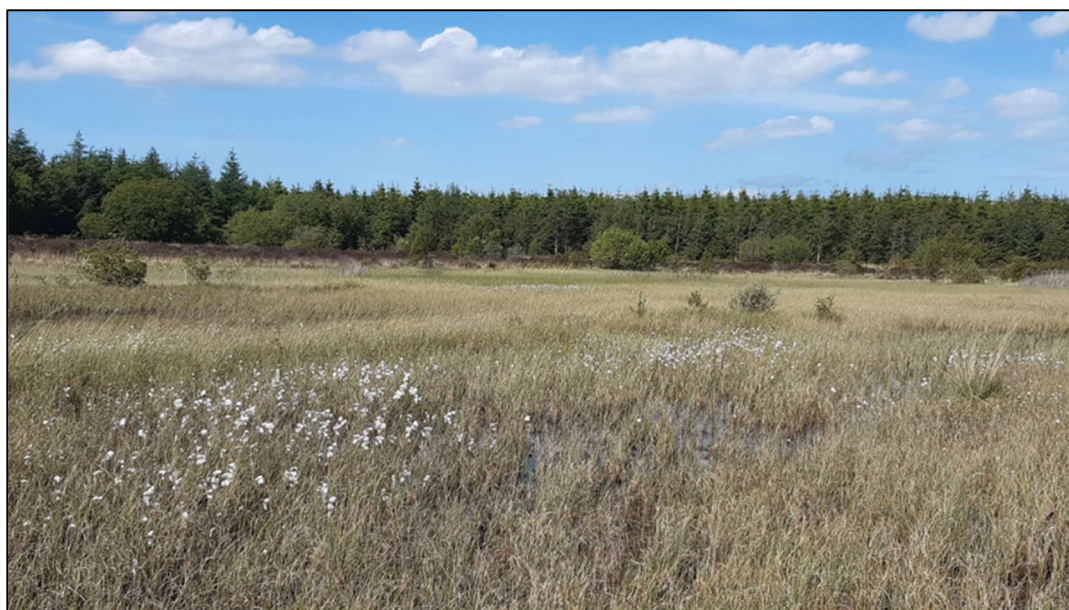
Figure 3.5 View of Pioneering Fen forming Habitat Belmont Bog (2020)

In May 2020, a site visit by BNM ecologists confirmed the presence of fen-forming habitats in the NW section of Belmont, with indicator species such as Black Bog Rush *Schoenus nigricans*, Common Butterwort *Pinguicula vulgaris* and Lustrous Bog-moss *Sphagnum subnitens* present.

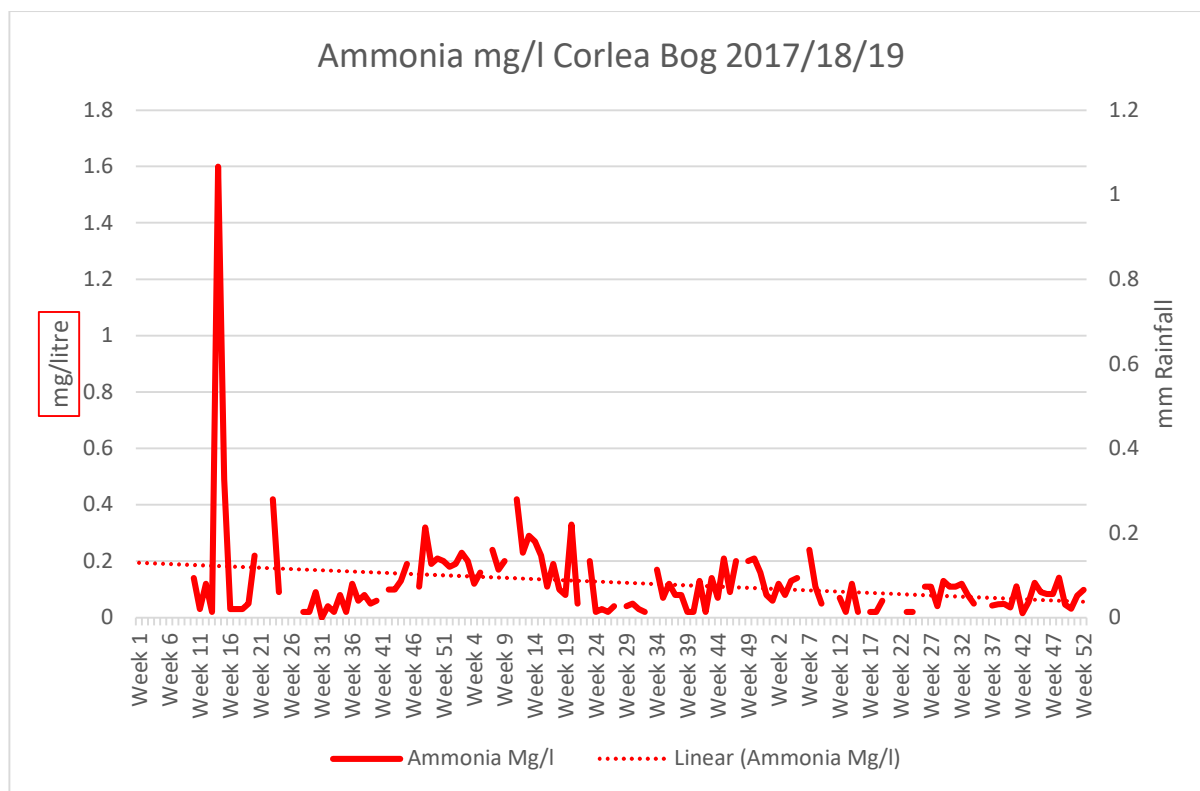
Figure 7.1. Ammonia levels over the period 2015-2019 at Longfordpass and Corlea.

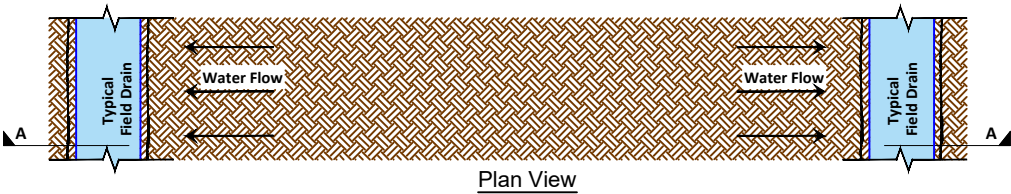
Phase 1
Drain Blocking

(NOTE: If any vegetation present, it should be carefully removed at the start and left aside for replacement at the end of the process, to help bind and stabilise the top of the drain block.)
Drain blocks are constructed using an Excavator operating at a perpendicular direction to the field drains. Key is cut in the drain approximately 500mm deep, and ensuring that it is wider than the actual drain. 500mm of peat is removed from bottom of drain also and placed behind the machine for replacement later. Area behind the machine is to be used as a borrow pit. Remove turf and degraded peat. Place this material close by to be used as cover later. 'Clay' like peat is extracted from pit and compacted in 300mm layers using the excavator bucket. The peat is firmly compacted using the machine bucket before laying more peat from the borrow pit. The drain block is built up at least 300-500mm above the ground level of the bog to allow for subsequent shrinkage of the peat as it dries. The borrow pit is back filled with the peat extracted from the bottom of drain. The sides of the borrow pit are to be pressed down and graded with the excavator bucket.

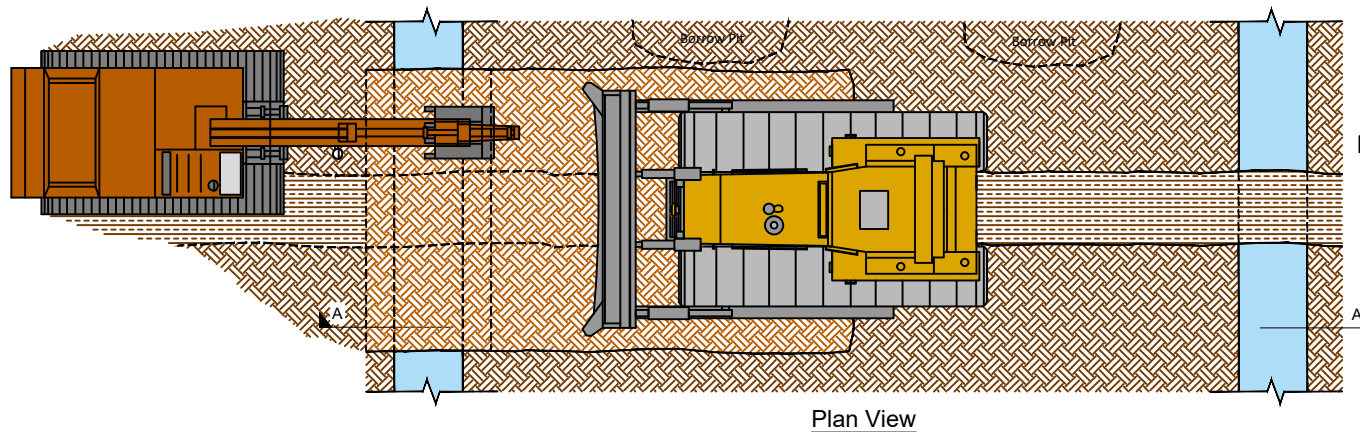
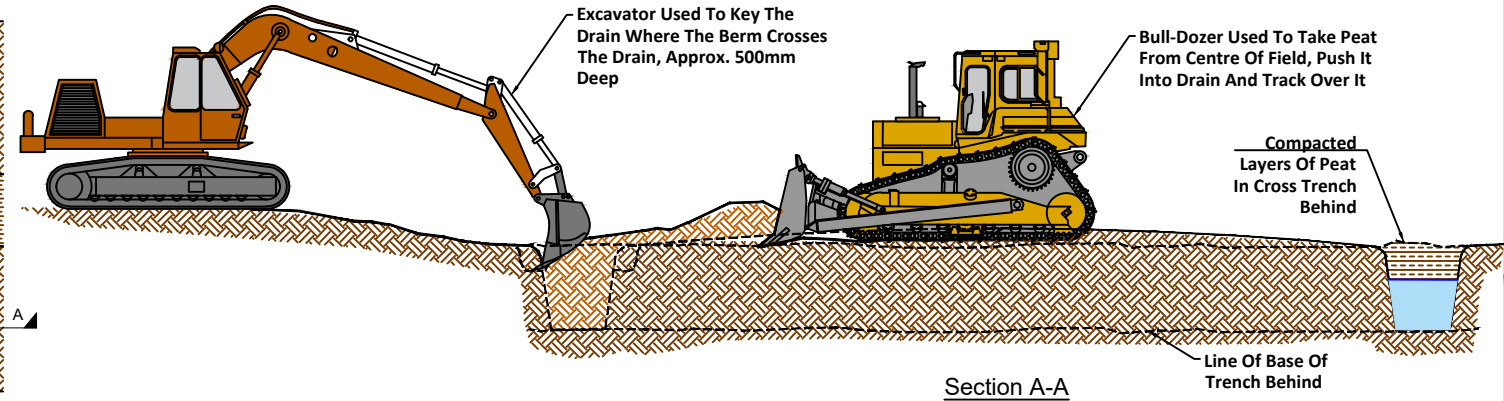
An Excavator is used to form a key(5m long) in the drain's edges where the berm crosses.
A strip of peat(5m wide) is taken from the central camber of the field, pushed into the drain and compacted by the bull-dozer tracking over the drain block.

Next the bull-dozer is used to complete the central cross section of Berm by taking peat from the centre of the field and pushing it in line with the field to form an approximately 5m Wide x 1m High Cross Berm.

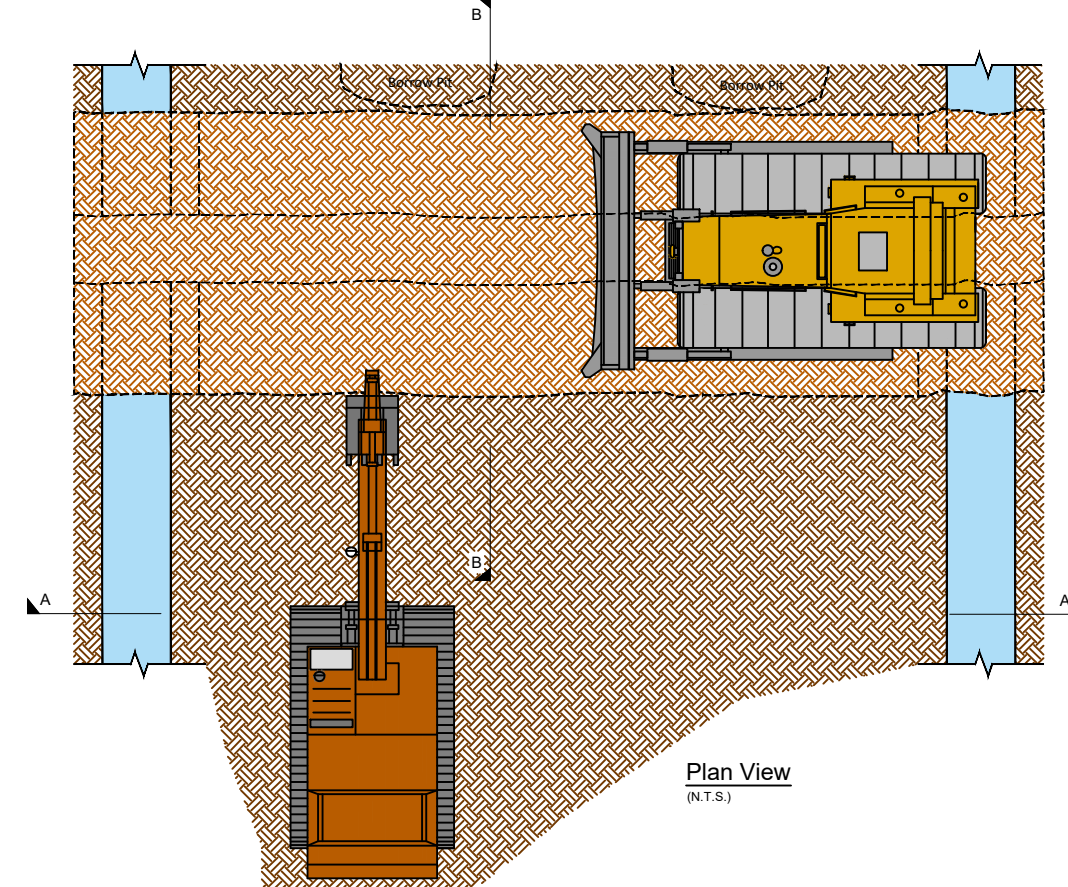
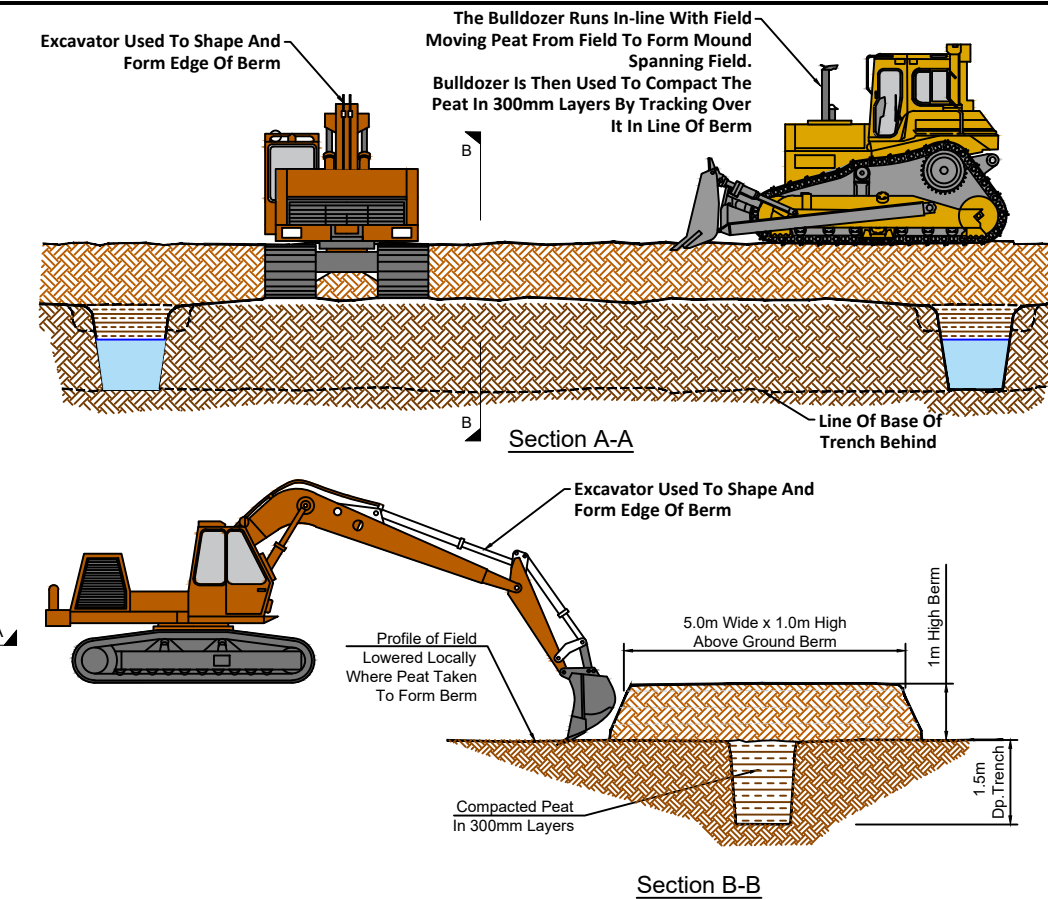
The excavator bucket is used to form and shape the edges of the compacted berm.

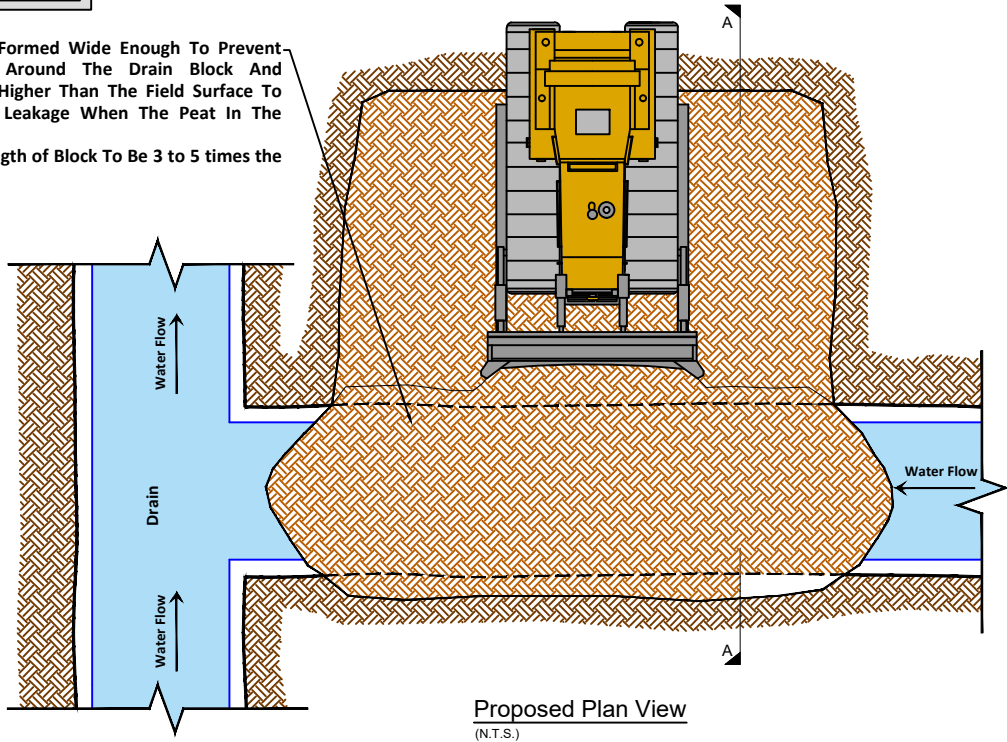
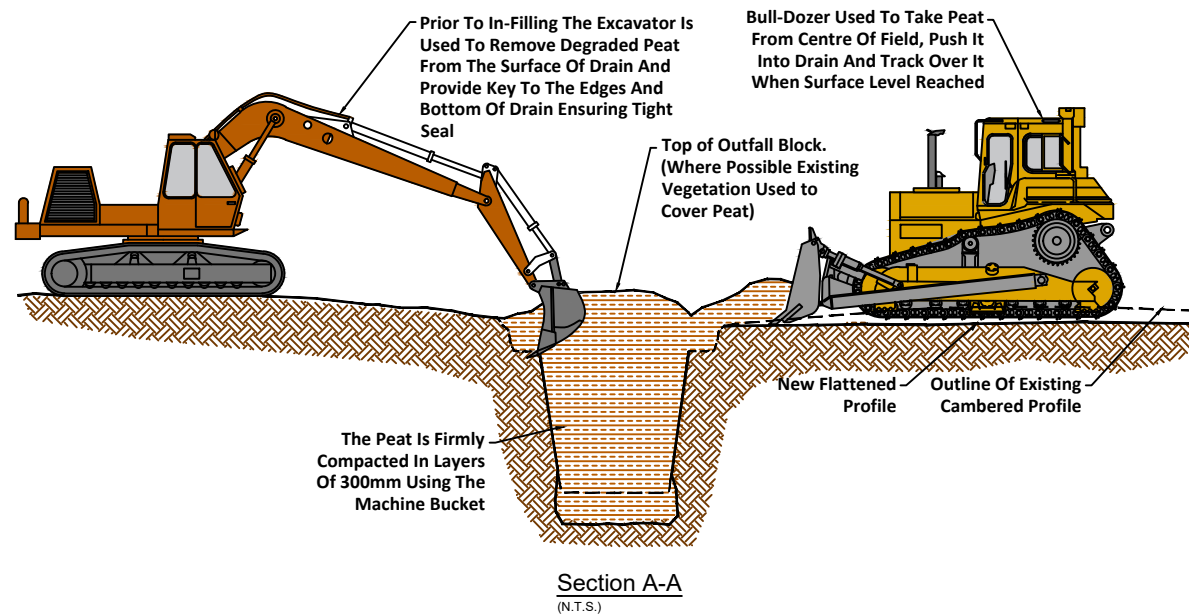
Blocking Of Outfall

The Blocks Are Formed Wide Enough To Prevent Water Moving Around The Drain Block And 300mm-500mm Higher Than The Field Surface To Prevent Further Leakage When The Peat In The Blocks Subsides.
Approximate Length of Block To Be 3 to 5 times the Width Of Drain

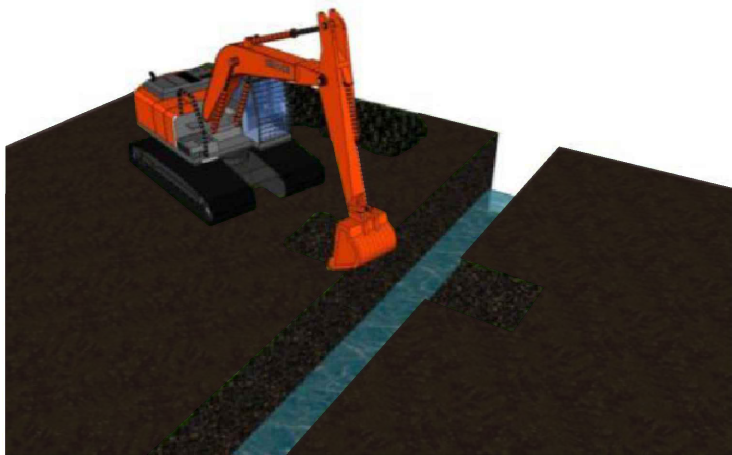
1. Before building of drain blocks, the sides and bottom of the ditch is cleaned using the excavator to remove dry degraded peat, to ensure a good peat-to-peat contact.
(If any vegetation present, it should be carefully removed and left aside for replacement at the end of the process.)

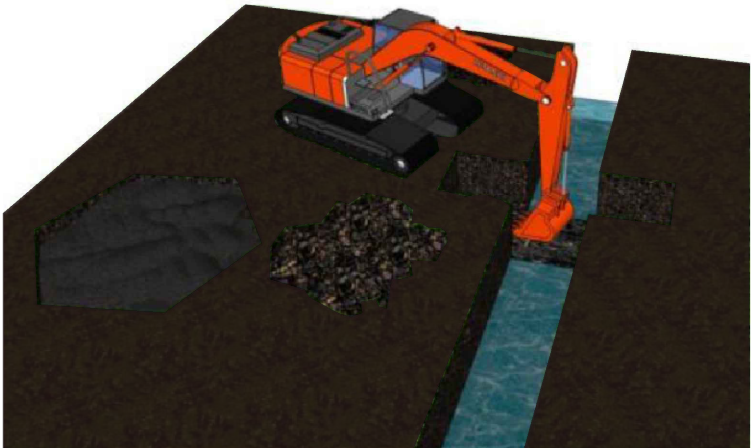
3. Open an area behind machine to be used as a borrow pit. Avoid using the surface layer of peat (top 100-200mm) which is likely to be very permeable. Only use the deeper, more compacted peat to build the drain block.
(If any vegetation present, it should be carefully removed and left aside for replacement at the end of the process.)

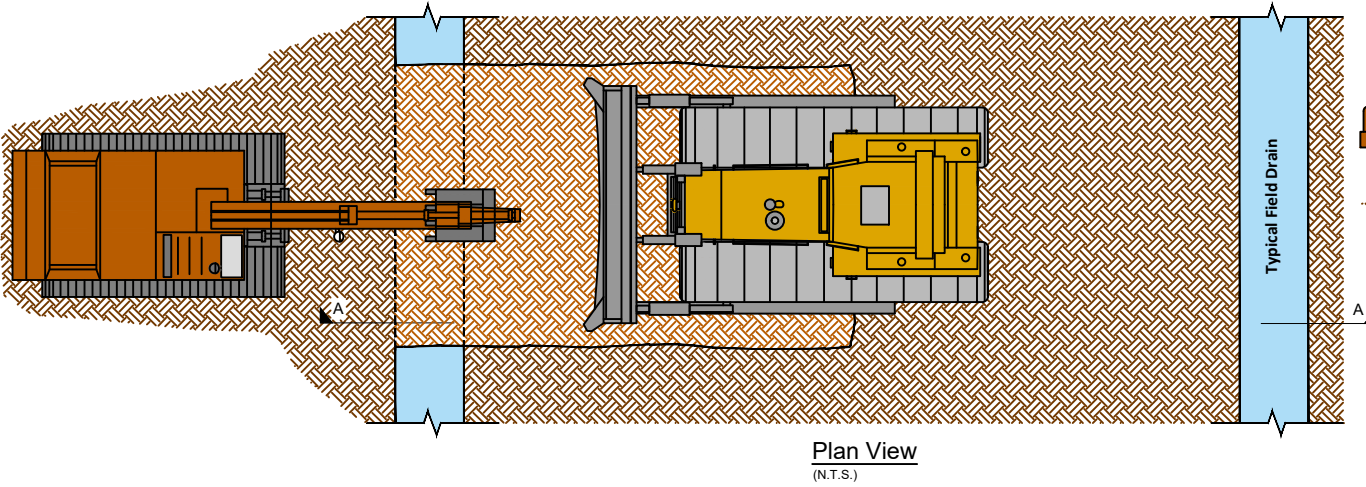
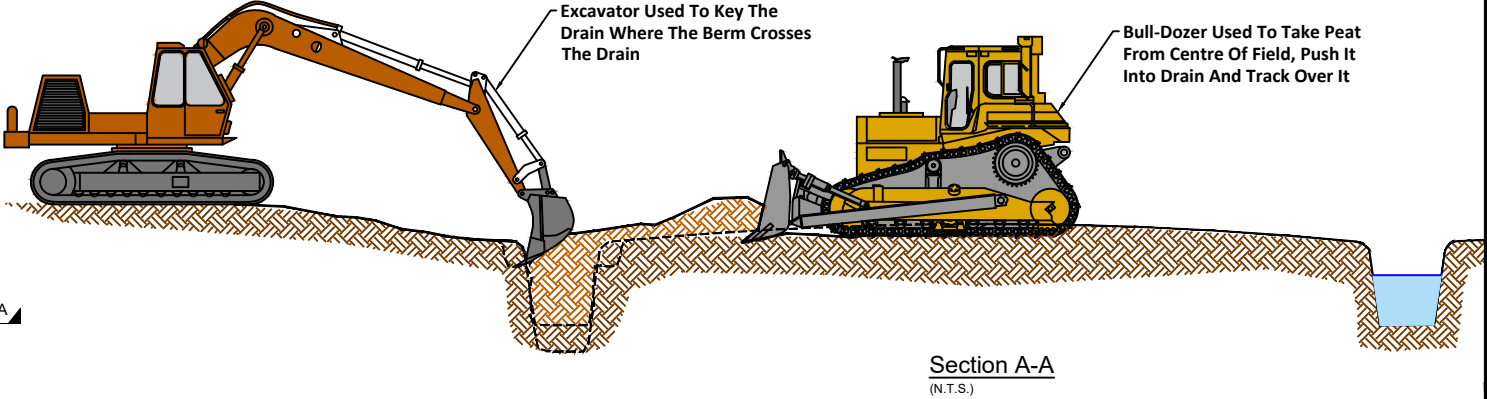
An Excavator is used to form a key in the drain where the berm crosses. A strip of peat is taken from the central camber of the field, pushed into the drain and compacted by the bull-dozer tracking over the drain block.

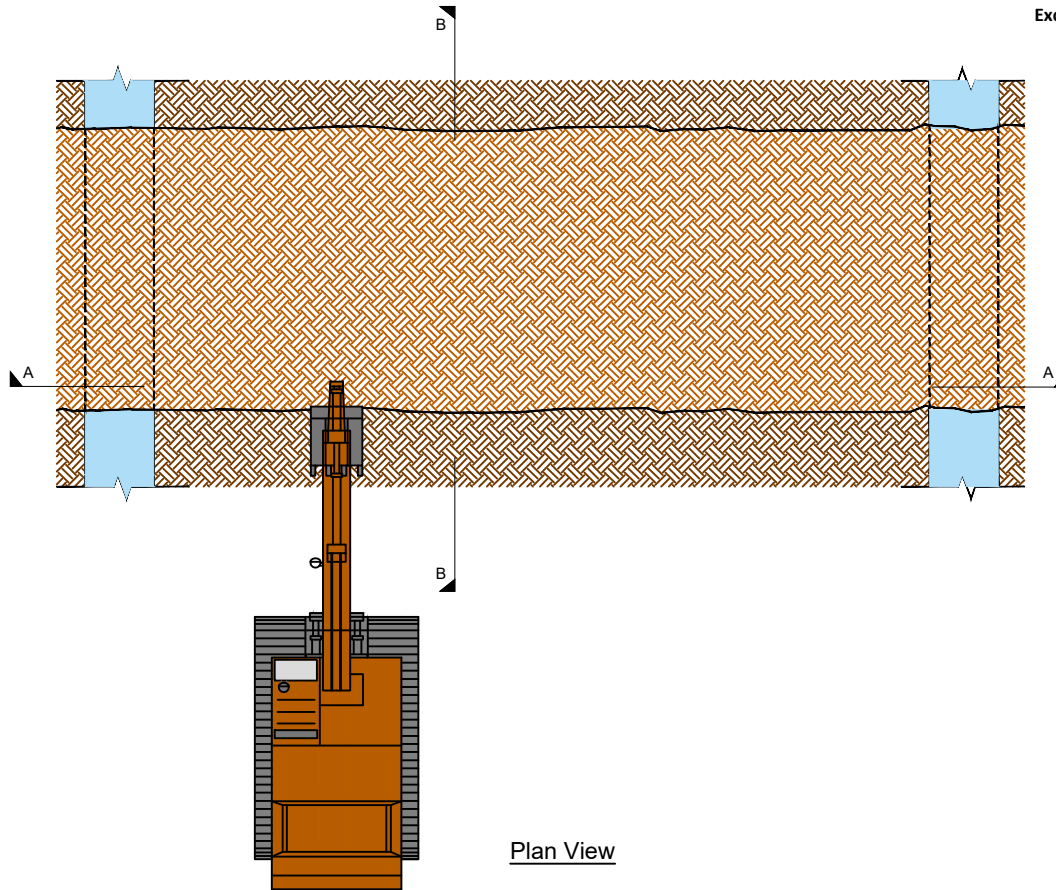
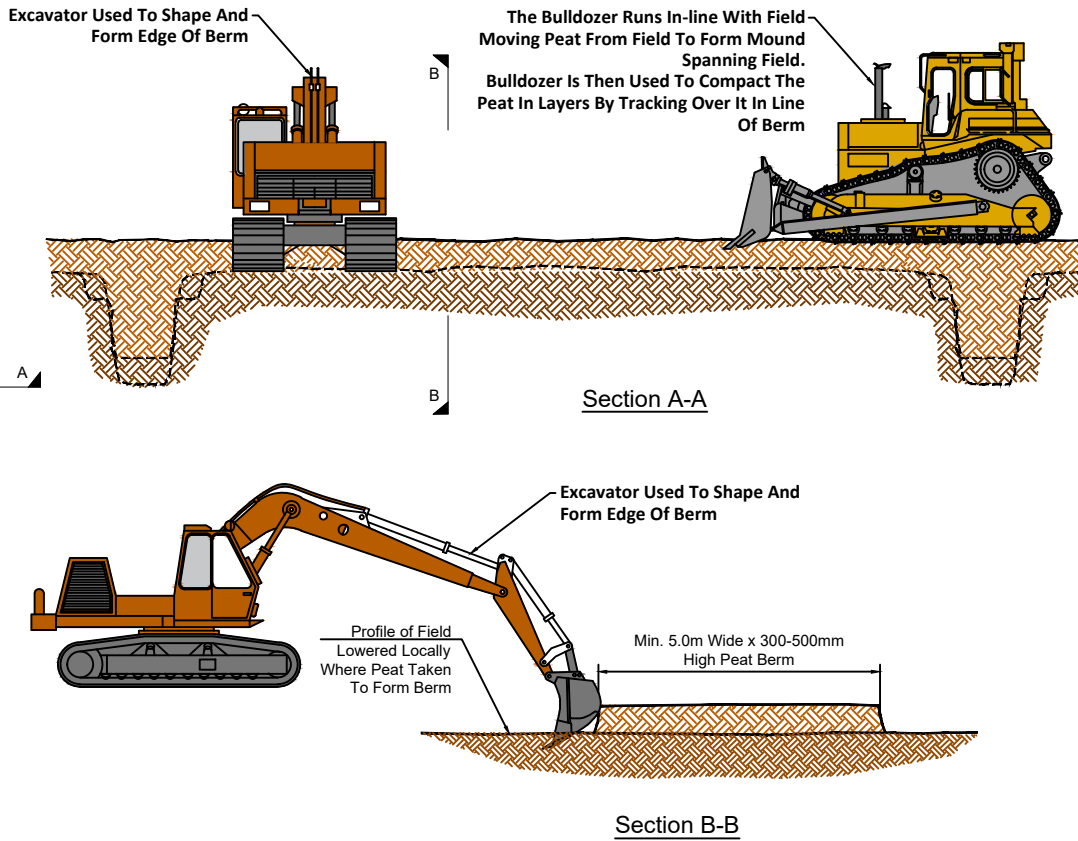
Phase 2 Forming Peat Berm

Next the bull-dozer is used to complete the central cross section of Berm by taking peat from the centre of the field and pushing it in line with the field to form a minimum 5m Wide x 300-500mm High Cross Berm. The peat material in the berm is compacted in layers by the dozer tracking over it. The excavator bucket is used to form and shape the edges of the compacted berm.

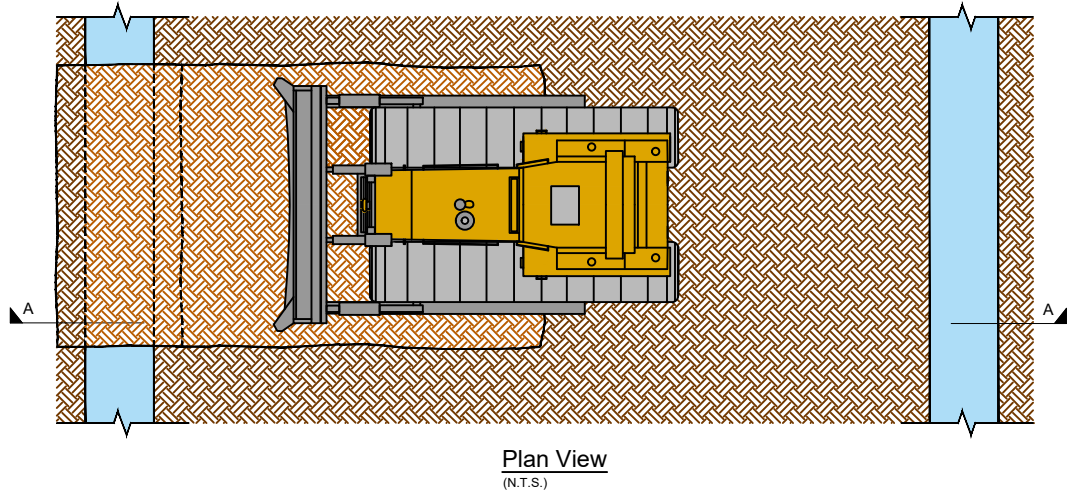
The Bull-dozer is used to create a 5m Length key along both edges of the drain, approximately 500mm Wide x 500mm Deep. Next a strip of peat is taken from the central camber of the field, pushed into the drain and compacted by the bull-dozer tracking over the drain block, to form an approximately 5m Wide 'Speed Bump'.

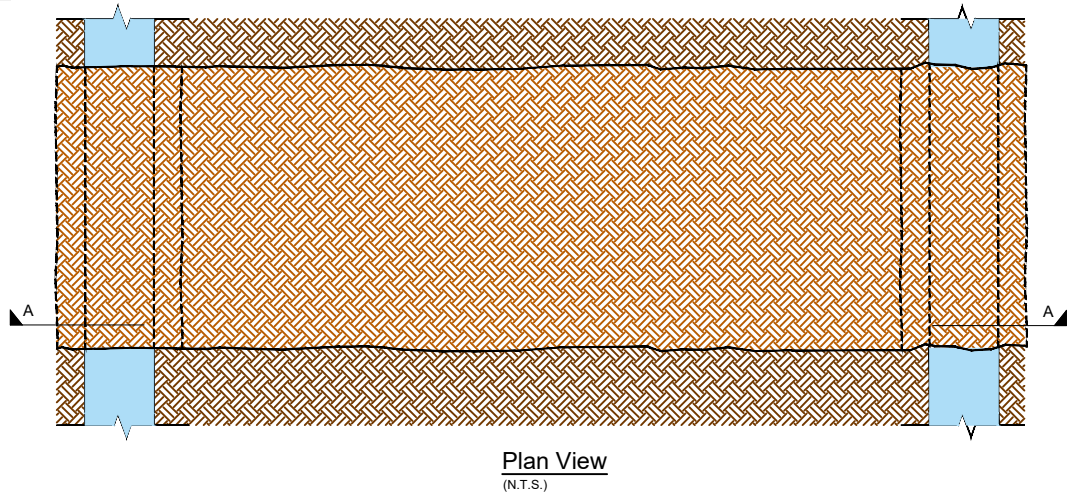
Complete Fields With Speed Bump (3 Per 100m)

Drain Blocks are built up at least 300mm-500mm above the existing ground level to allow for peat subsidence and to prevent water from flowing over the drain block and eroding it before it becomes stabilised.
