**Article 6(3)
Appropriate
Assessment Screening
Report**

Mountlucas Bog, Co
Offaly
Decommissioning and
Rehabilitation 2021

Project Title: Mountlucas Bog, Co Offaly
Decommissioning and Rehabilitation
2021

Document Title: Article 6(3) Appropriate Assessment
Screening Report

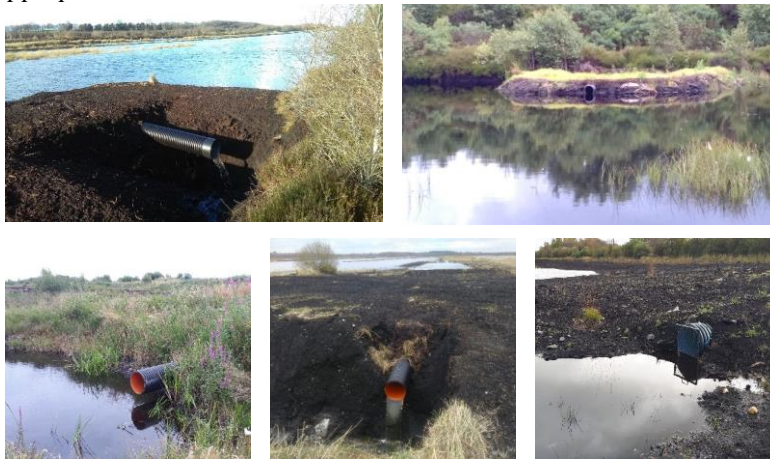
Plate 2-2 Examples of installed overflow pipes

The first step is to block the existing drain where the pipe exits to stop flows. A new transverse field drain and pipe is then placed above the route of the previously blocked and now redundant pipe, to a specified invert level. The drain holding the new, raised pipe, is filled in using an excavator or bulldozer as appropriate.

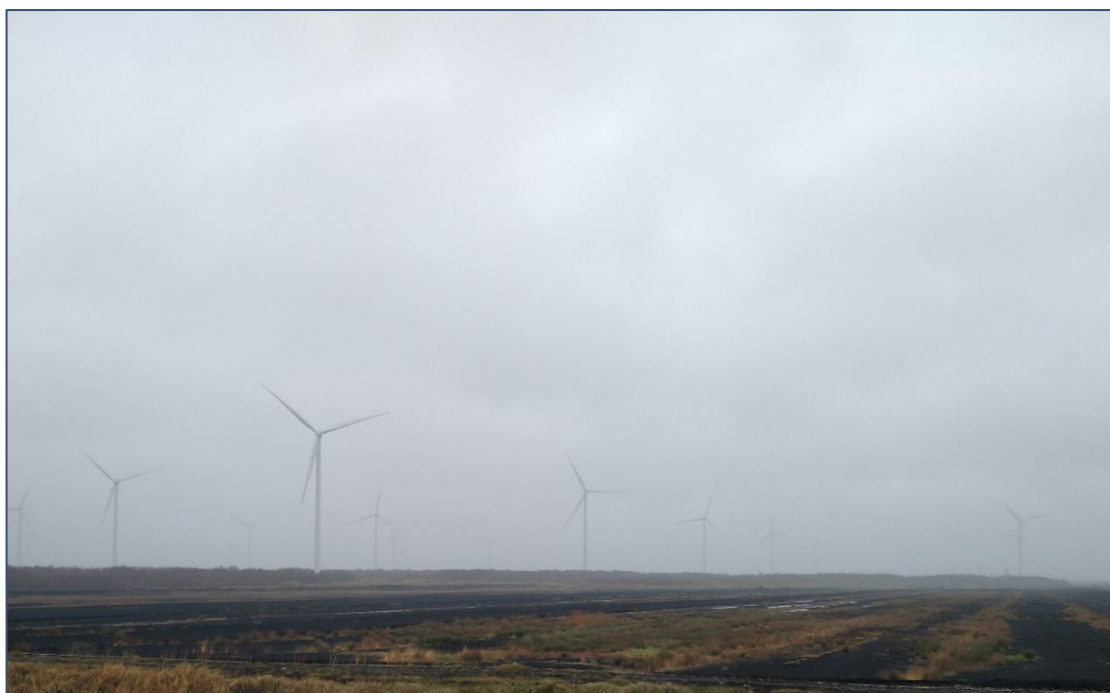
Plate 2-3 View of predominantly bare peat fields in the south of Mountlucas Bog (January 2021).

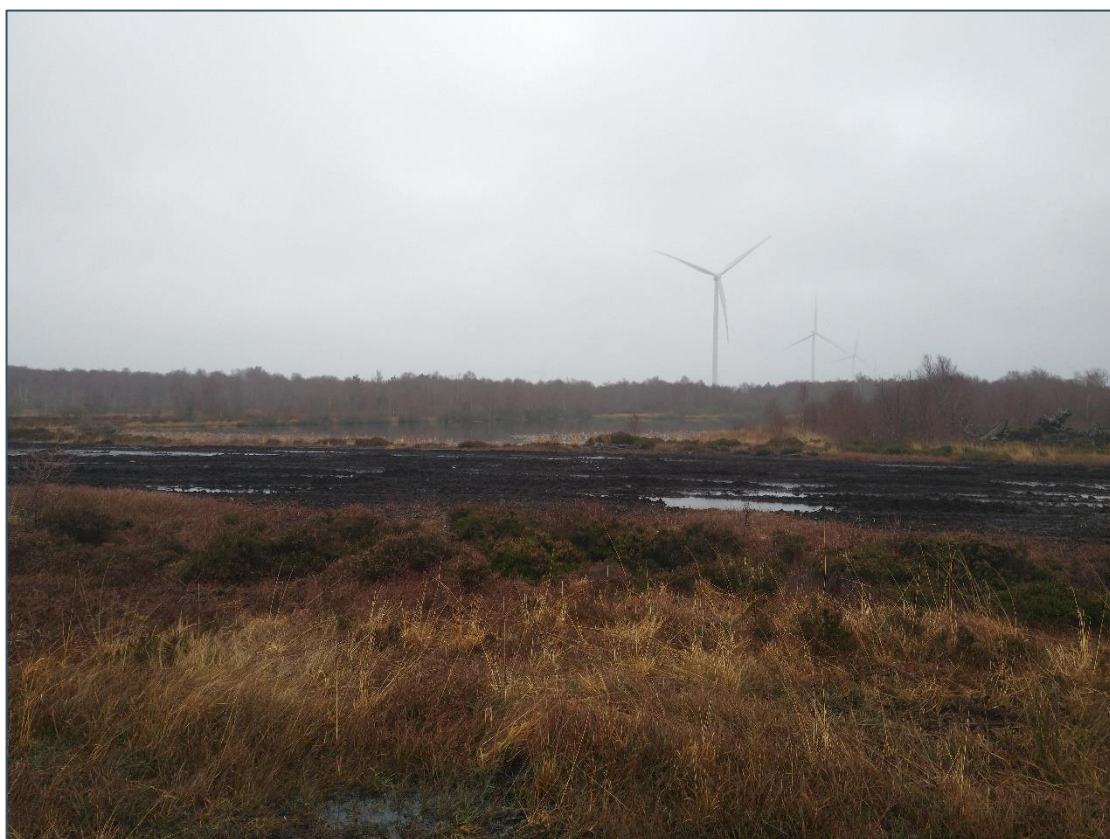
Plate 2-4 Mosaic of heath, bare peat, scrub and open water in the west of Mountlucas Bog (January 2021).

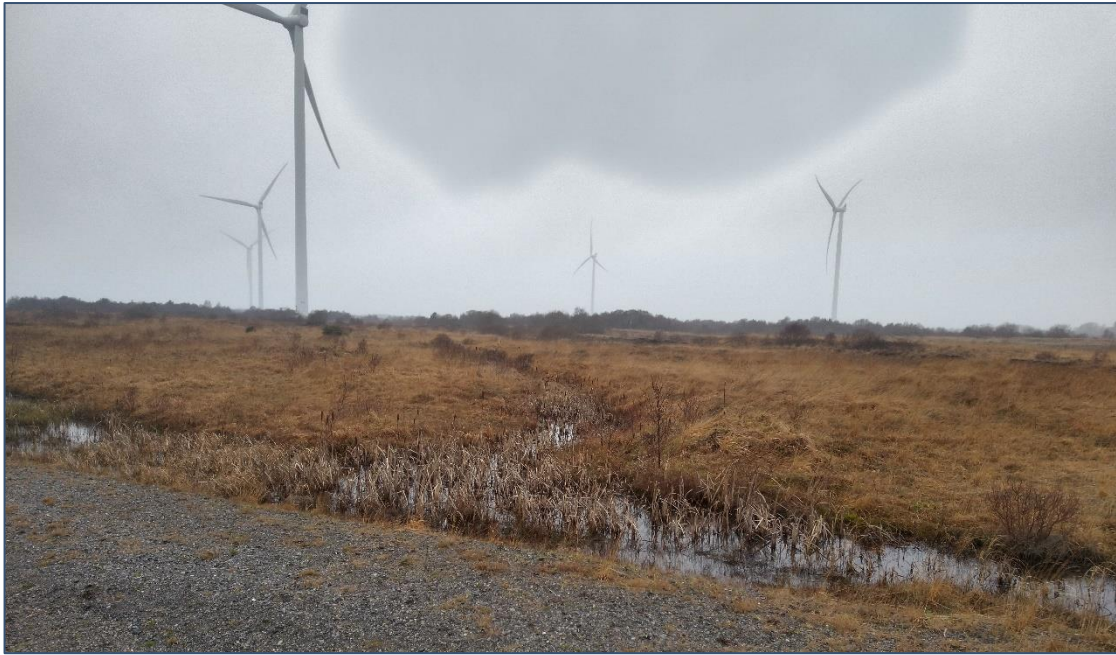
Plate 2-5 Pioneer open cutaway with reedmace growing in ditches in the north of Mountlucas Bog (January 2021).

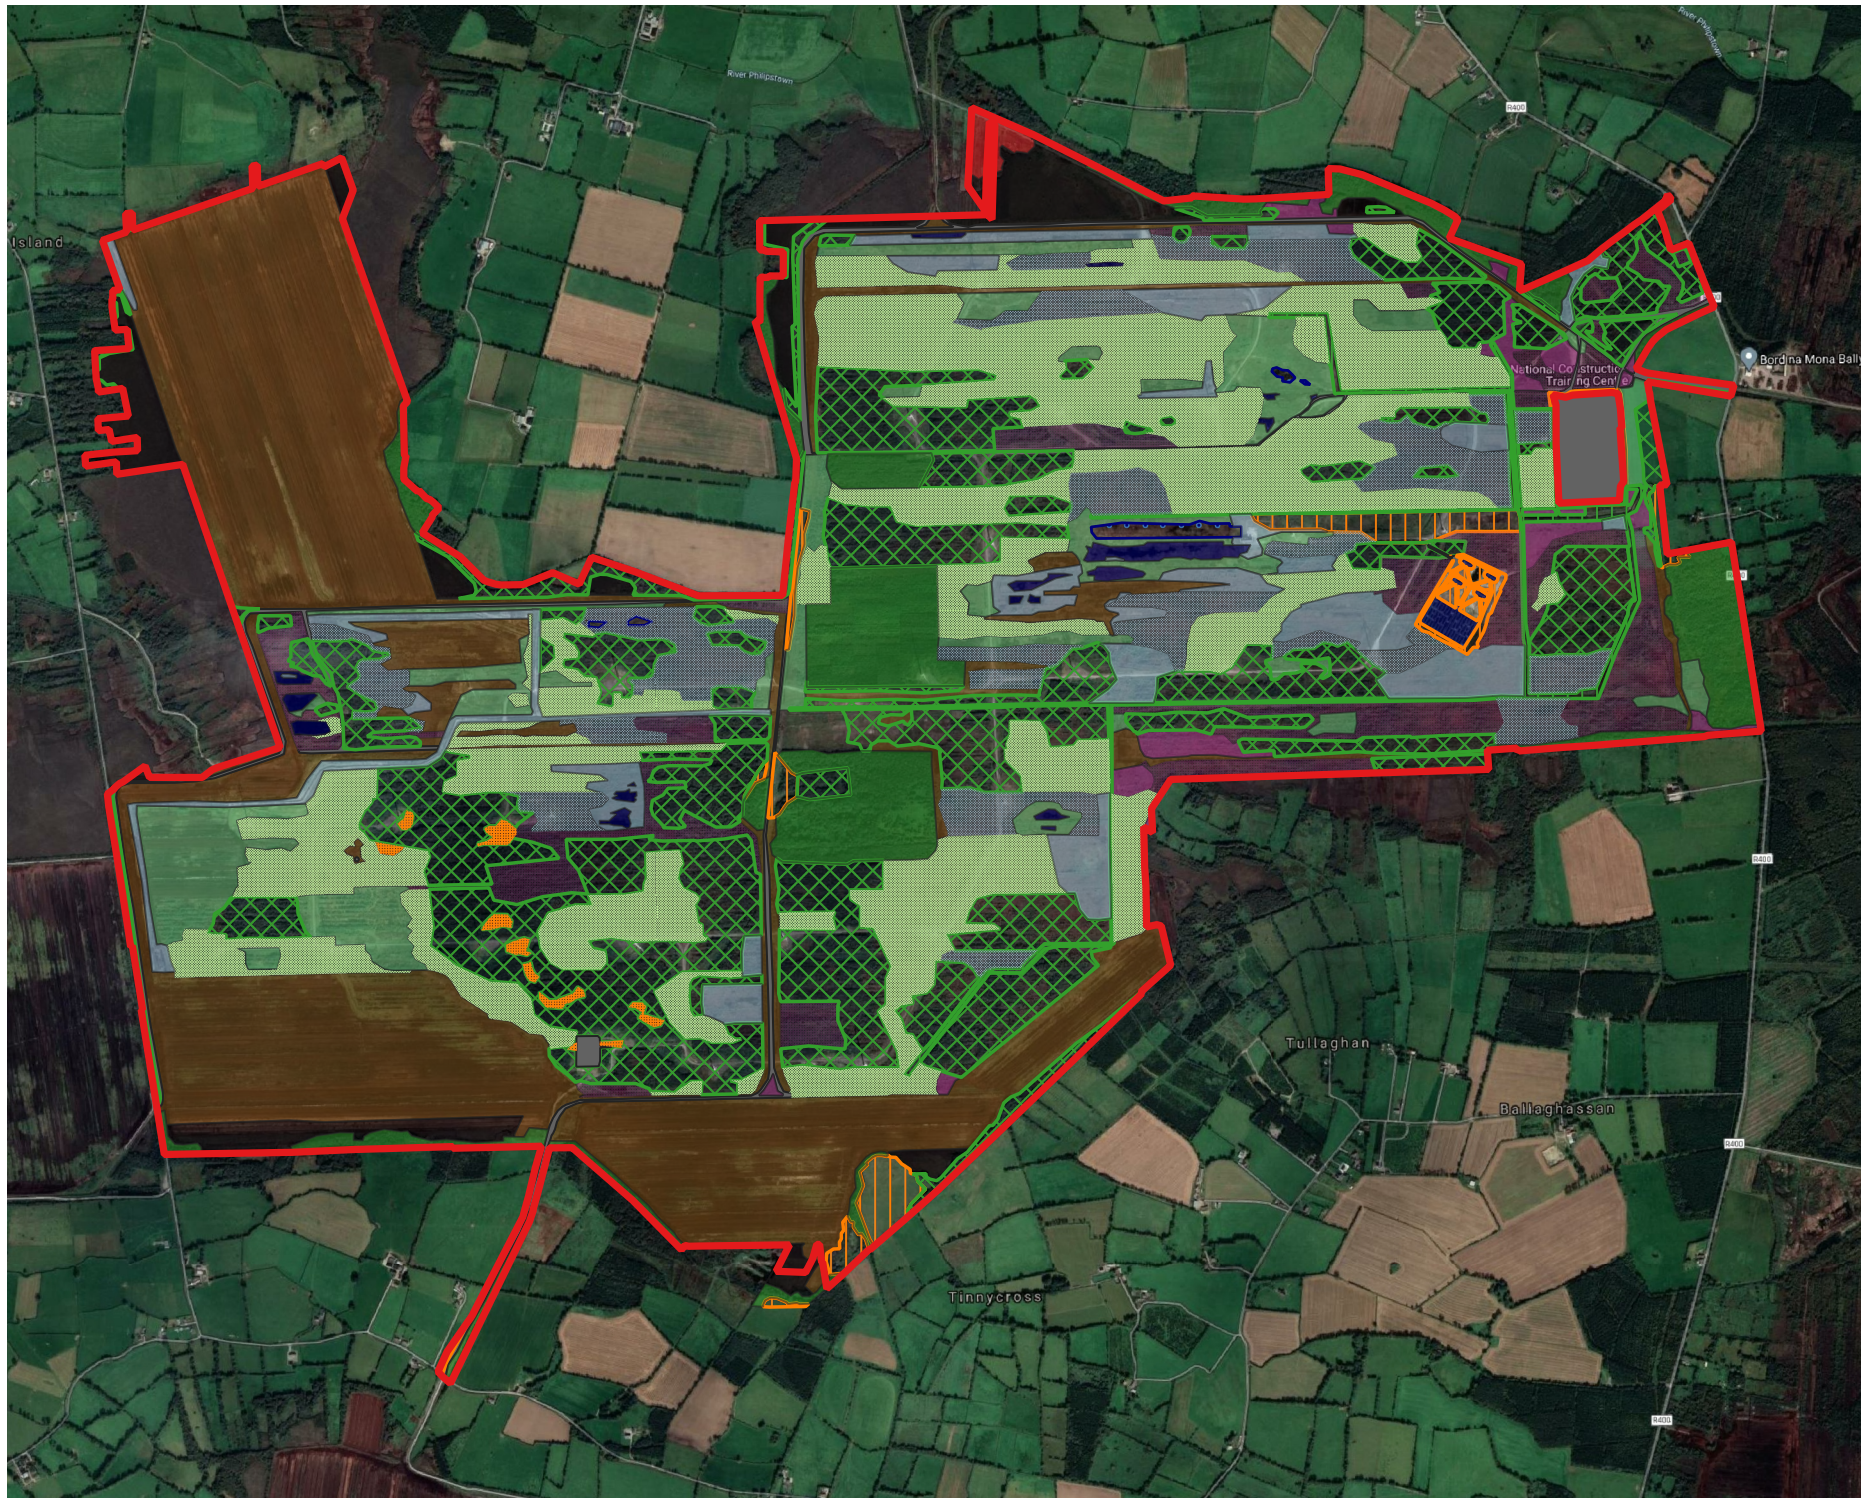
A significant portion of the site is relatively dry and is currently developing birch scrub and woodland. In areas where rehabilitation measures will be applied, other peatland and wetland habitats such as fen, wet woodland, reed swamp and embryonic *Sphagnum*-rich vegetation will develop. Woodland is expected to develop on the drier mounds and peripheral headlands. Habitats currently evaluated as not requiring rehabilitation (i.e., windfarm infrastructure plus buffer, medicinal herb trial area, former aquaculture venture, FÁS training facility, BOGFOR trial areas, areas leased for grazing or under license to Mountlucas gun club, railway line) will remain in line with existing baseline trends for these habitats.

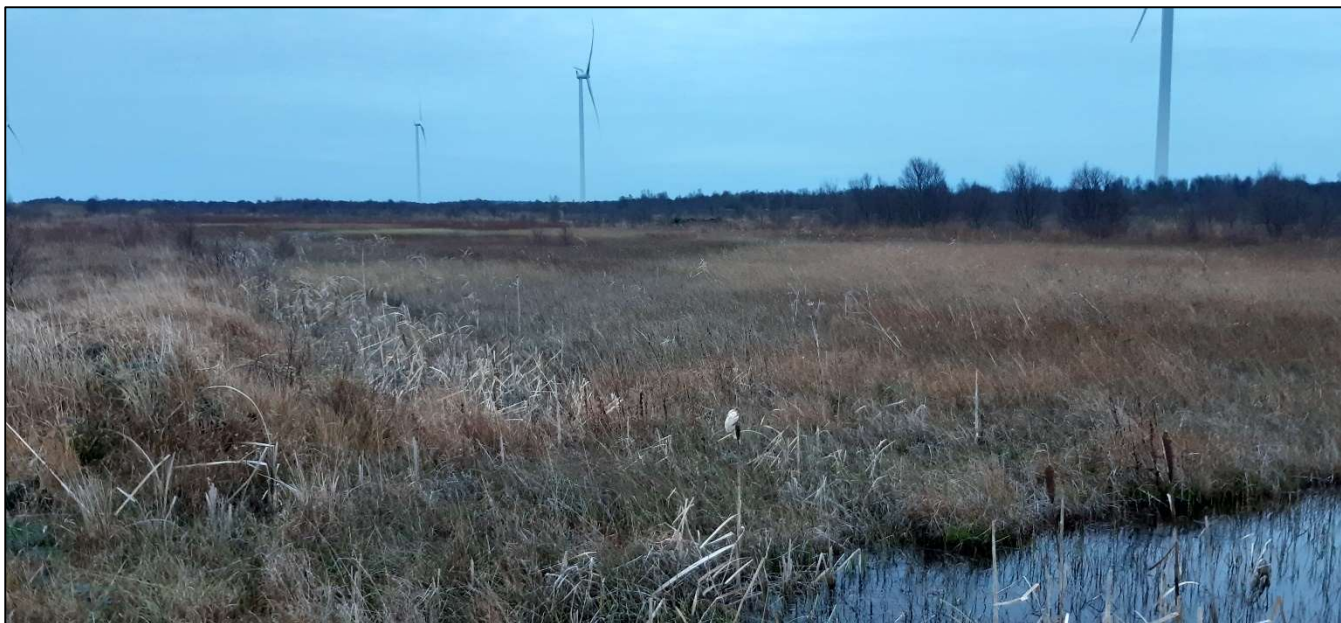
Figure 3.5 Wetland vegetation at Mountlucas (November 2020)

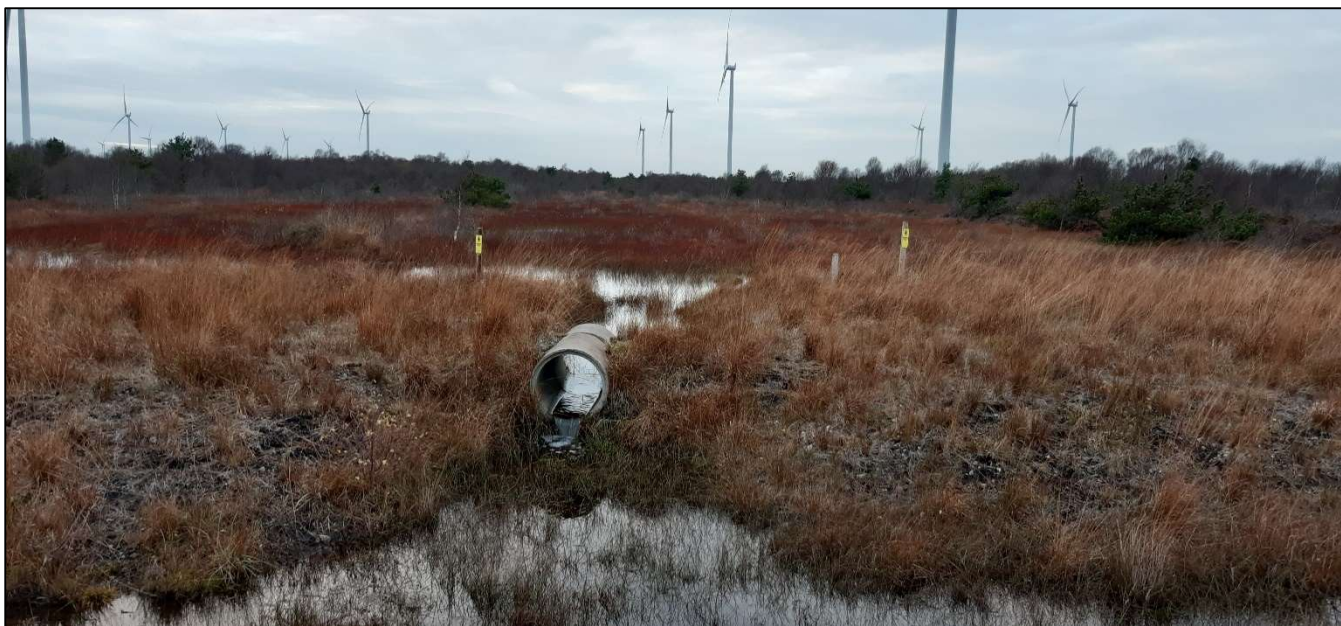
Figure 3.6 Wetland habitats, pioneering Birch Woodland and scrub at Mountlucas (November 2020)

Parts of Mountlucas Bog have re-vegetated due to natural re-colonisation. The bog is relatively dry and developing Birch scrub/ woodland, although there are also some smaller wetlands with open water and a mosaic of poor fen and some Reed swamp vegetation. The areas that were in industrial peat production until recently and not included within the wind farm development comprise extensive bare peat. A habitat map of Mountlucas Bog is shown in Figure 3.4.

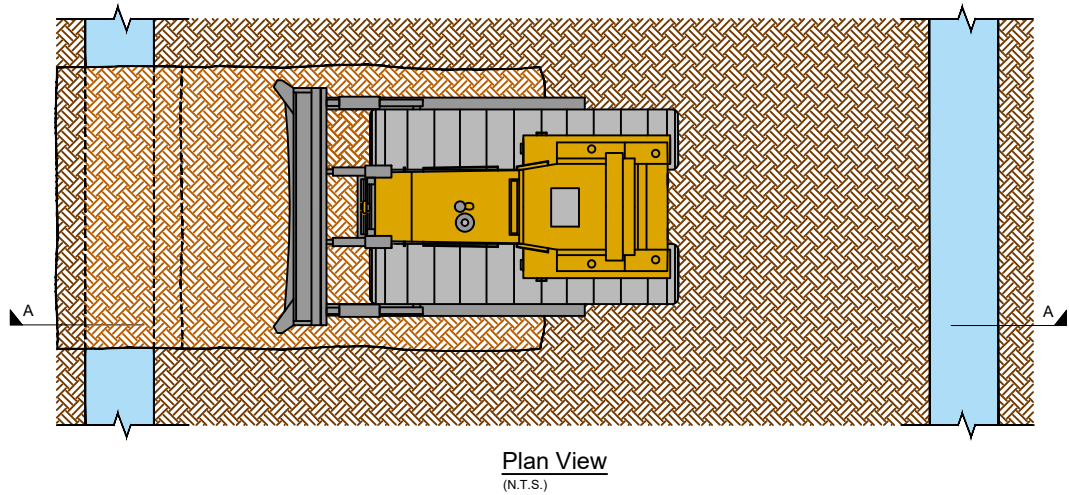
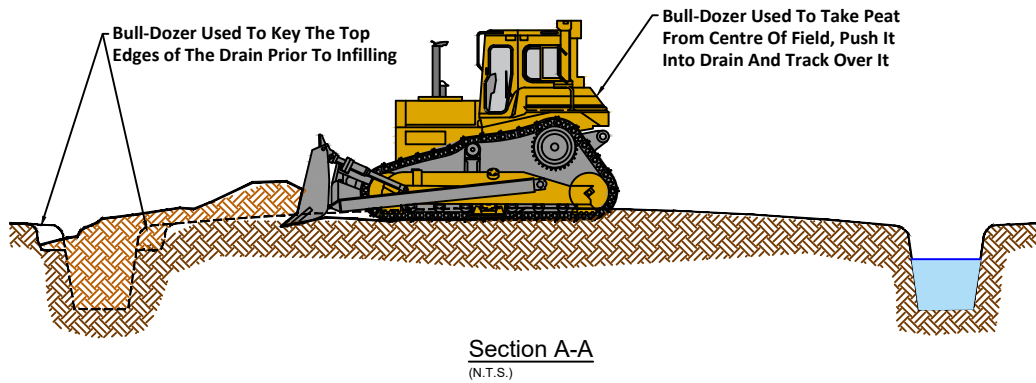
Complete Fields With Speed Bump (3 Per 100m)

The Bull-dozer is used to create a 5m Length key along both edges of the drain, approximately 500mm Wide x 500mm Deep. Next a strip of peat is taken from the central camber of the field, pushed into the drain and compacted by the bull-dozer tracking over the drain block, to form an approximately 5m Wide 'Speed Bump'.

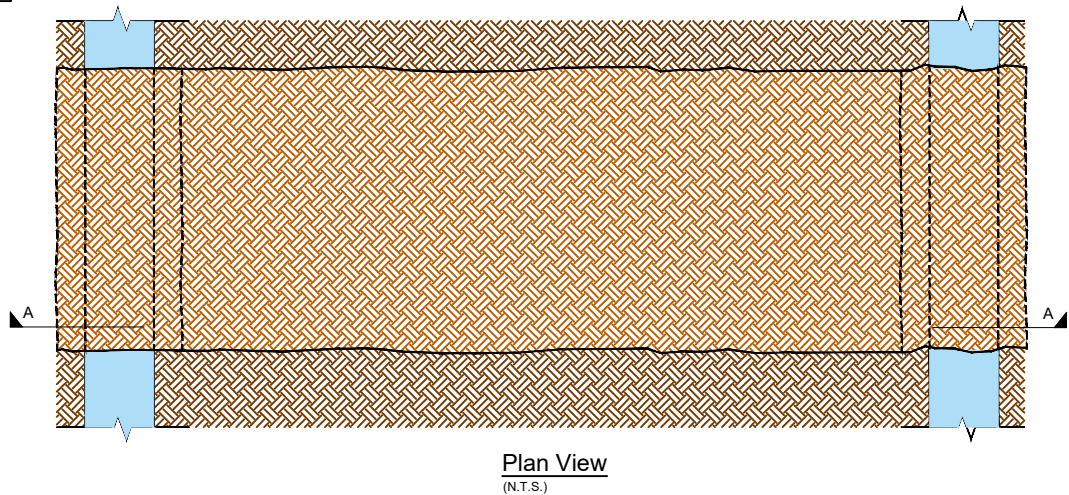
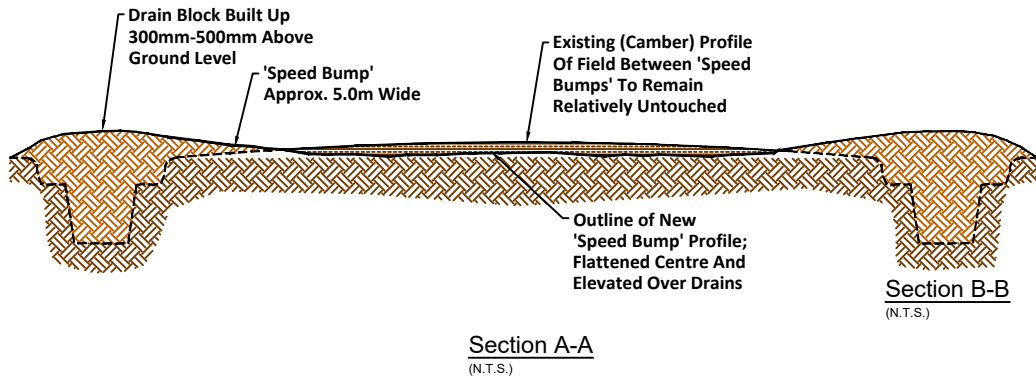
Drain Blocks are built up at least 300mm-500mm above the existing ground level to allow for peat subsidence and to prevent water from flowing over the drain block and eroding it before it becomes stabilised.

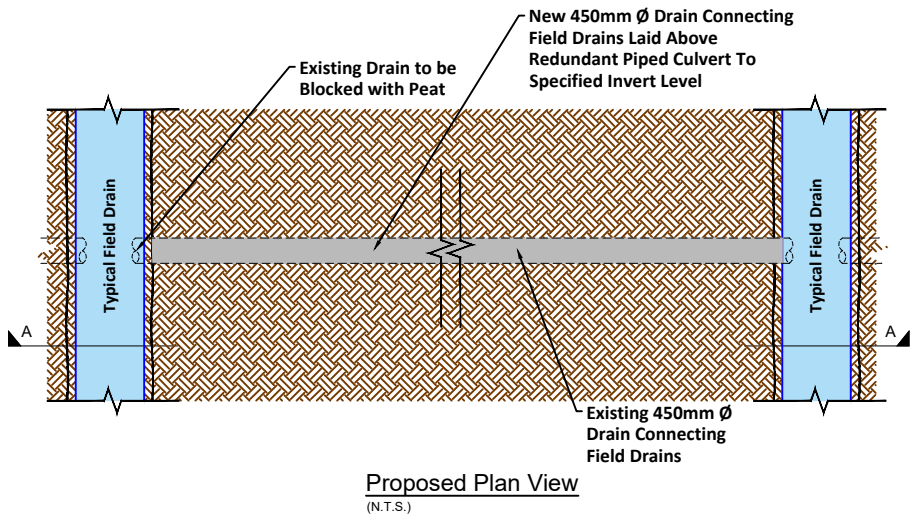
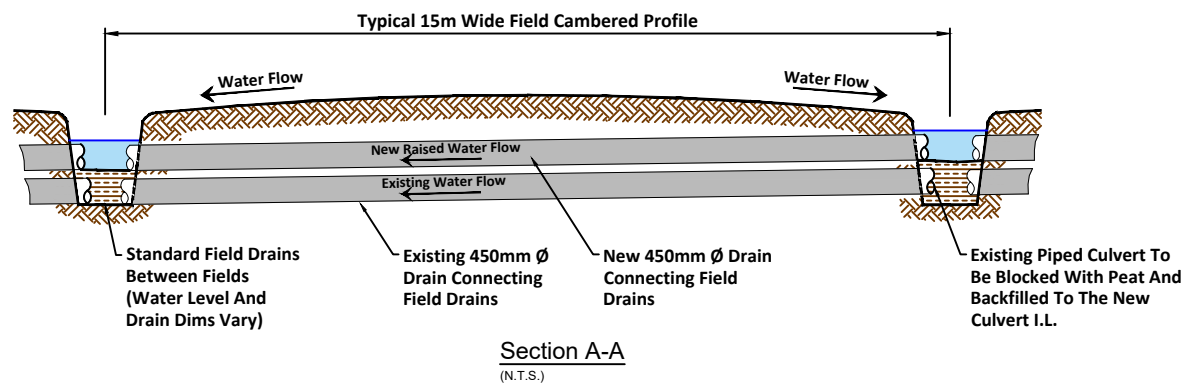
Drawn By:	Checked By:	Approved:
CAD Designer	Discip. Lead	Design Lead
P.K.	D.K.	P.N.
Date: 20/01/21	Scale: Not to Scale	A3
Drawing No.: PCAS-0100-014		Rev: c

Raise Piped Culverts To Control Water Levels
