Kilmacshane Bog

Cutaway Bog Decommissioning and Rehabilitation Plan 2021

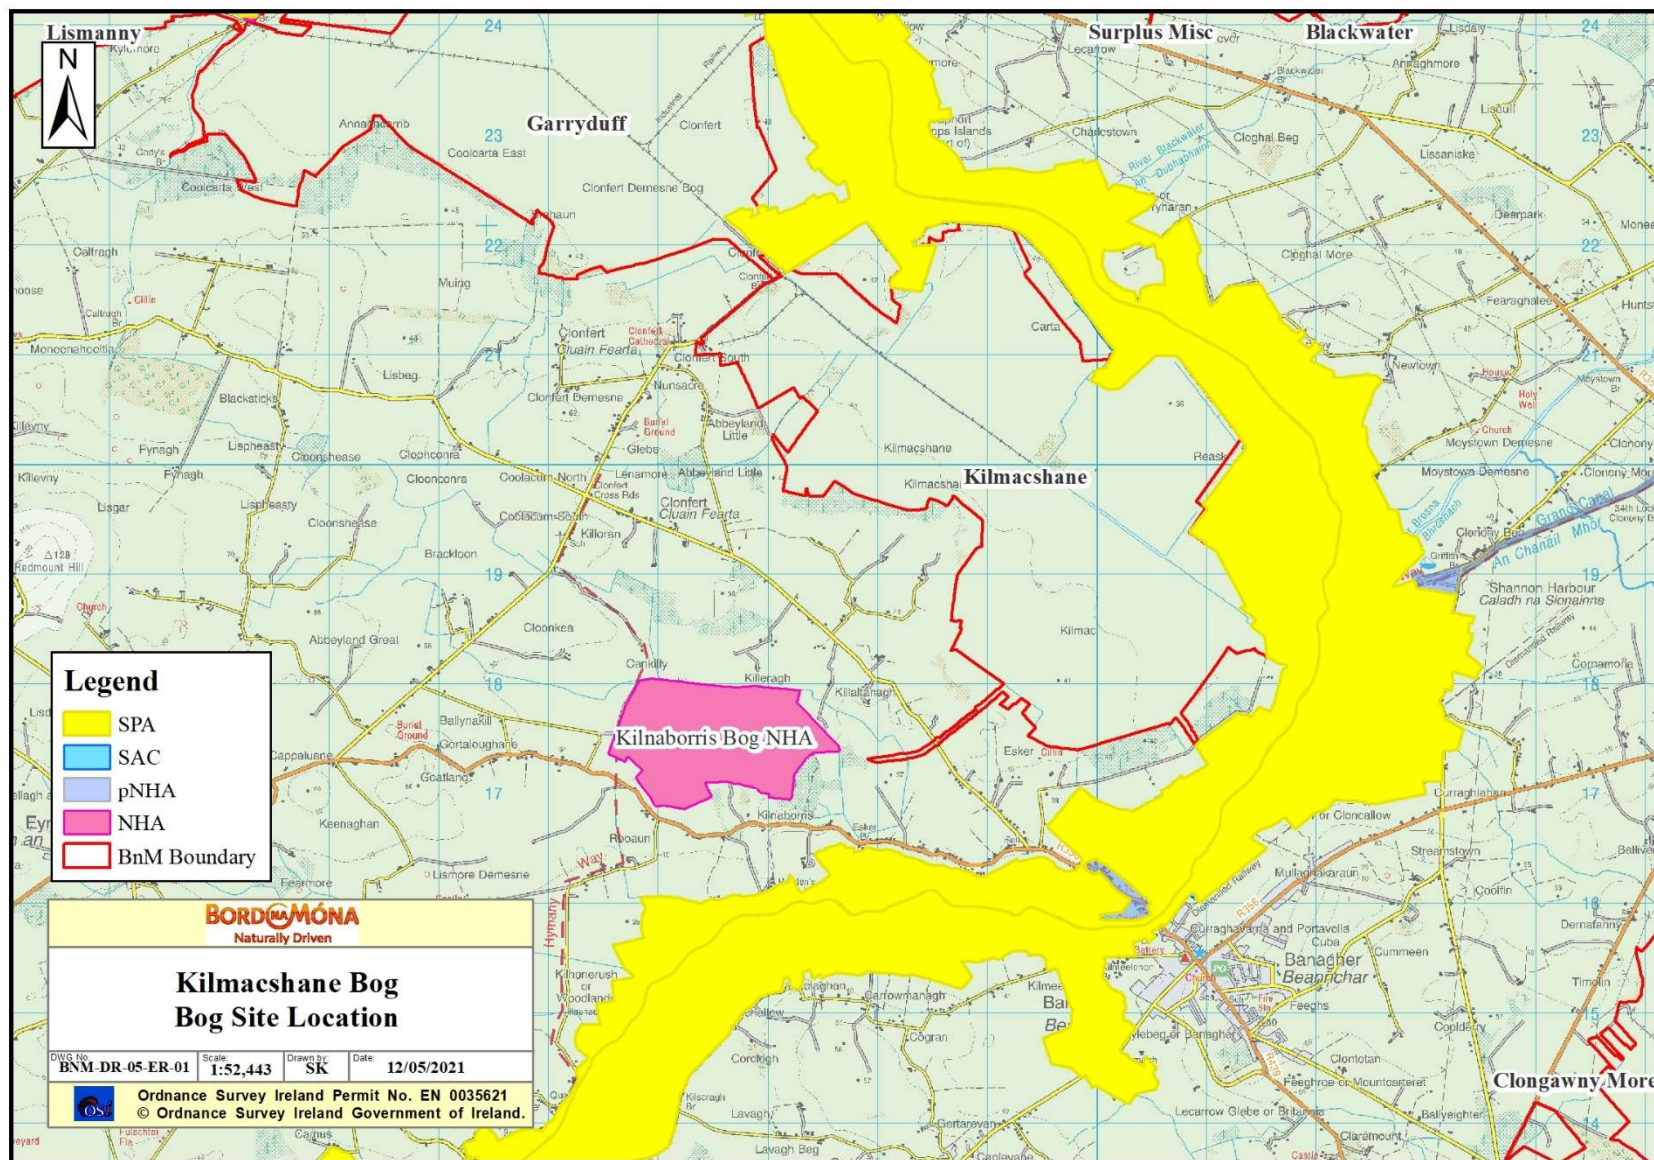
Figure 3.1 Location of Kilmacshane Bog in context to other Bord na Móna bogs and surrounding area.

- The area of Kilmacshane Bog (Figure 3.1).
- EPA IPC Licence - Ref. P0502-01. As part of Condition 10.2 of this license, a rehabilitation plan must be prepared for permanent rehabilitation of the boglands within the licensed area. Kilmacshane Bog is part of the Blackwater Bog group.

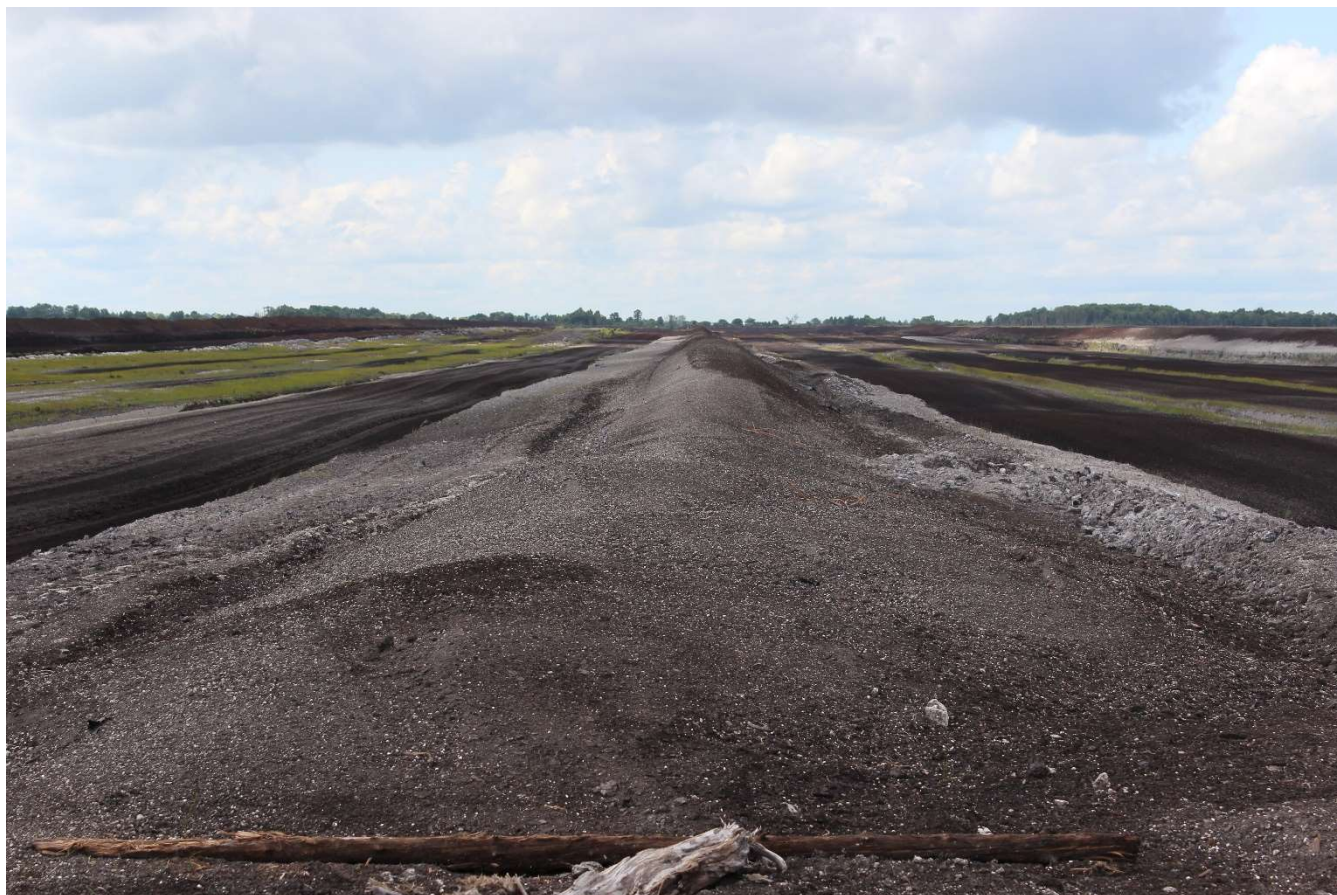
Figure 3.2. View of the typical peat surface with existing drainage and early pioneering vegetation communities across Kilmacshane Bog

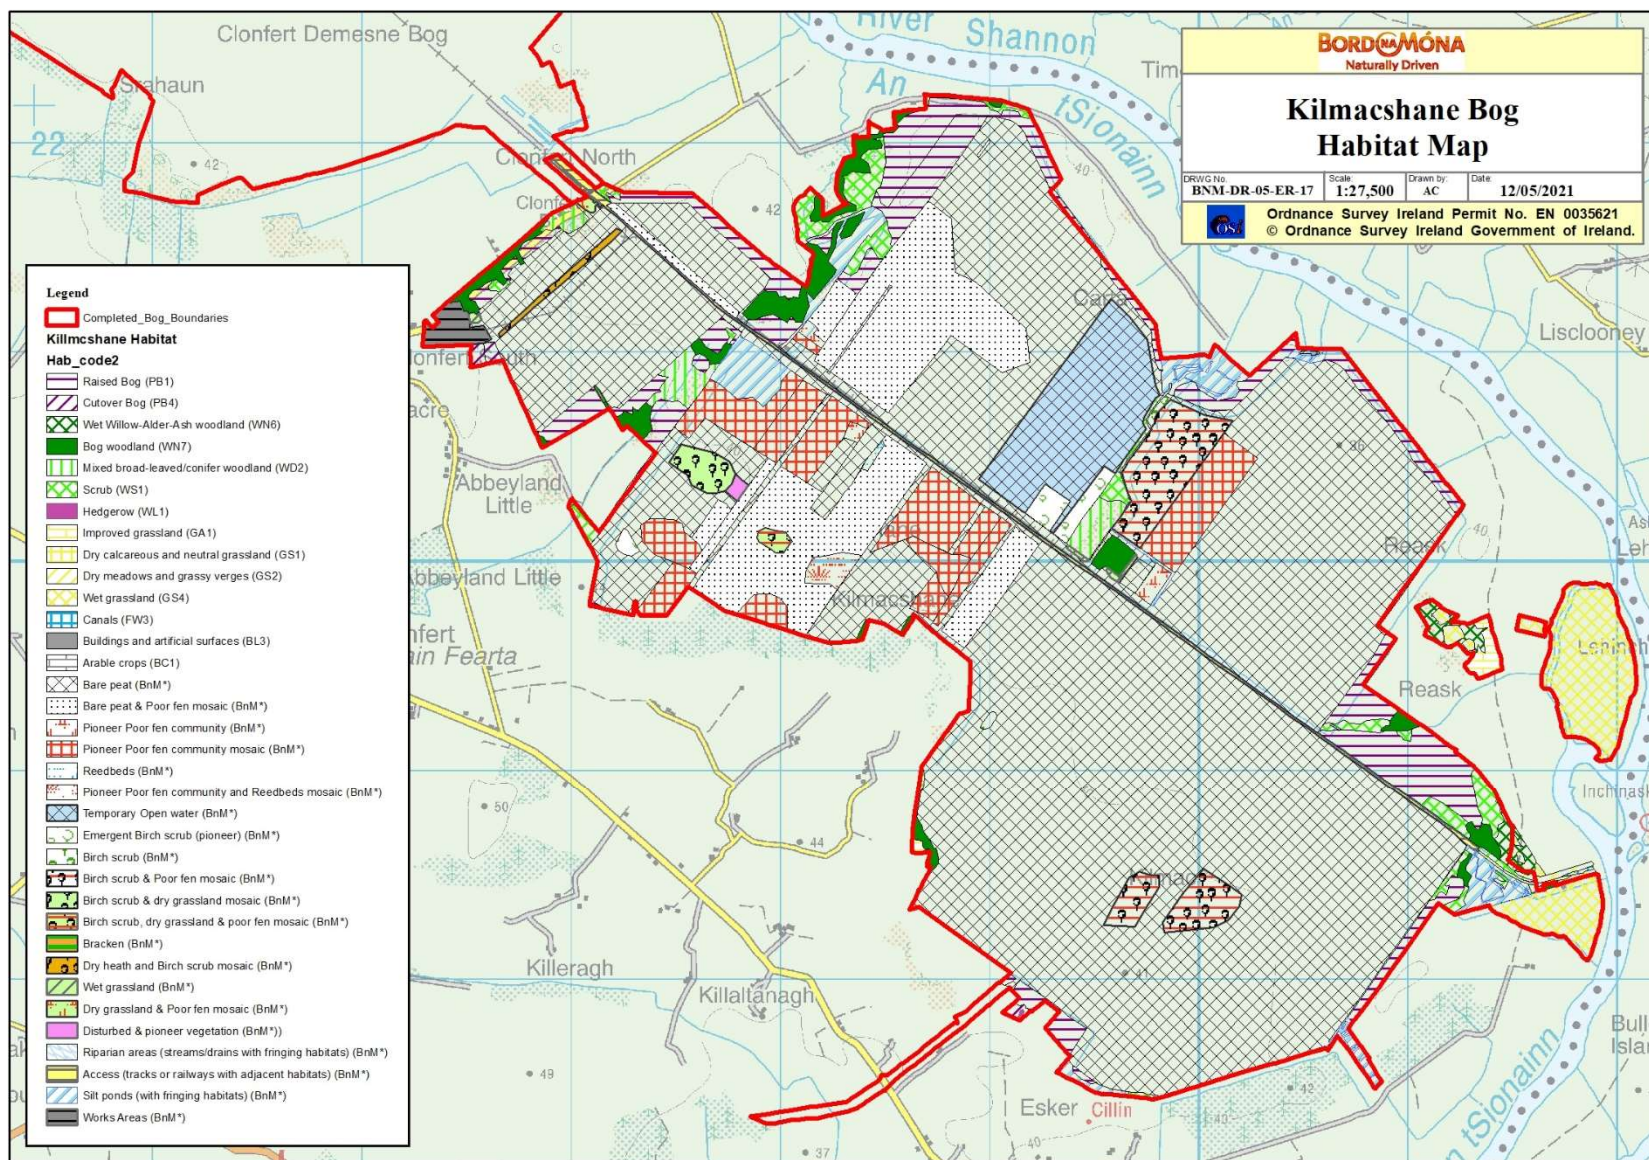
Figure 3.3 Habitat map of Kilmacshane Bog showing Bord na Móna habitat categorisation.

A habitat map of the site is shown in Figure 3.3.

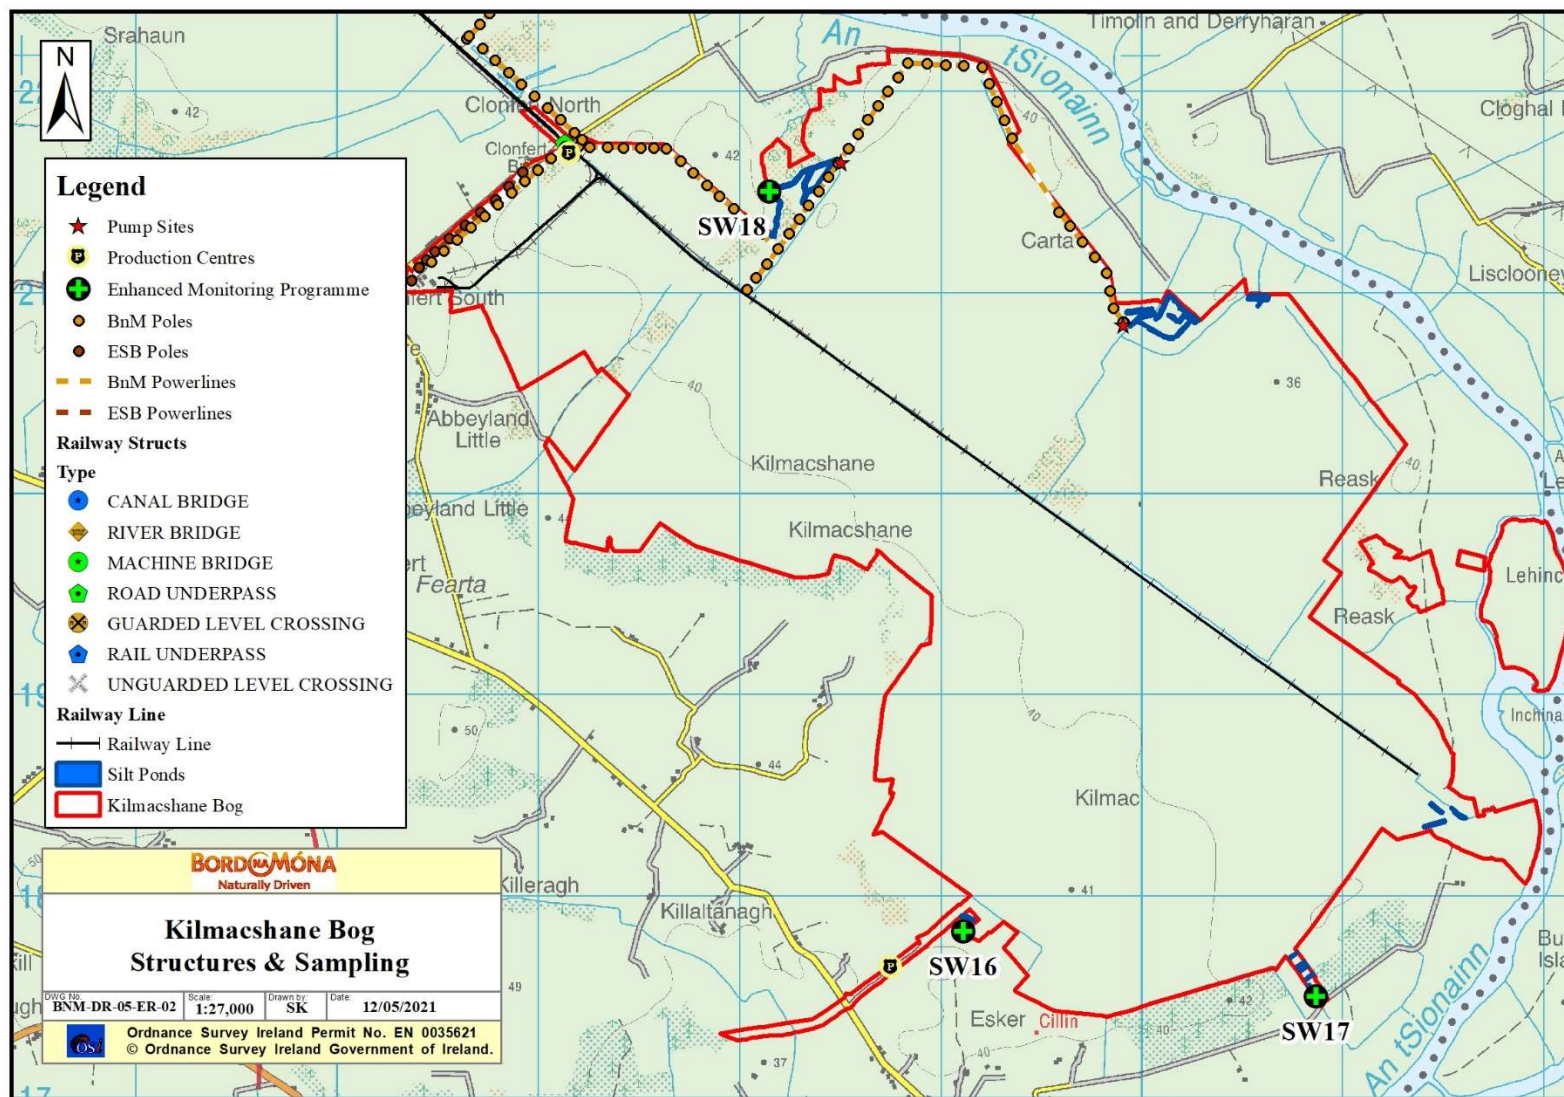
Figure 3.4. Map of Kilmacshane Bog showing structures and designated emission points.

The majority of the bog that is within the ownership of Bord na Móna has been used for peat extraction. There are some intact bog remnants (outside the BnM boundary) along the margins that are being used for domestic turf cutting (private turbary). Some of these private turbaries have been cut out completely. Domestic turf cutting is not having a significant impact on the BnM bog area but is having a significant impact on some of these private marginal bog remnants. A bog railway crosses through the site (Figure 3.4).

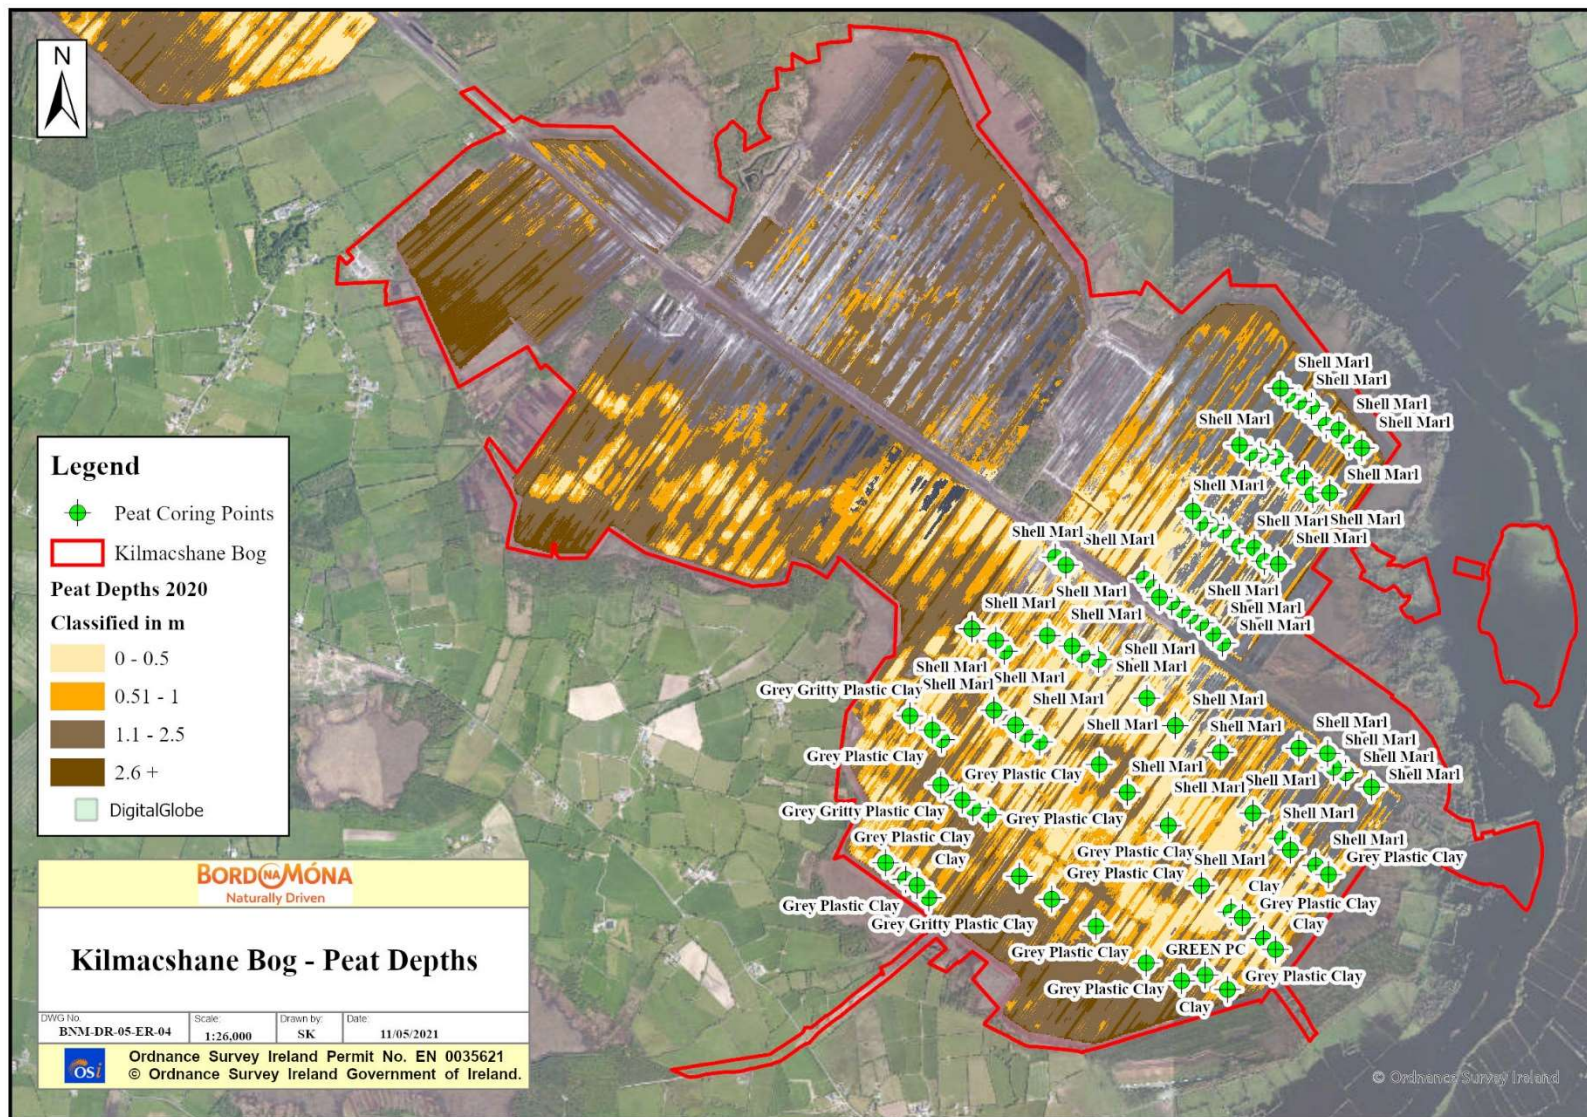
Figure 8.2. Peat Depth Map for Kilmacshane Bog. There are areas of deep peat in sections of the bog, particularly south of the railway. Much of the northern side of the bog and the areas along the railway has been cutaway.

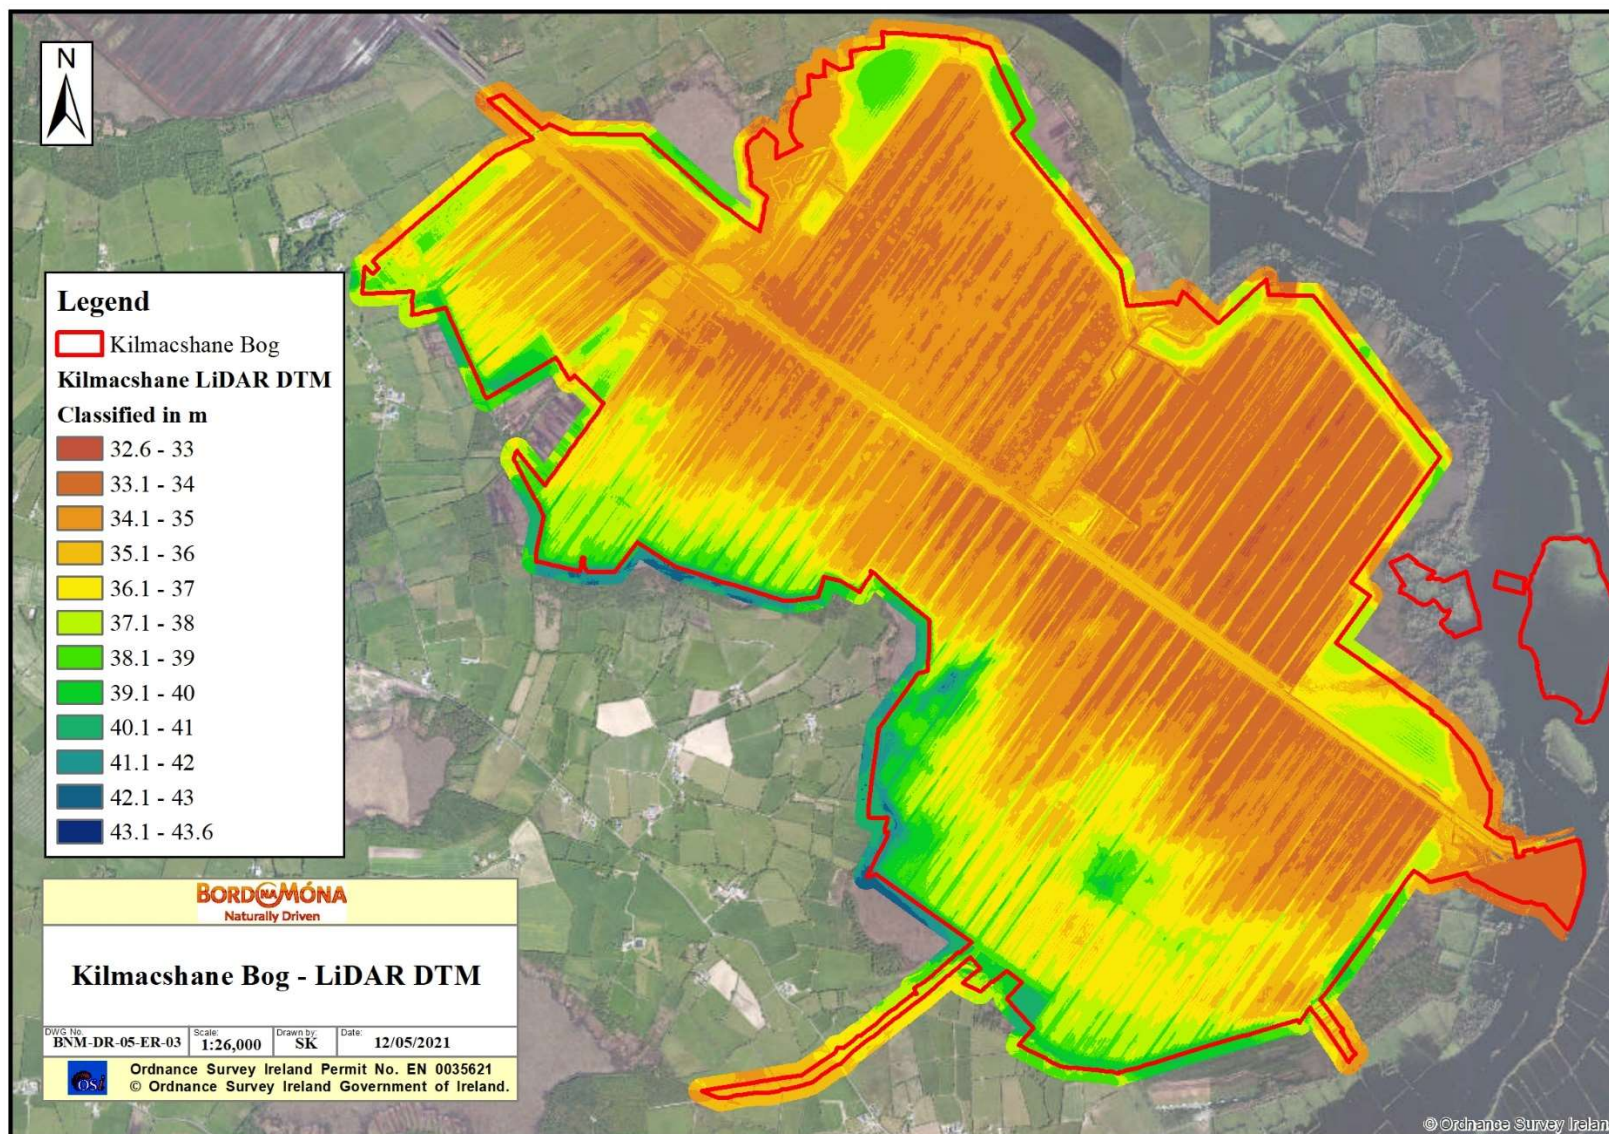
Figure 8.3. LIDAR topography map of Kilmacshane Bog. Low areas and basins are orange-yellow, more elevated areas are blue-green. There is some more elevated ground along the southern margin

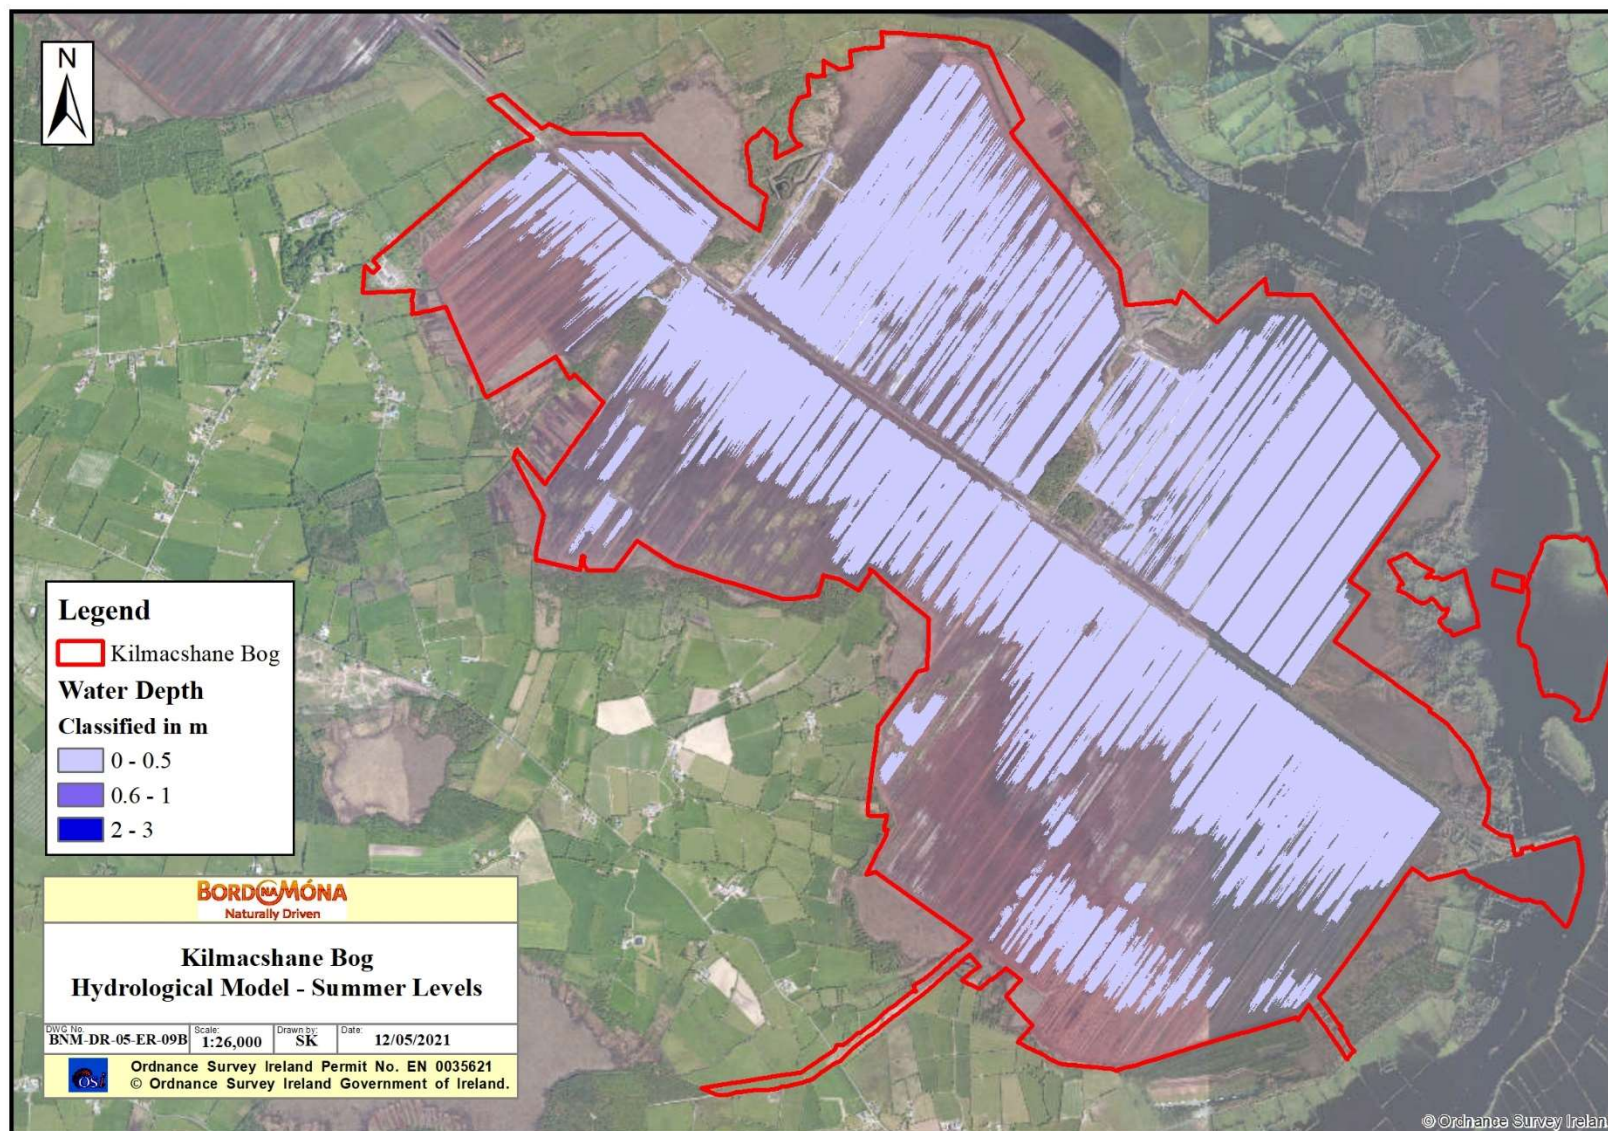
Figure 8.4. Hydrological model of Kilmacshane Bog. This shows expected water depths showing range of expected water depths based on current topography in the summer if pumps are turned off.

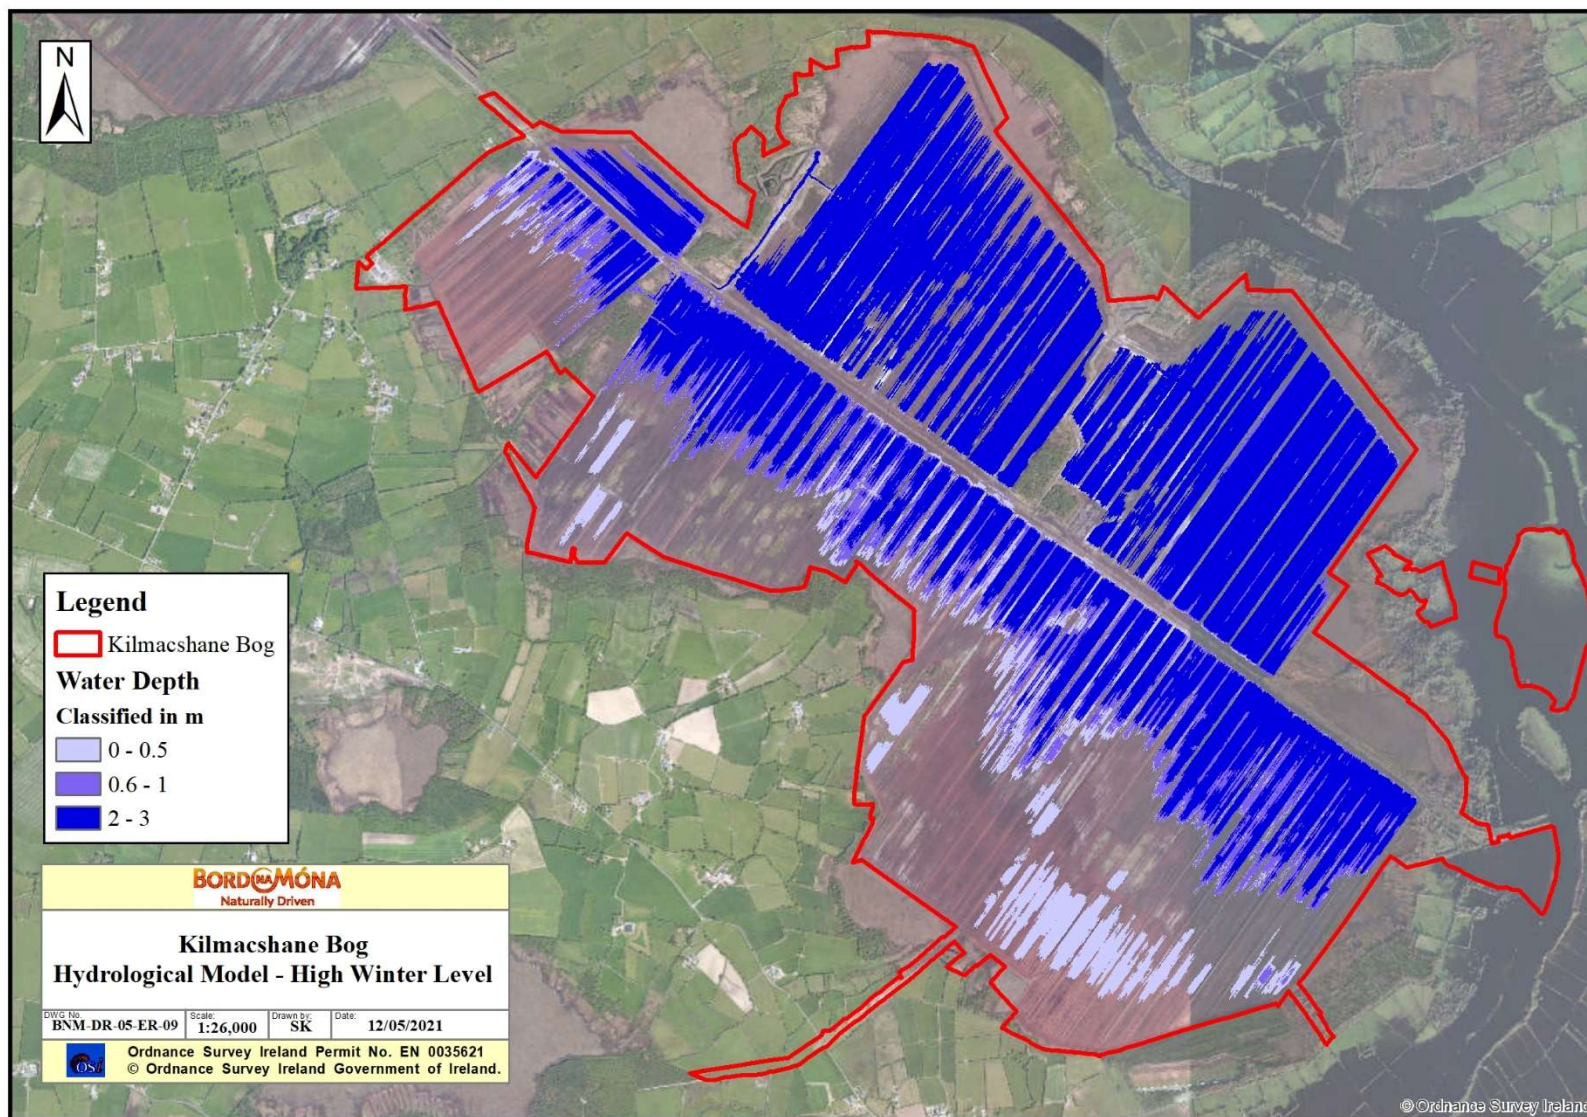
Figure 8.5. Hydrological model of Kilmacshane Bog. This shows expected water depths showing range of expected water depths based on current topography in the **winter** if pumps are turned off.

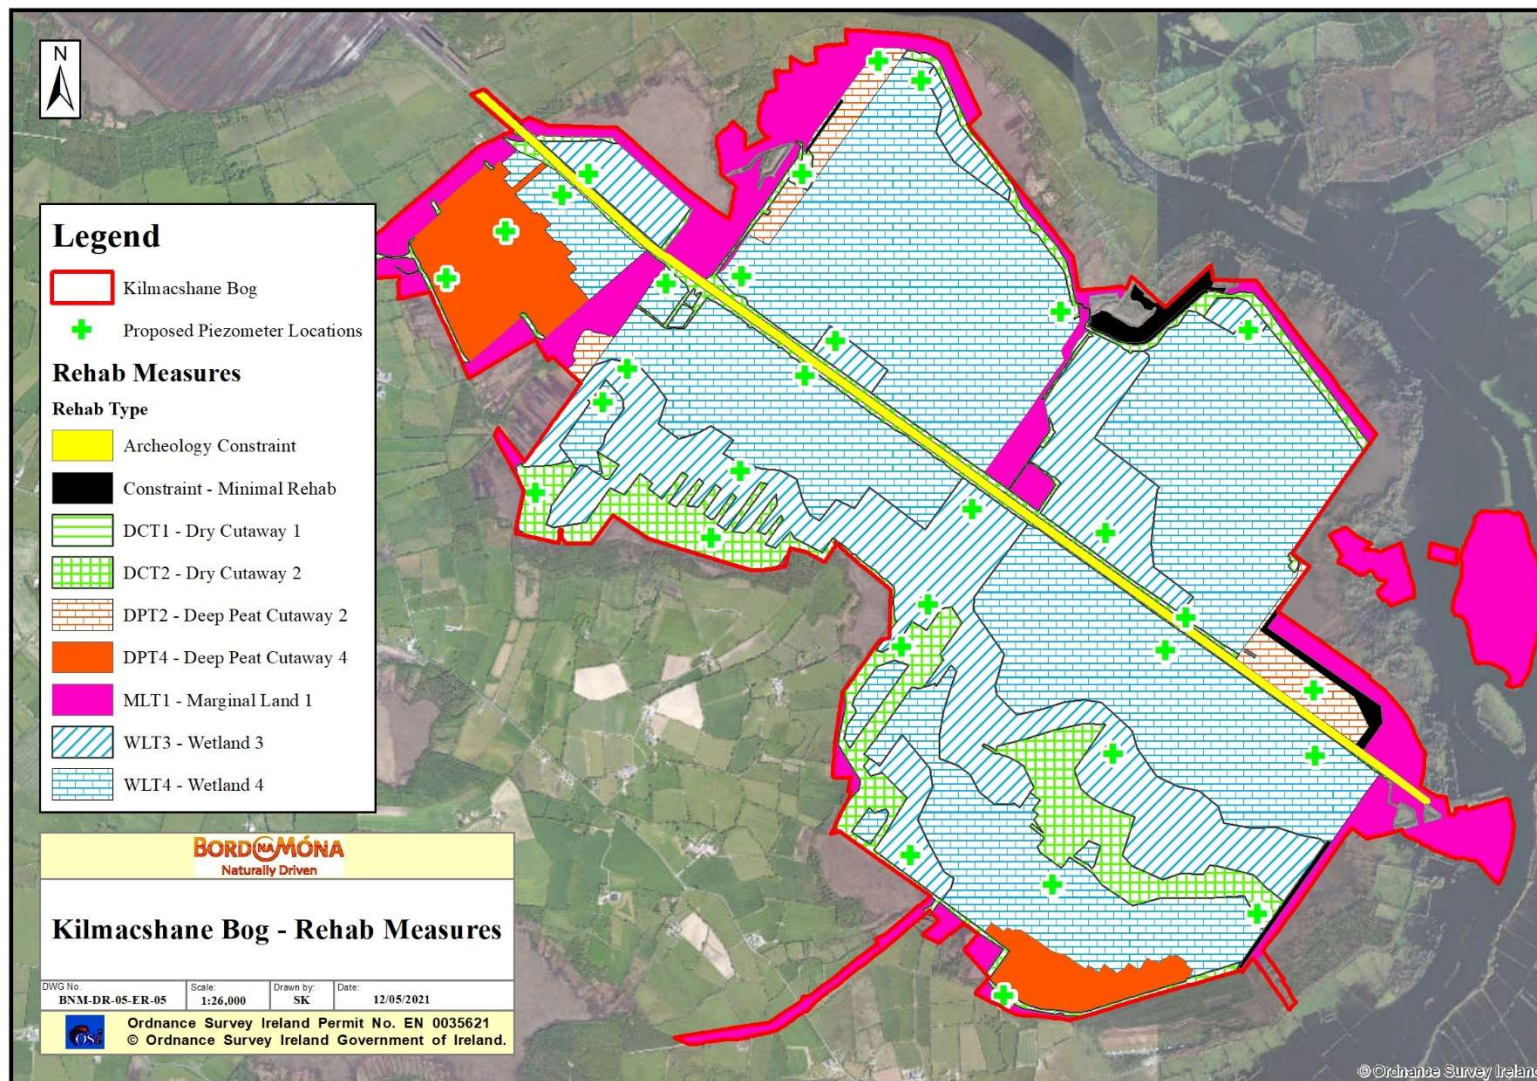
Figure 8.6. Indicative Enhanced Rehabilitation Plan for Kilmacshane Bog. *Note that the types of rehab and areas of rehab may change in response to stakeholder consultation and refinement of the enhanced rehabilitation measures.*

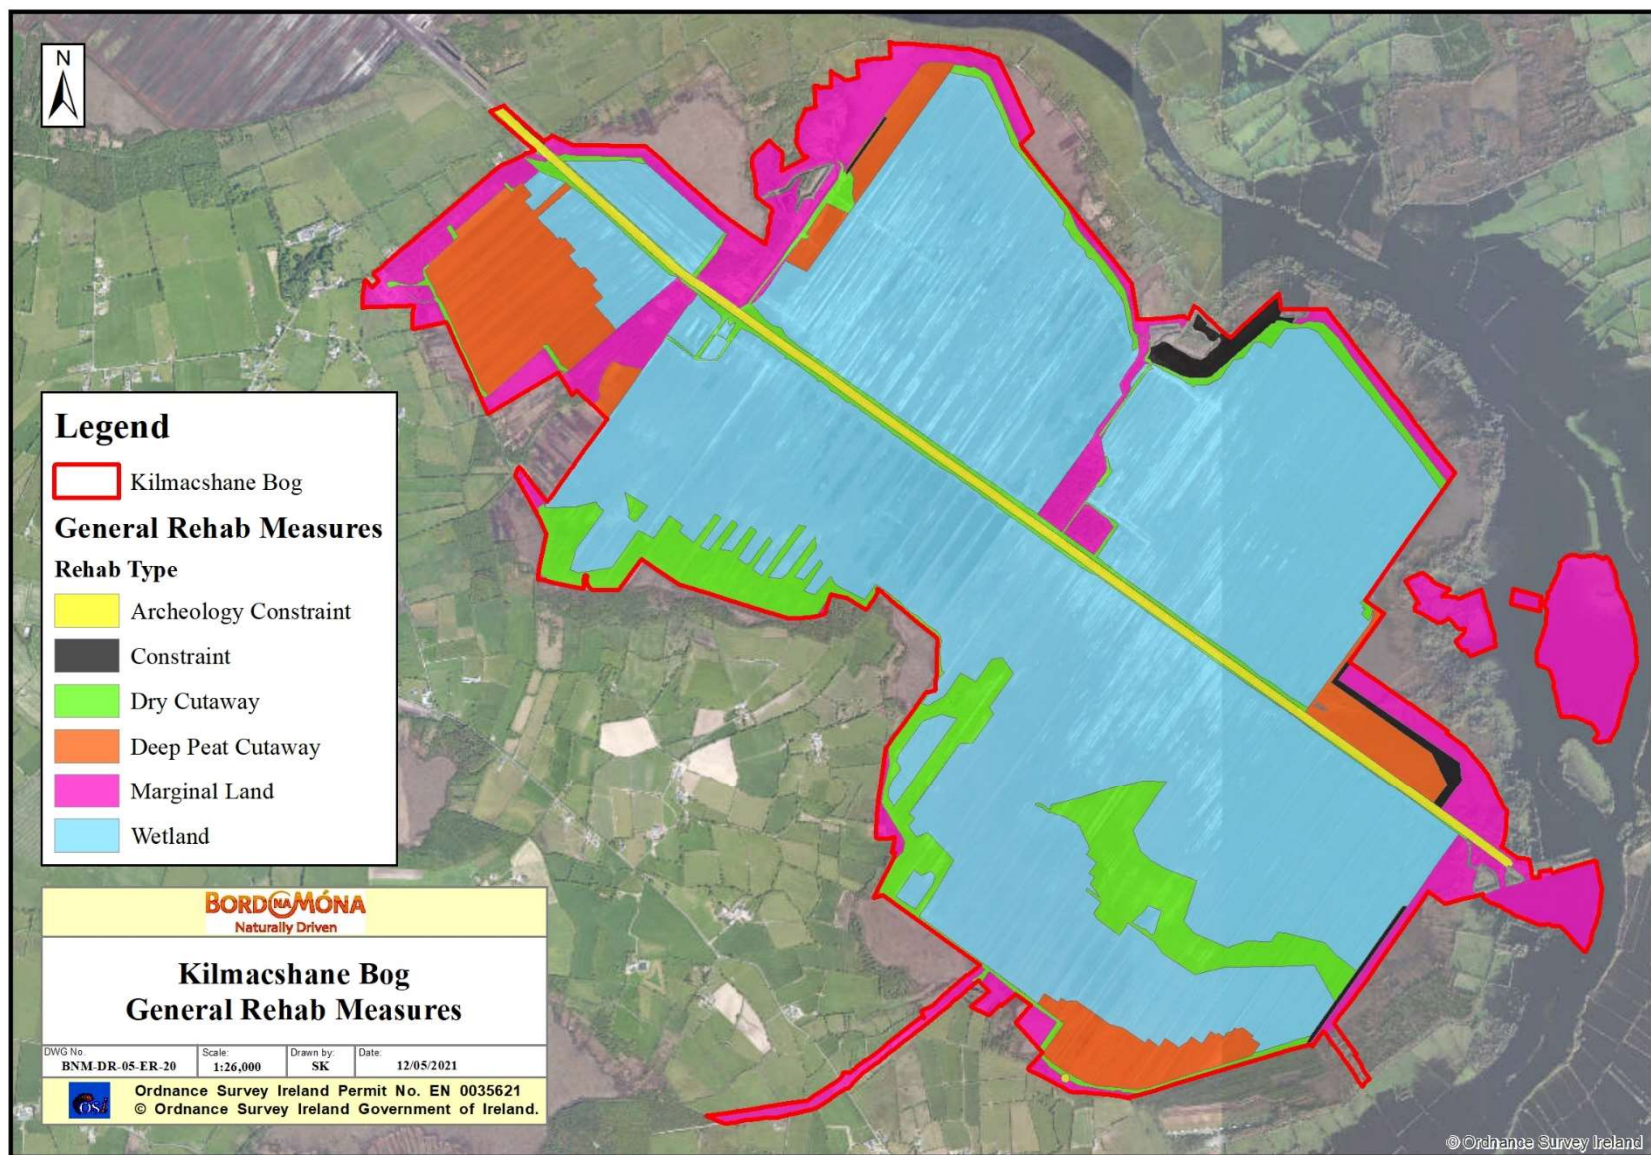
Figure Ap-1. Indicative standard rehabilitation plan for Kilmacshane Bog.

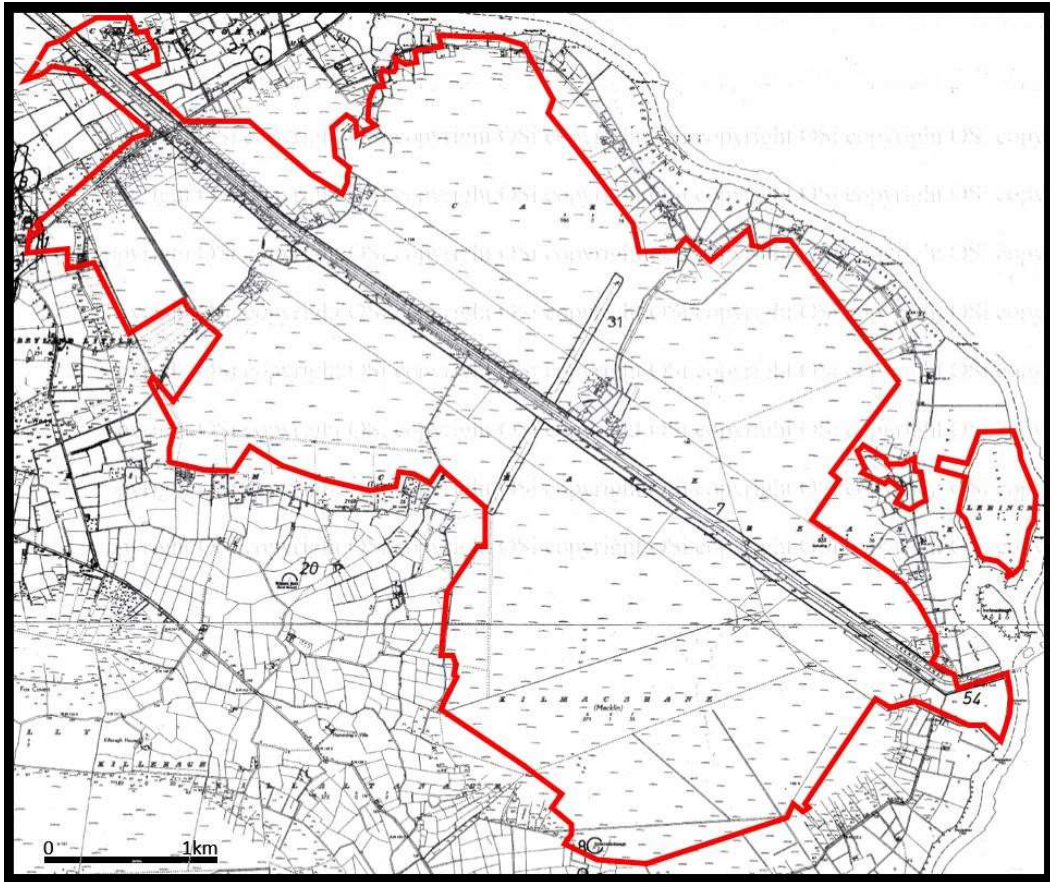
Fig. 1. Kilmacshane Bog, Co. Galway, detail of the Record of Monuments and Places map sheets Nos. 101 and 109. The proposed rehabilitation area is outlined with the red line. There are several Recorded Monuments in the area.

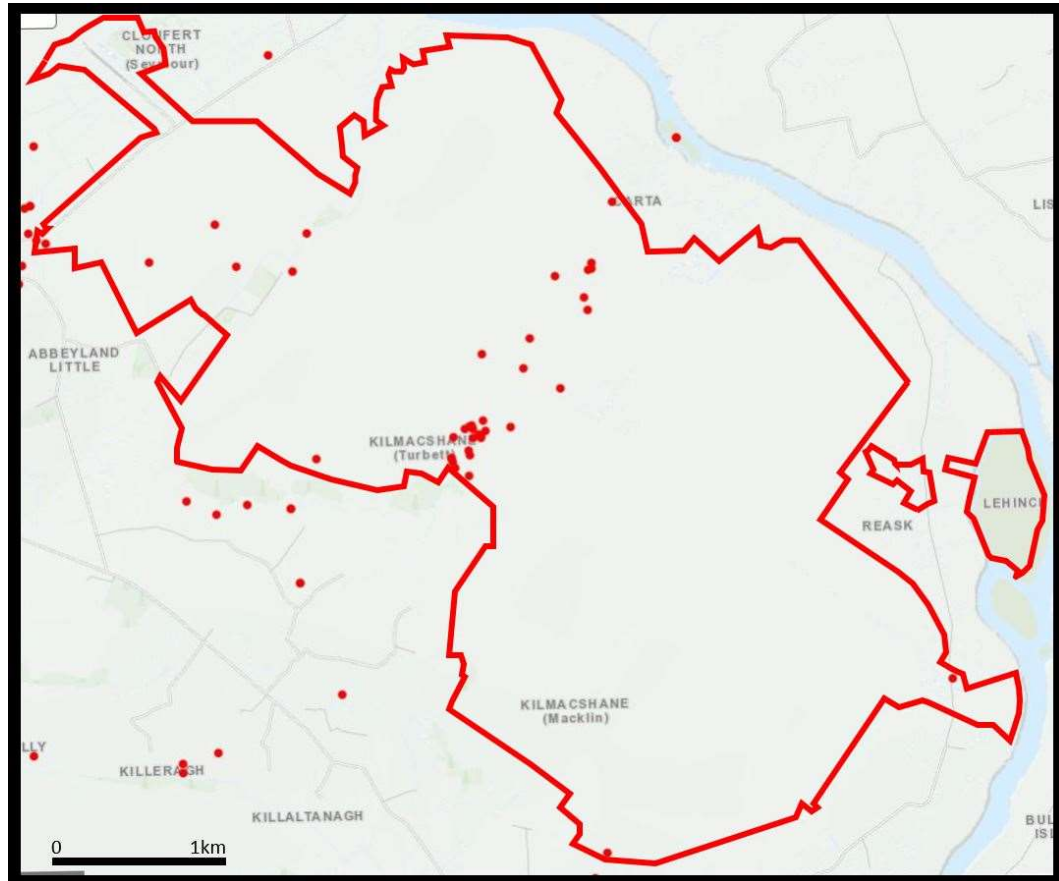
Fig. 2. Kilmacshane Bog, Co. Galway, detail of the Sites and Monuments Record. The proposed rehabilitation area is outlined with the red line. There are 39 SMRs in the area.

publication of the RMP. This review established that there are 39 monuments entered in the SMR in the proposed rehabilitation area. The monuments are indicated in Table 3 and Fig. 2 below.

Apart from GA101-002---- (a quarry), GA101-007---- and GA109-054---- (a canal), GA101-072---- (a palstave findspot) and GA109-008---- (a Holy Well) these are all monuments identified by the IAWU survey in 1992 that were notified to the Archaeological Survey of Ireland.
