**Bord na Móna**

**Knappoge Bog**

**Cutaway Bog Decommissioning and  
Rehabilitation Plan 2022**

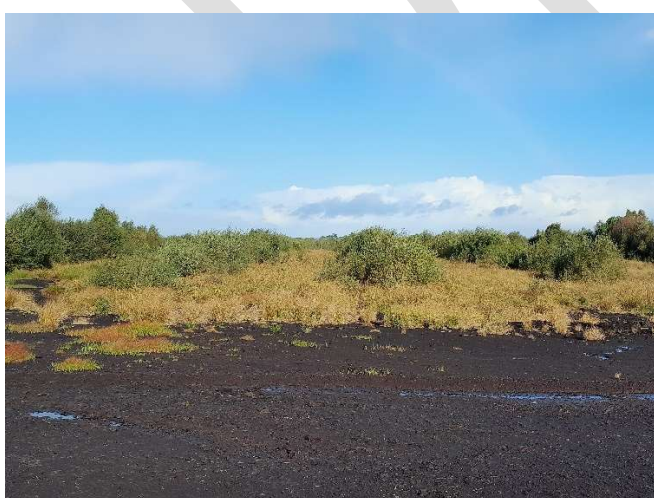
*Pioneering vegetation on cutaway including Scrub and Soft Rush dominated Poor fen (Oct 2021)*

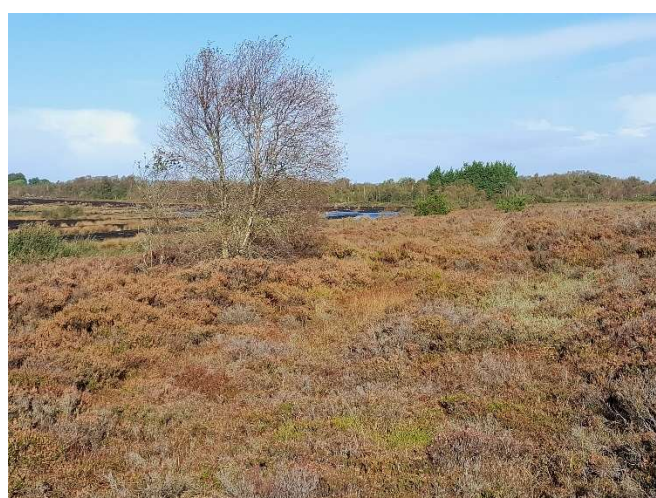
*Bog vegetation with Sphagnum within raised bog remnant on north east of site (Oct 2021)*

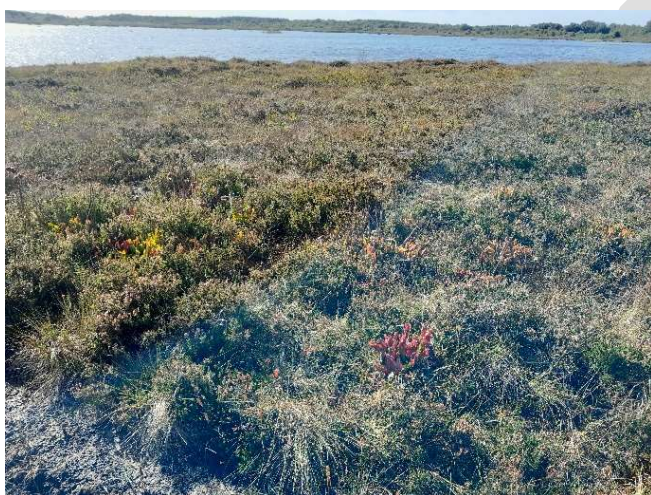
*Invasive Canadian Pitcher Plant on Knappoge bog*

The invasive species Canadian Pitcher Plant (*Sarracenia purpurea*) was noted during a survey of Knappoge bog in October 2021 (see **Error! Reference source not found.**).
