# **Bord na Móna**

## **Prosperous Bog**

# **Cutaway Bog Decommissioning and Rehabilitation Plan 2022**

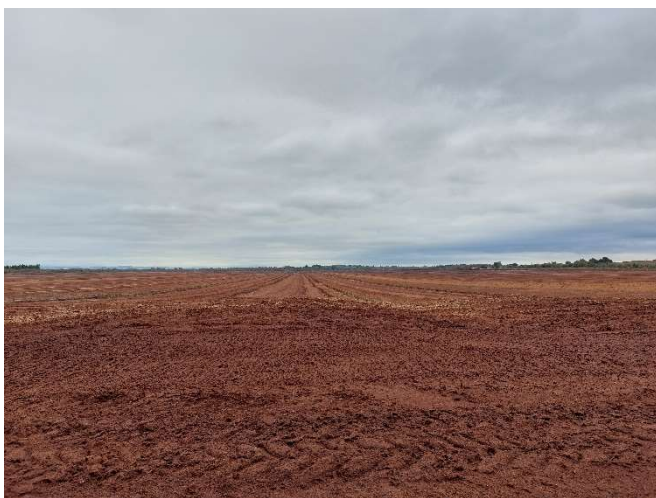
*Bare Peat is the main habitat at Prosperous Bog.*

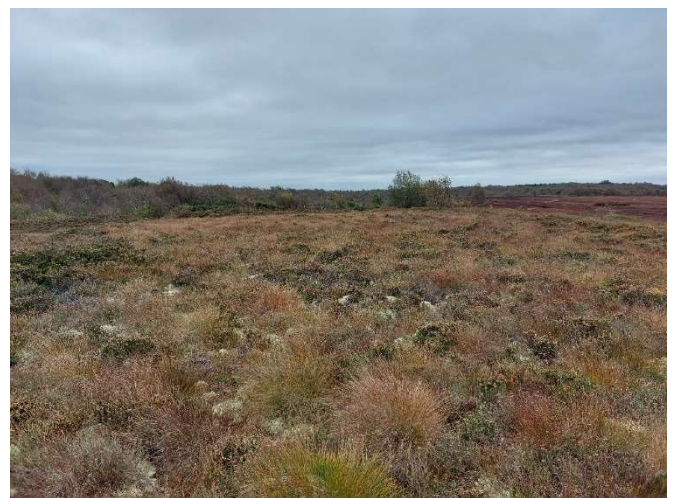
*Cutover bog along the eastern margin of Prosperous.*

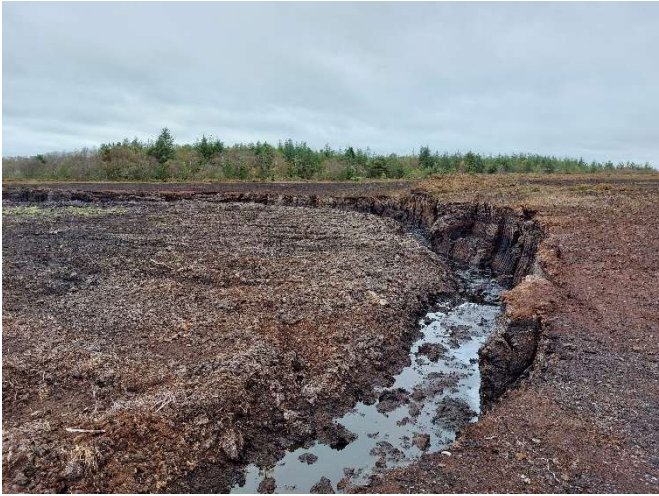
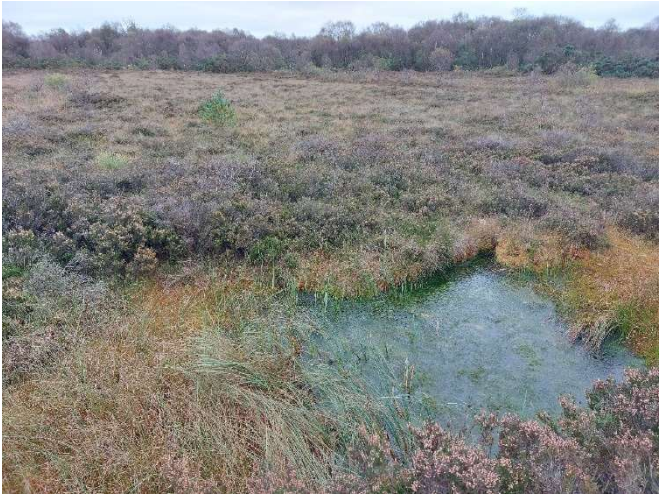
Table 1: Photos of Habitats at Prosperous Bog (October 2021).

<p><i>Turbary area adjacent to the south-western boundary of Prosperous bog</i></p>	<p><i>Heather (<i>Calluna vulgaris</i>) dominated community established on the former cutover areas in the south-east of the site.</i></p>

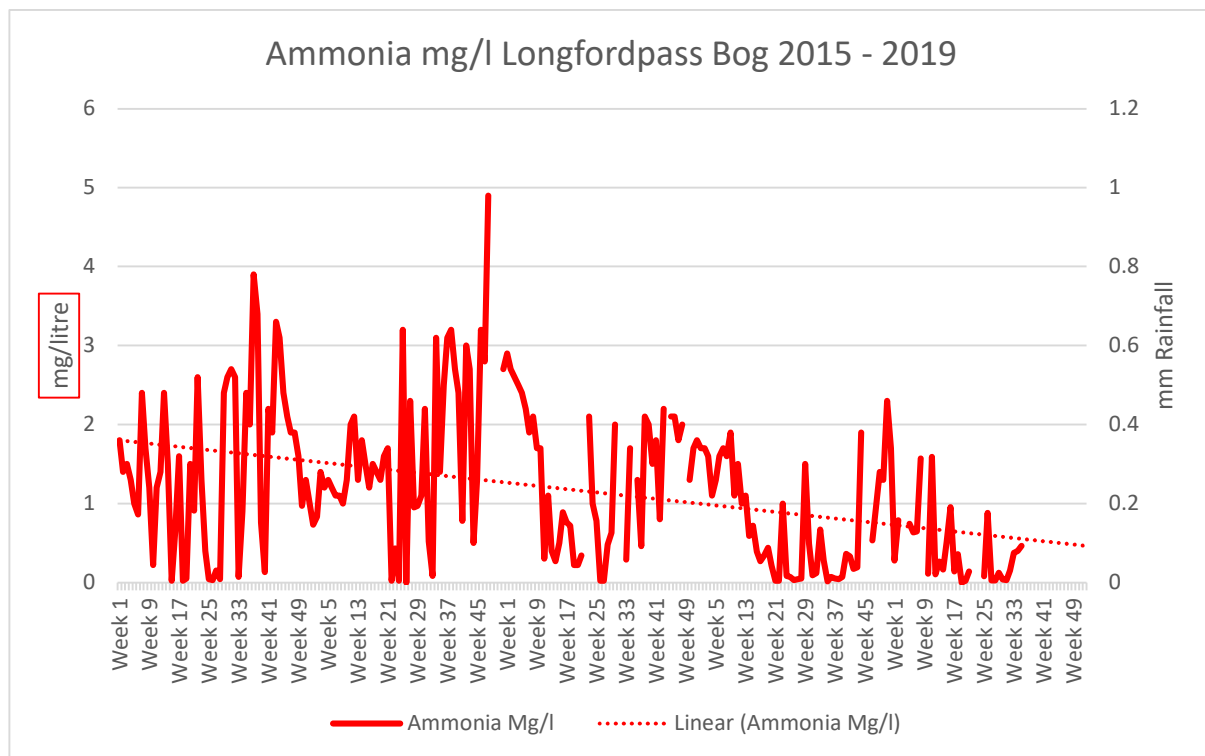
**Plate 7.1** Example of decreasing ammonia emissions at Longfordpass bog following cessation of peat extraction and commencement of rehabilitation.

Similarly monitoring of surface water ammonia emissions from a Corlea bog in Mountdillon over the past 4 yrs. post cessation of peat extraction with ongoing rehabilitation, indicate downward trends.

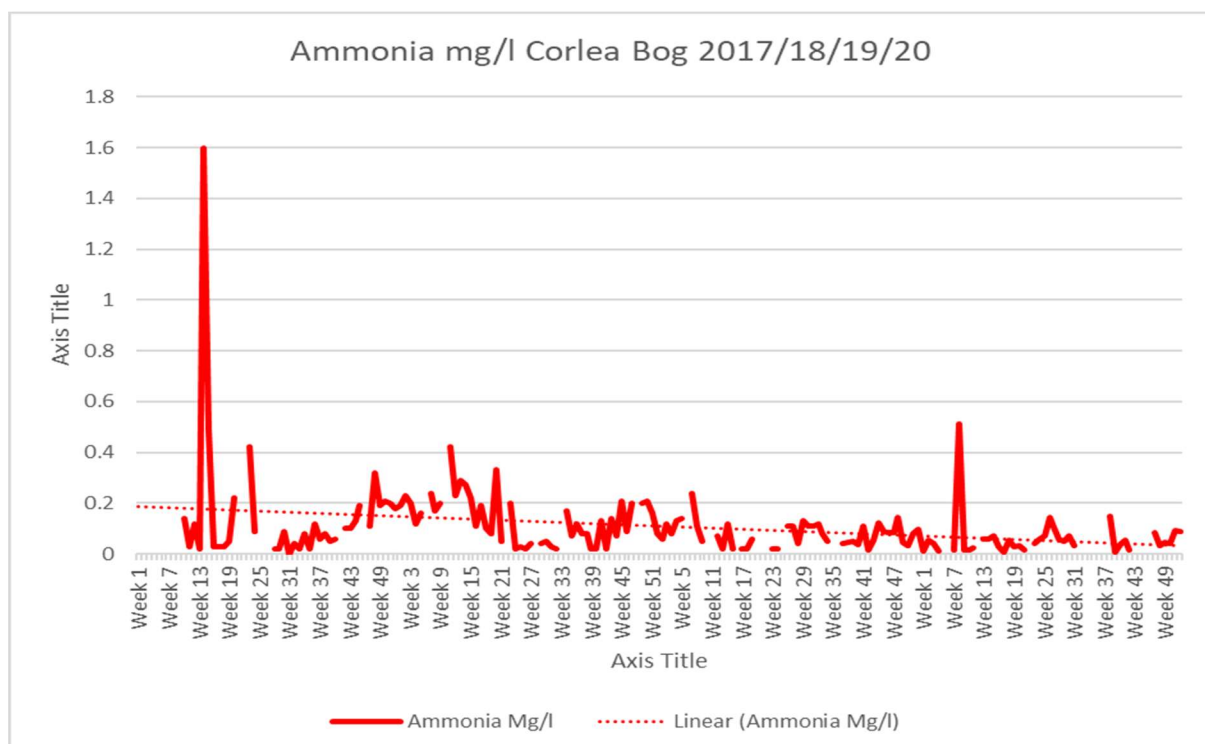
**Plate 7.2** Example of decreasing ammonia emissions at Corlea bog following cessation of peat extraction and commencement of rehabilitation

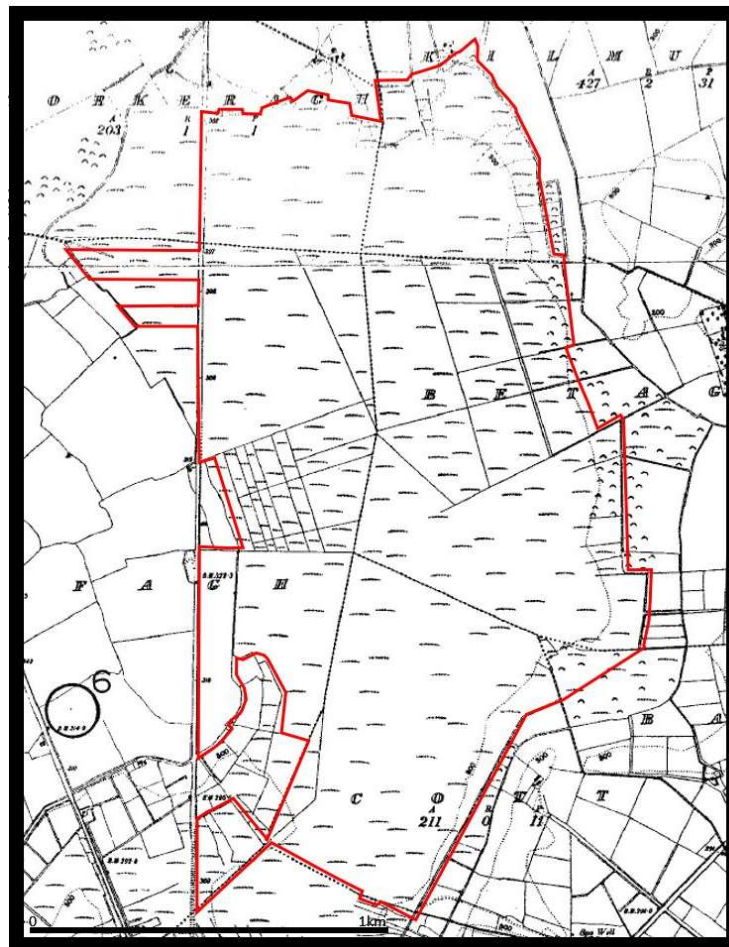
Fig. 1. Prosperous Bog, Co. Kildare, detail of the RMP map sheets Nos. 9 and 13. The proposed rehabilitation area is outlined with the red line. There are no RMPs in the rehabilitation area.

The Record of Monuments and Places (RMP) for Co. Kildare which was established under Section 12 of the National Monuments (Amendment) Act, 1994 was examined as part of the assessment (DAHGI 1995). This record was published by the Minister in 1996 and includes sites and monuments that were known in Prosperous Bog before that date. This review established that there are no RMPs located in the proposed rehabilitation area (see Fig. 1).

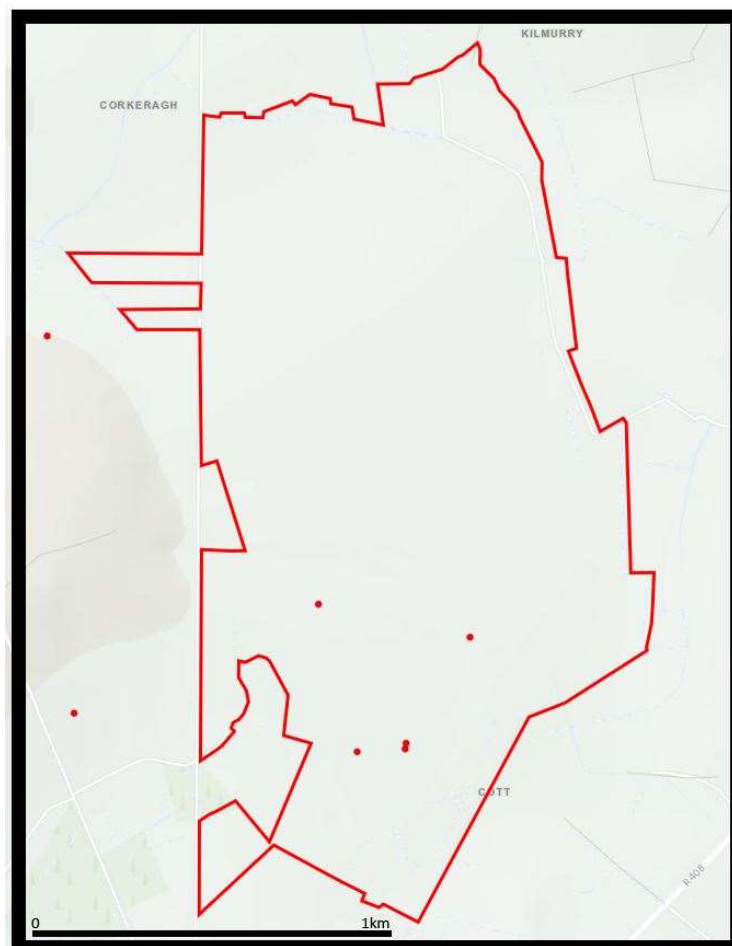
Fig. 2. Prosperous Bog, Co. Kildare, detail of the SMR. The proposed rehabilitation area is outlined with the red line. There are five SMRs in the rehabilitation area.

The Sites and Monuments Record (SMR) which is maintained by the Department of Housing, Local Government and Heritage was examined as part of the assessment on the 25th of November 2021. The SMR consists of records included in the RMP and sites and monuments notified to the Dept. since the publication of the RMP. This review established that there are five entries in the SMR in the proposed rehabilitation area (see Table 1). These entries are the material notified by the Peatland Survey 2005 and are classified as Structure – peatland.

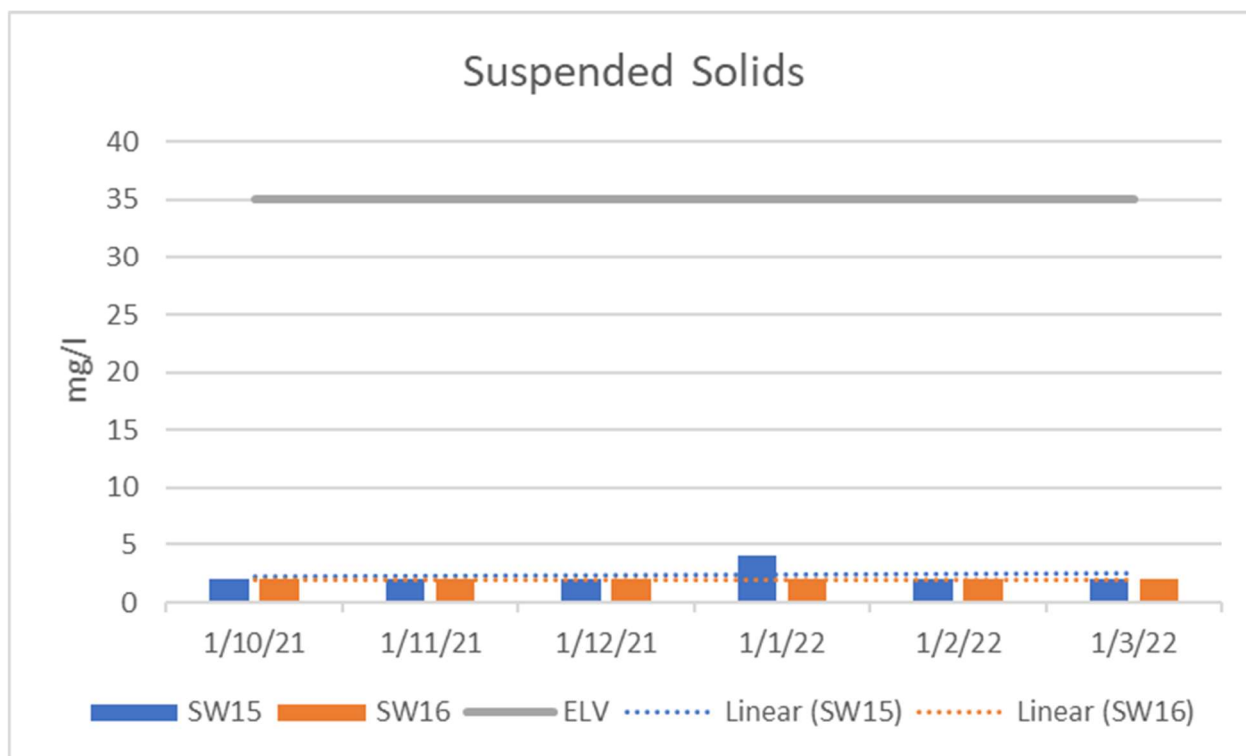
Figure AP13.1. Suspended solids in water sampling at Prosperous from different discharge points. 35 mg/l is the emission limit value.

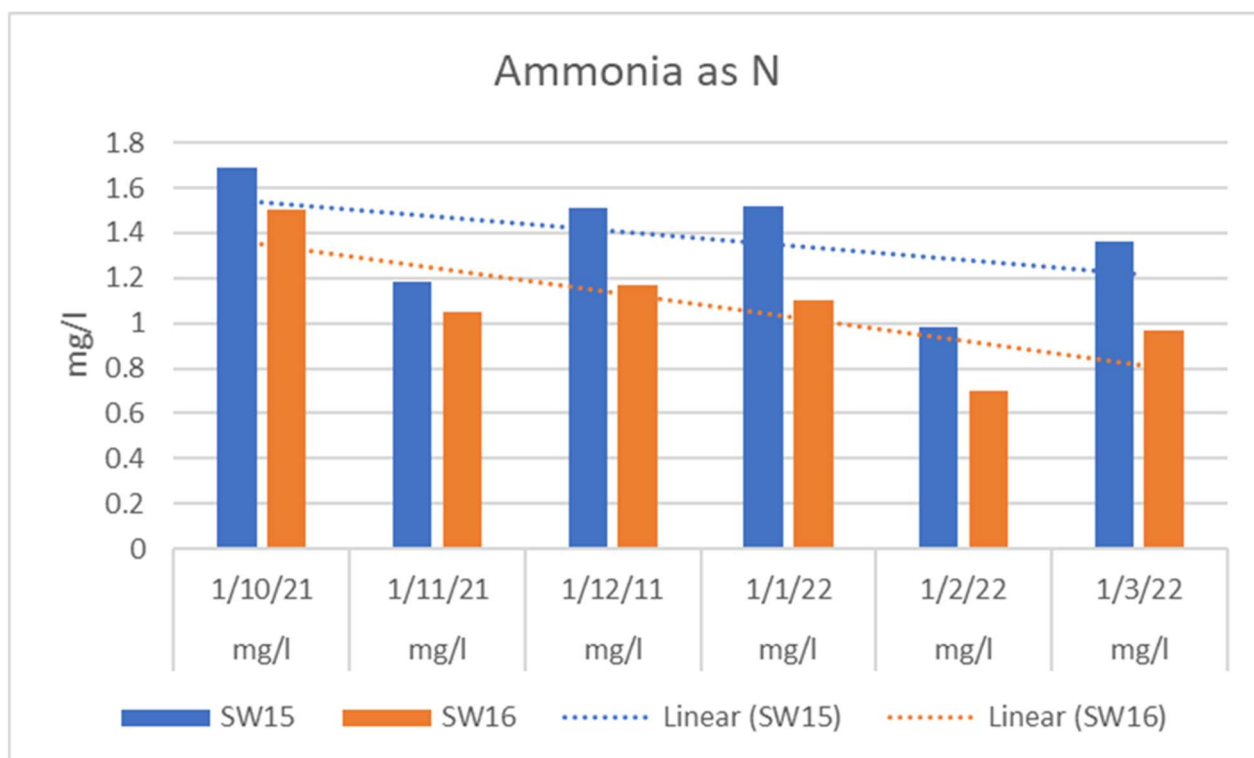
Figure AP13.2. Ammonia concentrations in water sampling from Prosperous from different discharge points. The main trigger level for ammonia is 4.53mg/l for reporting to EPA.
