Bord na Móna

Knappoge Bog

**Cutaway Bog Decommissioning and
Rehabilitation Plan 2022**

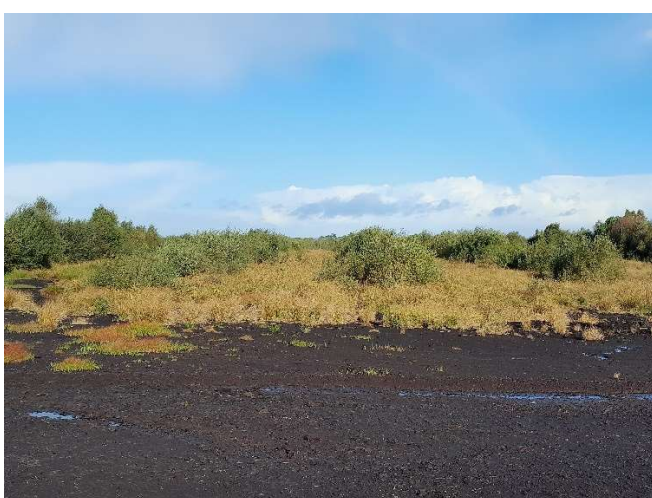
Pioneering vegetation on cutaway including Scrub and Soft Rush dominated Poor fen (Oct 2021)

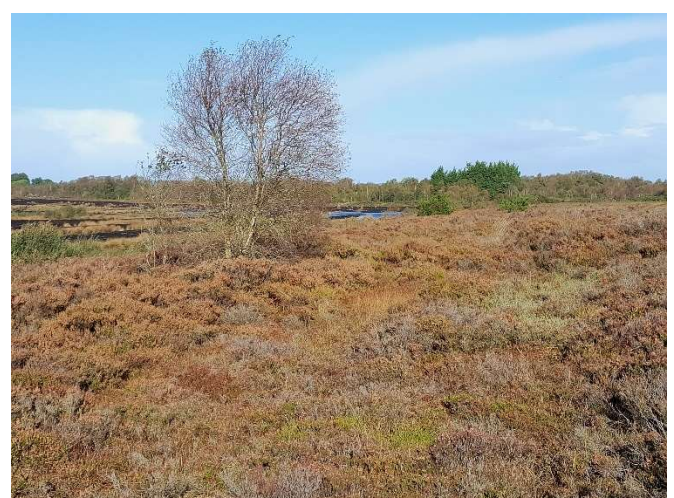
Bog vegetation with Sphagnum within raised bog remnant on north east of site (Oct 2021)

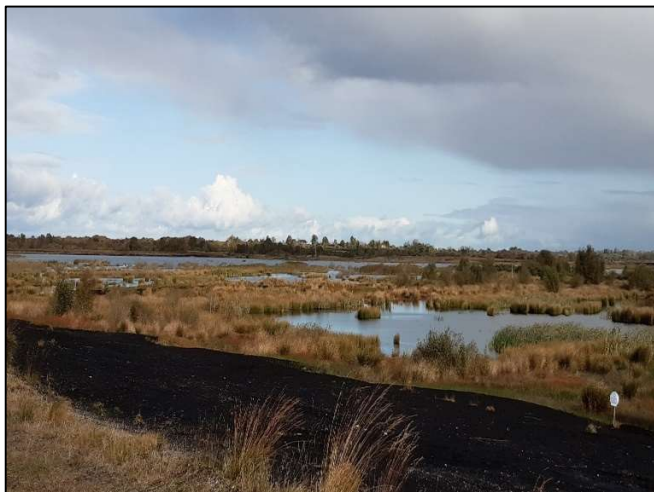
Mesotrophic lake and wetland habitats developing at Knappoge Bog west (Oct 2020)

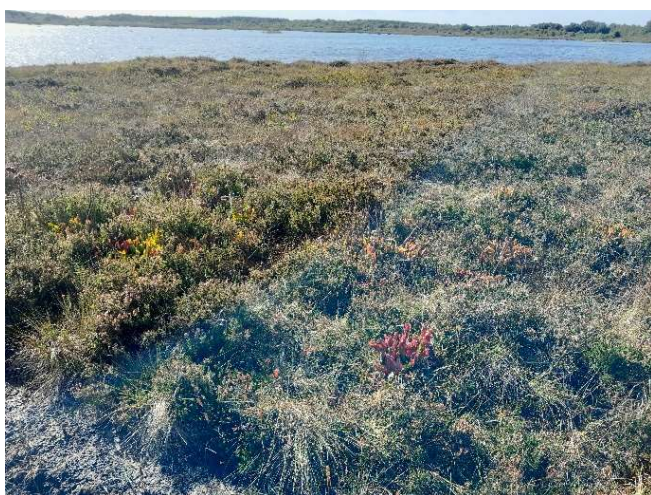
Invasive Canadian Pitcher Plant on Knappoge bog

The invasive species Canadian Pitcher Plant (*Sarracenia purpurea*) was noted during a survey of Knappoge bog in October 2021 (see **Error! Reference source not found.**).

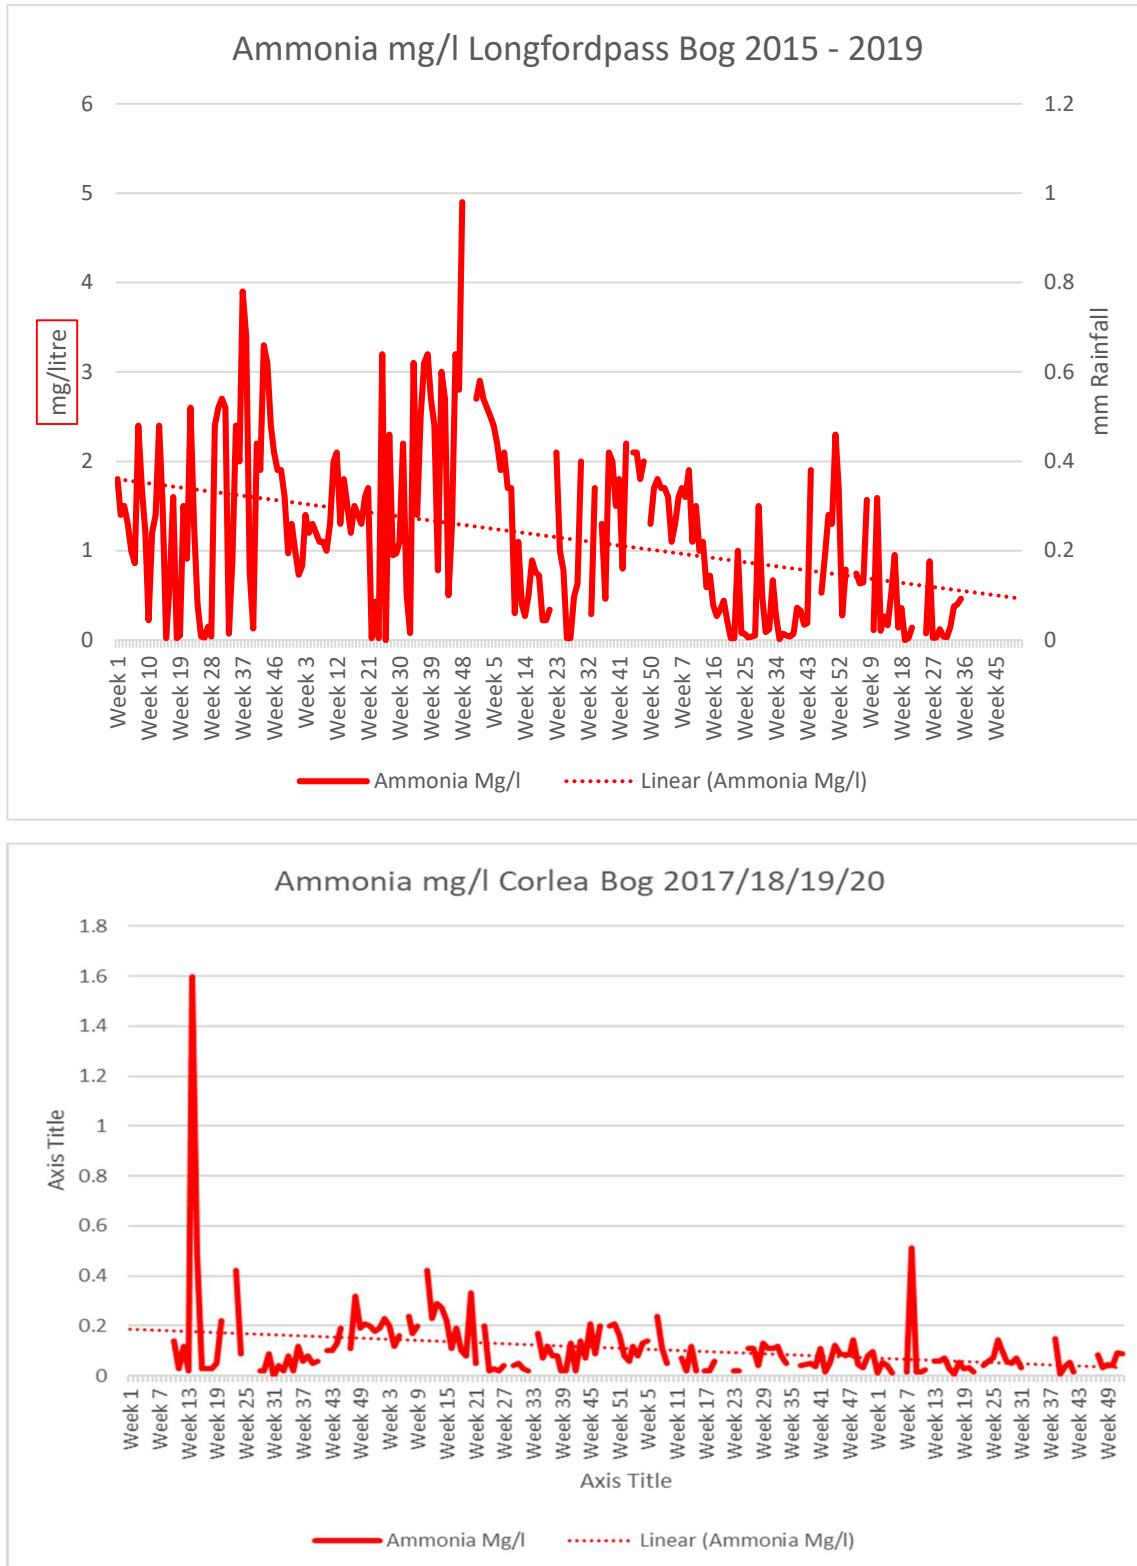
Figure 1 Ammonia levels over the period 2015-2019/2020 at Longfordpass and Corlea.

Similarly monitoring of surface water ammonia emissions from a Corlea bog in Mountdillon over the past 4 yrs. post cessation of peat extraction with ongoing rehabilitation, indicate downward trends.

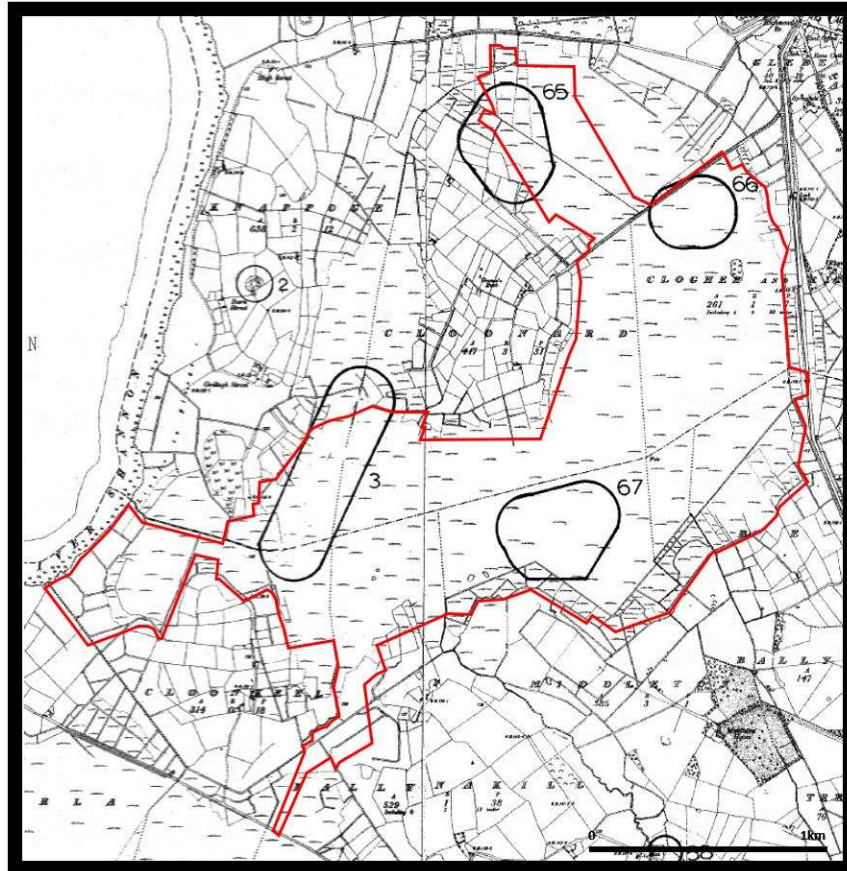
Fig. 1. Knappoge Bog, Co. Longford, detail of the Record of Monuments and Places map sheets Nos. 12 and 13. The proposed rehabilitation area is outlined with the red line. There are a several Recorded Monuments in the rehabilitation area.

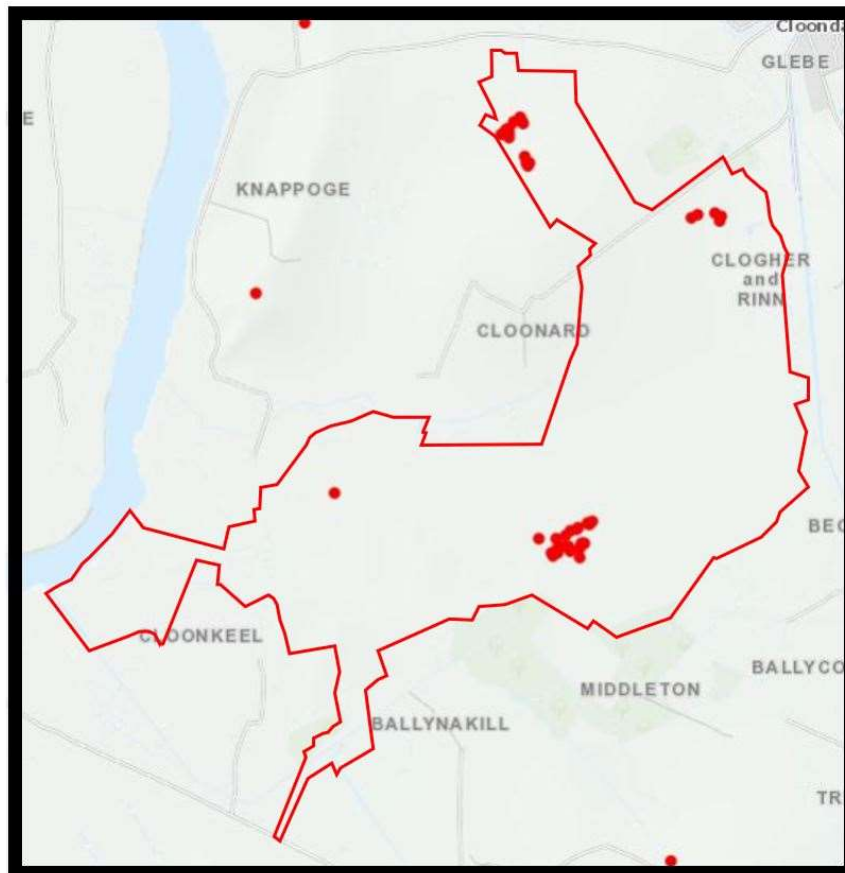
Fig. 2. Knappoge Bog, Co. Longford, detail of the Sites and Monuments Record. The proposed rehabilitation area is outlined with the red line. There are a large number of SMRs in the rehabilitation area.

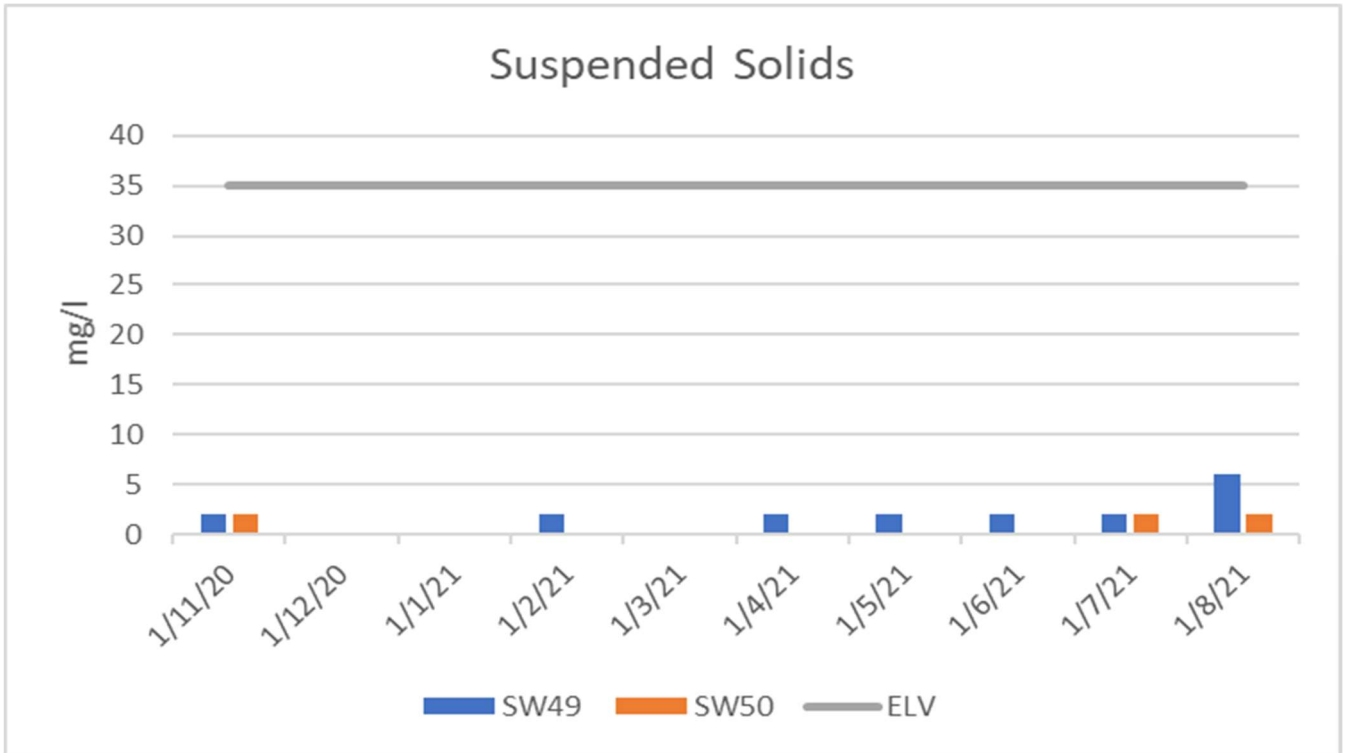
Figure AP13.1. Suspended solids in water sampling at Knappoge from different discharge points. 35 mg/l is the emission limit value.

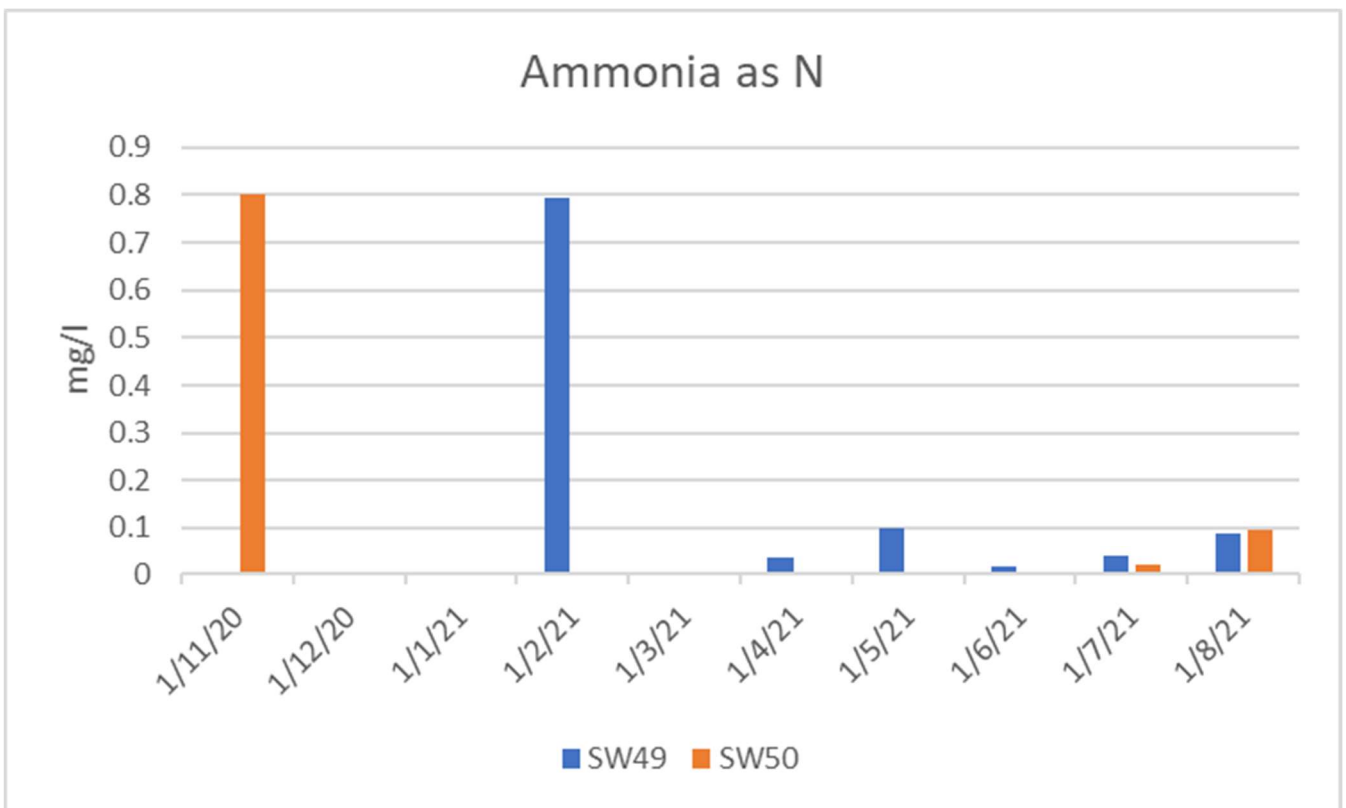
Figure AP13.2. Ammonia concentrations in water sampling from Knappoge from different discharge points. The main trigger level for ammonia is 4.53mg/l for reporting to EPA.
