Bord na Móna

Enhanced Decommissioning, Restoration and Rehabilitation Scheme (EDRRS)

Annual Report – Year 1

Commencement of Scheme to March 2022

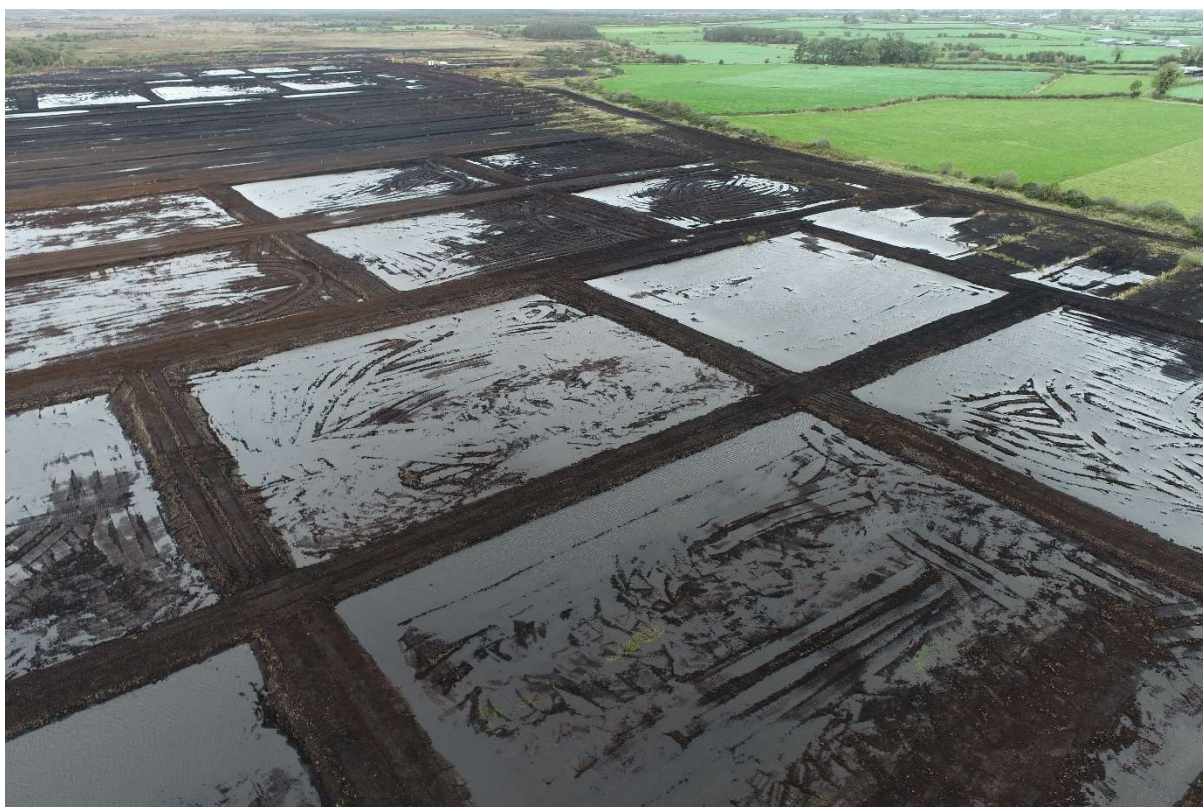
Plate B1.1: Belmont Bog rehabilitation measures – October 2021

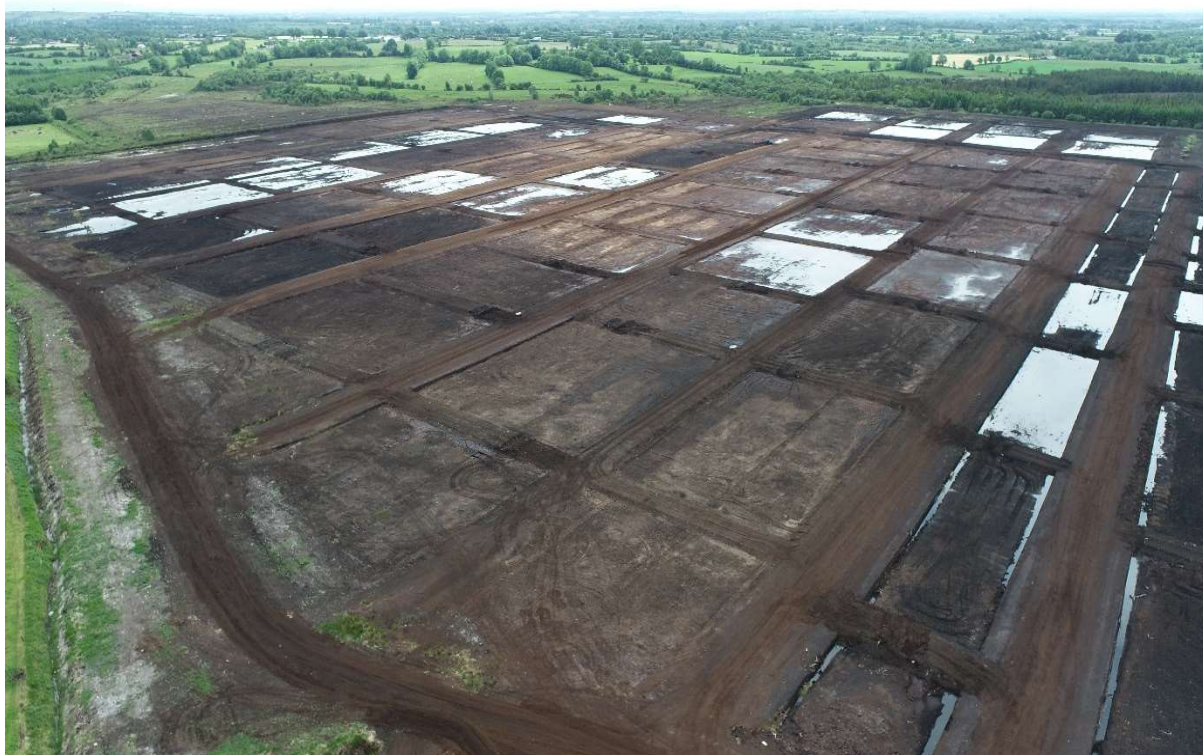
Plate B1.2: Belmont Bog rehabilitation measures – June 2022

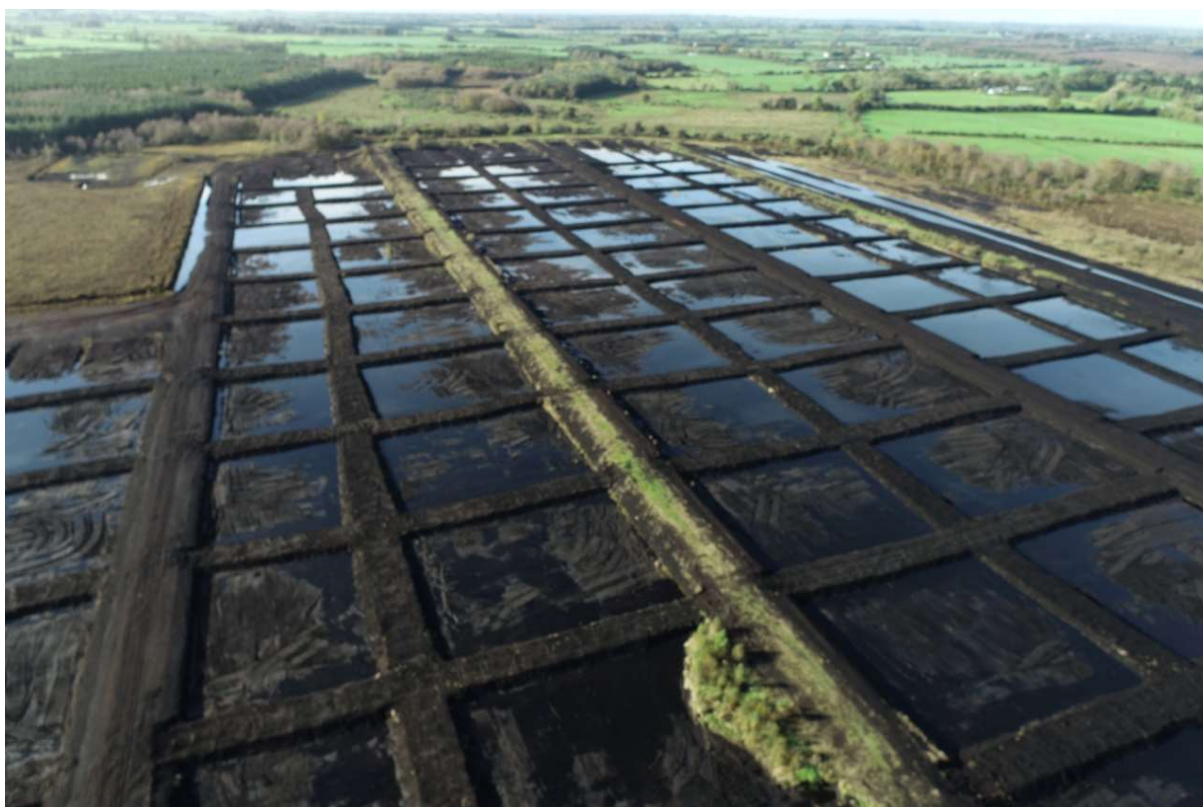
Plate B3.1: Garryduff Bog rehabilitation measures – October 2021

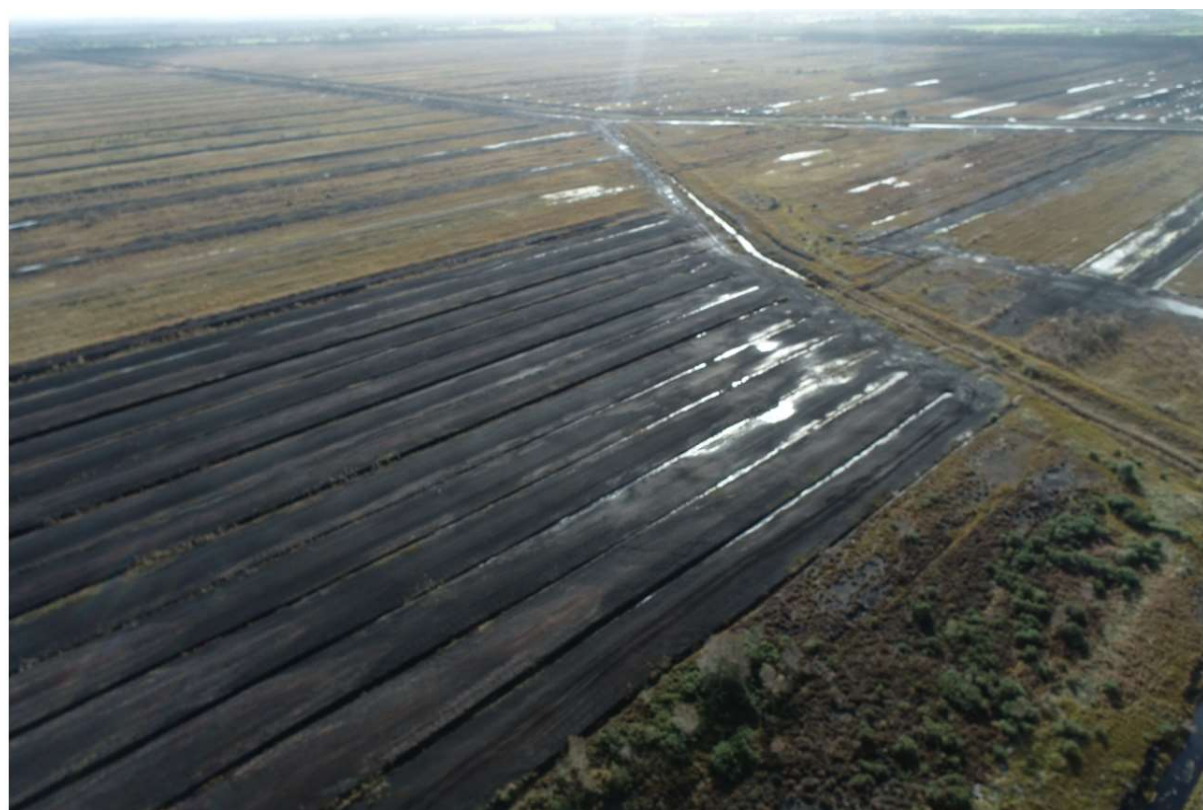
Plate B3.2: Garryduff Bog rehabilitation measures – October 2021

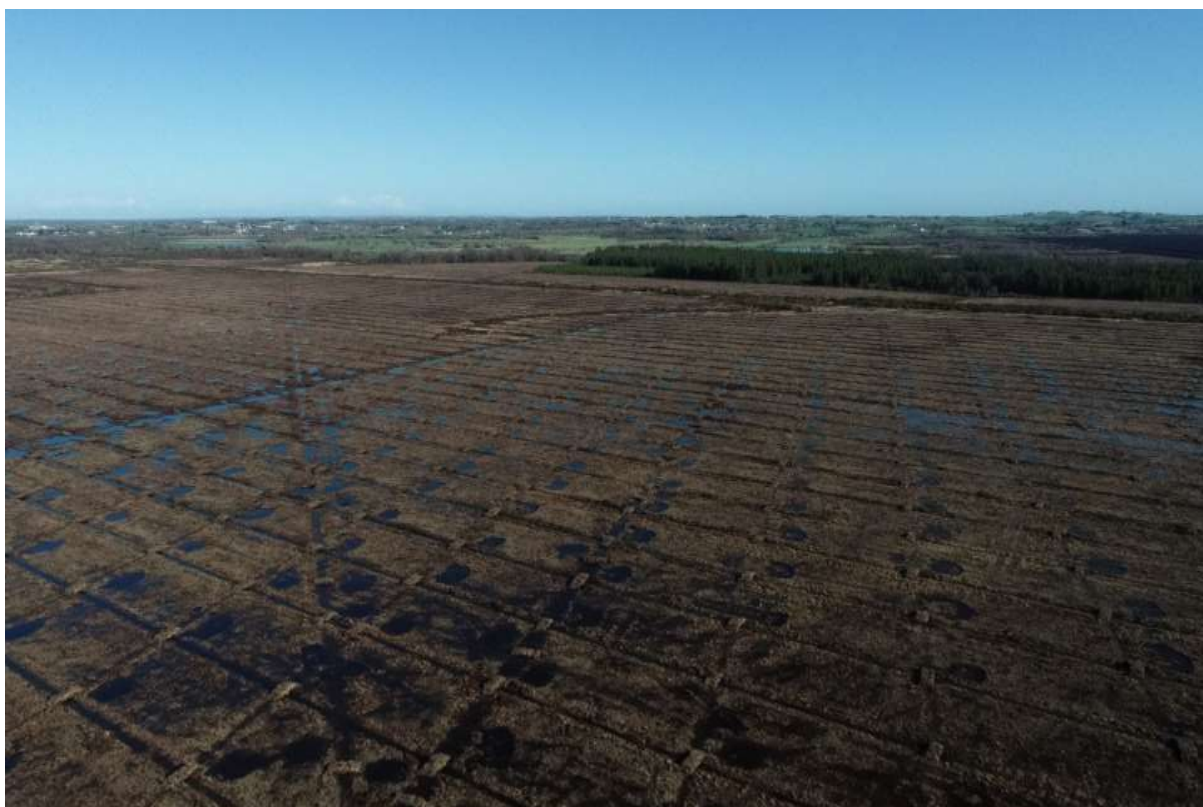
Plate B4.1: Kellysgrove Bog rehabilitation measures – March 2022

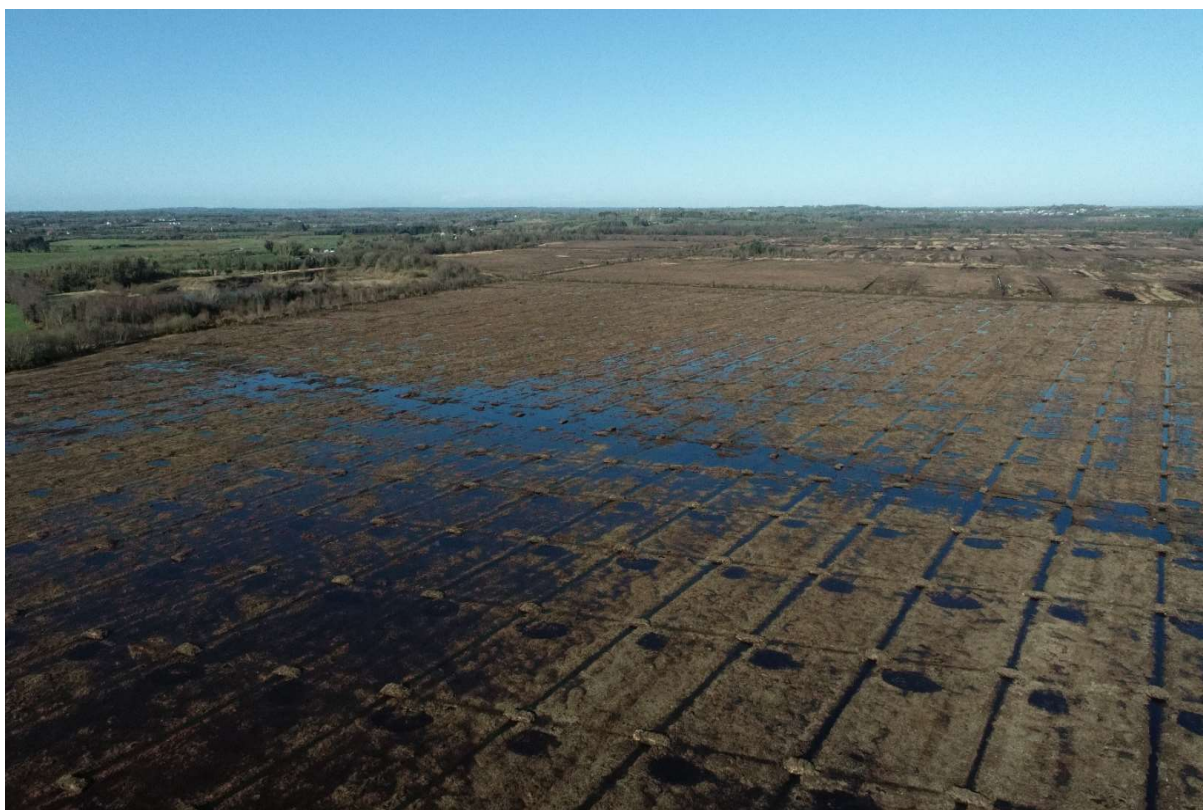
Plate B4.2: Kellysgrove Bog rehabilitation measures – March 2022

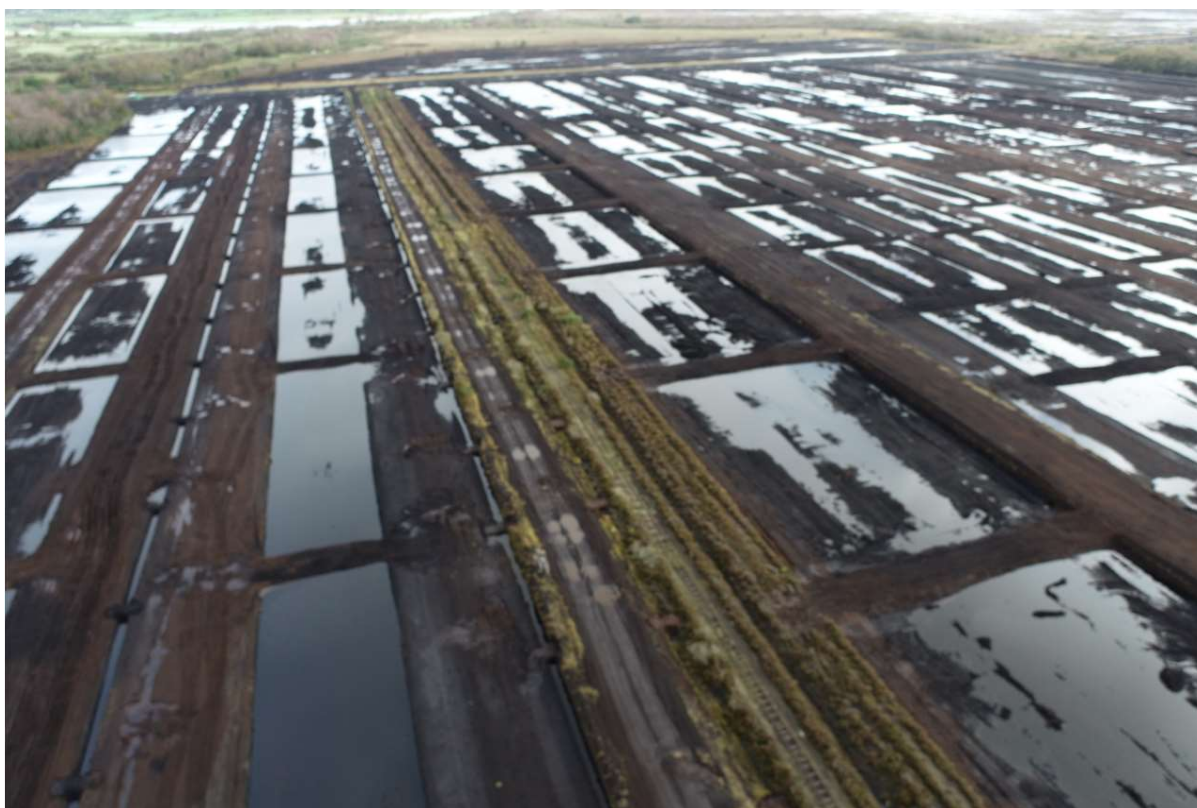
Plate B5.1: Kilmacshane Bog rehabilitation measures – October 2021

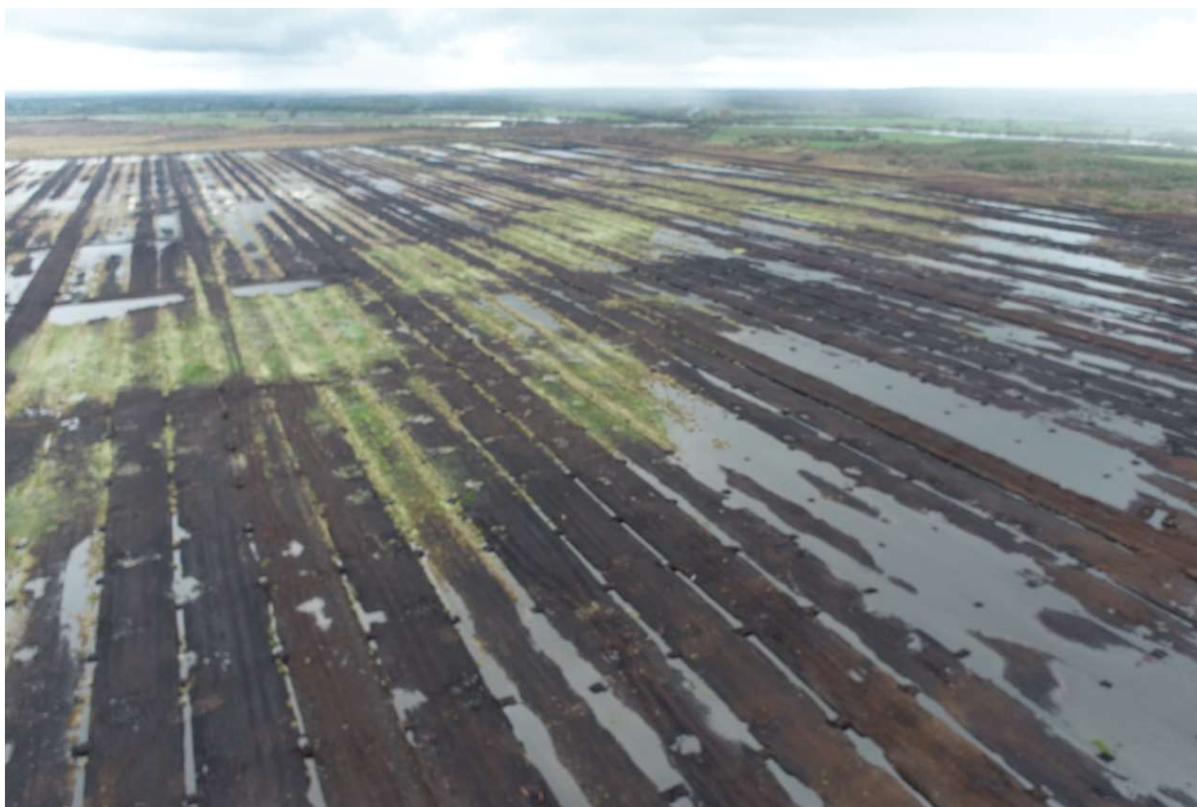
Plate B5.2: Kilmacshane Bog rehabilitation measures – October 2021

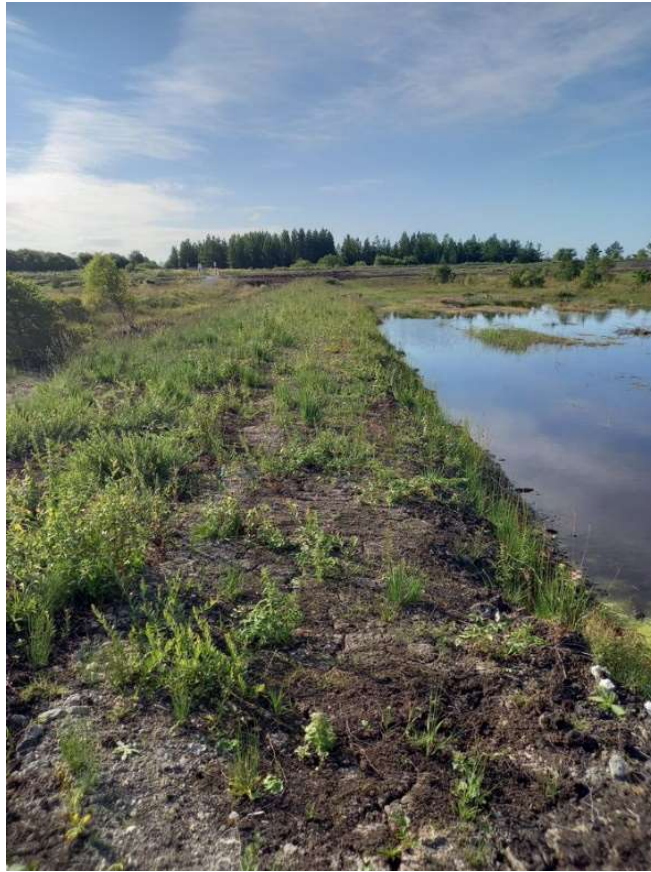
Plate B6.2 Boora Bog rehabilitation measures – July 2022

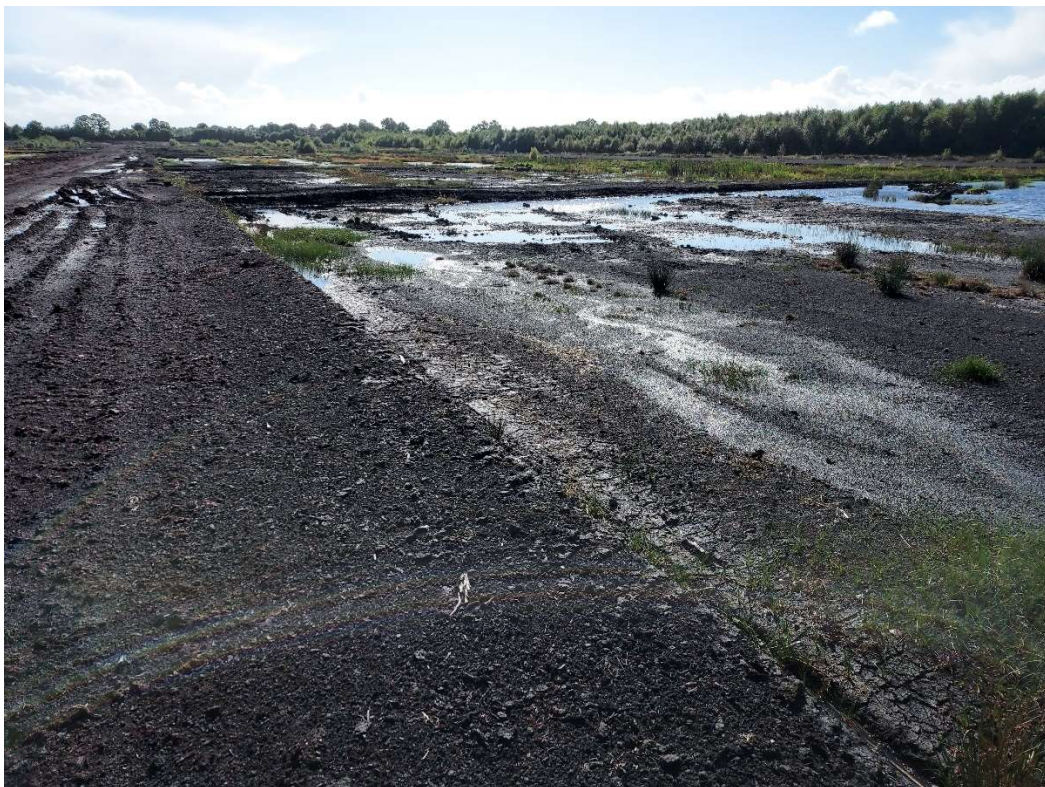
Plate B6.1 Boora Bog rehabilitation measures – Oct 2022

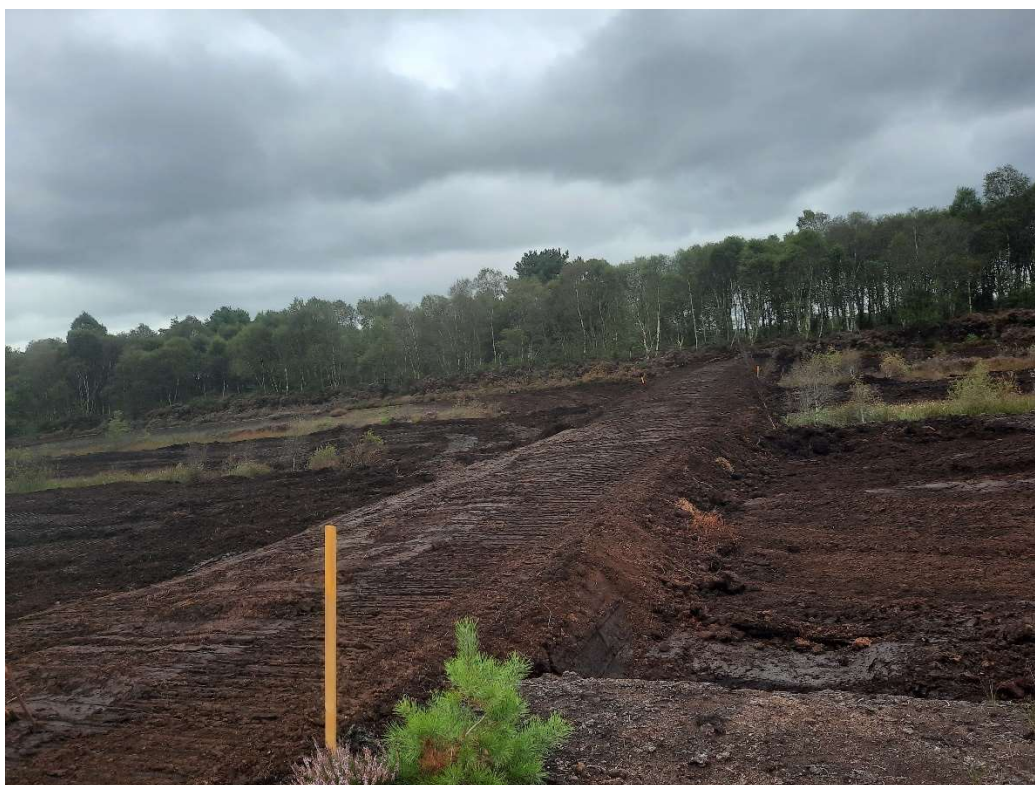
Plate B7.1: Derries Bog rehabilitation measures – August 2021

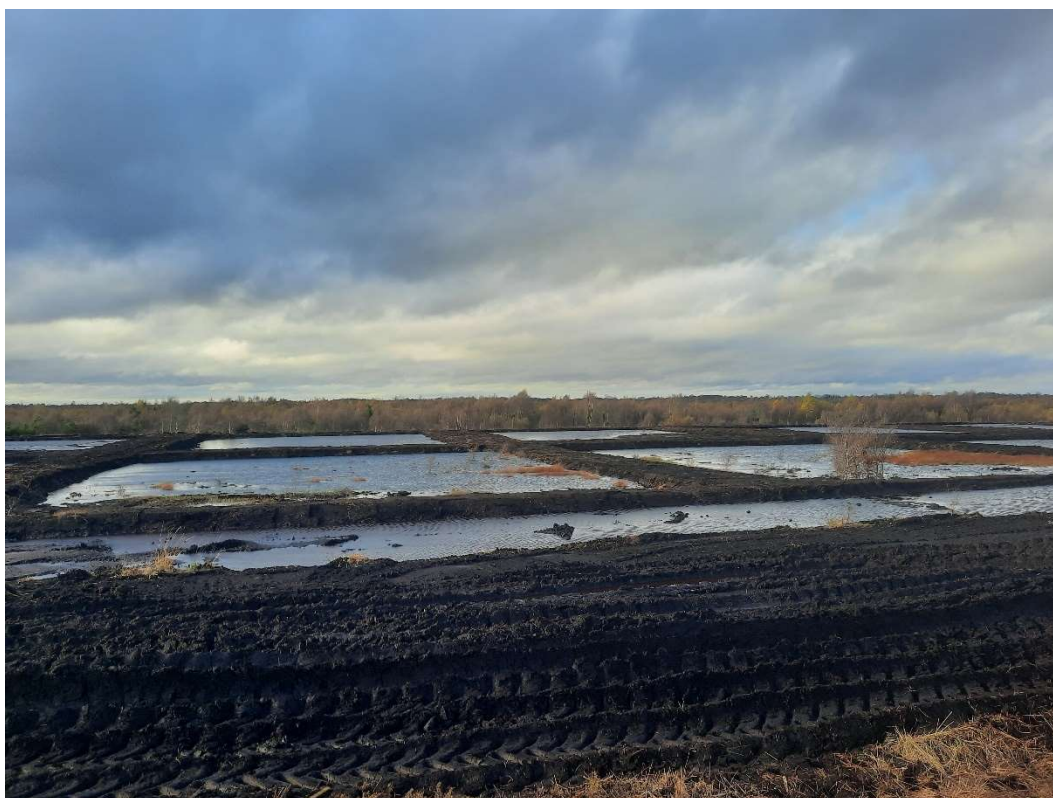
Plate B7.2: Derries Bog rehabilitation measures – October 2021

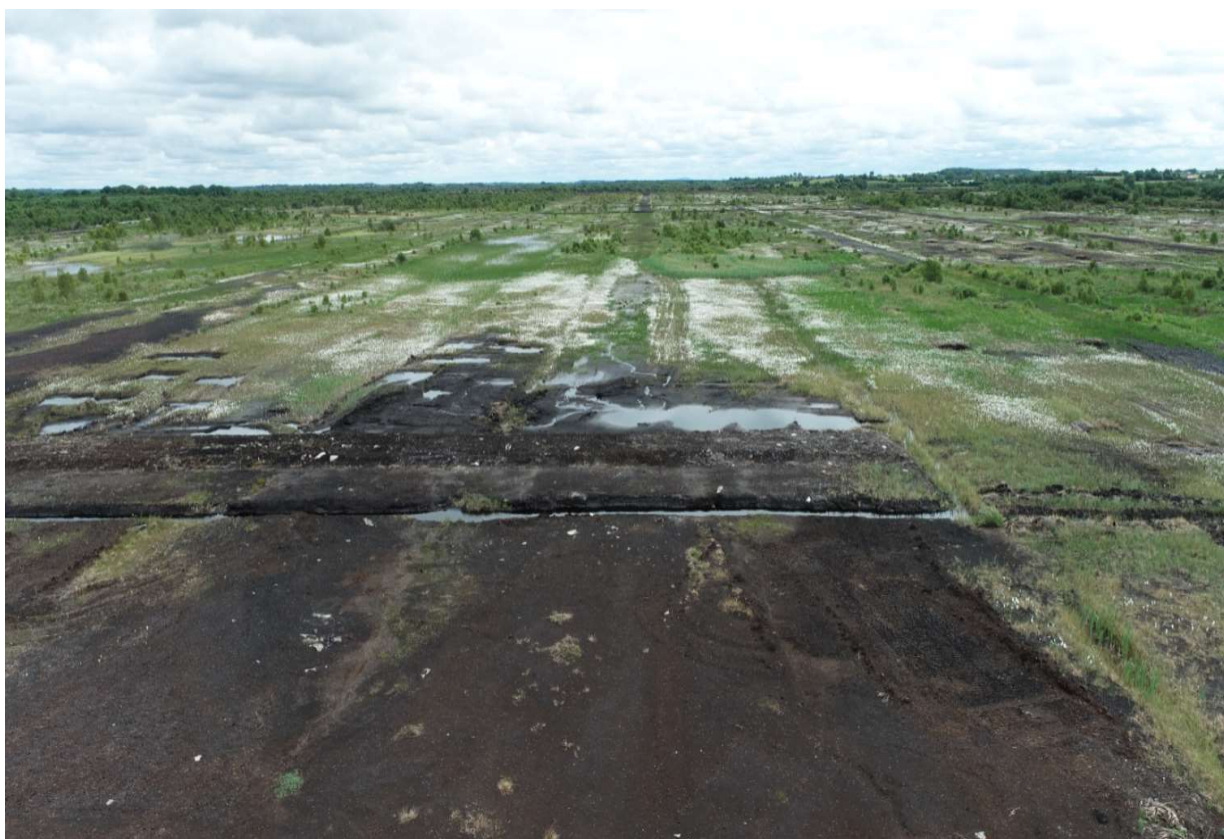
Plate B8.1: Oughter Bog rehabilitation measures – June 2022

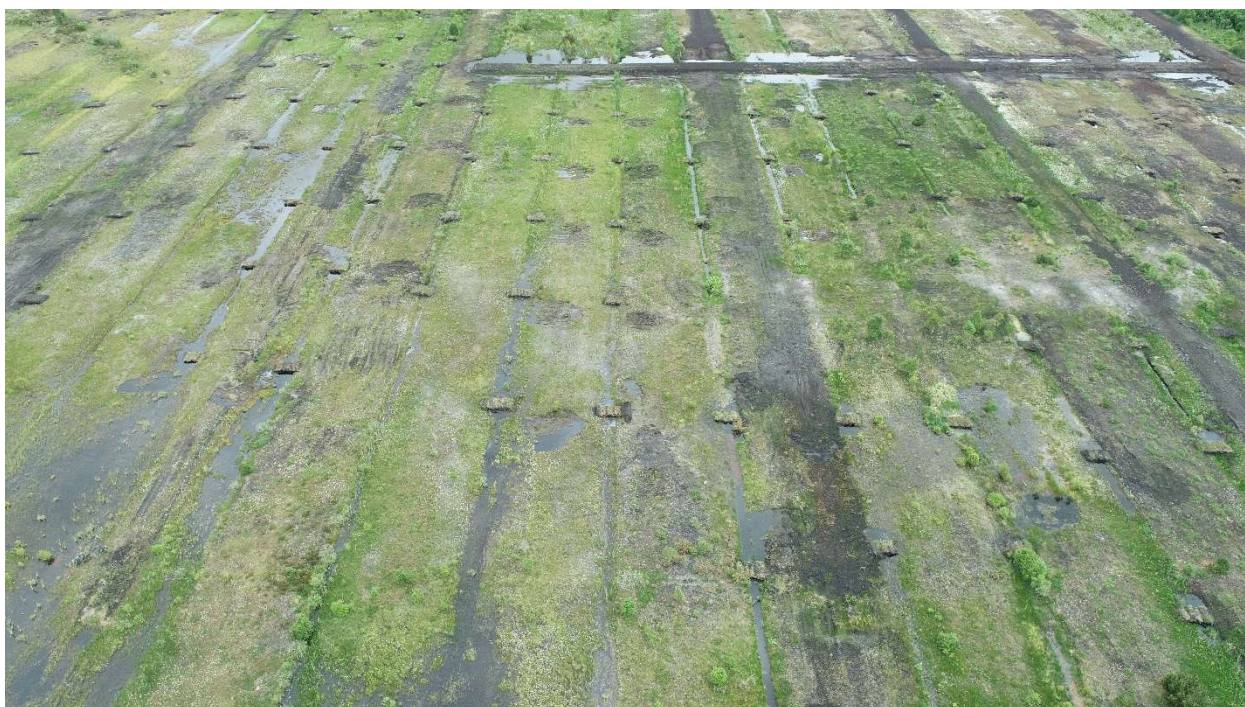
Plate B8.2: Oughter Bog rehabilitation measures – June 2022

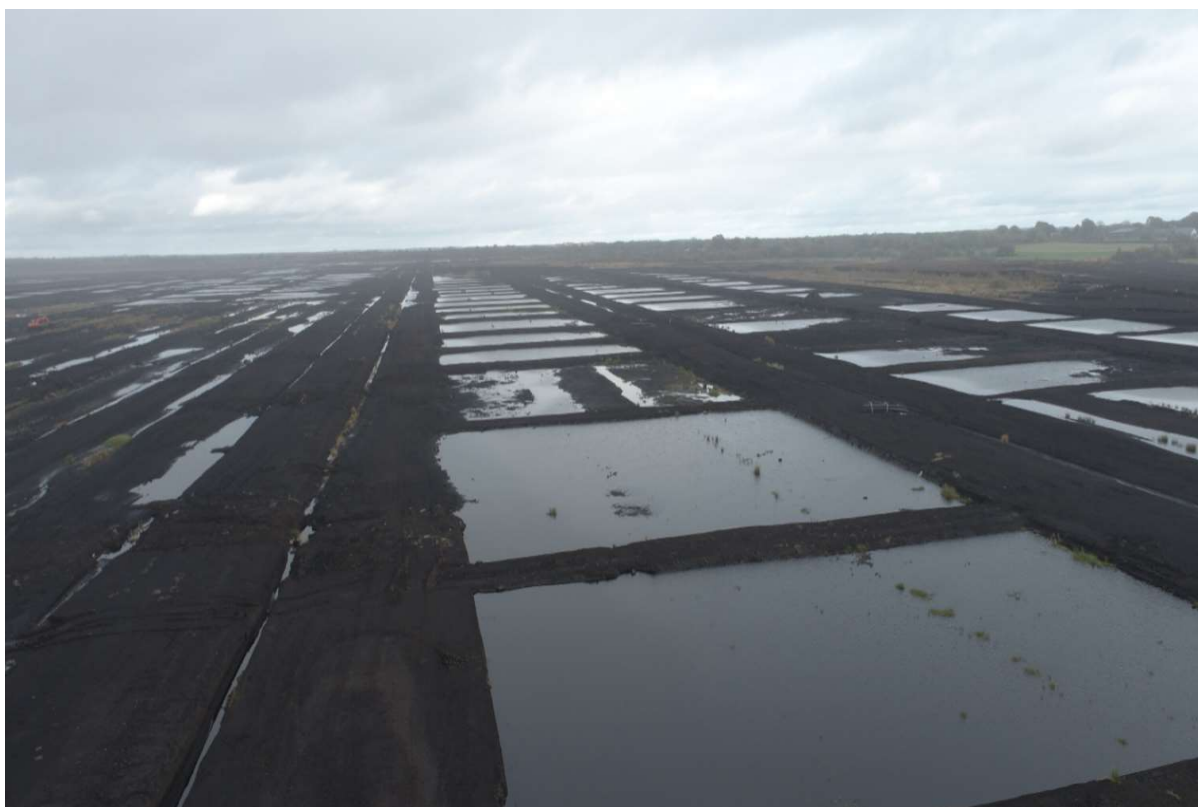
Plate B9.1: Pollagh Bog rehabilitation measures – November 2021

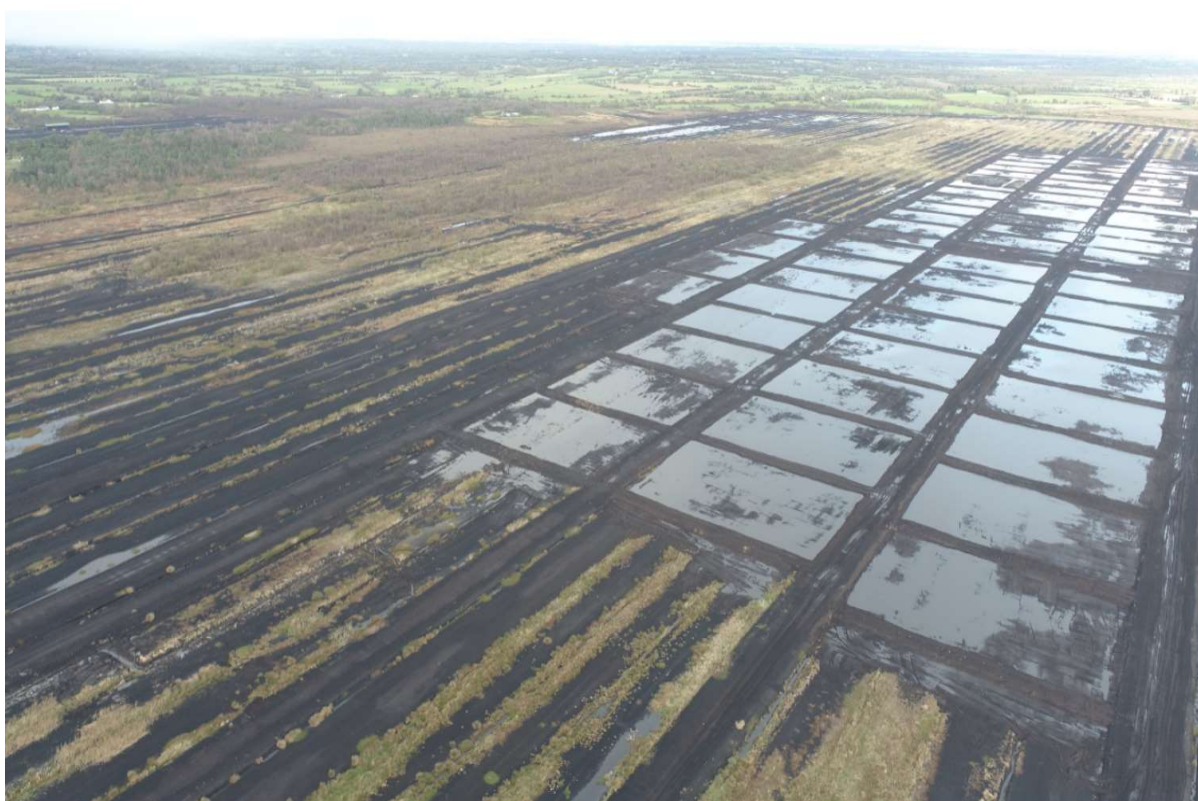
Plate B9.2: Pollagh Bog rehabilitation measures – November 2021

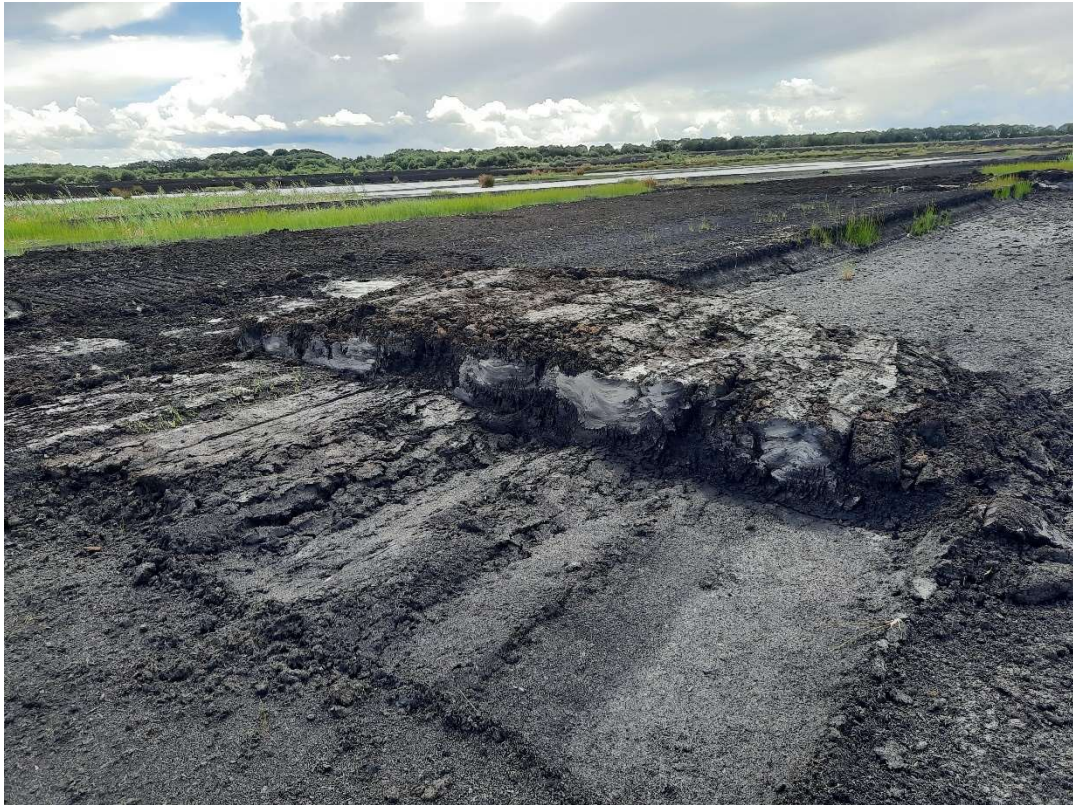
Plate B10.1: Turraun Bog rehabilitation measures – July 2021

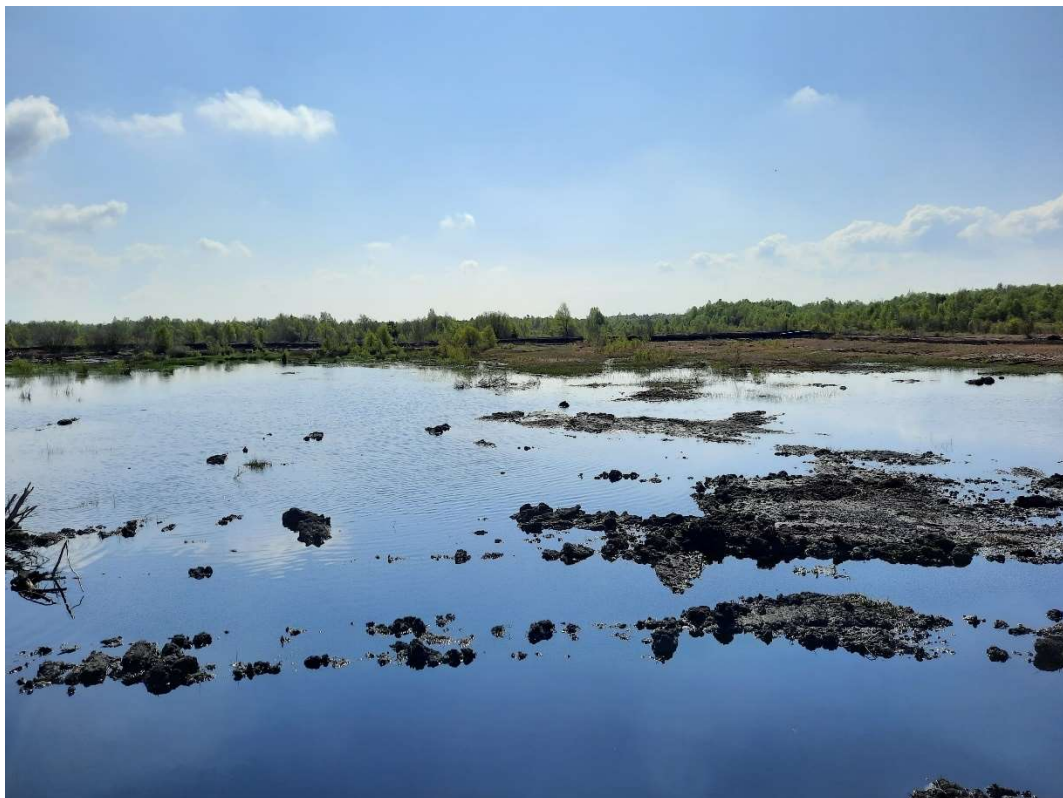
Plate B10.2: Turraun Bog rehabilitation measures – April 2021

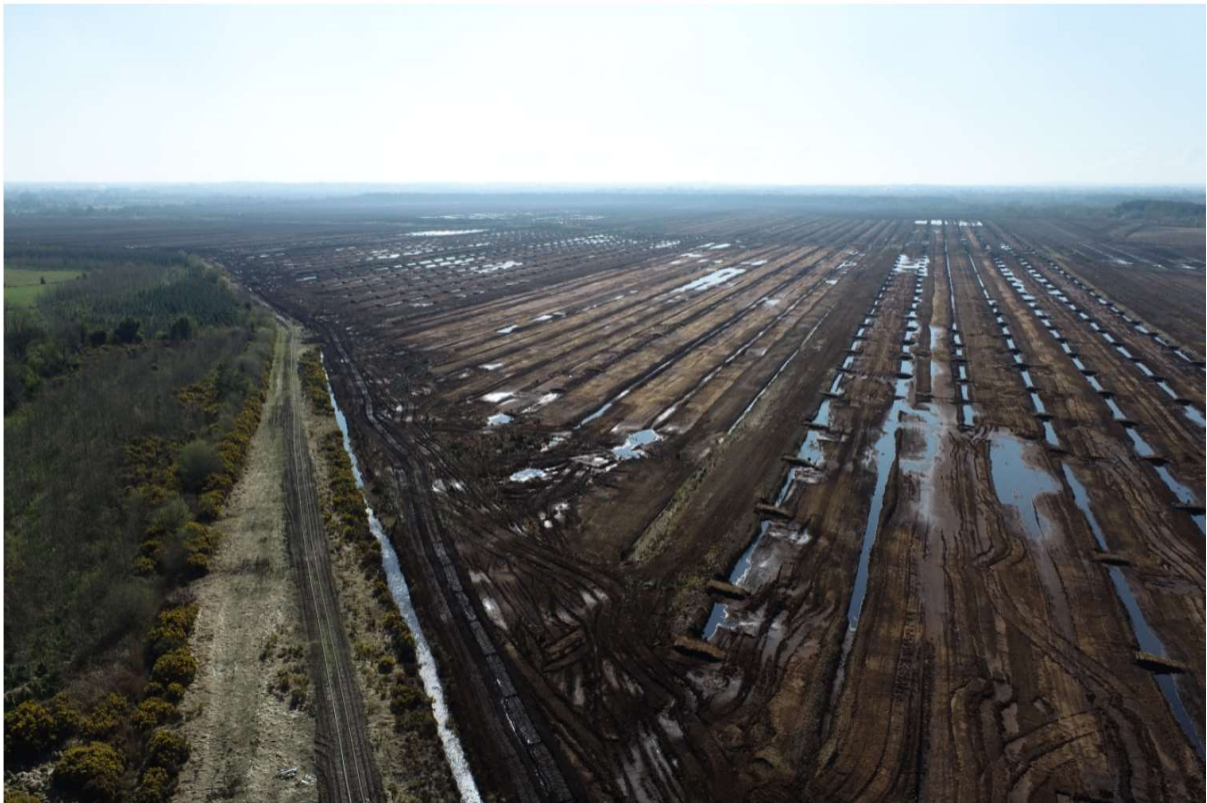
Plate B11.1: Castlegar Bog rehabilitation measures – April 2021

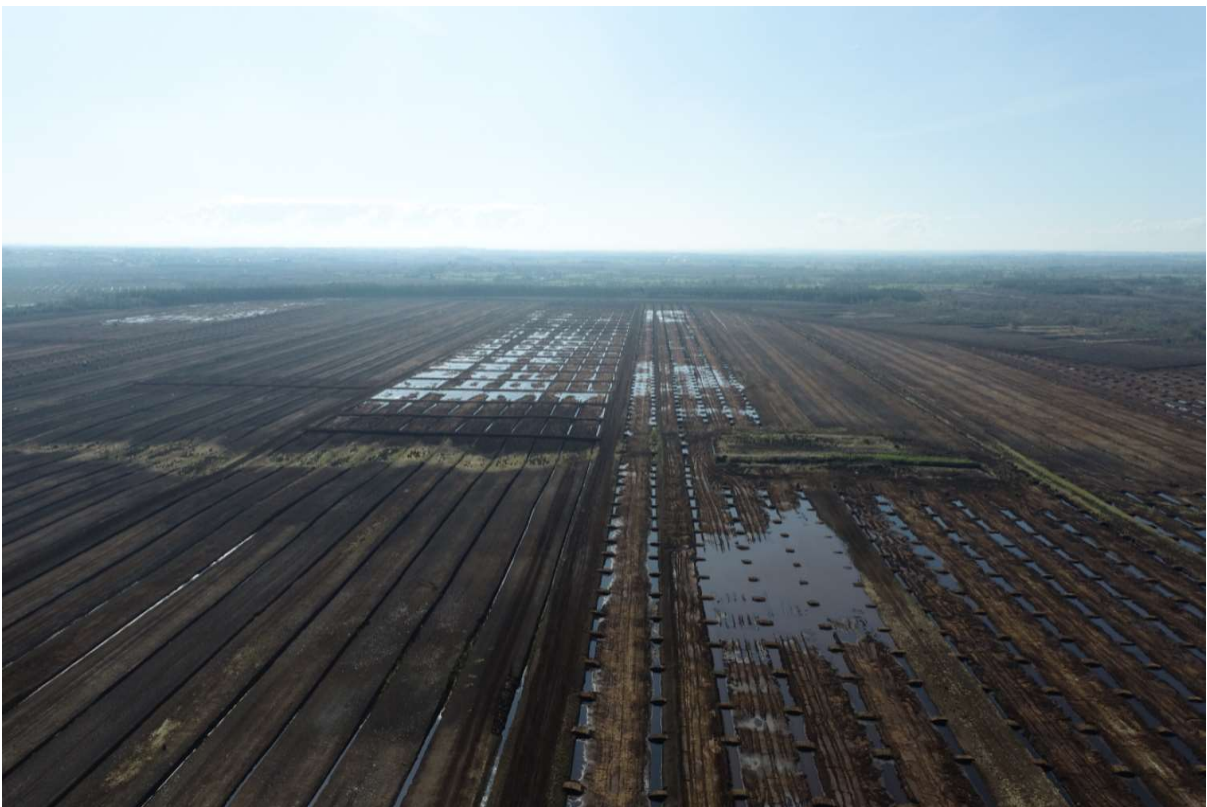
Plate B11.2: Castlegar Bog rehabilitation measures – April 2021

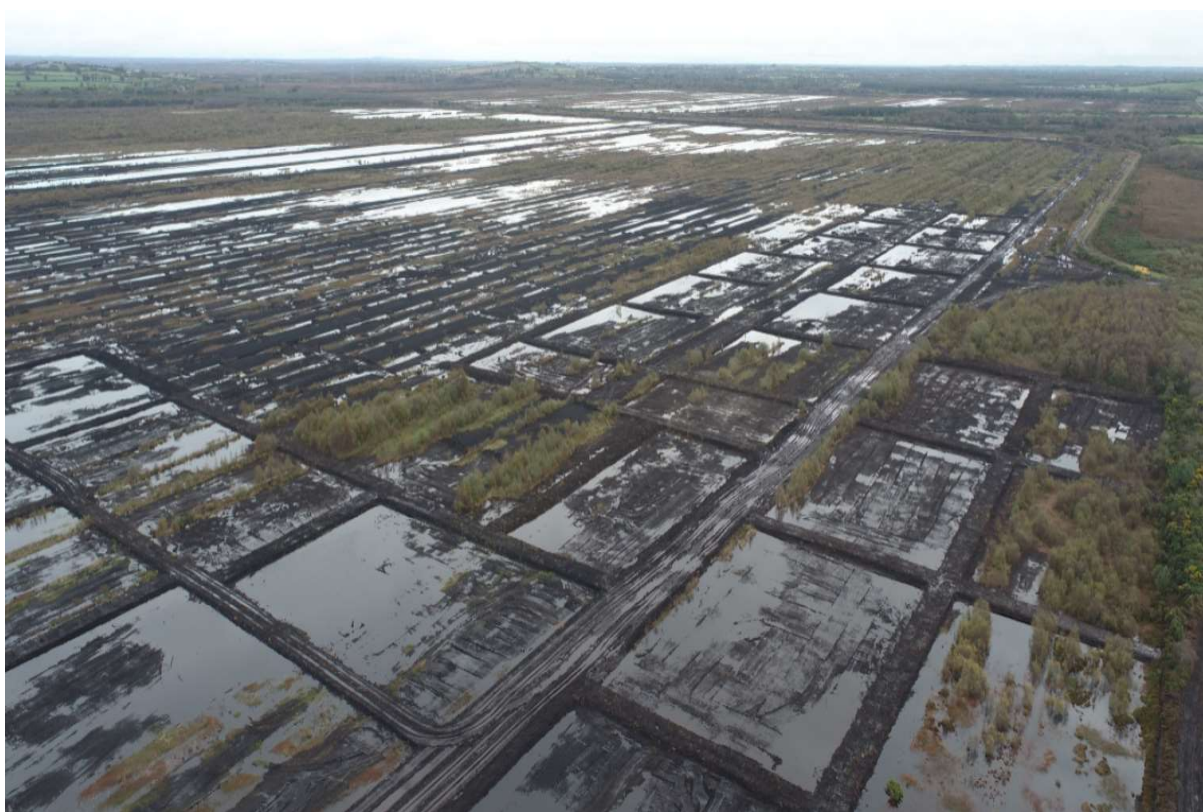
Plate B12.1: Cavemount Bog rehabilitation measures – October 2021

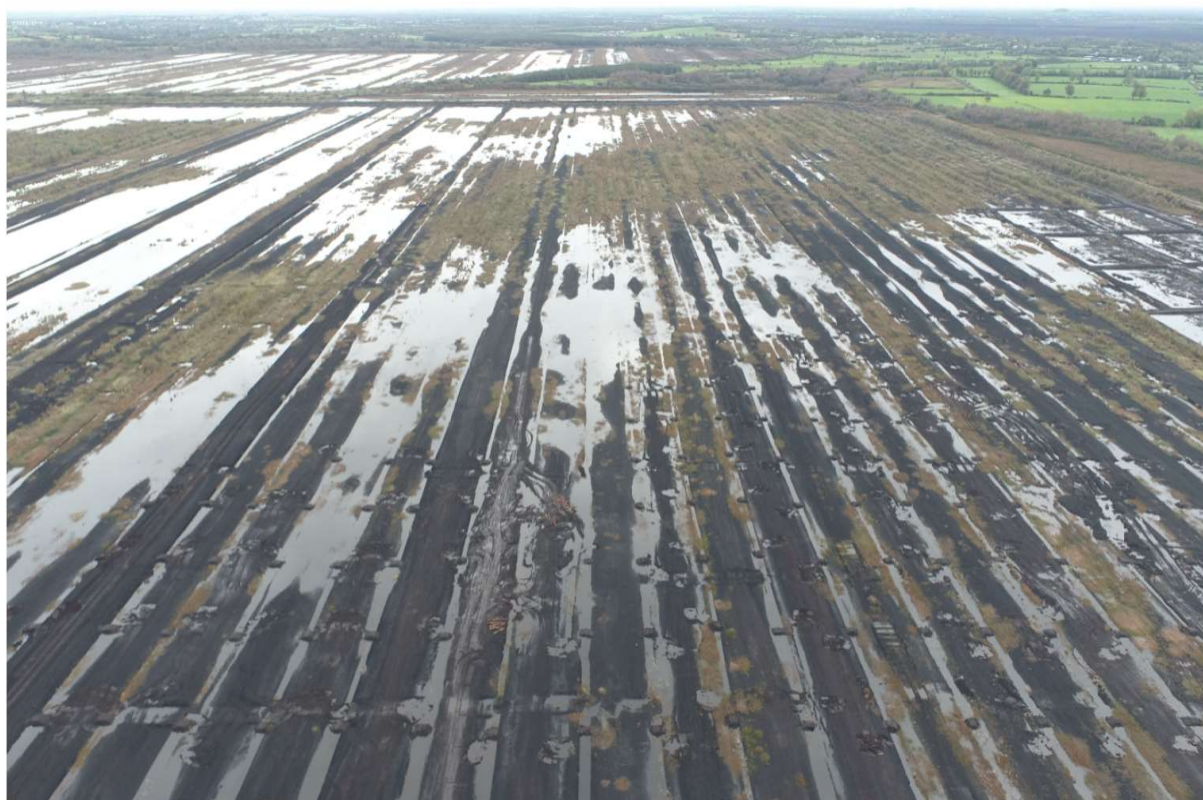
Plate B12.2: Cavemount Bog rehabilitation measures – October 2021

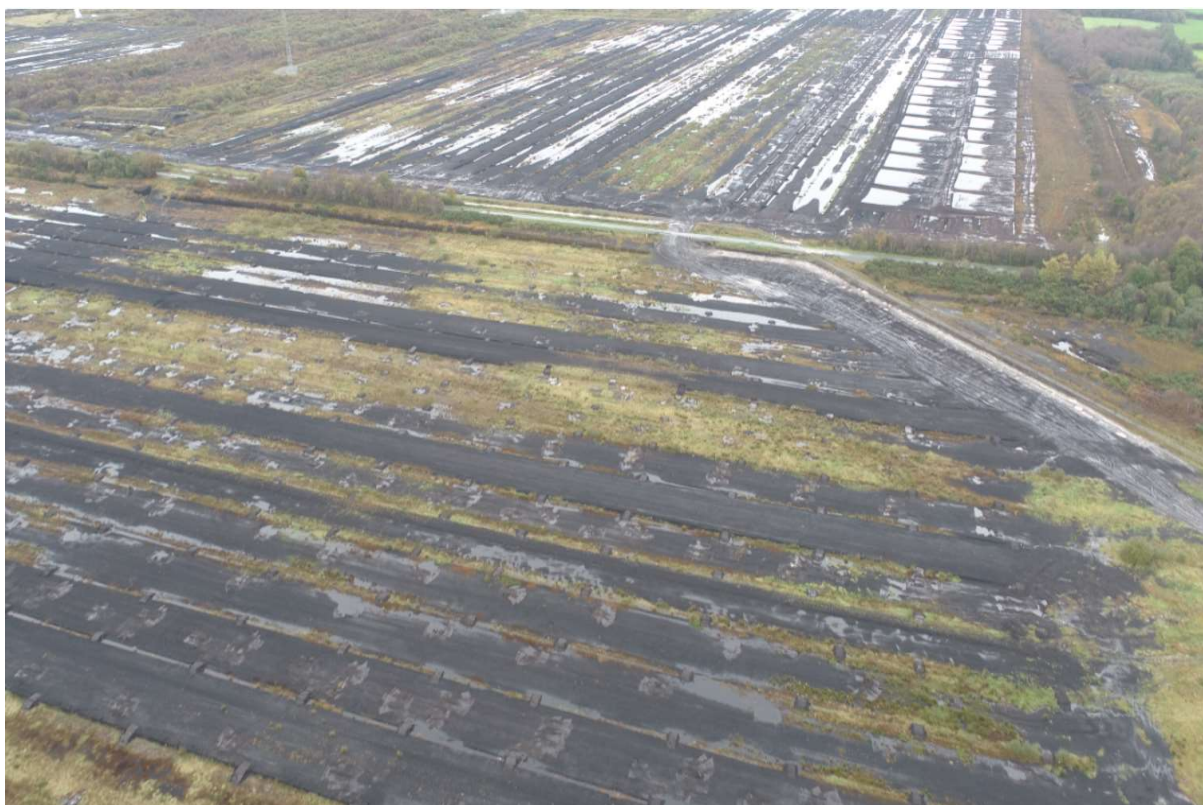
Plate B13.1: Clonad Bog rehabilitation measures – October 2021

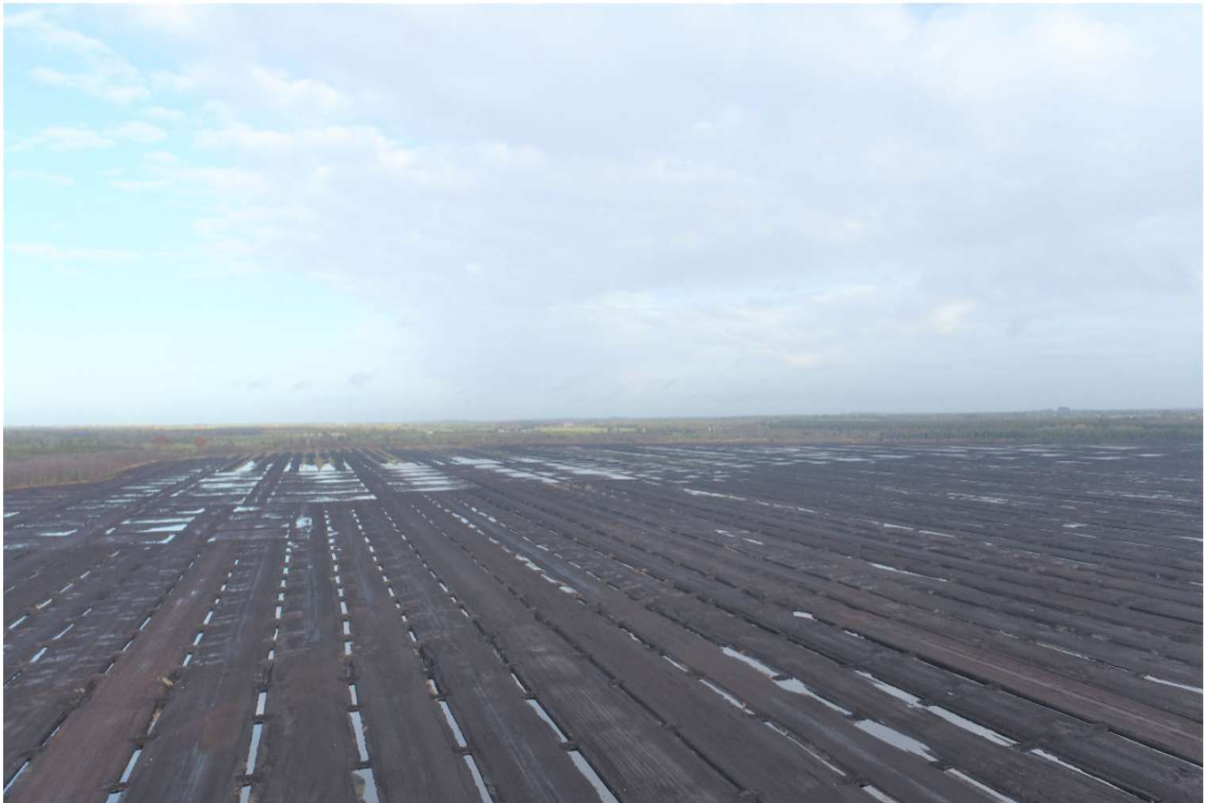
Plate B14.1: Esker Bog rehabilitation measures – November 2021
