Bord na Móna

Enhanced Decommissioning, Restoration and Rehabilitation Scheme (EDRRS)

Annual Report – Year 1

Commencement of Scheme to March 2022

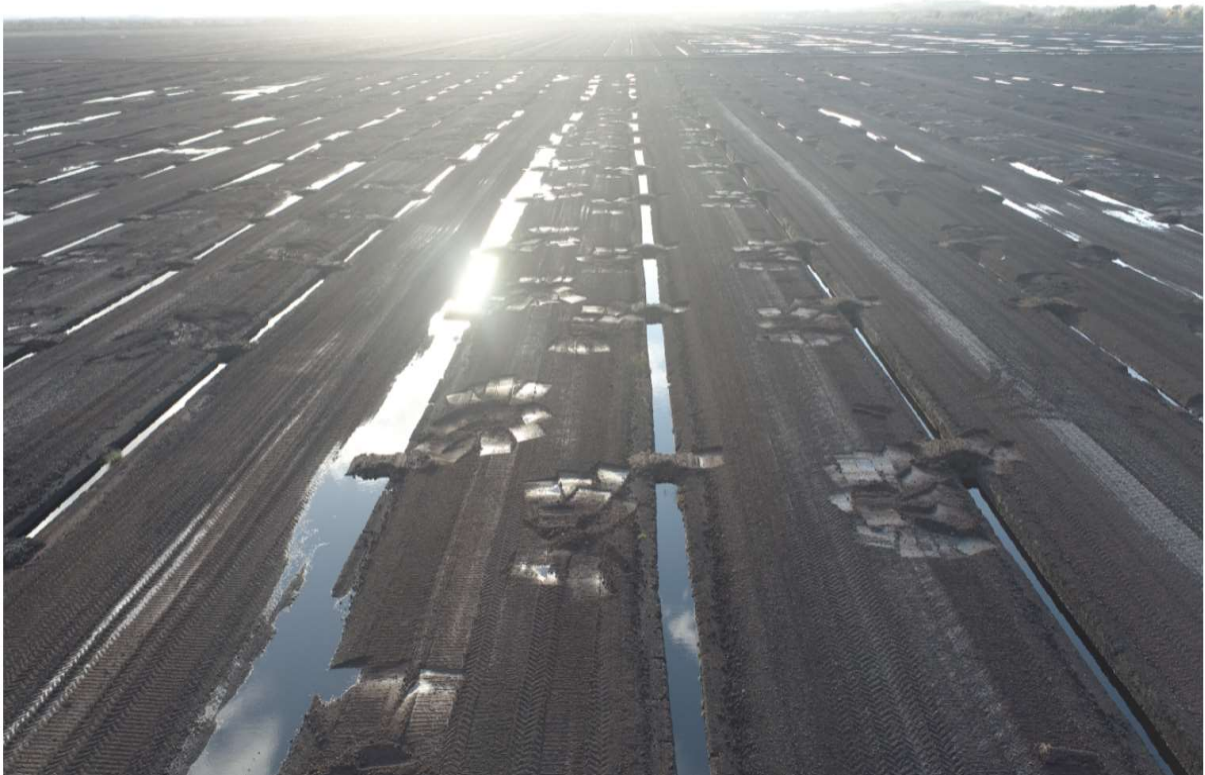
Plate B14.2: Esker Bog rehabilitation measures – November 2021

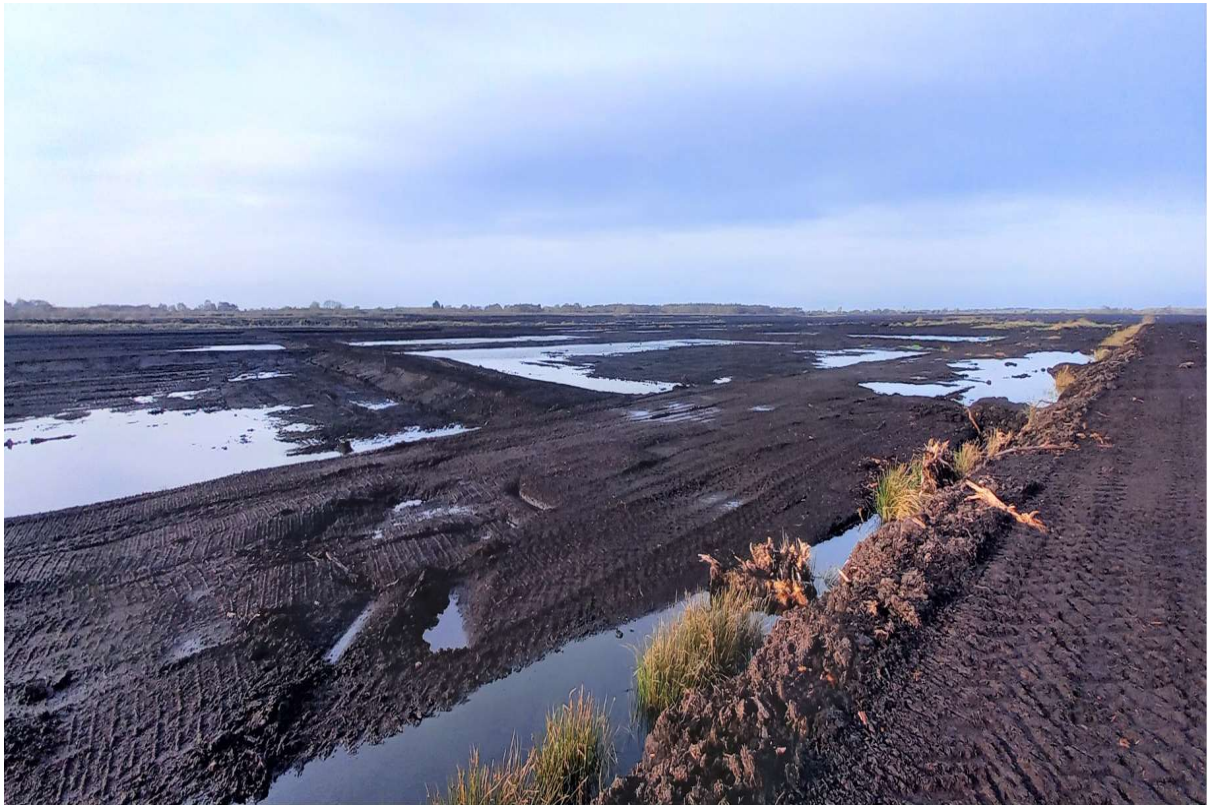
Plate B15.1: Mountlucas Bog rehabilitation measures – October 2021

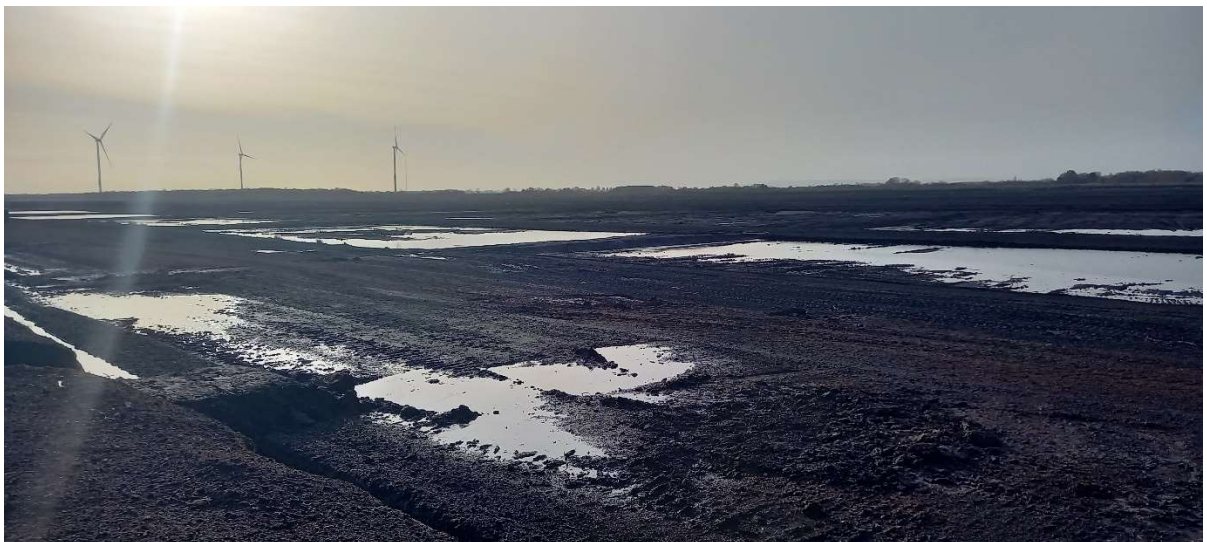
Plate B15.2: Mountlucas Bog rehabilitation measures – September 2021

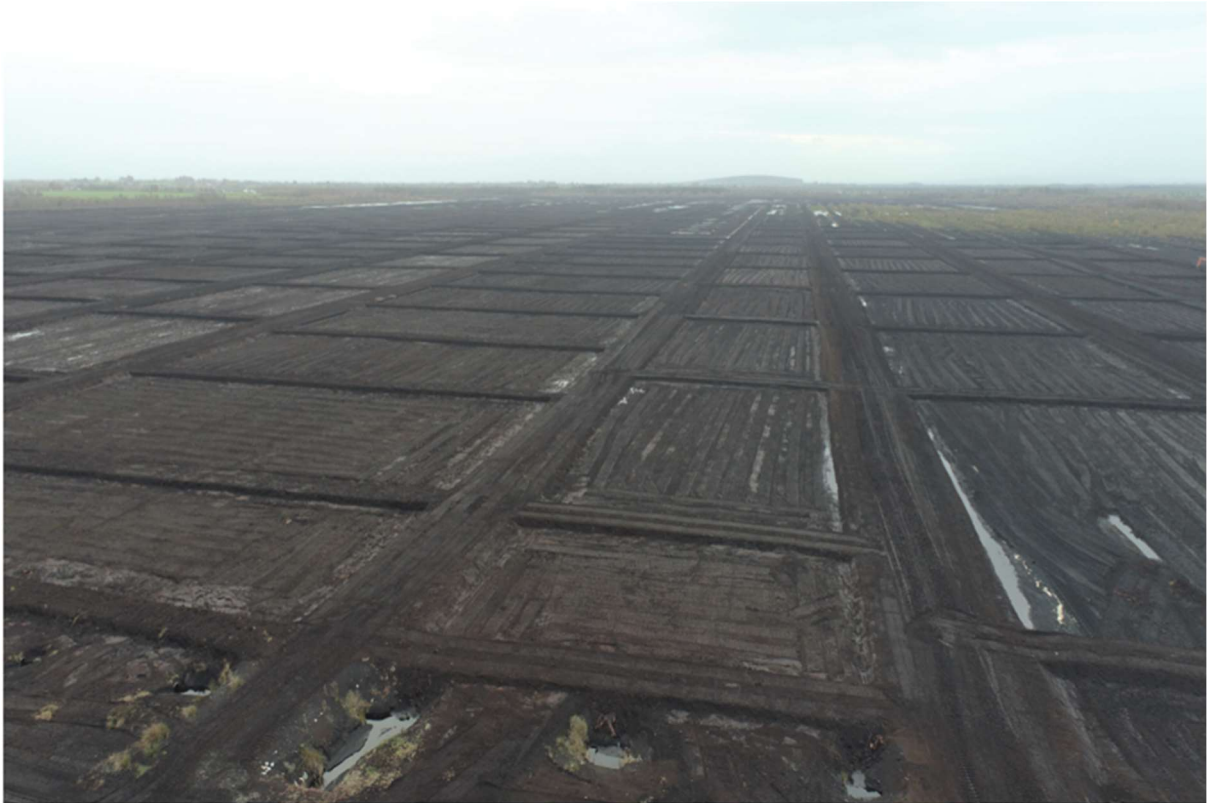
Plate B16.1: Ummeras Bog rehabilitation measures – November 2021

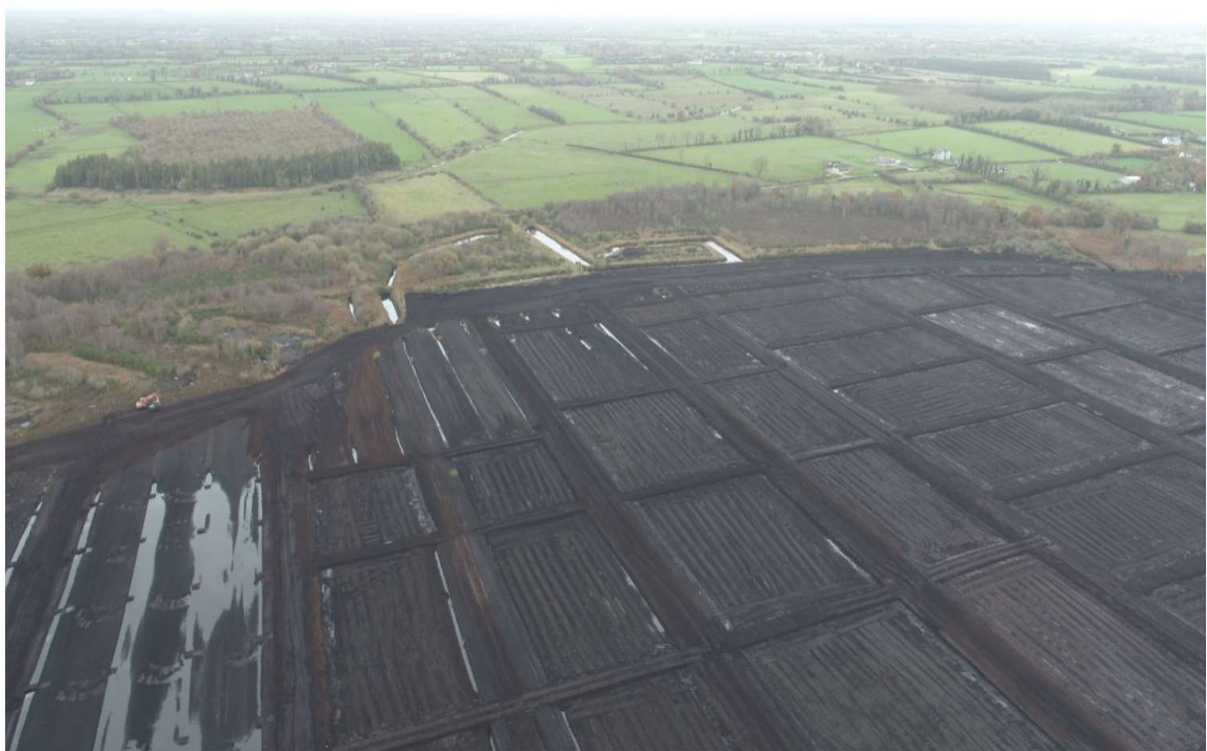
Plate B16.2: Ummeras Bog rehabilitation measures – November 2021

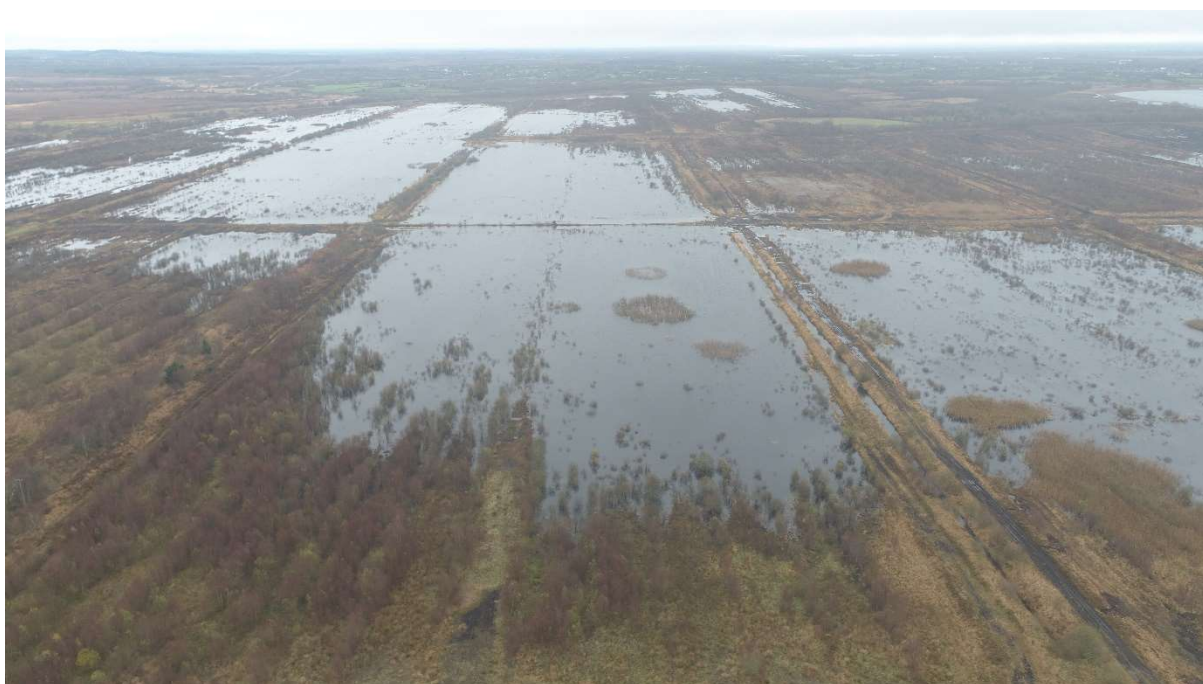
Plate B17.1: Derrycashel Bog following rehabilitation - November 2021

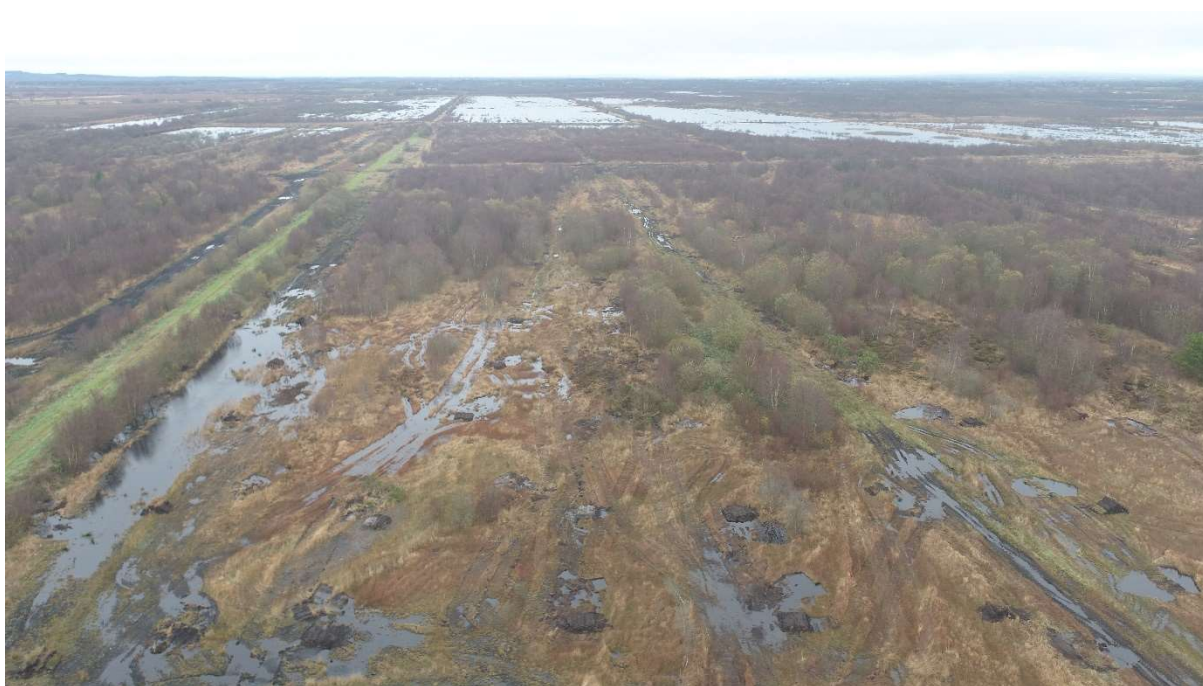
Plate B.17.2: Derrycashel Bog following rehabilitation - November 2021

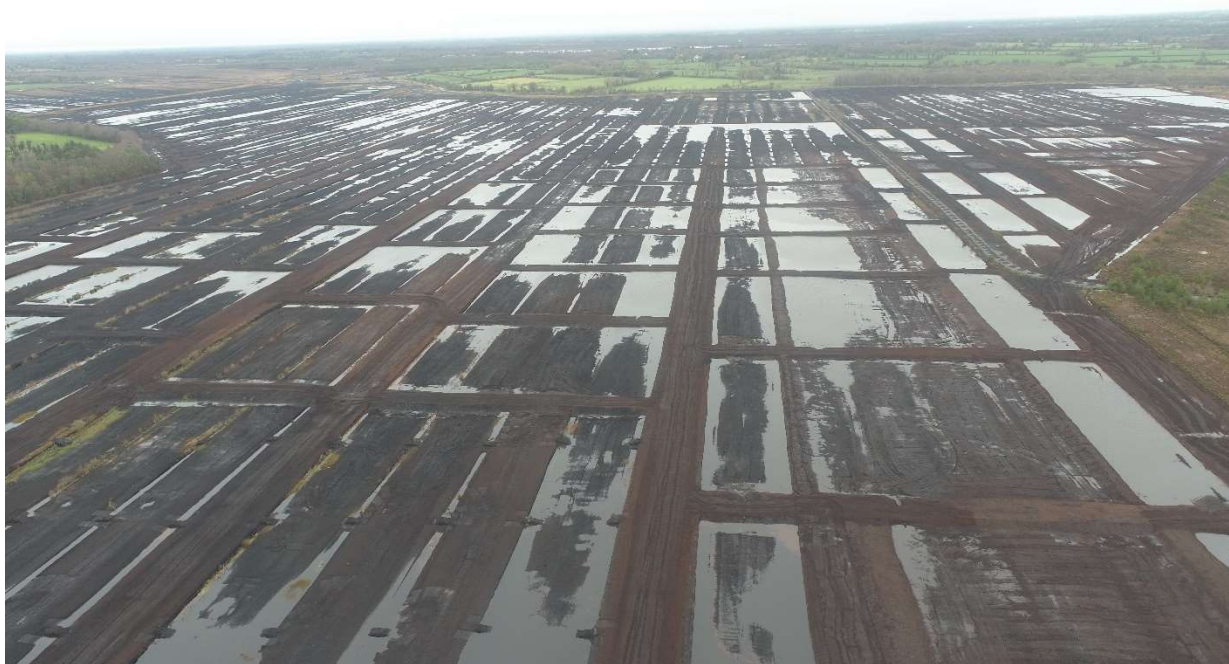
Plate B18.1: Derrycolumb Bog rehabilitation measures - November 2021

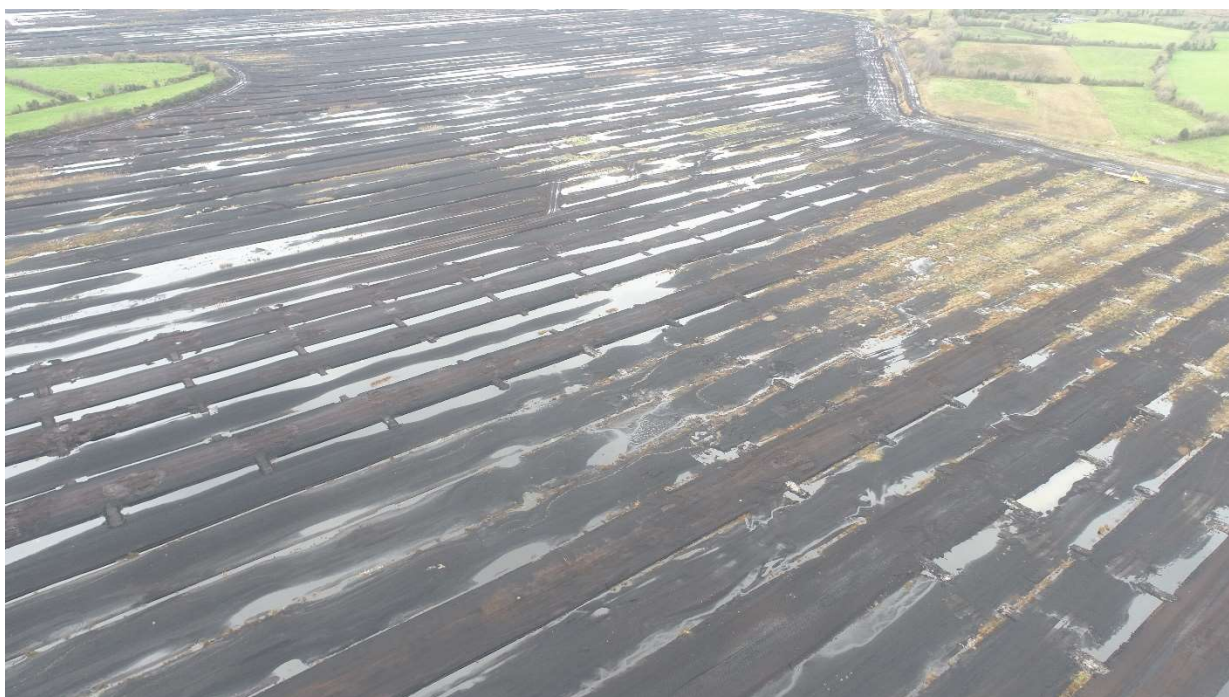
Plate B18.2: Derrycolumb Bog rehabilitation measures - November 2021

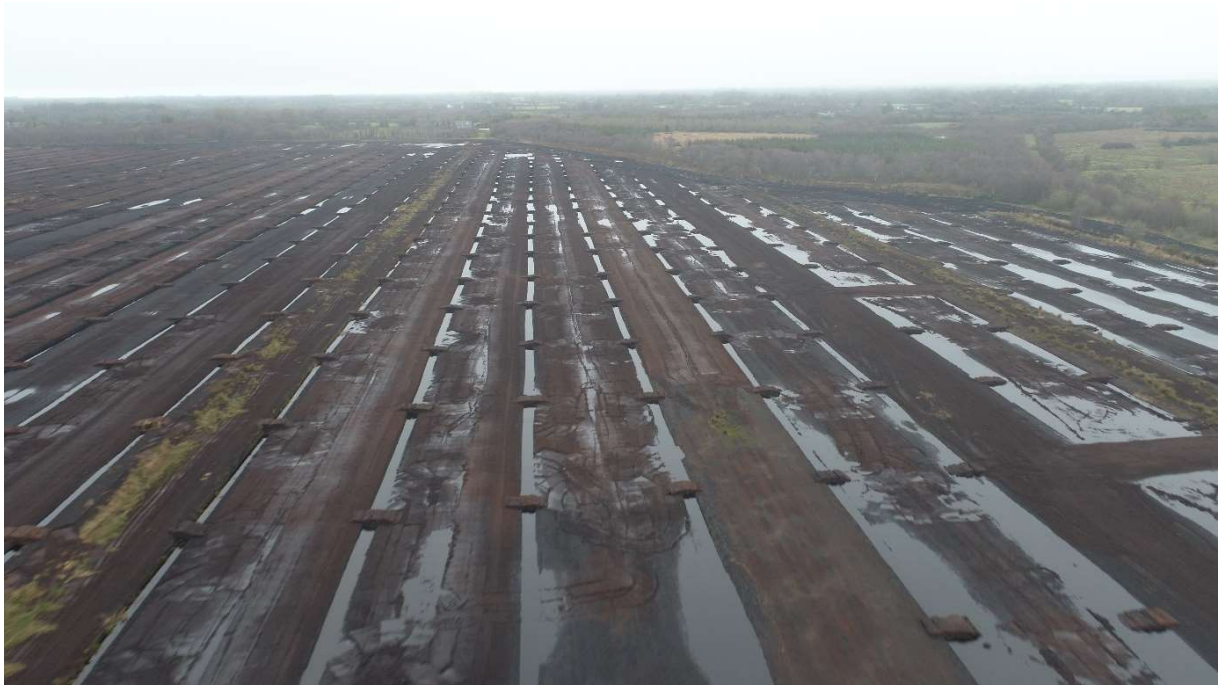
Plate B19.1: Edera Bog rehabilitation measures - November 2021

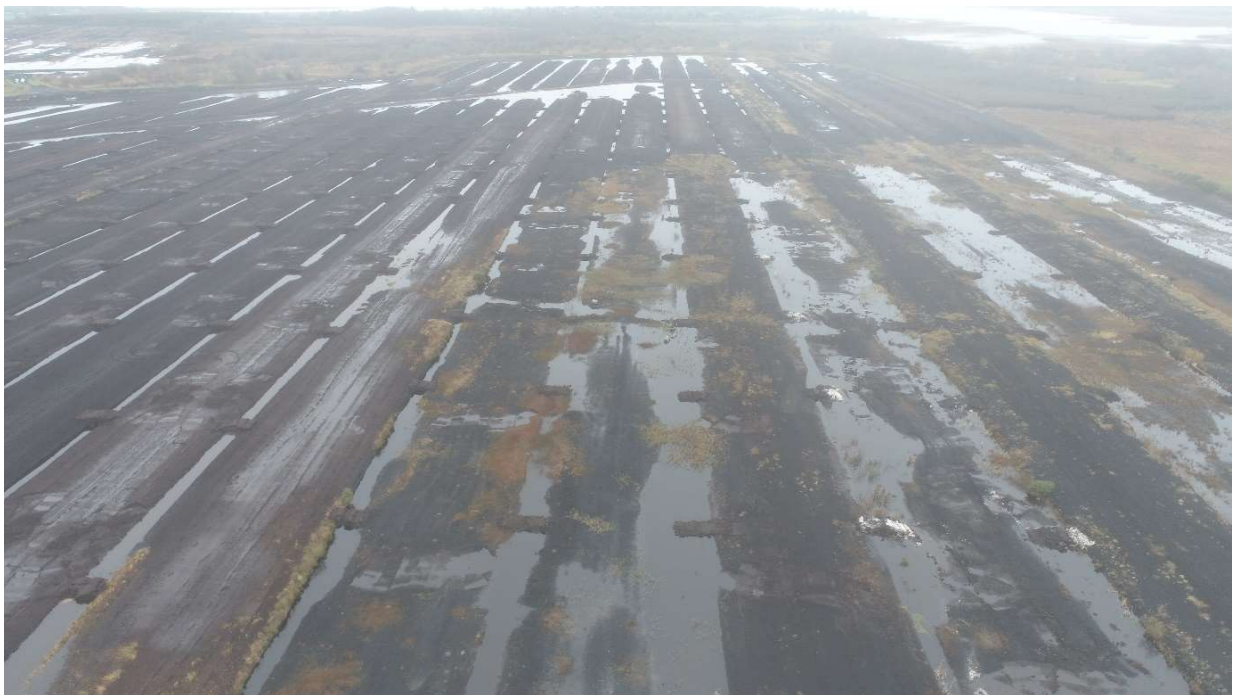
Plate B19.2: Edera Bog rehabilitation measures - November 2021
