Bord na Móna

Clynan Bog

Cutaway Bog Decommissioning and Rehabilitation Plan 2023

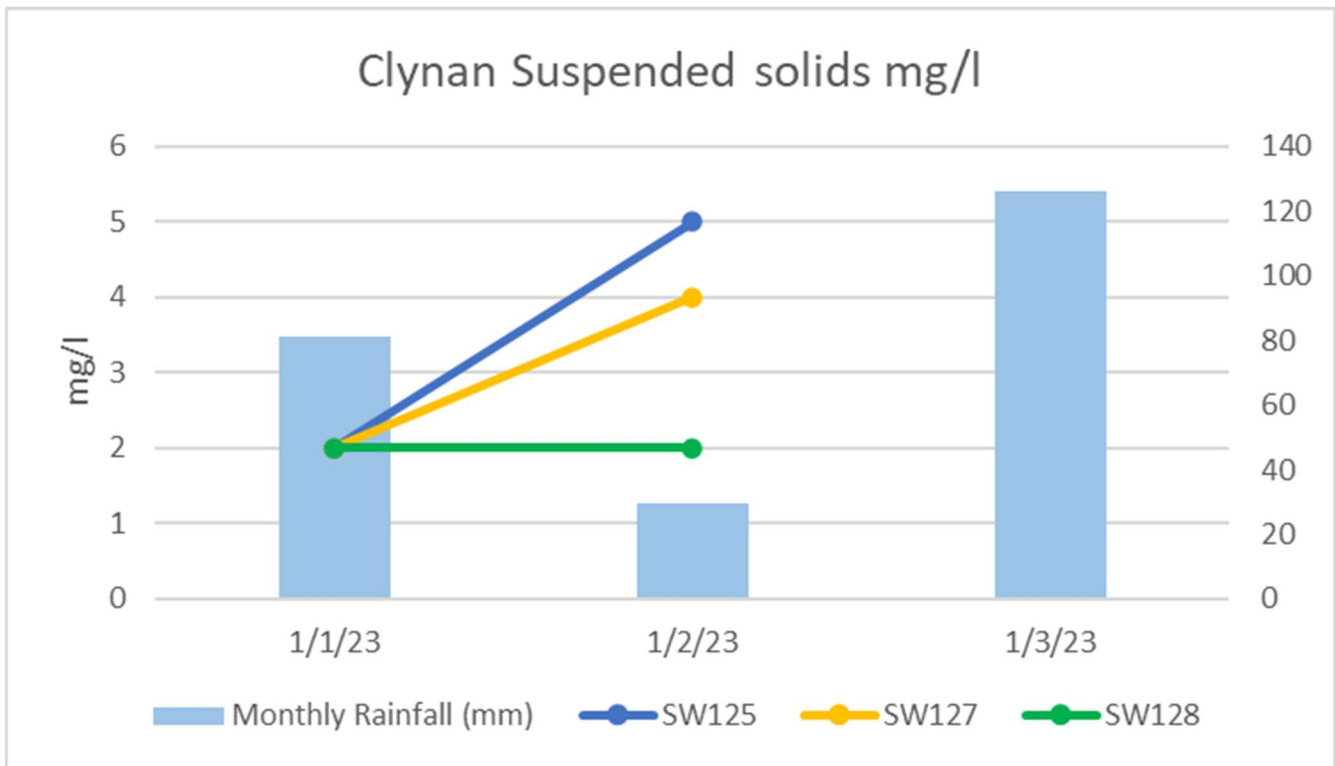
Figure AP13.1. Suspended solids in water sampling at Clynan bog from different discharge points. 35 mg/l is the emission limit value.

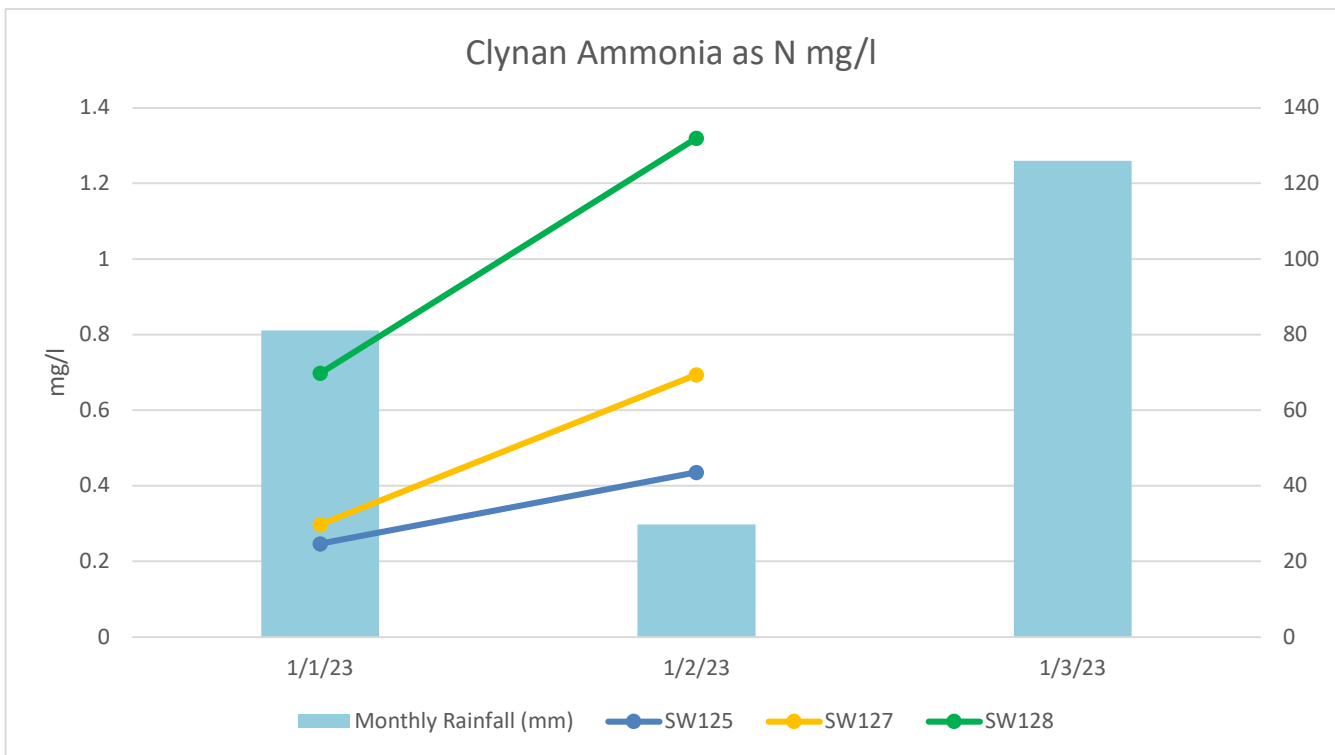
Figure AP13.2. Ammonia concentrations in water sampling from Clynan bog from different discharge points. The main trigger level for ammonia is 1.42mg/l for reporting to EPA.

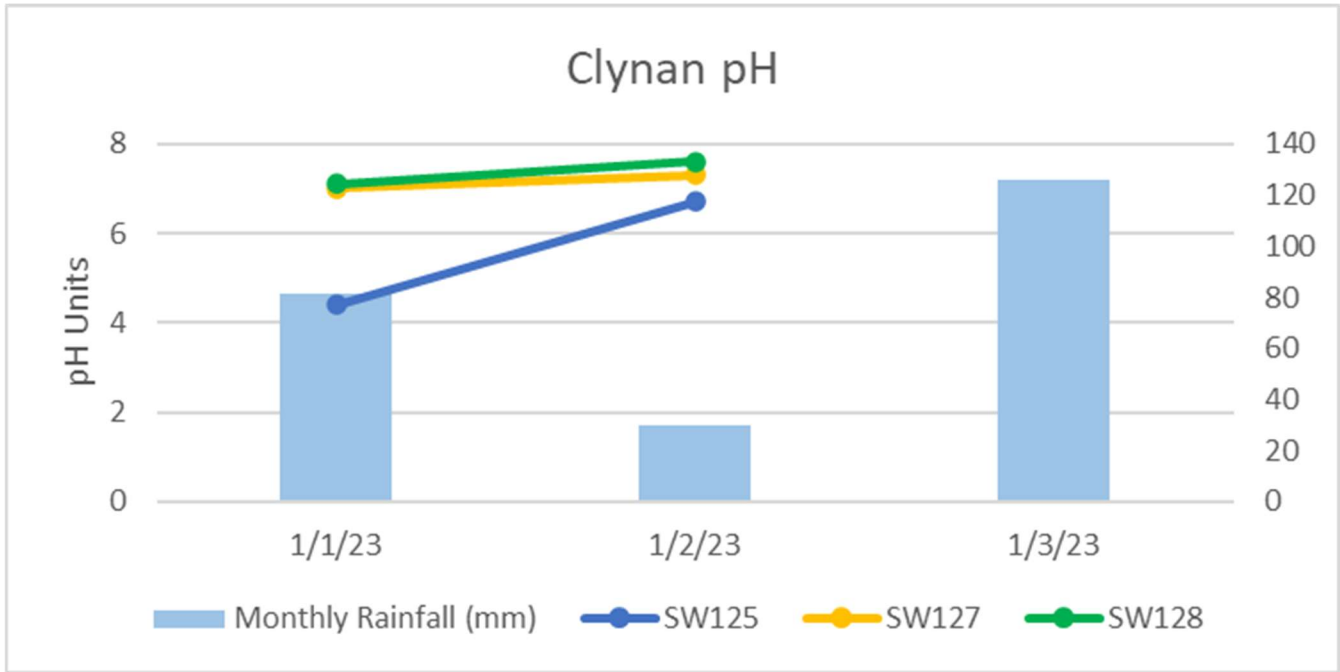
Figure AP13.1. pH in water sampling at Clynan bog from different discharge points.
