Bord na Móna

Corlea Bog

**Cutaway Bog Decommissioning and
Rehabilitation Plan**

2023

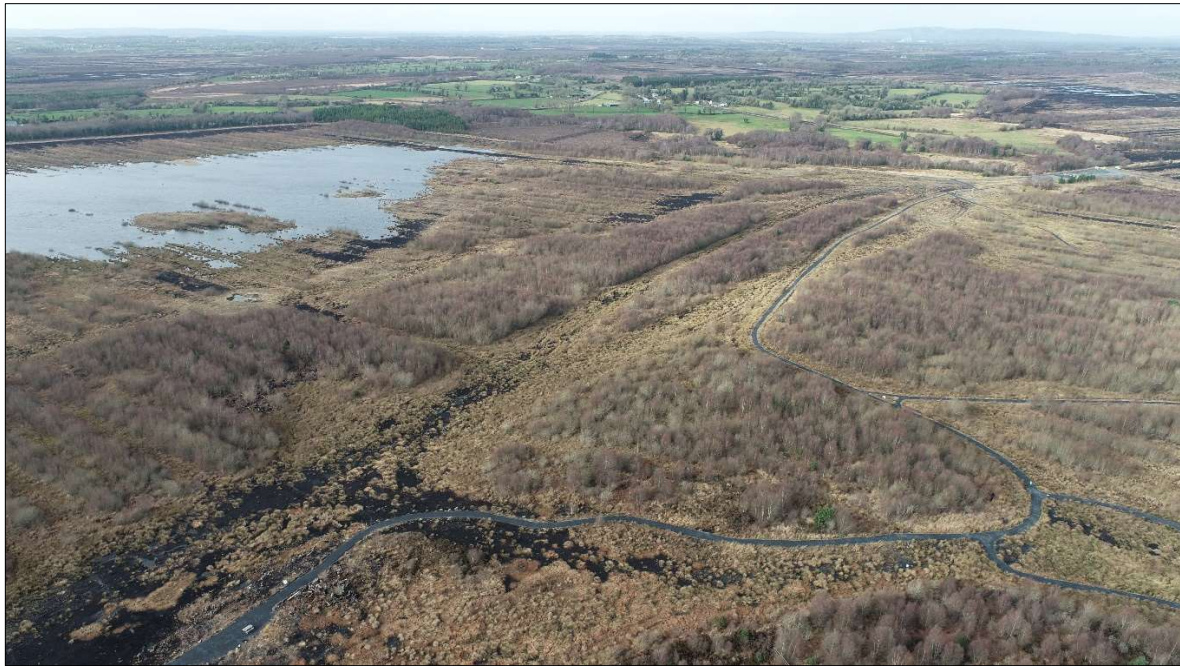
Drone view of the central elevated ridge (centre and right) and western basin (left) (2023).

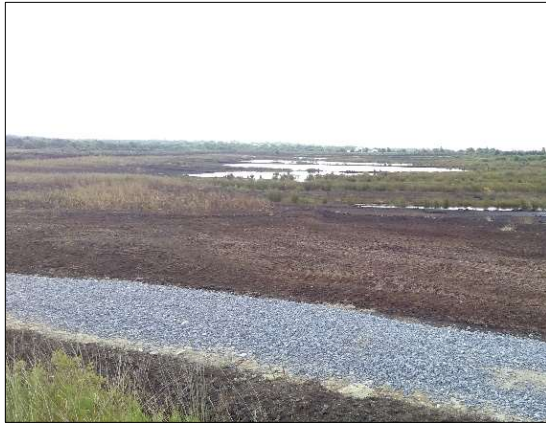
Bare peat along the headlands with the new track at the north-east basin.

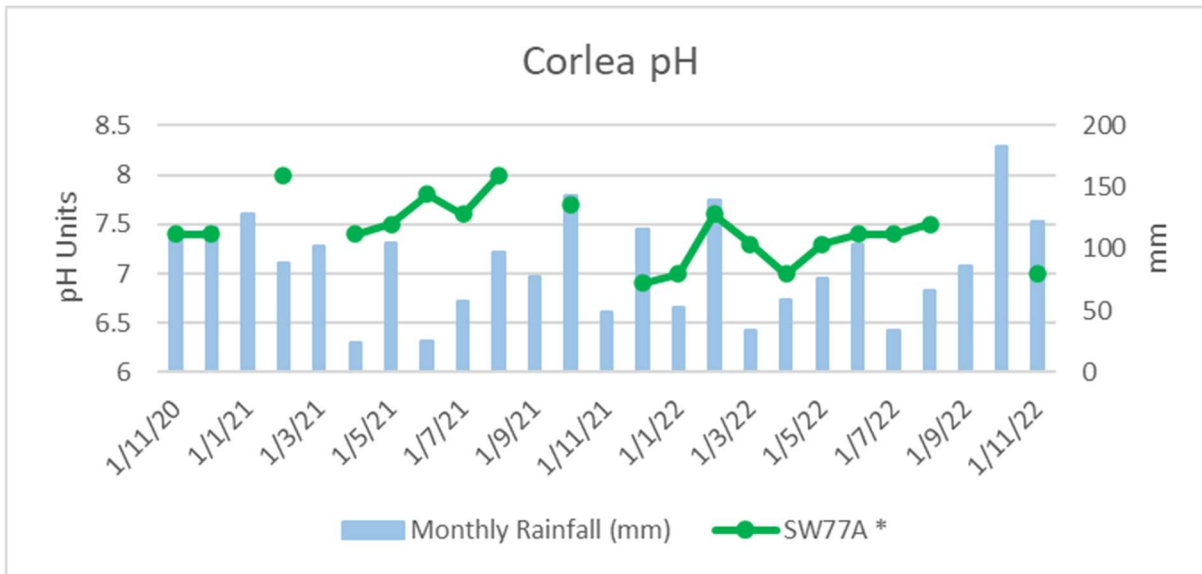
Plate 0-3 Corlea PH sampling results
