# Bord na Móna

## Drinagh Bog

# Cutaway Bog Decommissioning and Rehabilitation Plan 2023

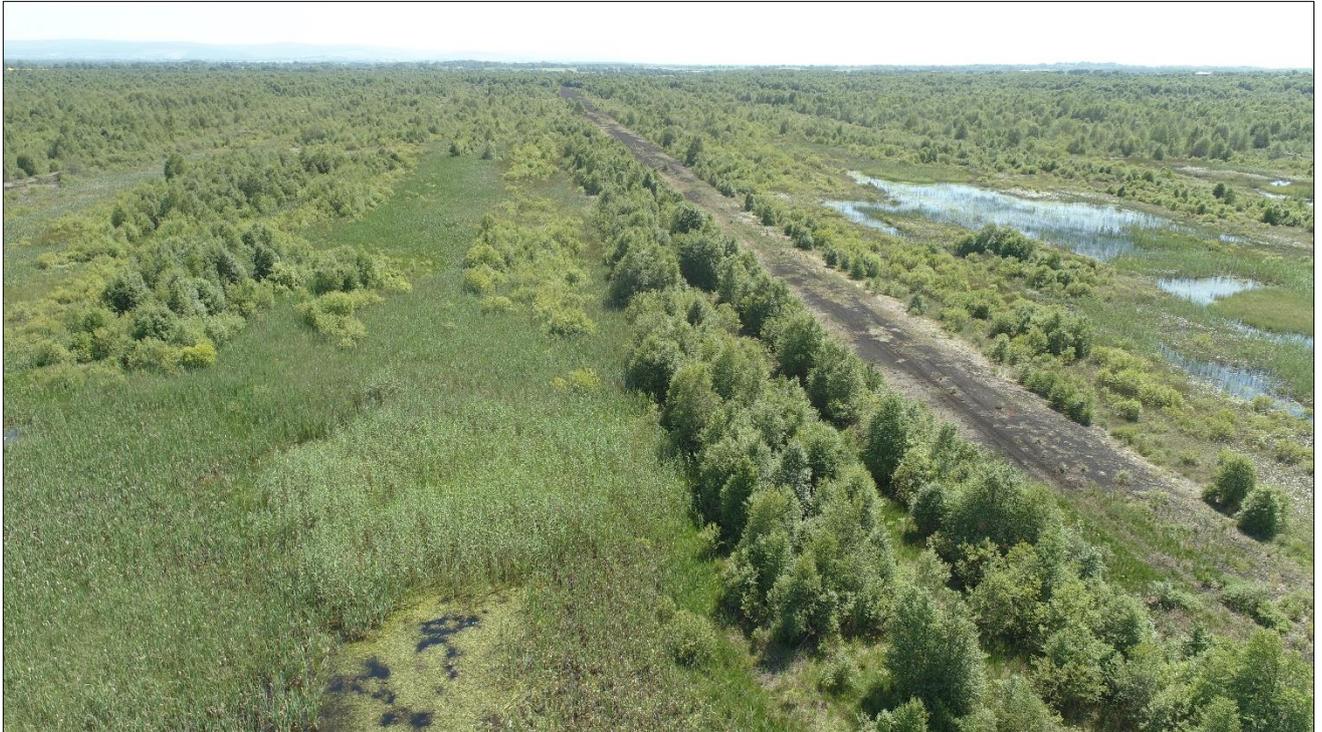
*Plate 3.1 Example of some wetland habitats within the north of the rehabilitation boundary grading into drier Birch dominated scrub and woodland.*

Within the larger eastern lobe of the rehabilitation boundary, the former cutover bog is currently developing pioneer cutaway wetland habitats (poor fen, Reed swamp, Birch woodland) (Plates 3.1-3.2). Much of the site is re-vegetating or re-wetted and the area of bare peat has been reduced significantly. Some rehabilitation measures have previously been carried out within the northeast of the bog by targeted drain blocking and berm construction. The resultant environmental conditions are therefore generally wetter at this location and closer to optimal condition than much of the rest of the site. This wetland area contains a substantial portion of open water. This area is developing into a wetland complex and there is a diverse mosaic of wetland habitats (several Poor fen vegetation communities) developing around the margins of the wetland. The areas of open water are shallow and there are frequent patches of emergent Common Reed and Bulrush developing in some sections as well as along the margins.

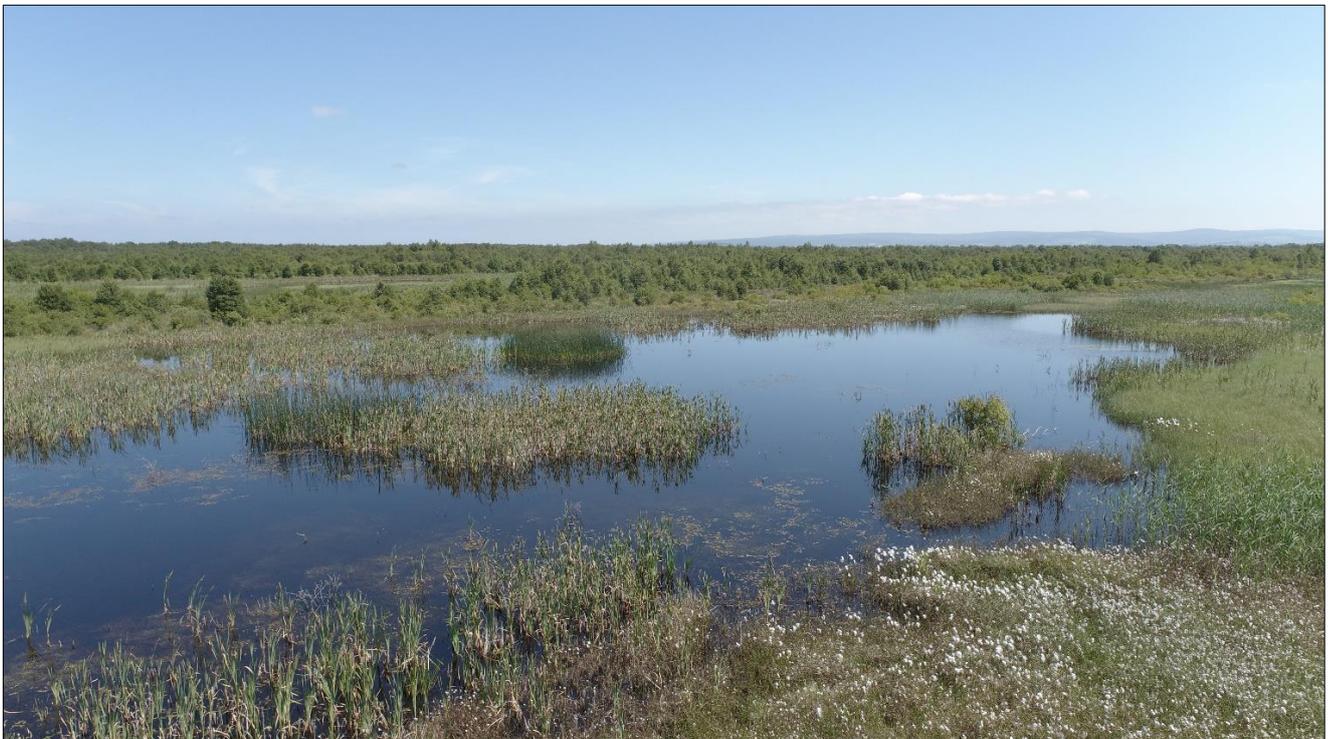
*Plate 3.2 Example of wetland habitats occurring within the north of the Drinagh bog rehabilitation boundary.*

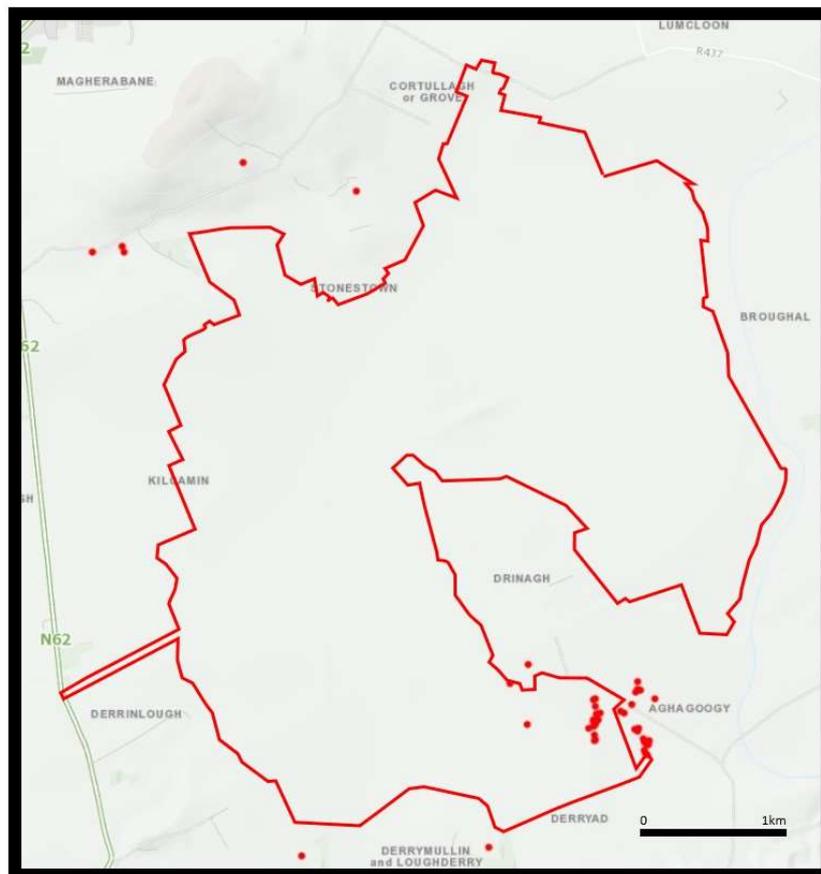
Fig. 2. Drinagh Bog, Co. Offaly, detail of the Sites and Monuments Record. The proposed rehabilitation area is outlined with the red line.

The Sites and Monuments Record (SMR) which is maintained by the Department of Housing, Local Government and Heritage was examined as part of the assessment on the 6th of March 2023. The SMR consists of records of sightings made by the IAWU Survey notified to the Dept. This review established that there are 18 sightings entered in the SMR in the proposed rehabilitation area. These are the sightings made by the IAWU survey in 1997 and are indicated in Table 1.
