# **Bord na Móna**

## **Clongawney Bog**

### **Draft Cutaway Bog Decommissioning and Rehabilitation Plan**

**2024**

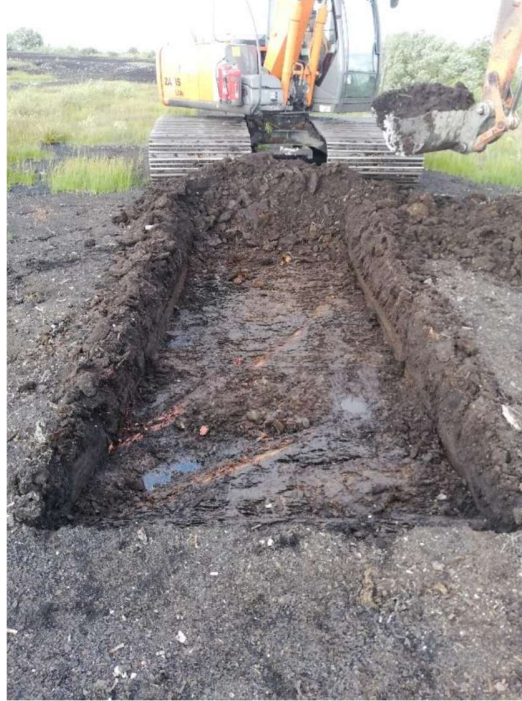
Plate 1. Timbers identified during monitoring in Clongawney Bog in 2019 at compound 2.

identified as of archaeological significance were noted in compounds 2 and 3 in Clongawney Bog at a depth of 0.38m and 2.8m (see Plates 1 and 2). The timbers were preserved *in situ*. However, no coordinates are provided in the monitoring report for these trial pits (Carroll 2020).
