Bord na Móna

Enhanced Decommissioning, Rehabilitation and Restoration Scheme (EDRRS)

**Annual Report – Year 2
April 2022 to March 2023**

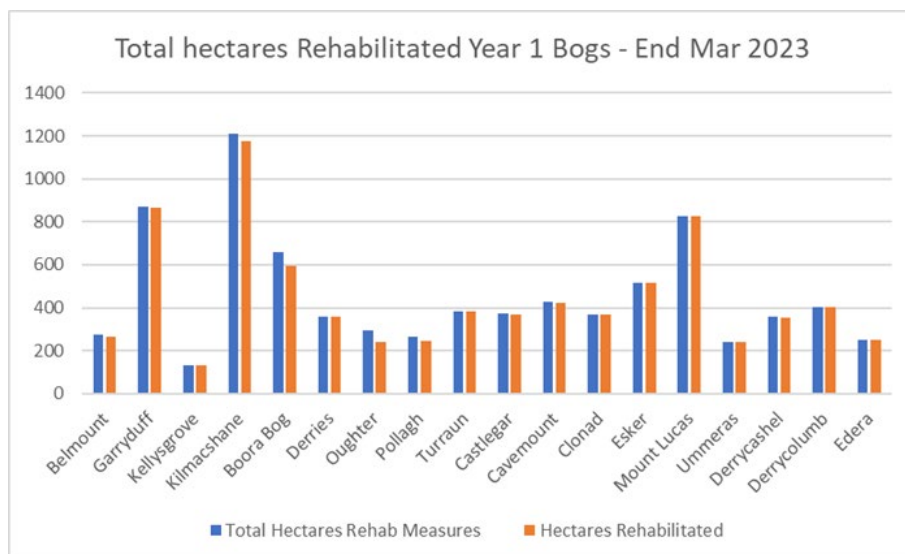
Figure 4.1 below shows the hectares rehabilitated (in orange) on the Year 1 bogs at the end March 2023 against the hectares to be rehabilitated (in blue).

Figure 4.1: Hectares rehabilitated in Year 1 bogs at the end of March 2023

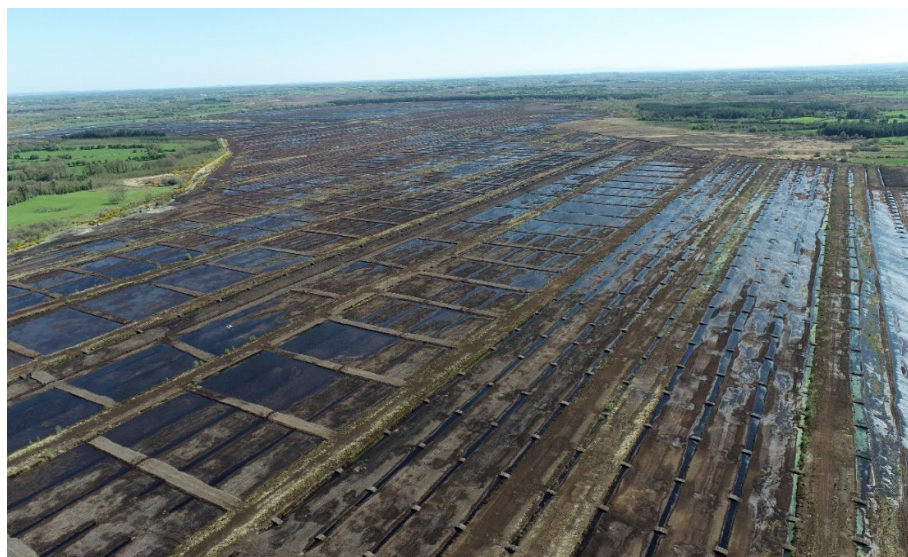
Many of the Year 1 bogs are re-wetting and some receptors, such as wintering wildfowl, breeding waders, etc. at least seem to be benefitting from the completed rehabilitation measures⁷. The image below from Castlegar Bog is an example of a Year 1 Bog showing completed drain blocks and cells. While there were still some outstanding measures to be completed as of the end of March 2023, large areas of the bog have been re-wetted. The outstanding measures on these bogs generally consist of minor measures such as completion of cell flow control measures, drain clearing or outfall measures.

Figure 4.2: Castlegar Bog (April 2023) – Example of Year 1 Bog post completion of majority of rehabilitation measures

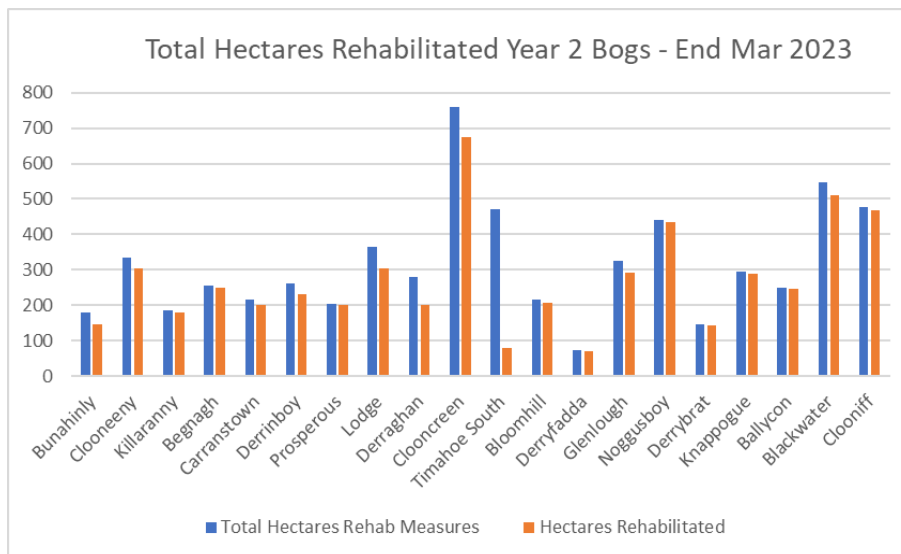
Figure 4.3 below shows the hectares rehabilitated (in orange) on the Year 2 bogs at the end March 2023 against the hectares to be rehabilitated (in blue).

Figure 4.3: Hectares rehabilitated in Year 2 bogs at the end of March 2023

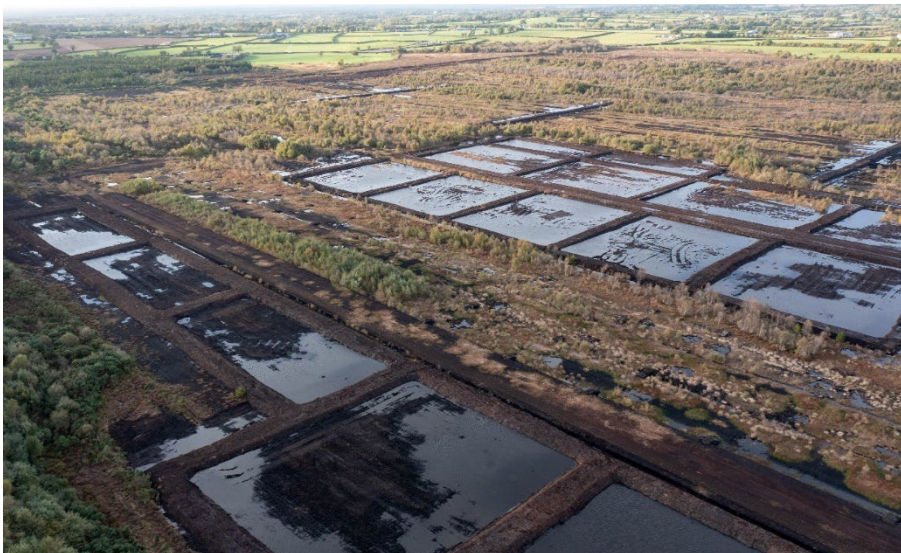
An example of the rehabilitation measures on one of the Year 2 bogs, Noggusboy is shown in Figure 4.4 below. Similar aerial images are included in Appendix B of this report for each of the Year 2 Bogs.

Figure 4.4: Example of Year 2 bog rehabilitation – Noggusboy Bog

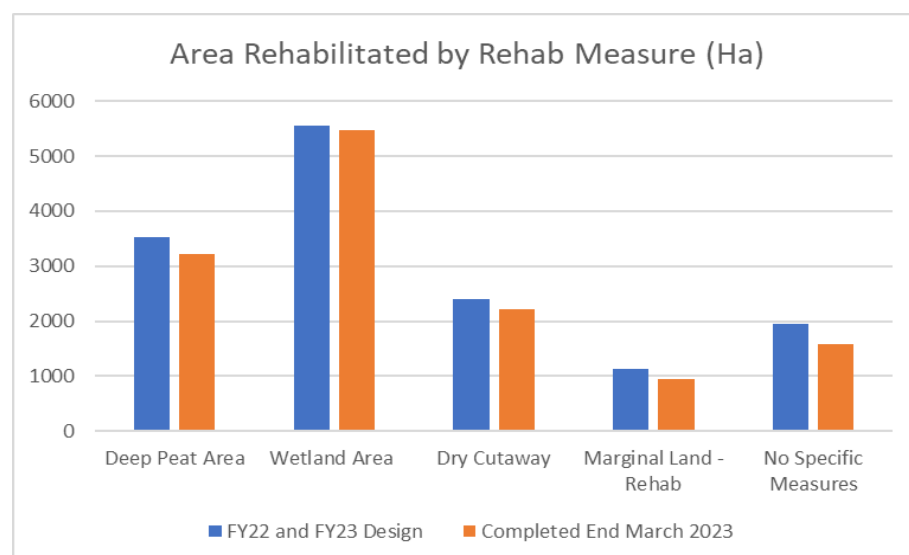
The rehab methodologies implemented in Year 1 and Year 2 of the scheme are reflective of the conditions encountered on the bogs rehabilitated during these periods. Table 4.5 shows the percentage of each methodology that was carried out on the Year 1 and Year 2 bogs. Wetland Type 4 is the methodology that was implemented on the largest area with Deep Peat Type 4 the second largest area.

This is likely to change as the rehabilitation continues as it is subject to the bog conditions such as the depth of peat, the underlying conditions and the existing vegetation.

Figure 4.5: Rehabilitated areas by Bog Cutaway Type

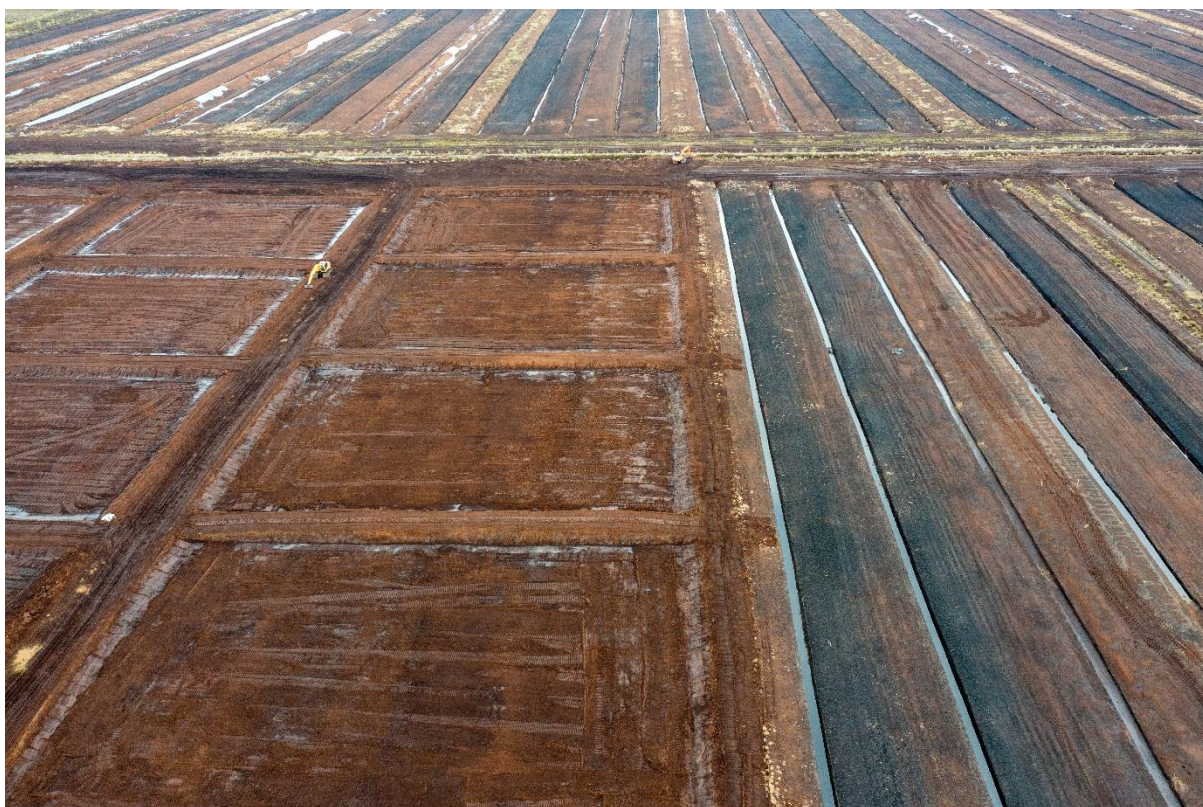
Plate B1.1: Bunahinly Bog rehabilitation measures - April 2023

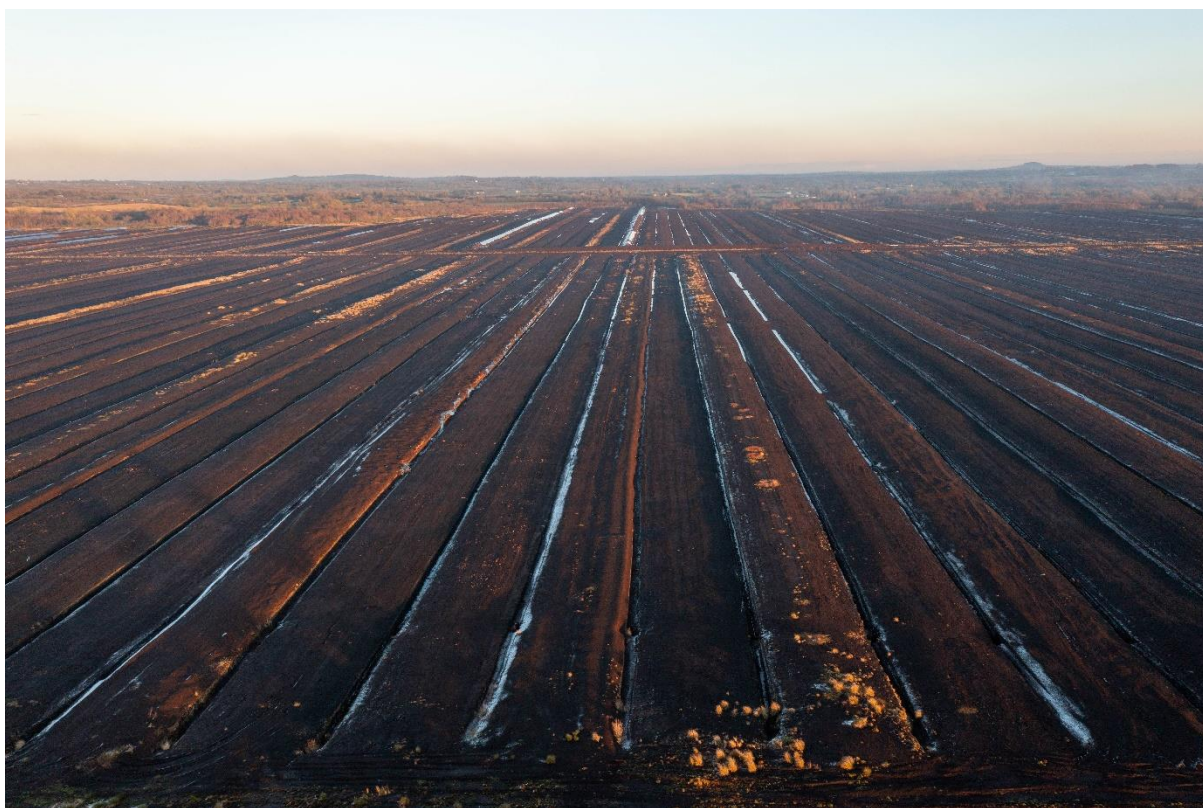
Plate B1.2: Bunahinly Bog rehabilitation measures - December 2022

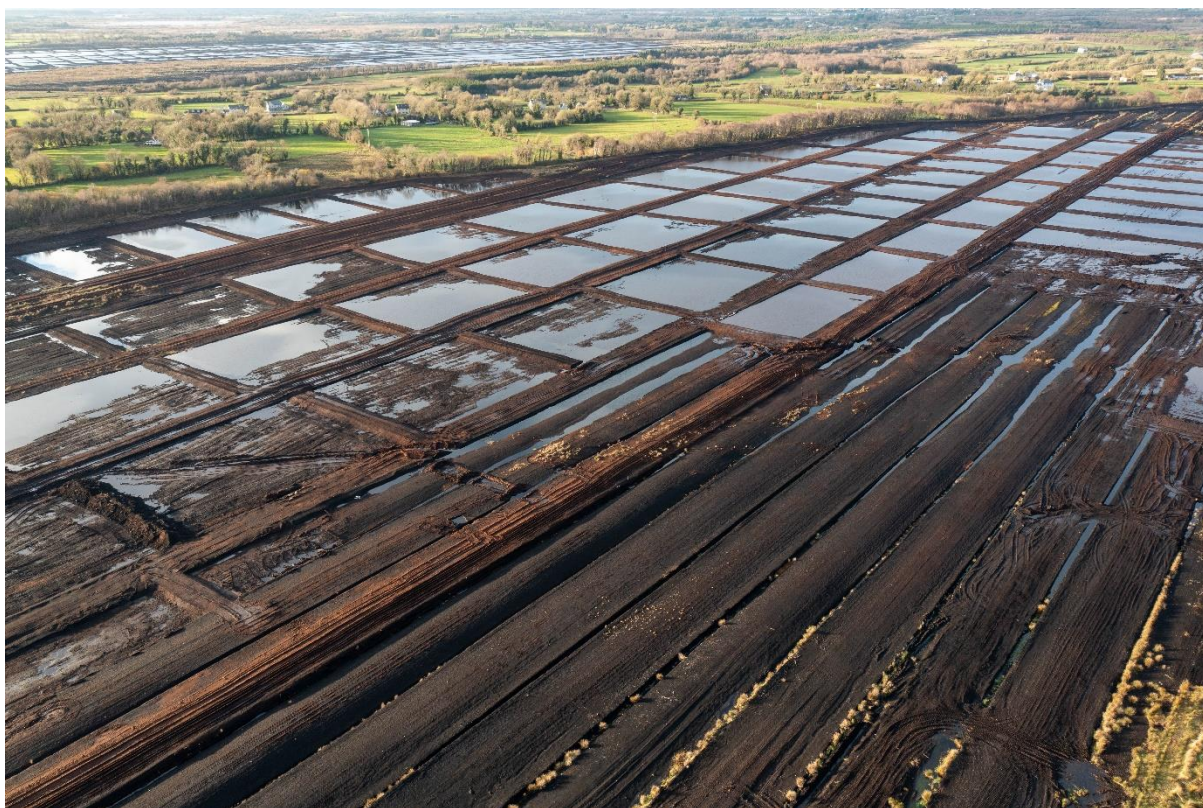
Plate B2.1: Clooneeny Bog rehabilitation measures - December 2022

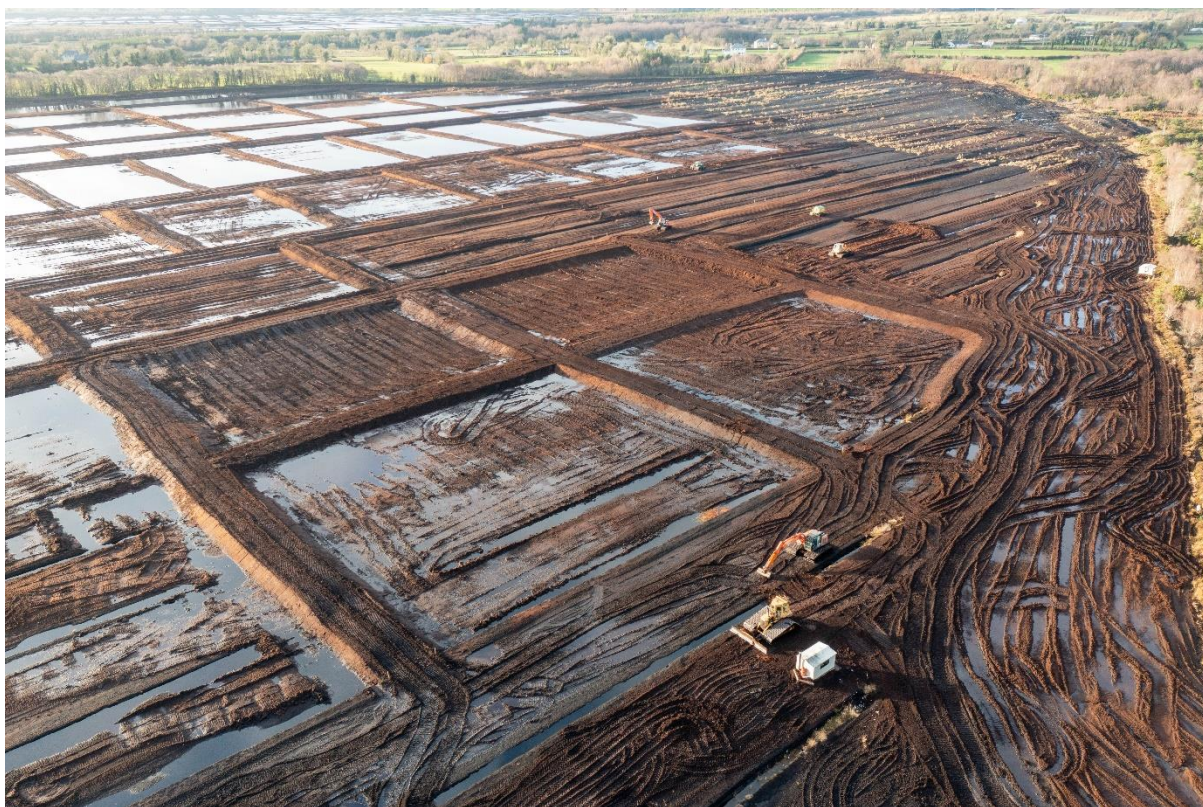
Plate B2.2: Clooneeny Bog rehabilitation measures - December 2022

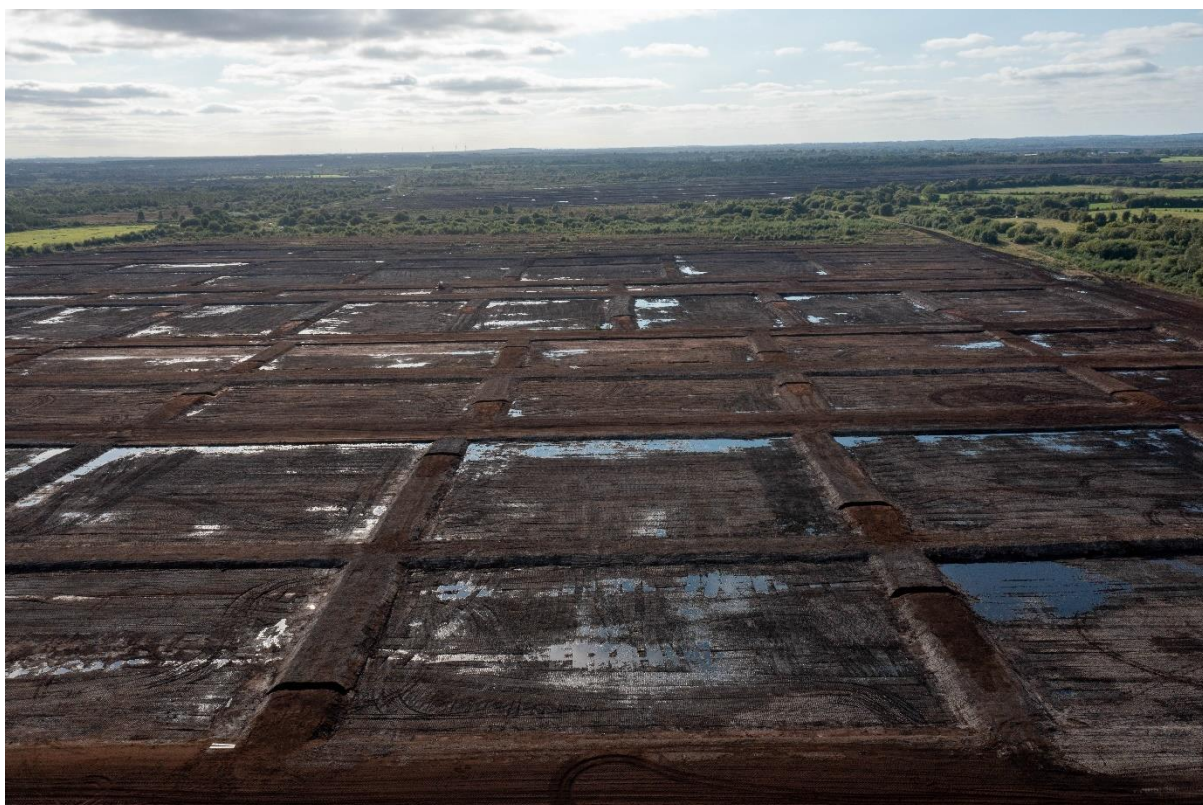
Plate B3.1: Killaranny Bog rehabilitation measures - September 2022

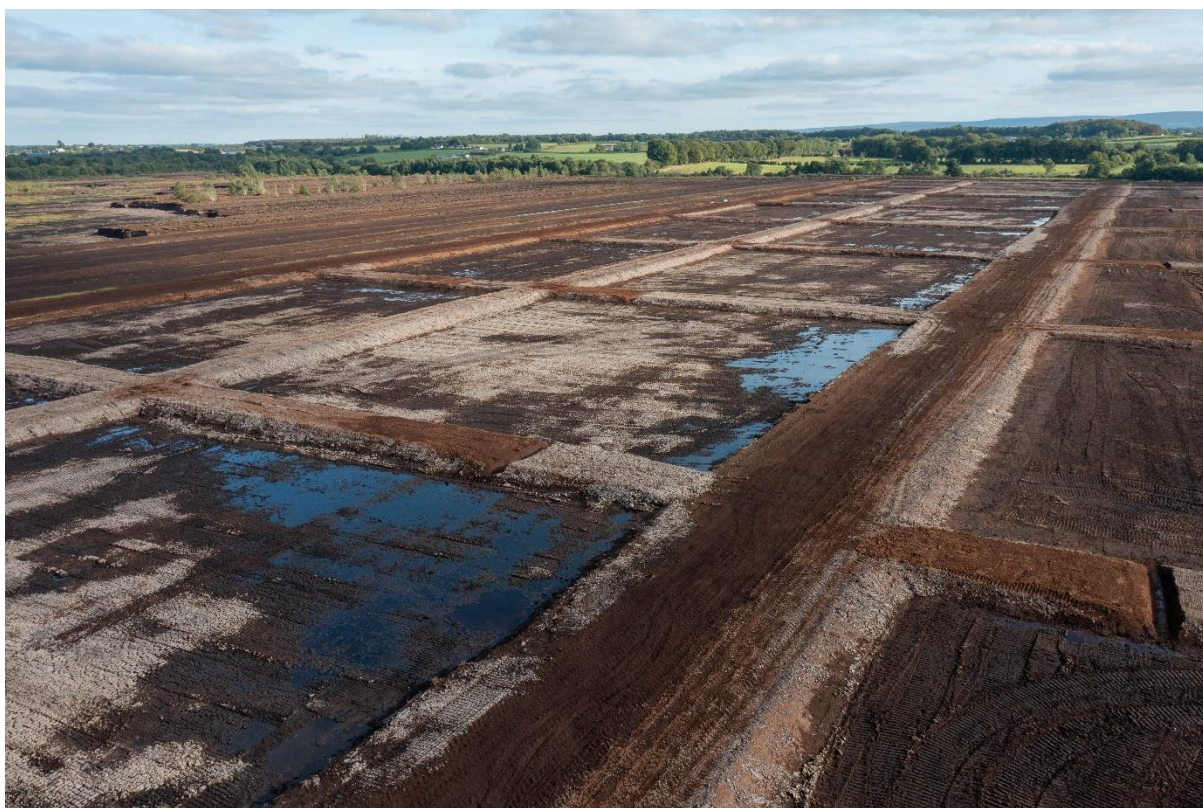
Plate B3.2: Killaranny Bog rehabilitation measures - September 2022

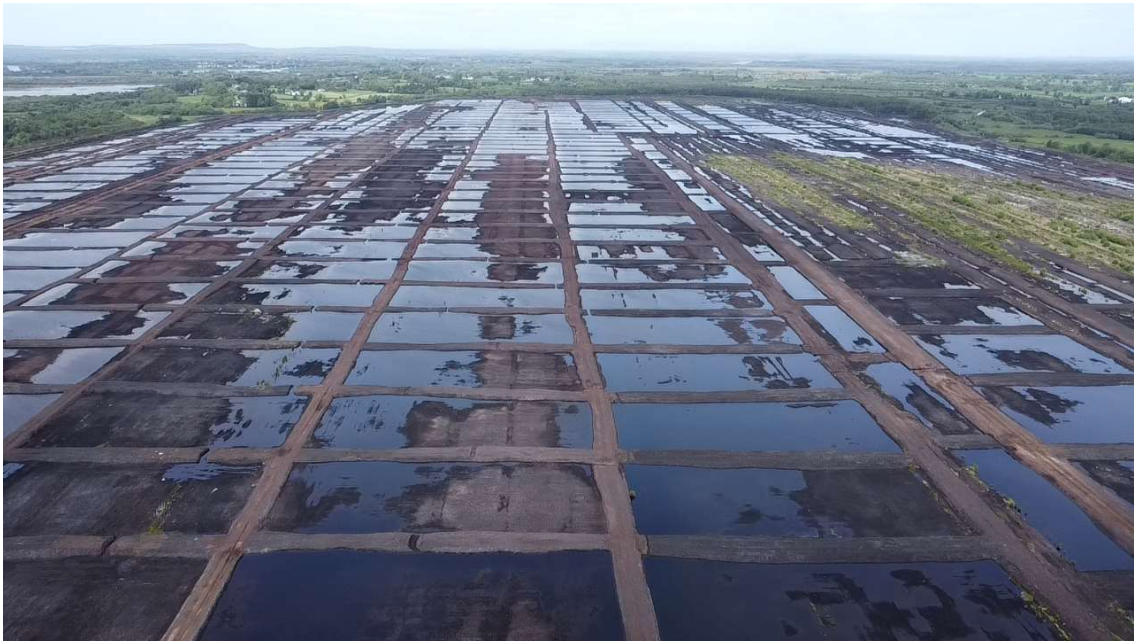
Plate B4.1: Begnagh Bog rehabilitation measures – Spring 2023

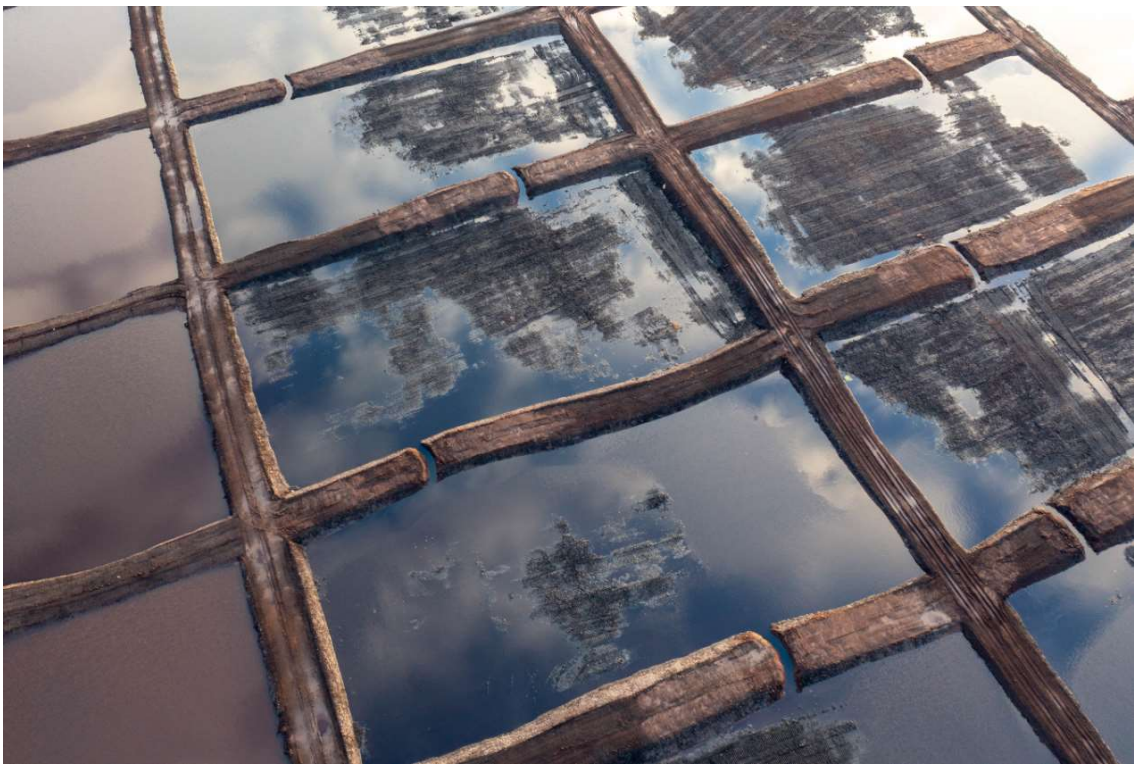
Plate B4.2: Begnagh Bog rehabilitation measures - December 2022

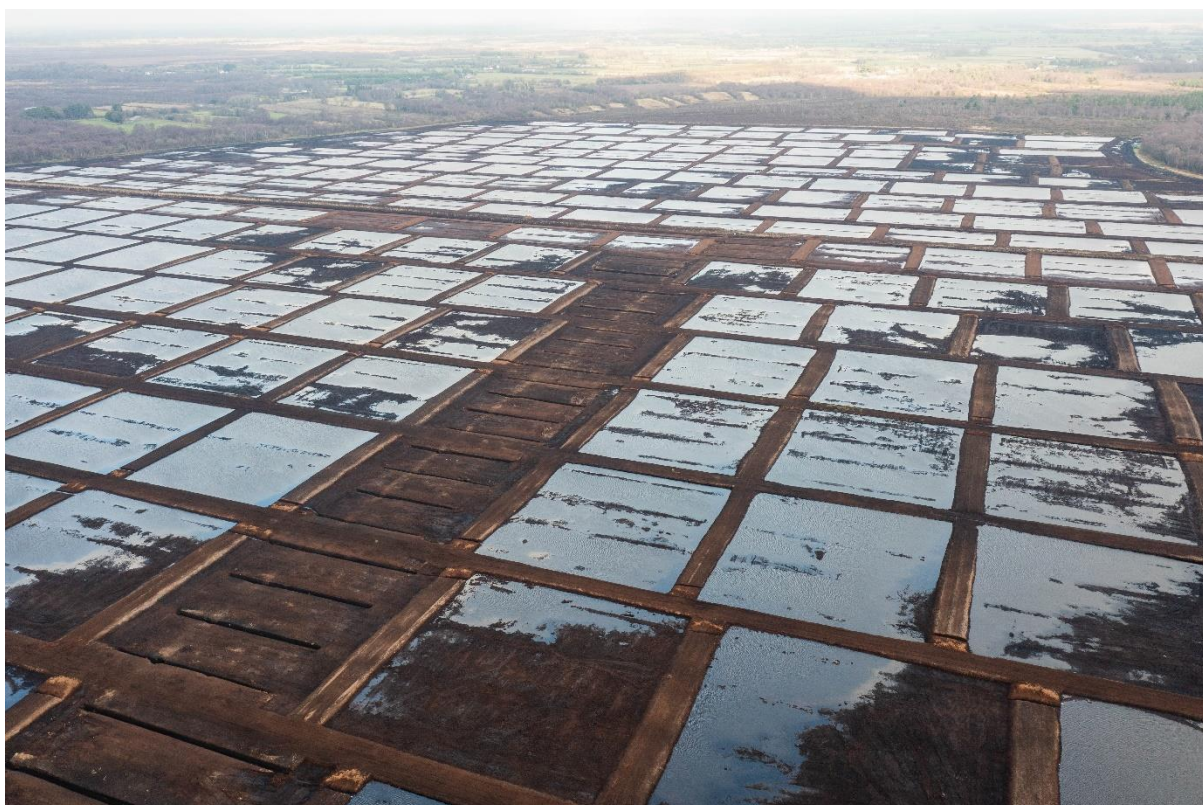
Plate B5.1: Carranstown Bog rehabilitation measures - February 2023

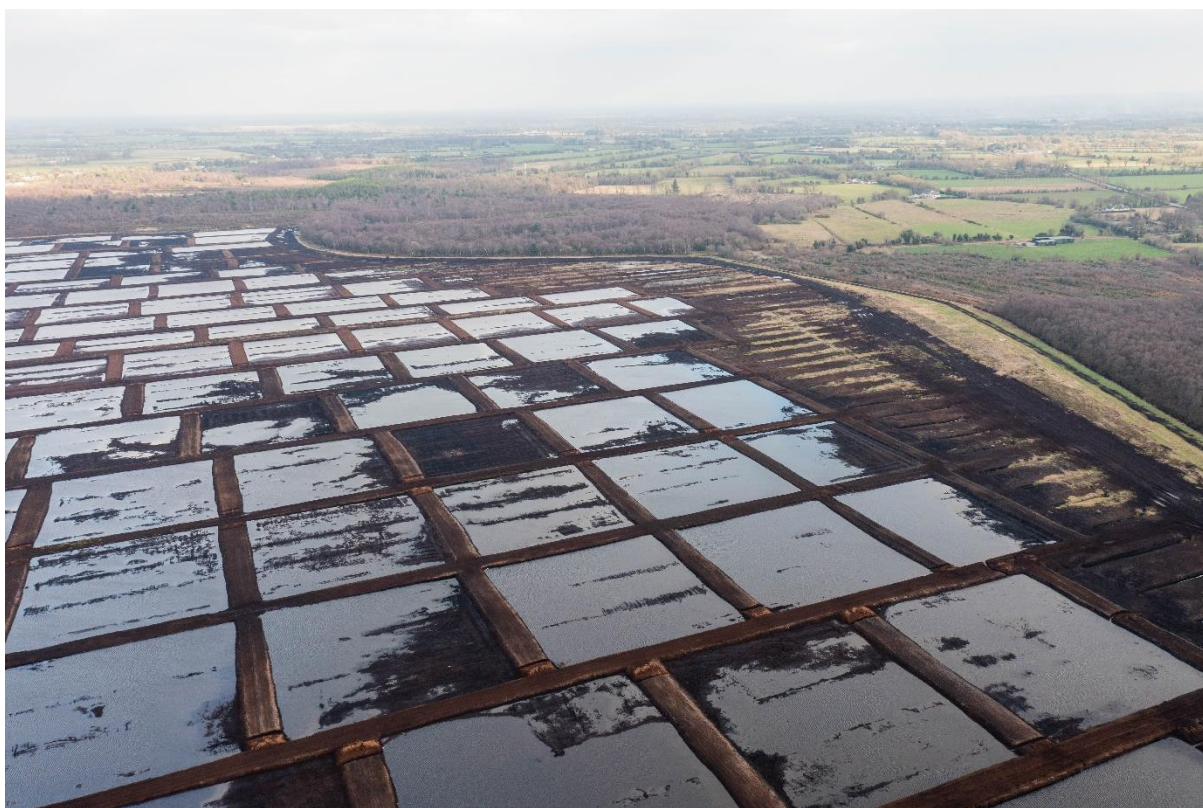
Plate B5.2: Carranstown Bog rehabilitation measures - February 2023

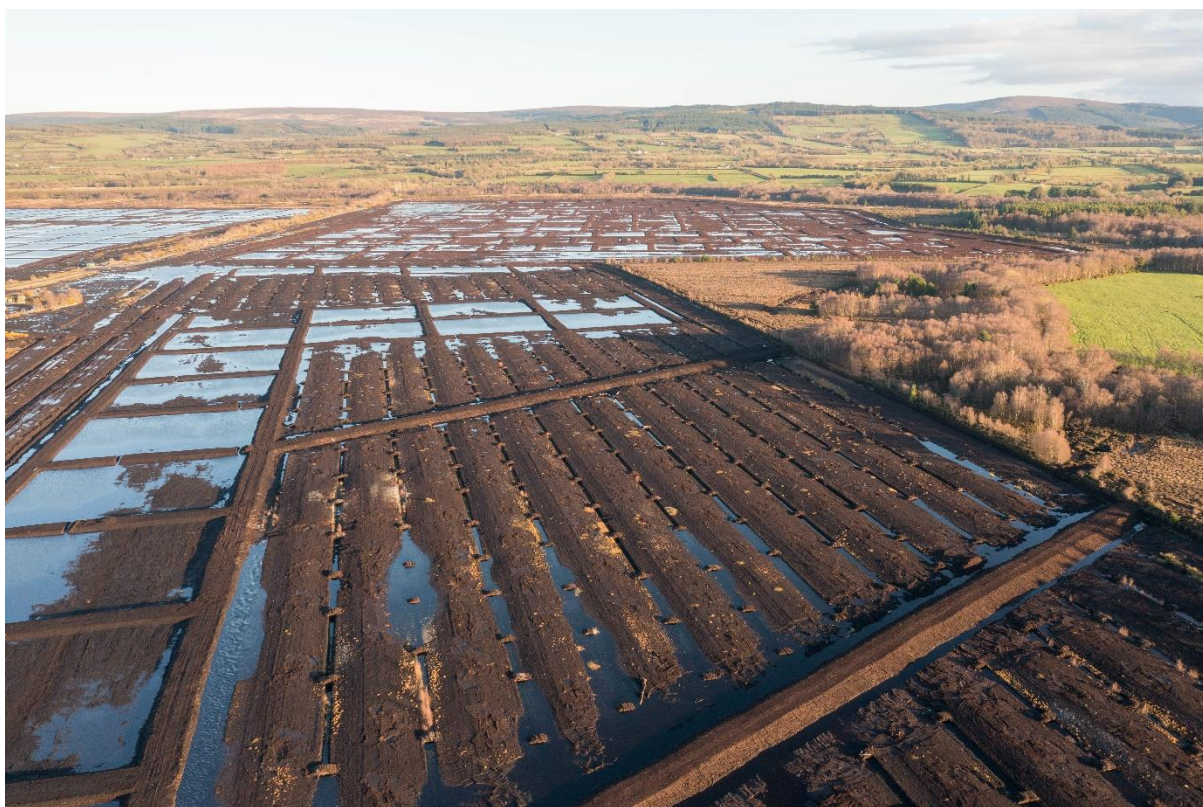
Plate B6.2 Derrinboy Bog rehabilitation measures - March 2023

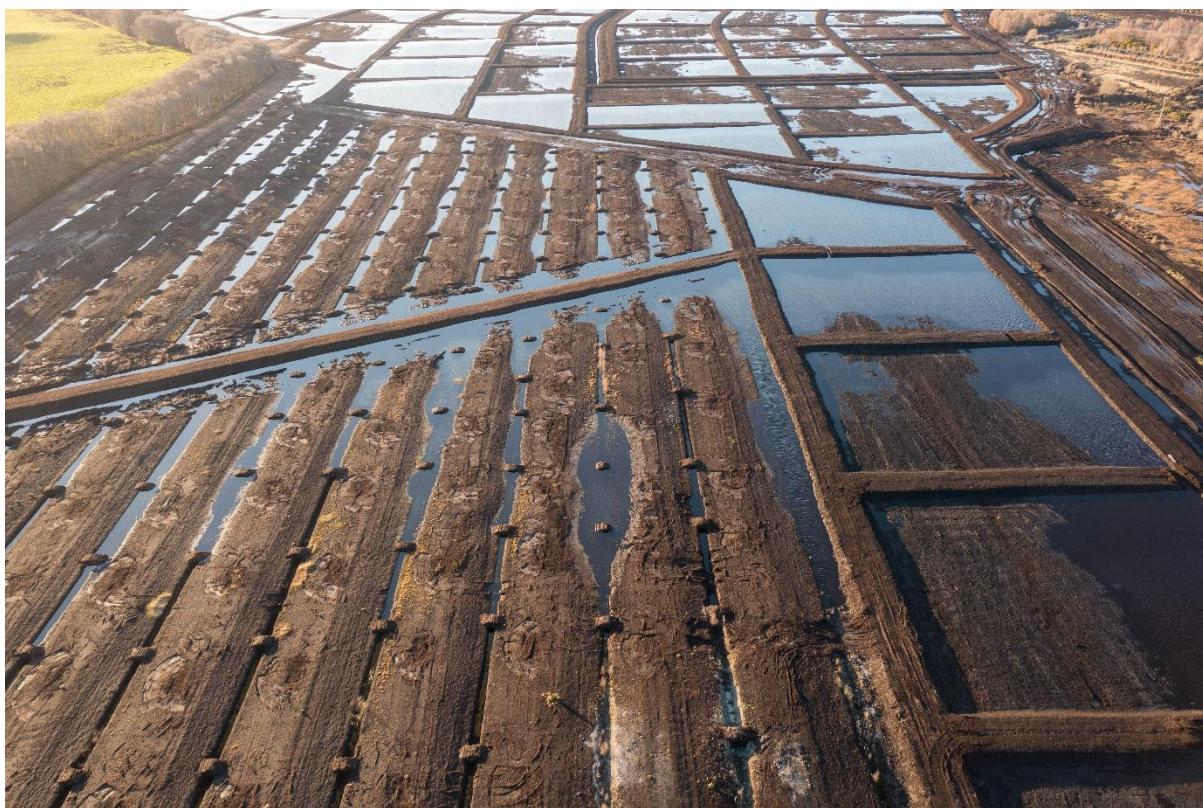
Plate B6.1 Derrinboy Bog rehabilitation measures - Oct 2022

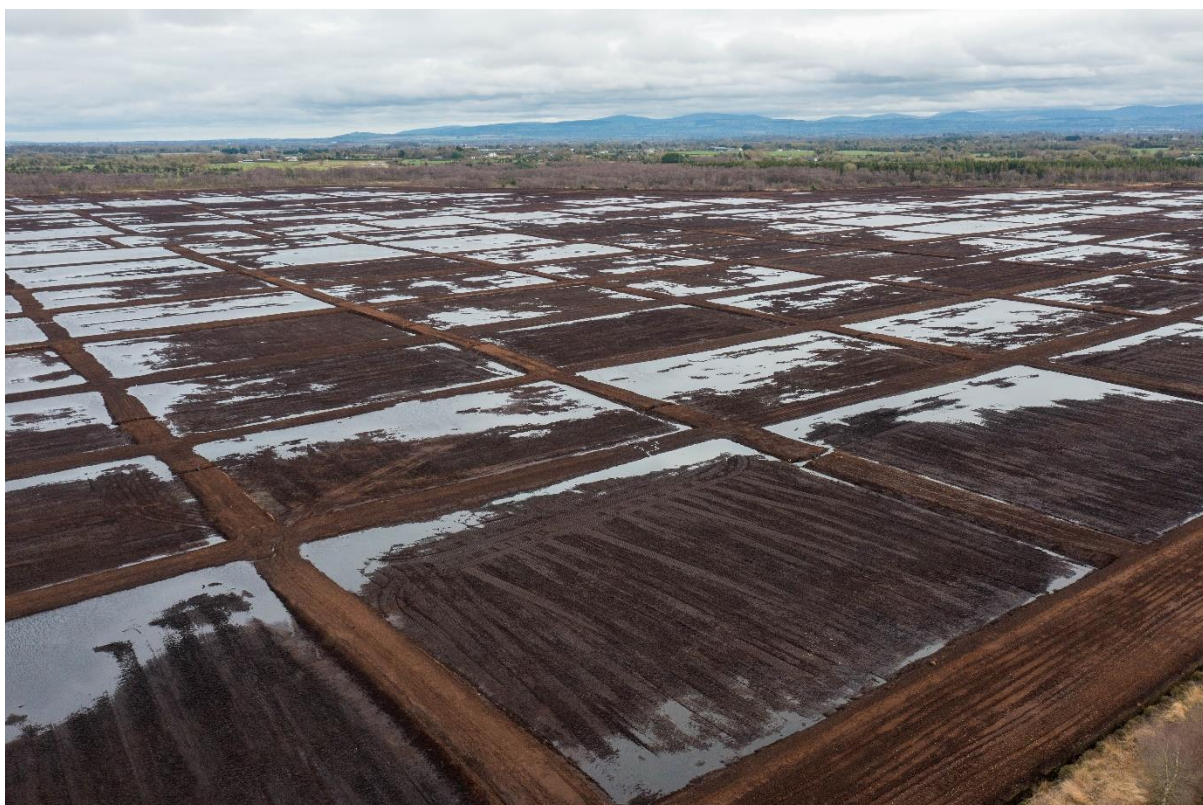
Plate B7.1: Prosperous Bog rehabilitation measures - February 2023

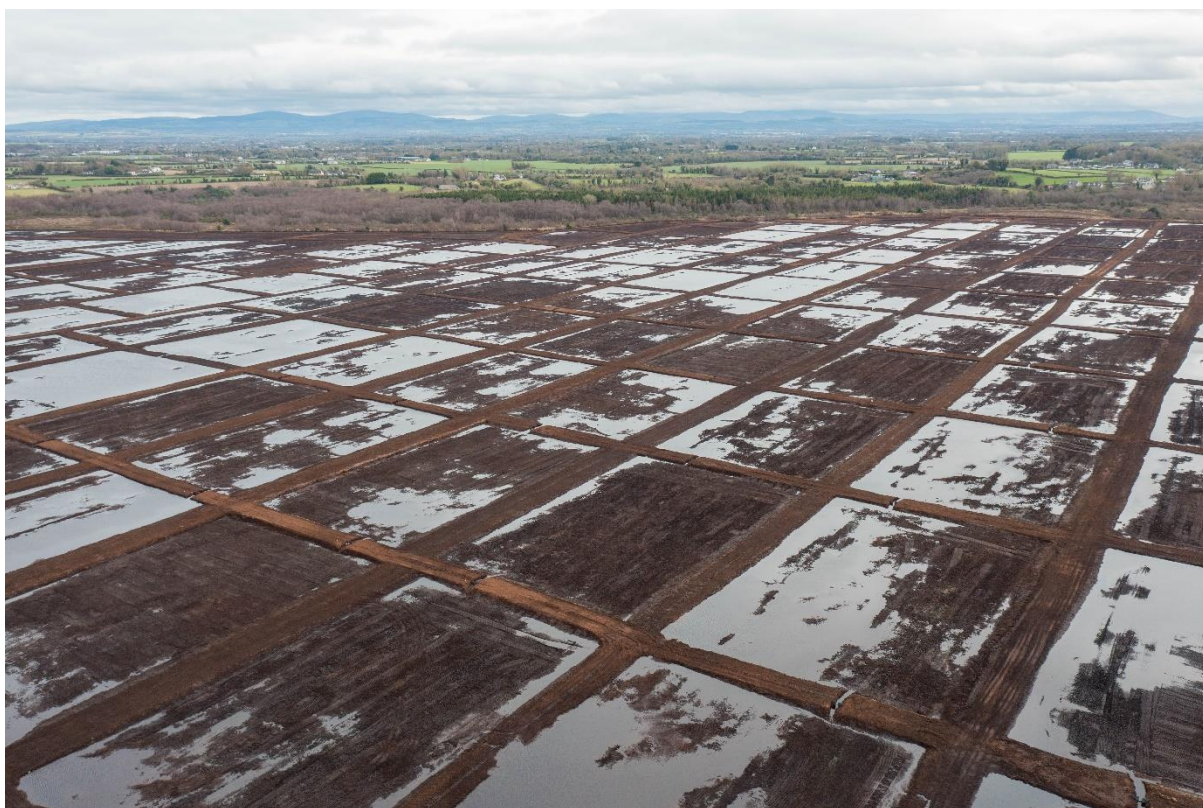
Plate B7.2: Prosperous Bog rehabilitation measures - February 2023

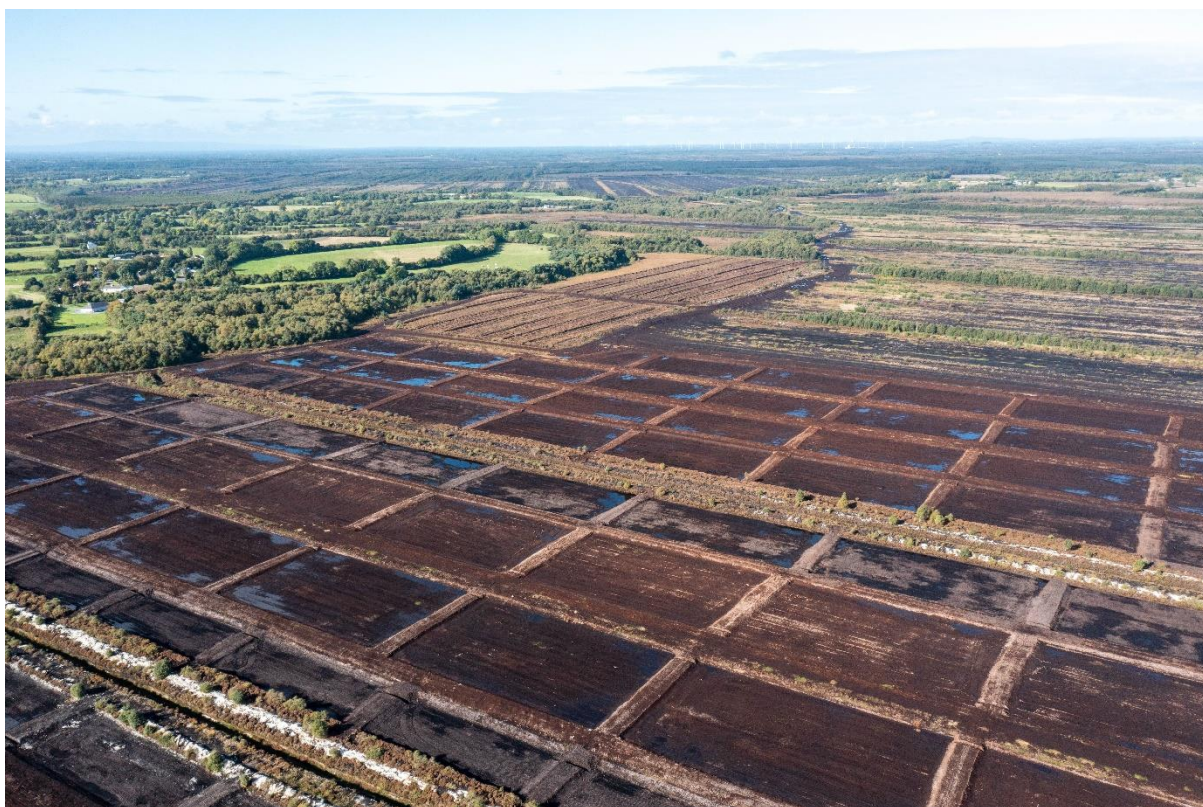
Plate B8.1: Lodge Bog rehabilitation measures - October 2022

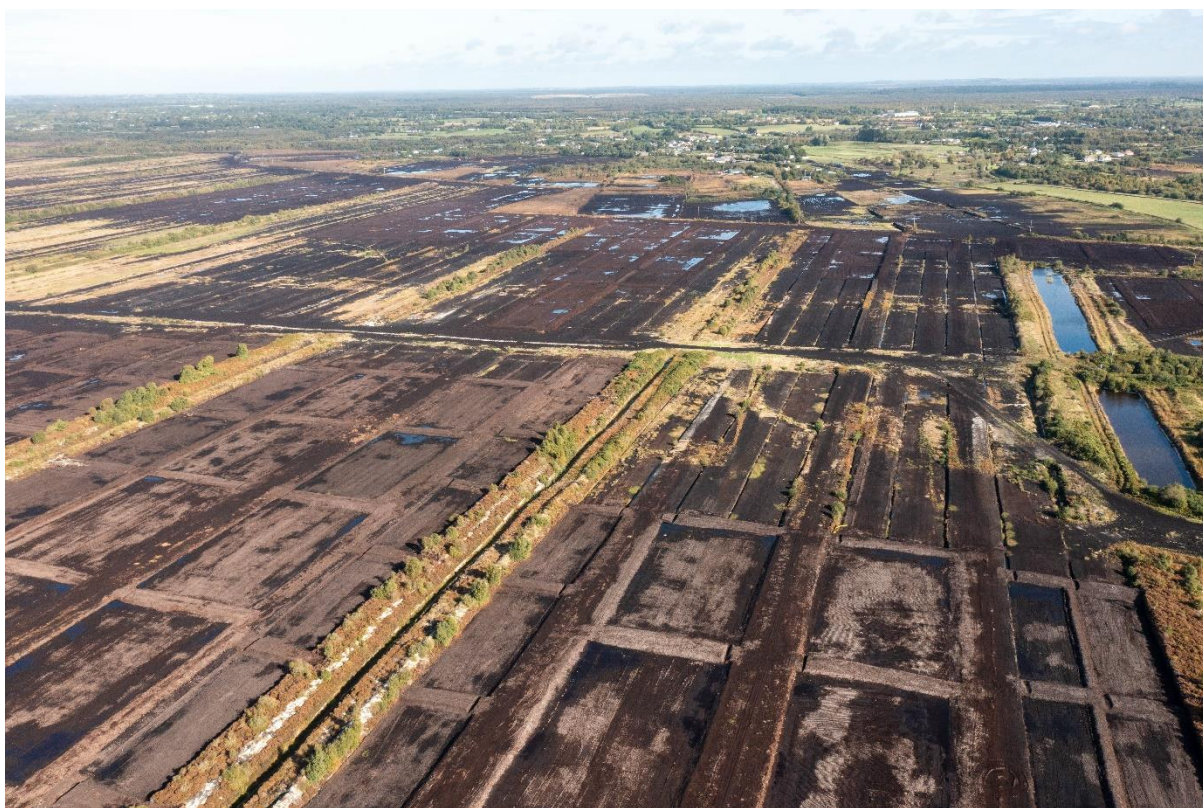
Plate B8.2: Lodge Bog rehabilitation measures - October 2022

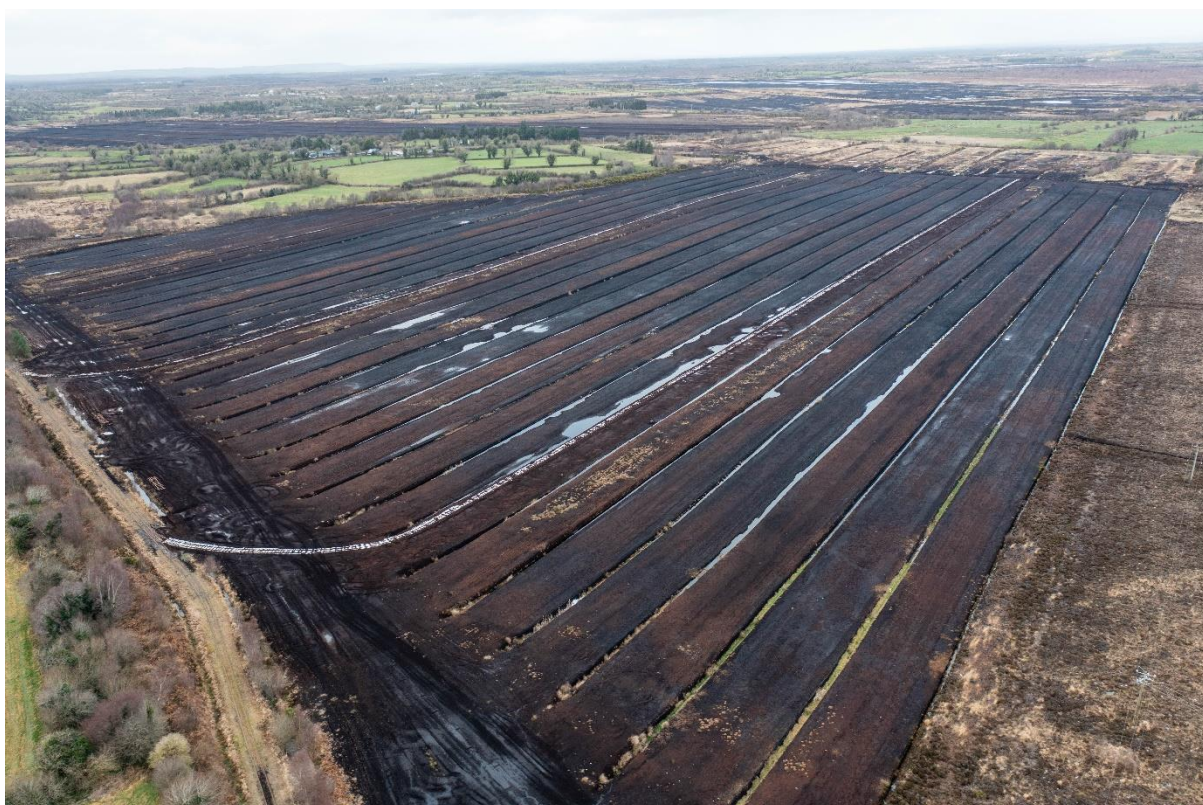
Plate B9.1: Derraghan Bog rehabilitation measures - February 2023

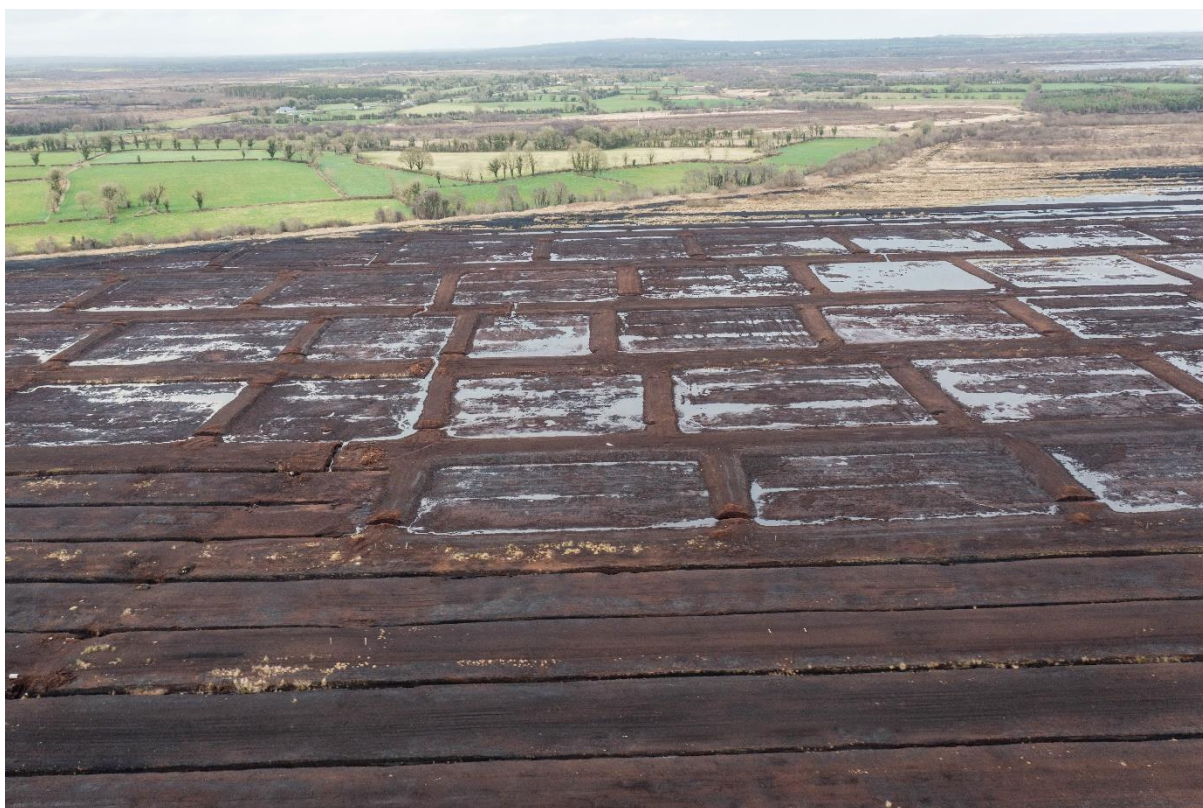
Plate B9.2: Derraghan Bog rehabilitation measures - February 2023

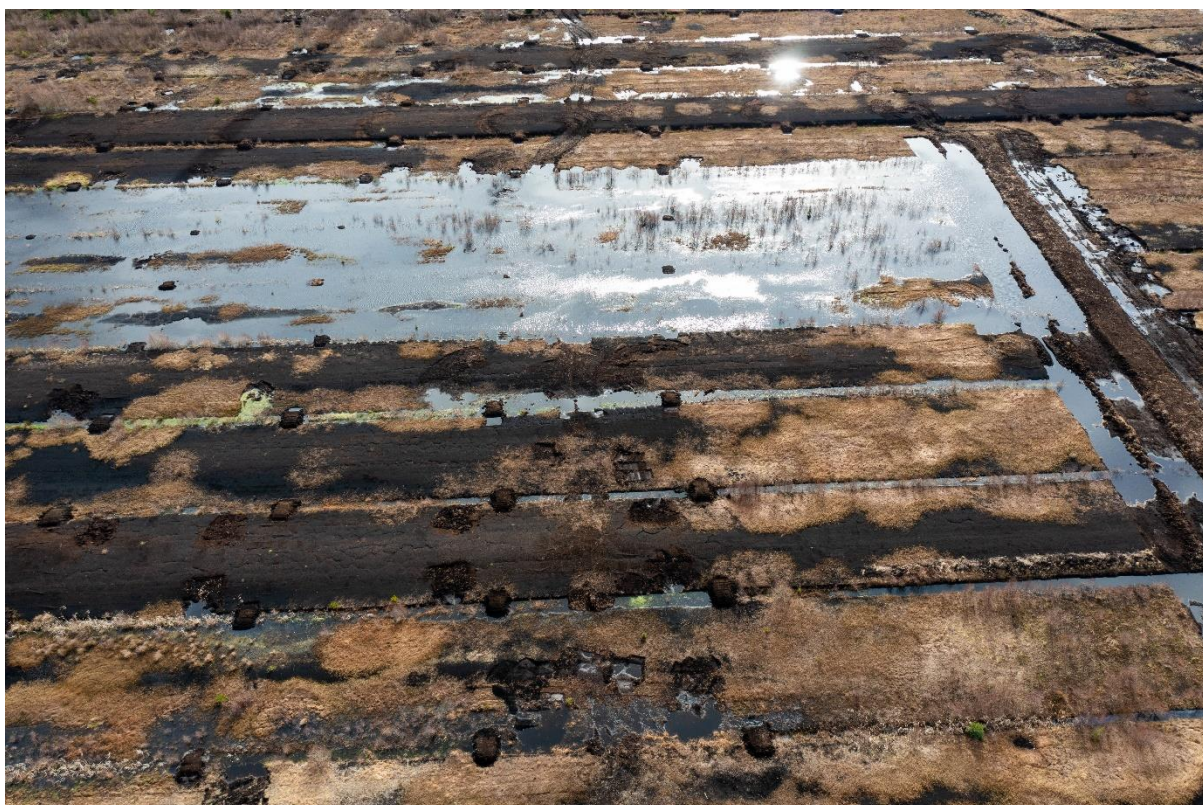
Plate B10.1: Cloncreen Bog rehabilitation measures - February 2023

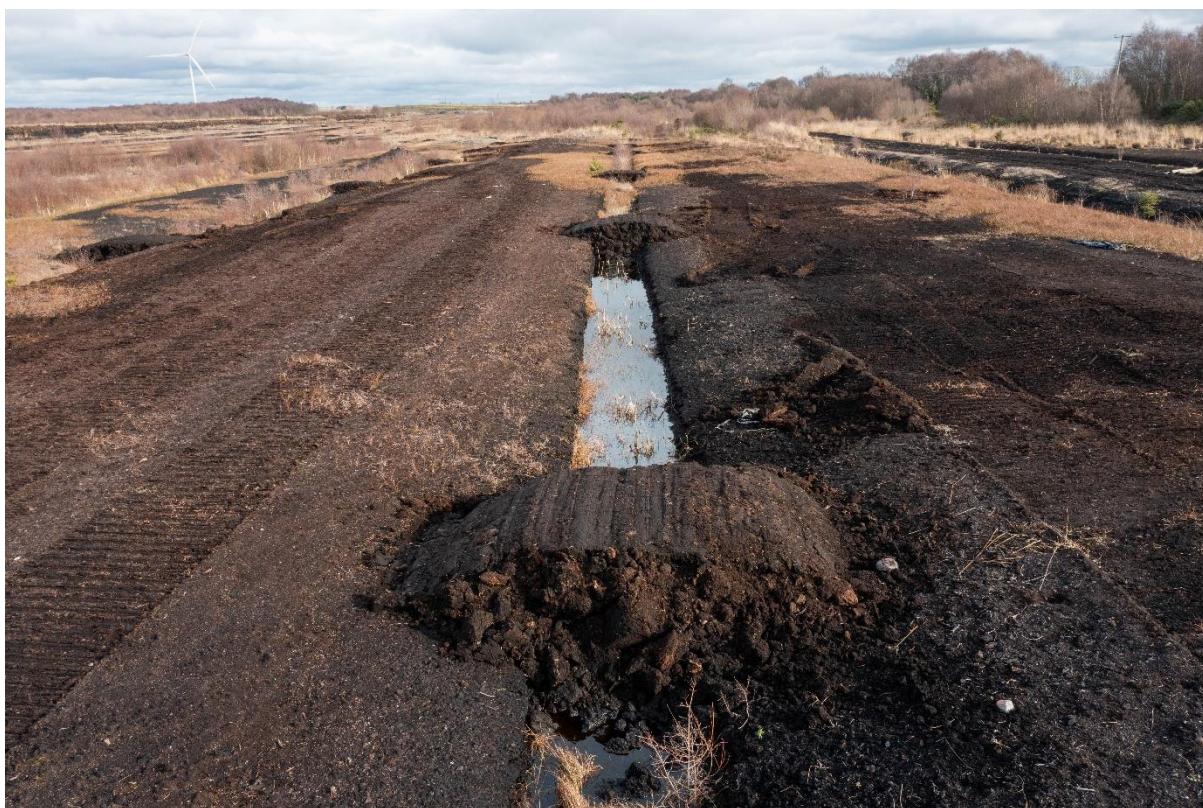
Plate B10.2: Cloncreen Bog rehabilitation measures - February 2023
