Bord na Móna

Enhanced Decommissioning, Rehabilitation and Restoration Scheme (EDRRS)

**Annual Report – Year 2
April 2022 to March 2023**

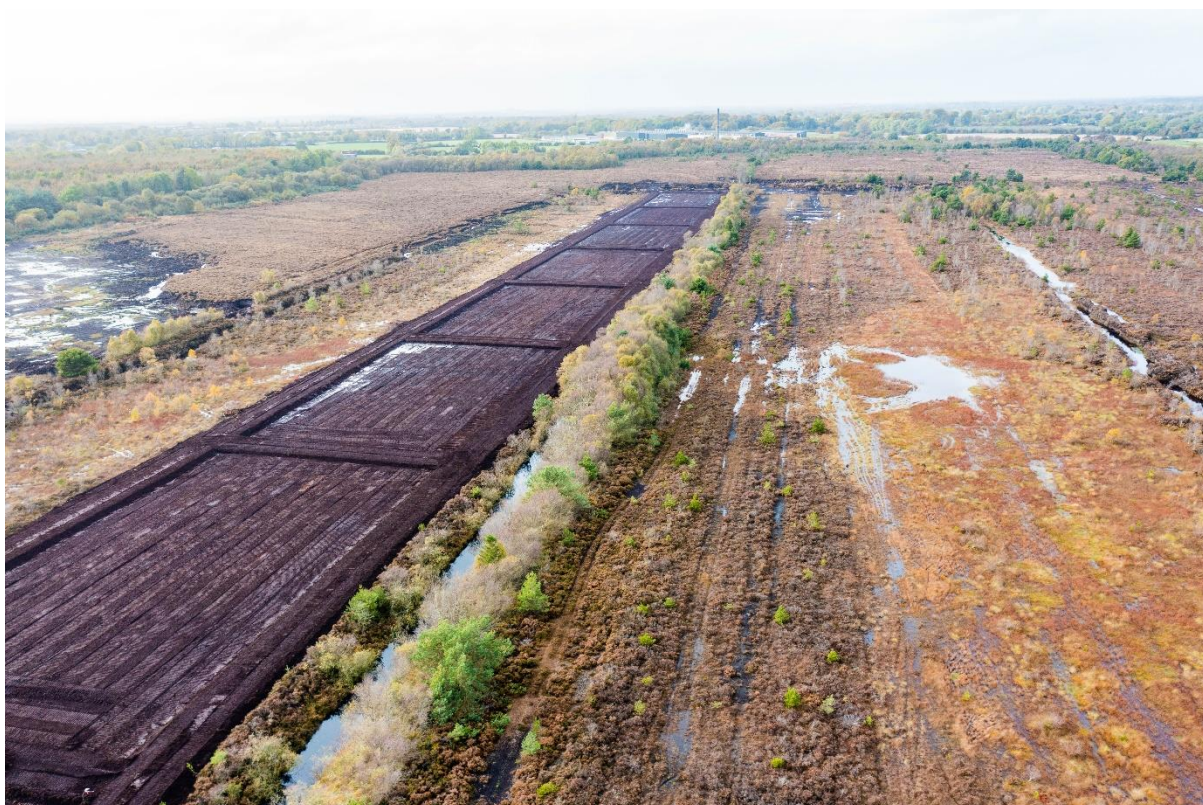
Plate B11.1: Timahoe South Bog rehabilitation measures - April 2021

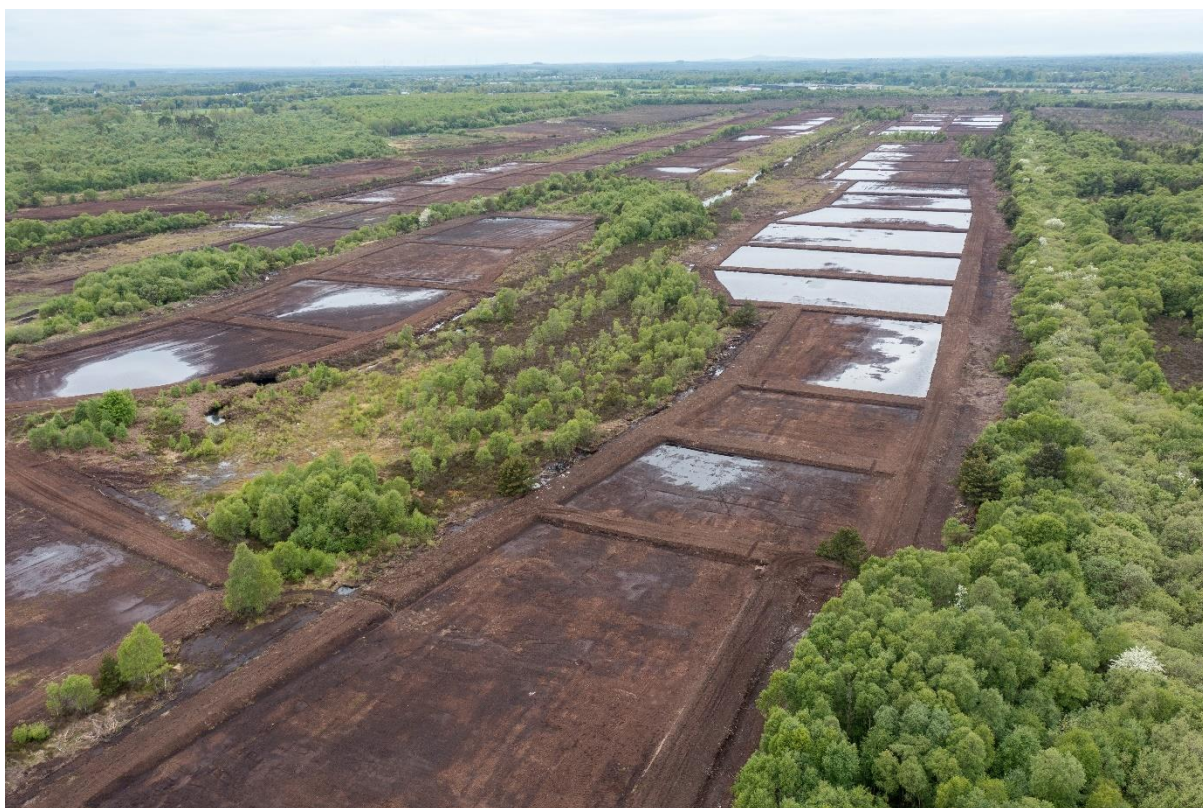
Plate B11.2: Timahoe South Bog rehabilitation measures - May 2023

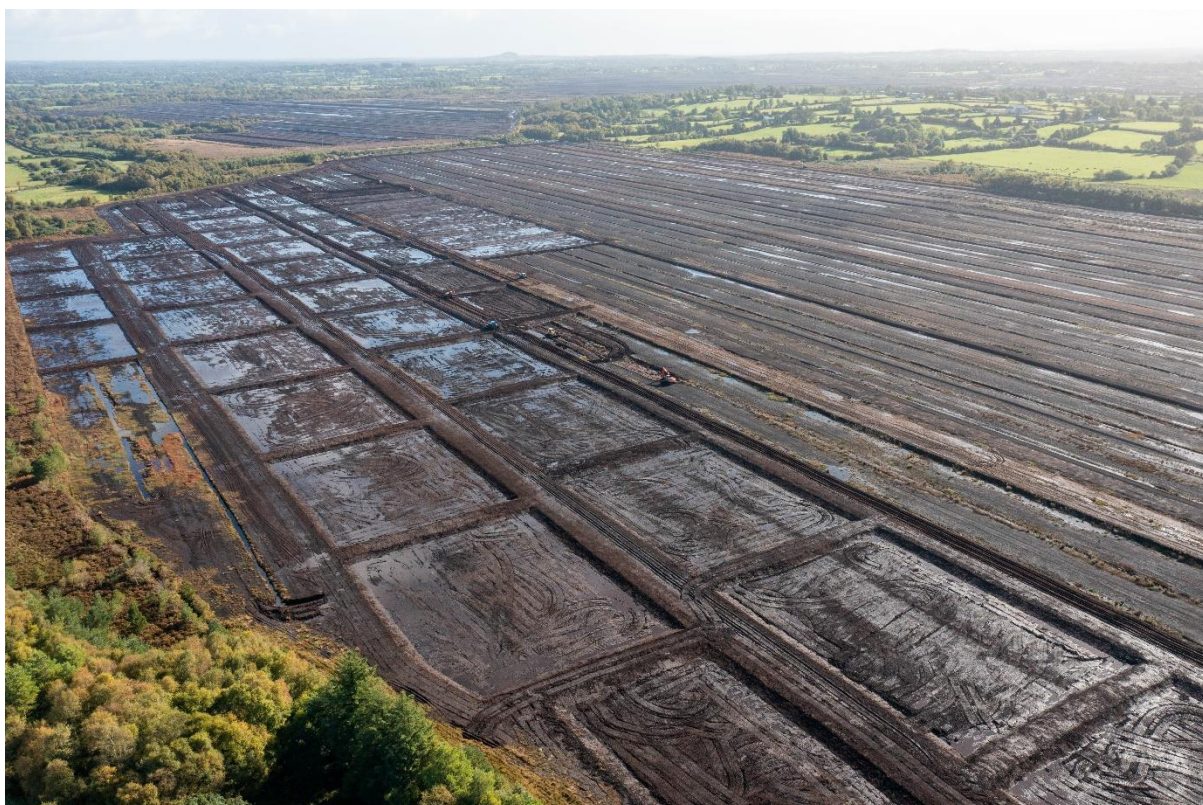
Plate B12.1: Bloomhill Bog rehabilitation measures - October 2022

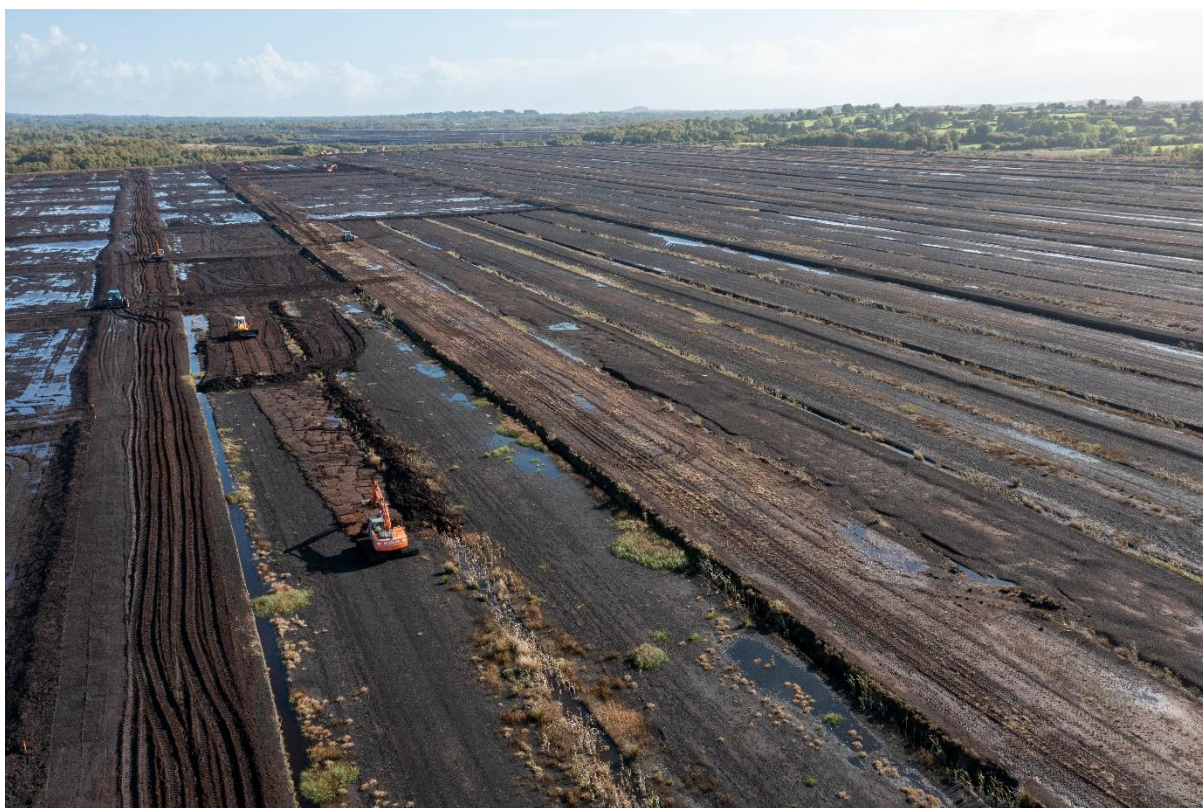
Plate B12.2: Bloomhill Bog rehabilitation measures - October 2022

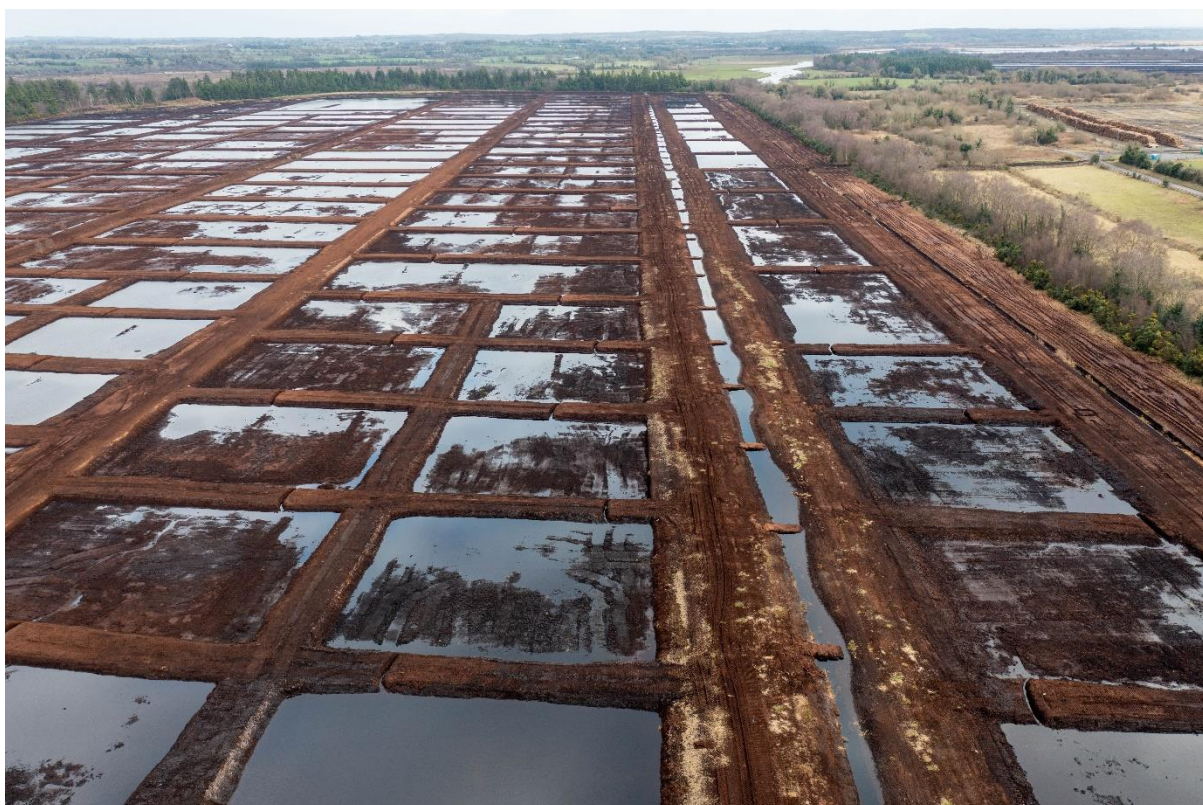
Plate B13.1: Derryfadda Bog rehabilitation measures - February 2023

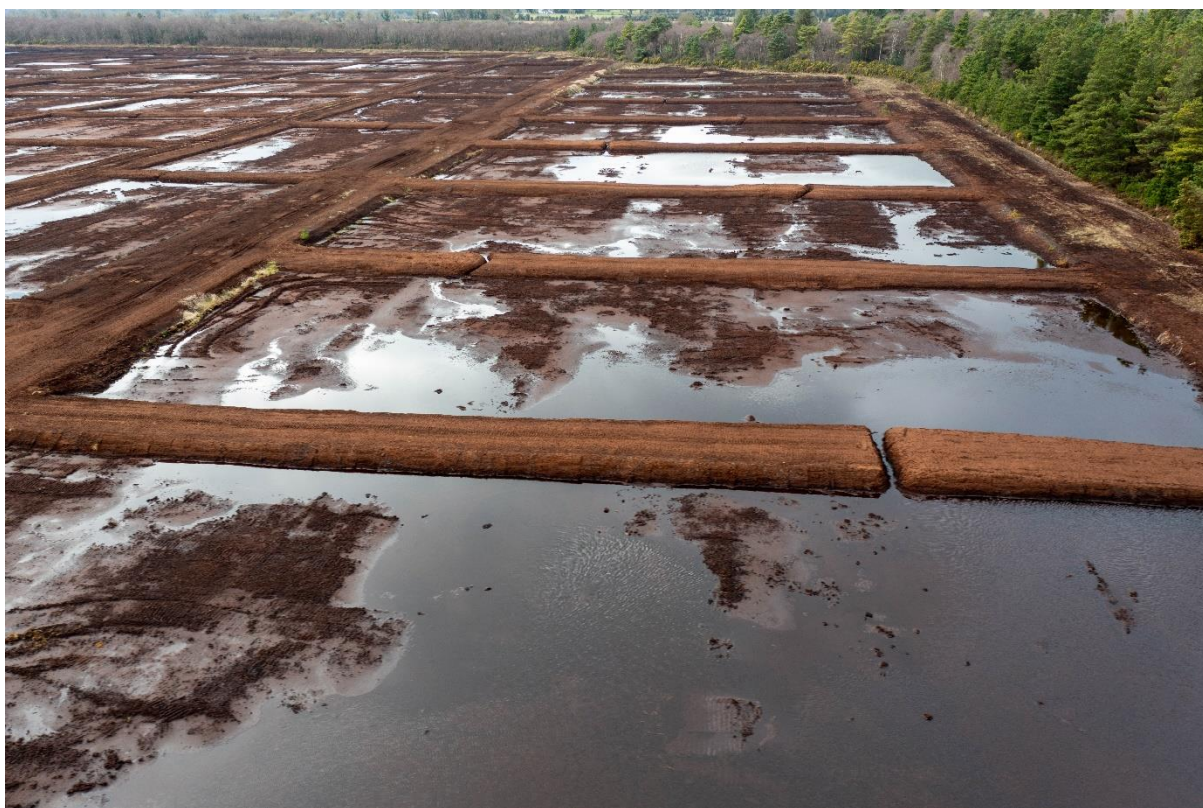
Plate B13.2: Derryfadda Bog rehabilitation measures - February 2023

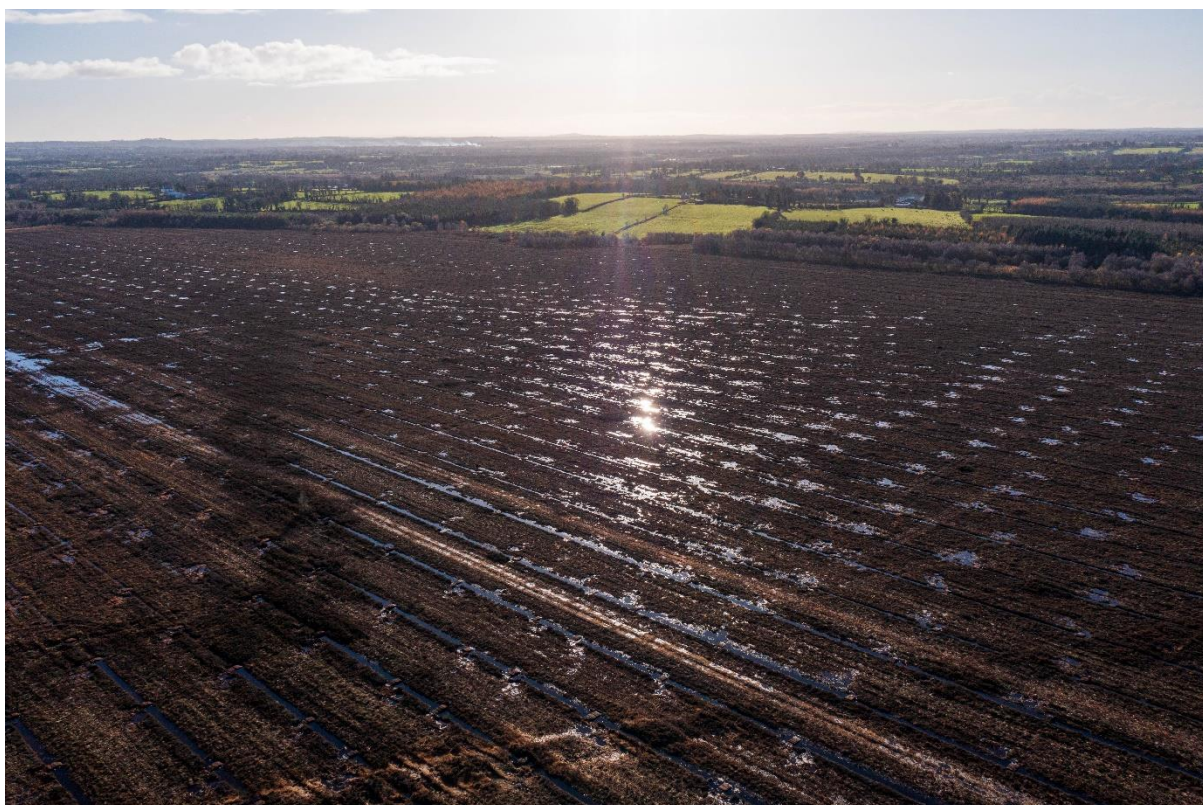
Plate B14.1: Glenlough Bog rehabilitation measures - November 2022

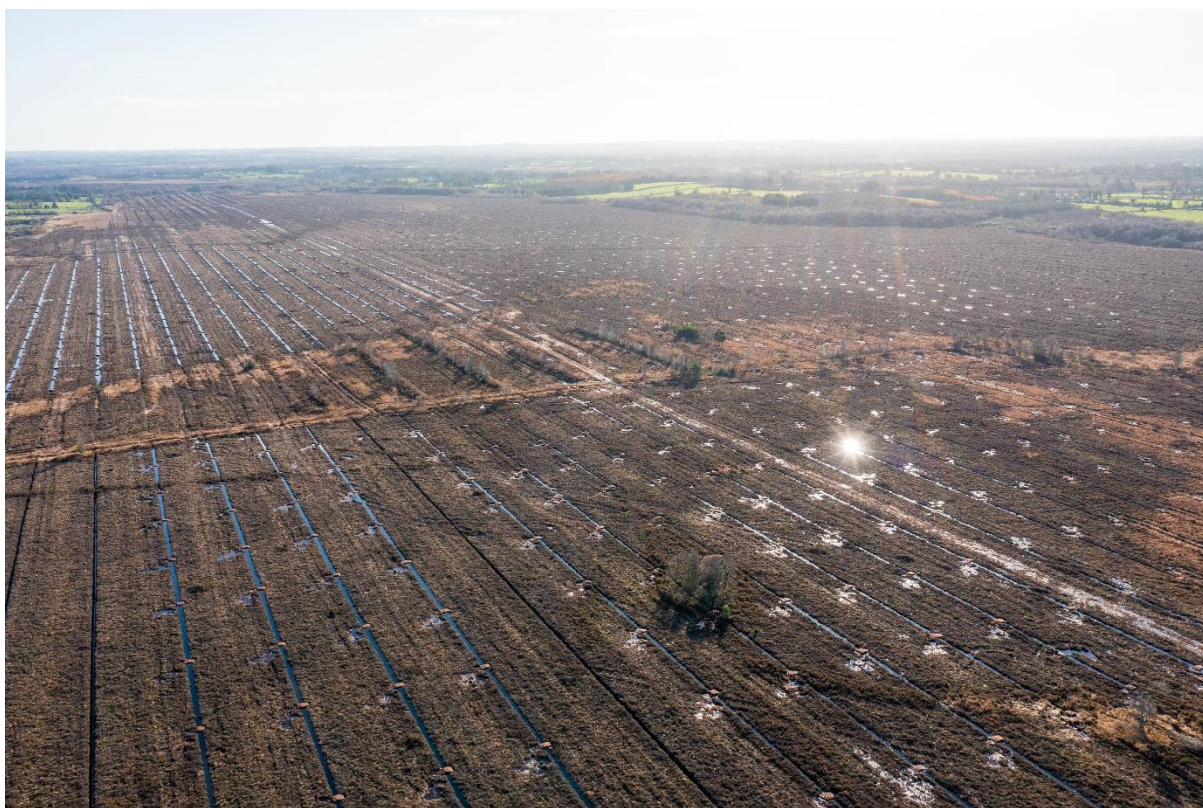
Plate B14.2: Glenlough Bog rehabilitation measures - November 2022

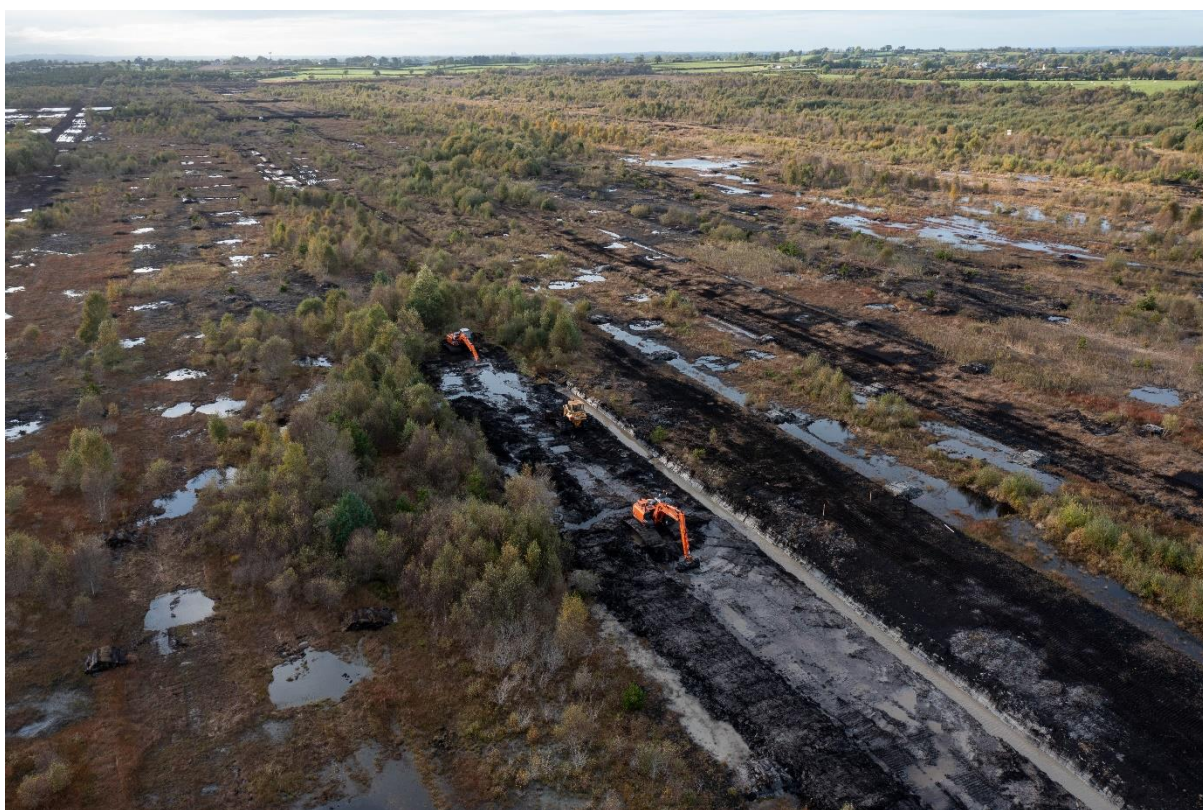
Plate B15.1: Noggusboy Bog rehabilitation measures - October 2022

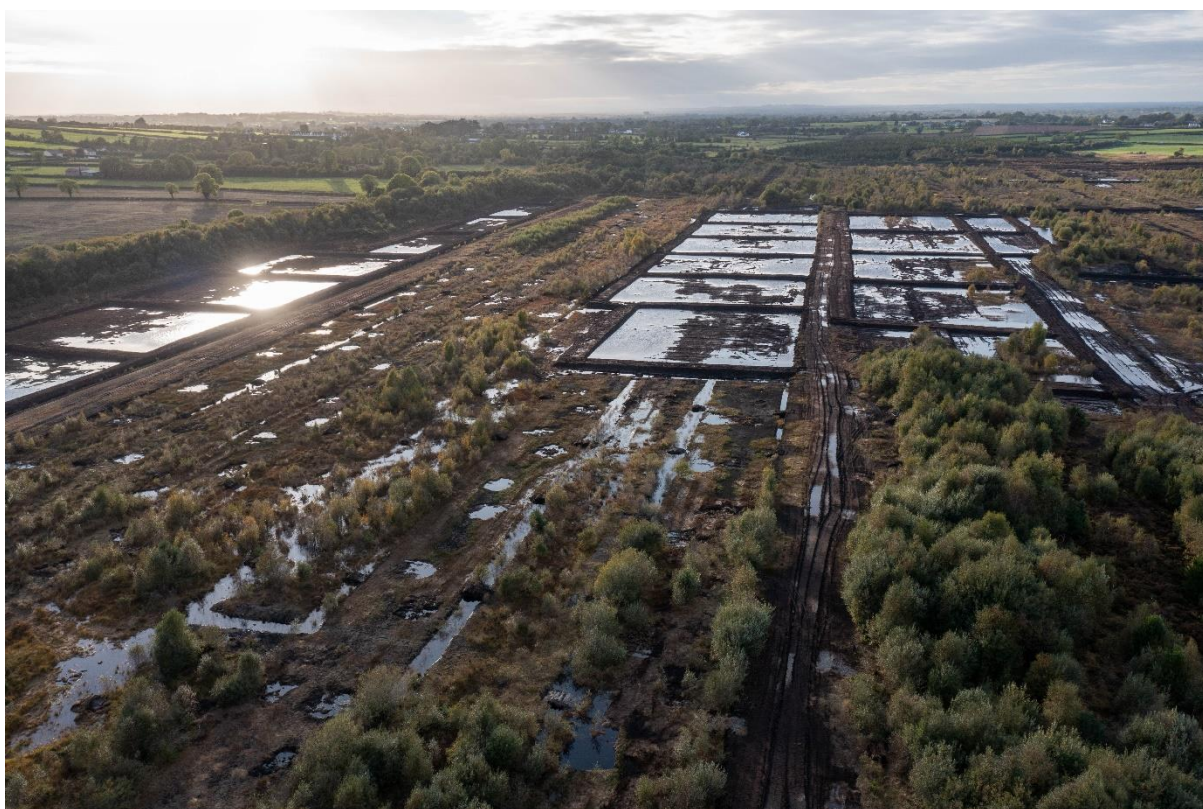
Plate B15.2: Noggusboy Bog rehabilitation measures - October 2022

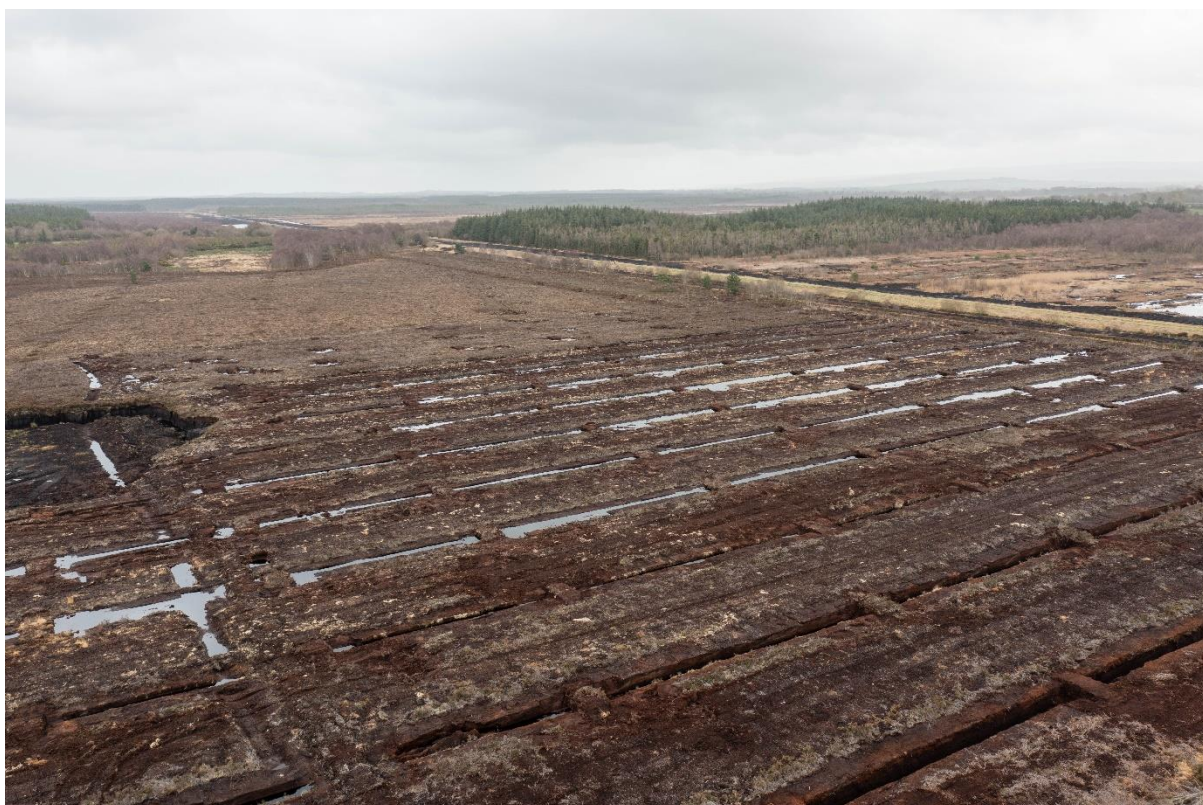
Plate B16.1: Derrybrat Bog rehabilitation measures - February 2023

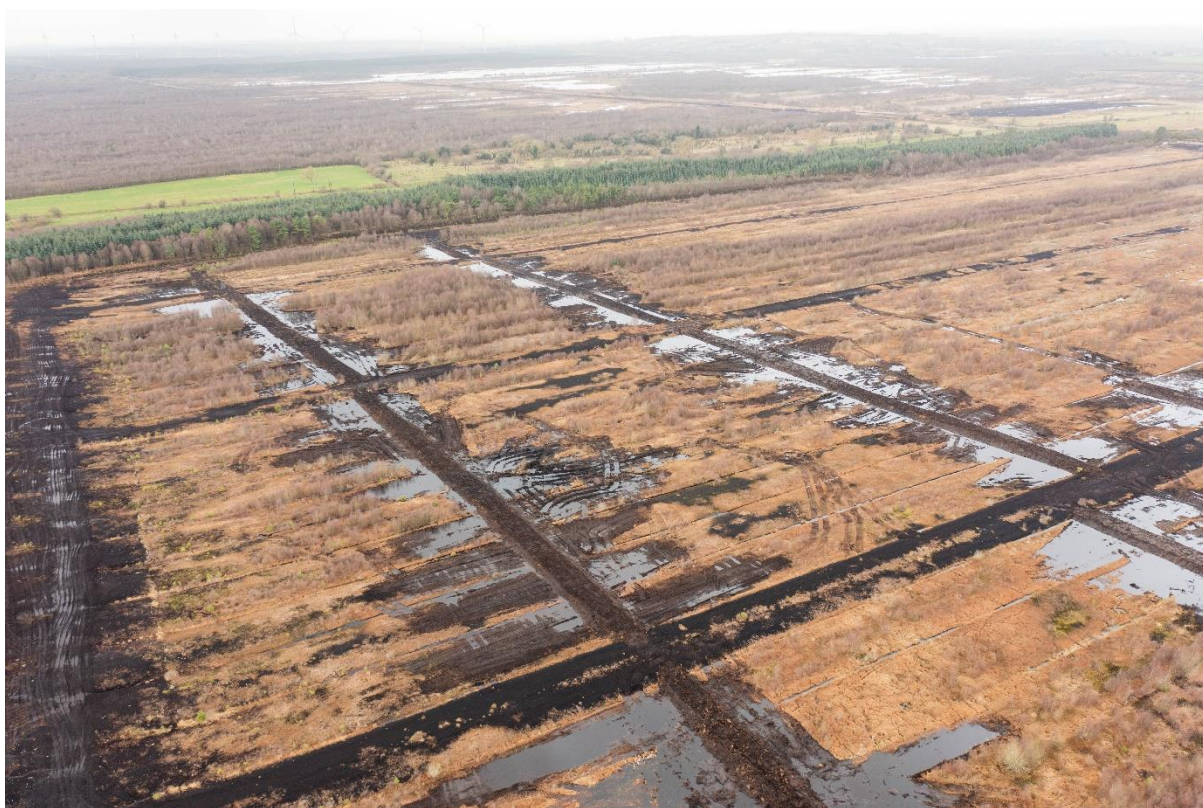
Plate B16.2: Derrybrat Bog rehabilitation measures - February 2023

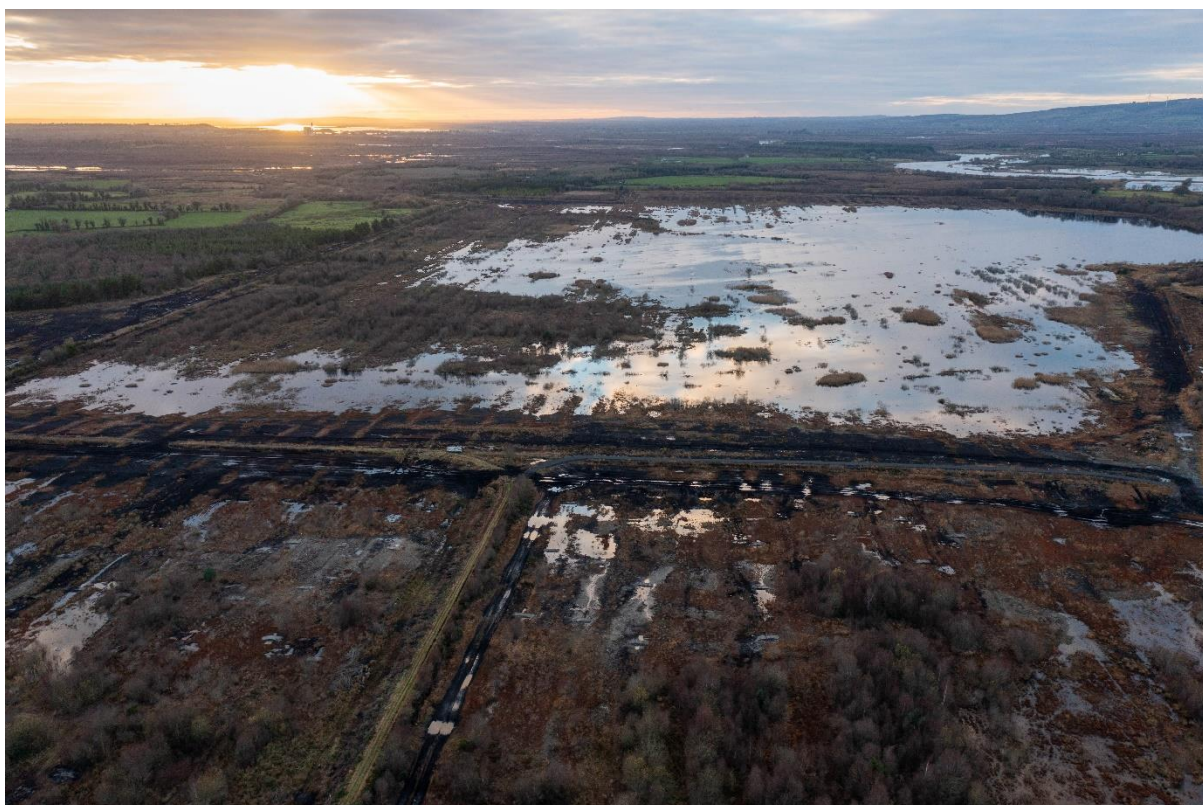
Plate B17.1: Knappoge Bog rehabilitation measures - December 2022

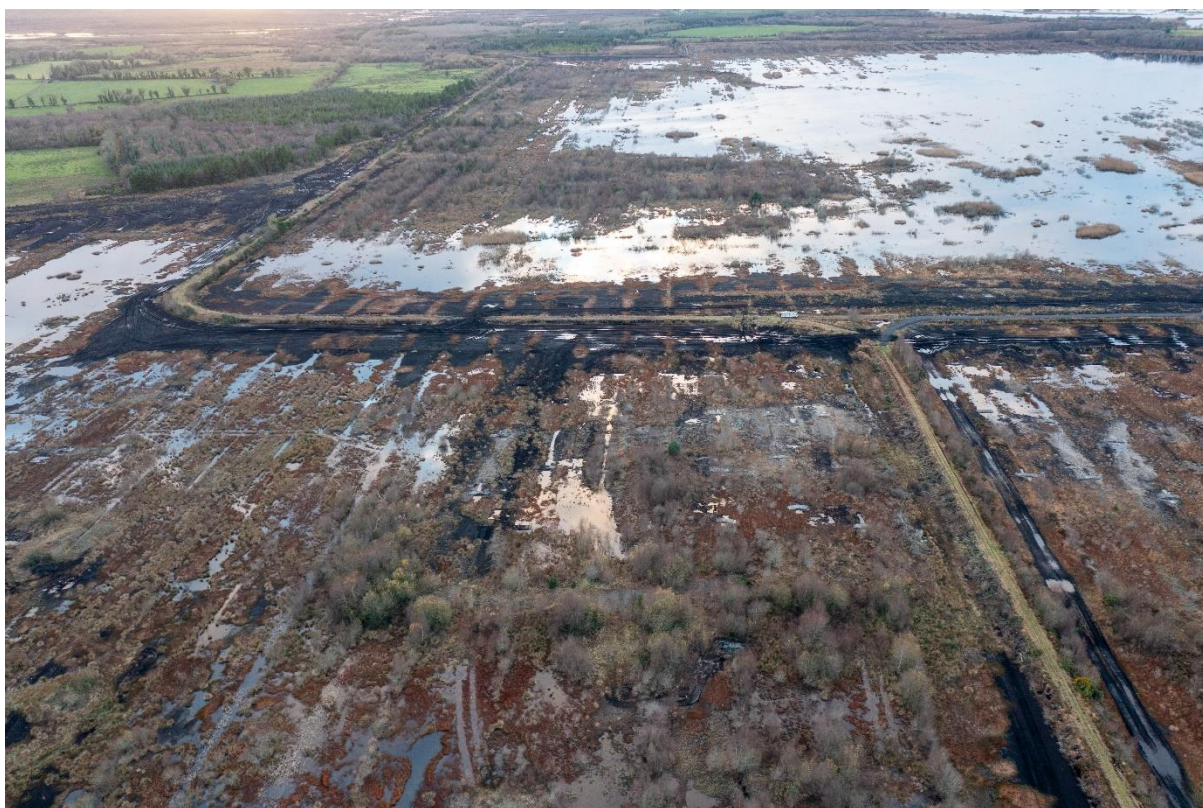
Plate B.17.2: Knappoge Bog rehabilitation measures - December 2022

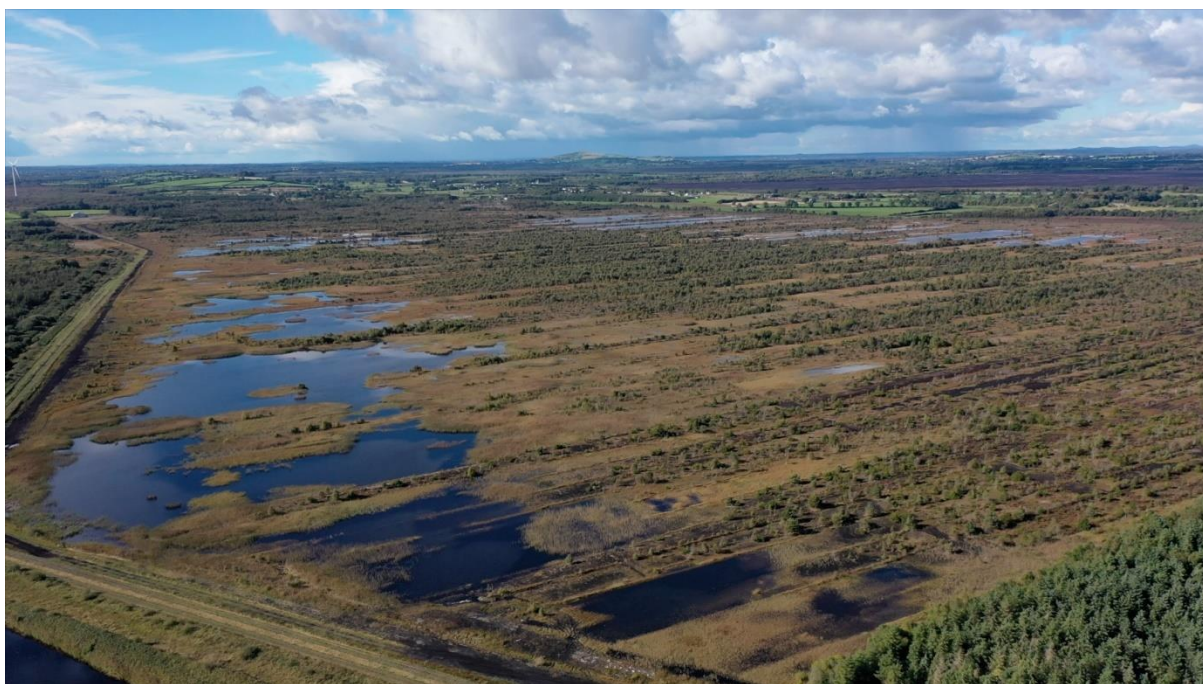
Plate B18.1: Ballycon Bog rehabilitation measures - September 2022

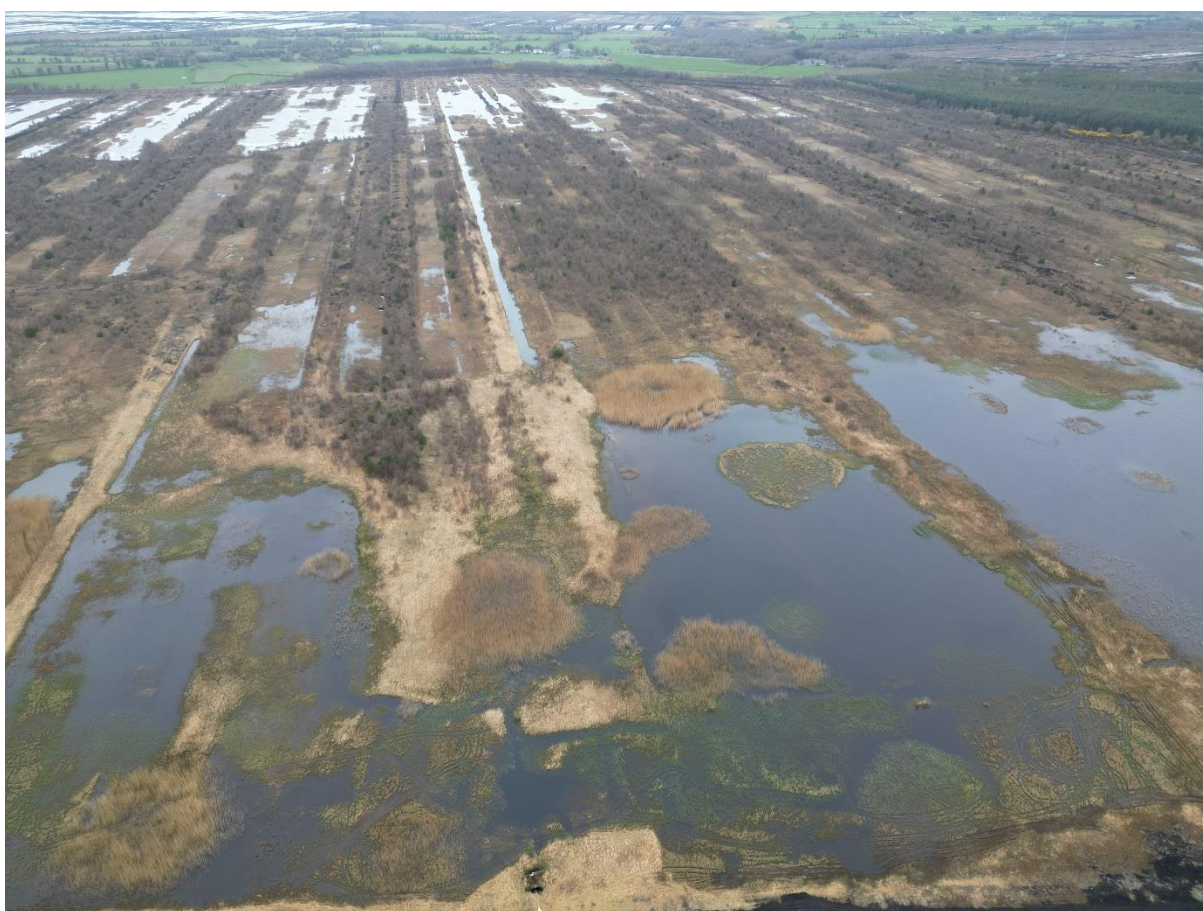
Plate B18.2: Ballycon Bog rehabilitation measures - November April 2023

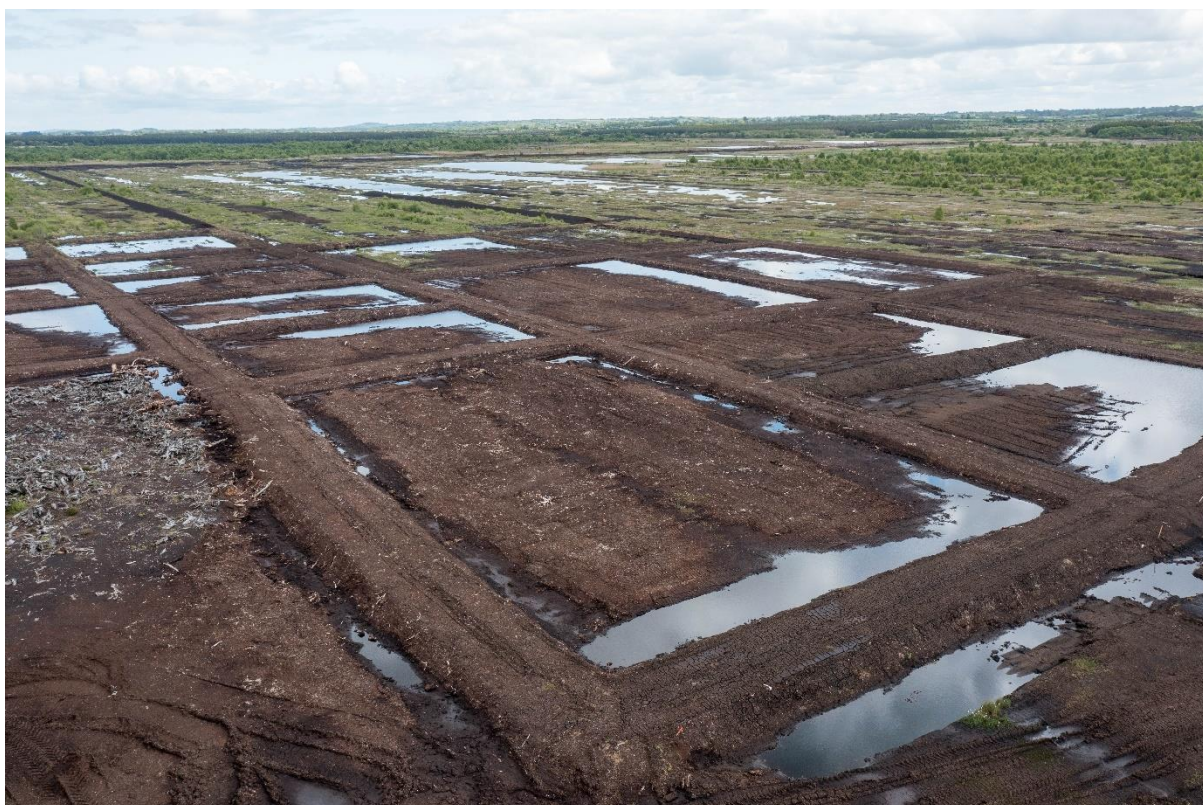
Plate B19.1: Blackwater Bog rehabilitation measures - May 2023

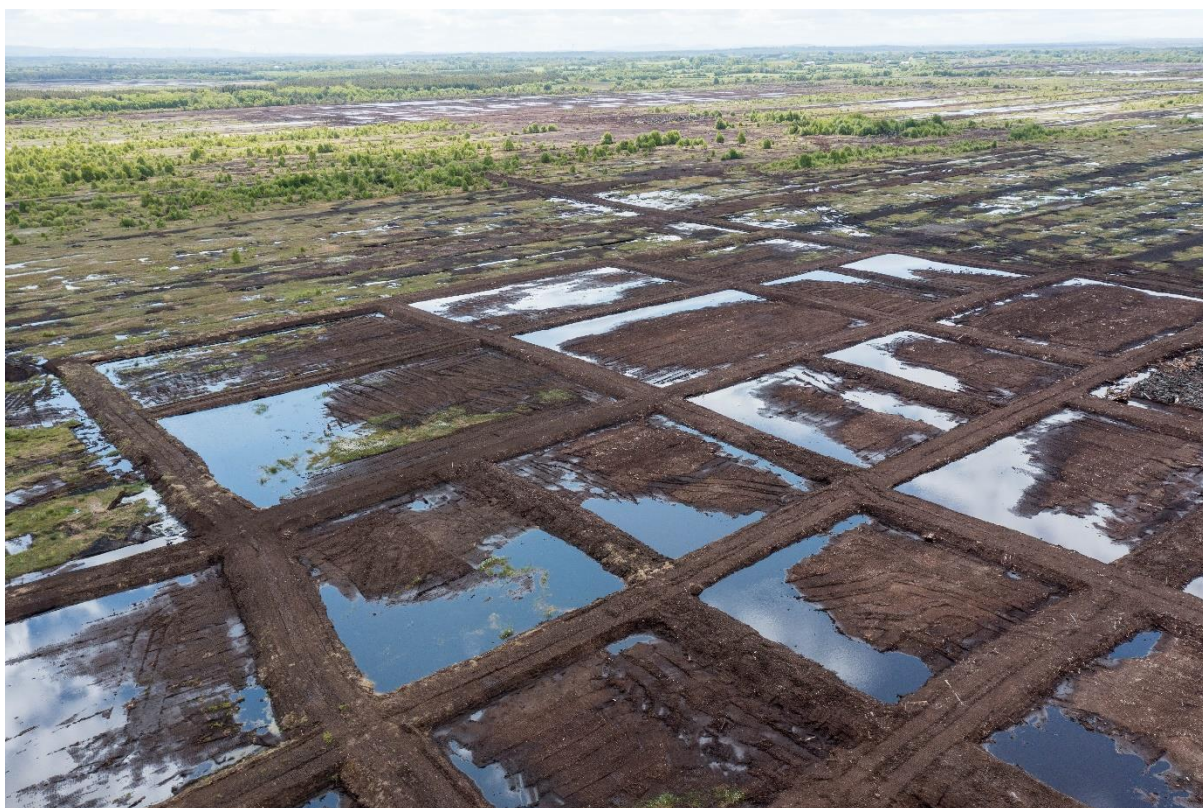
Plate B19.2: Blackwater Bog rehabilitation measures - May 2023

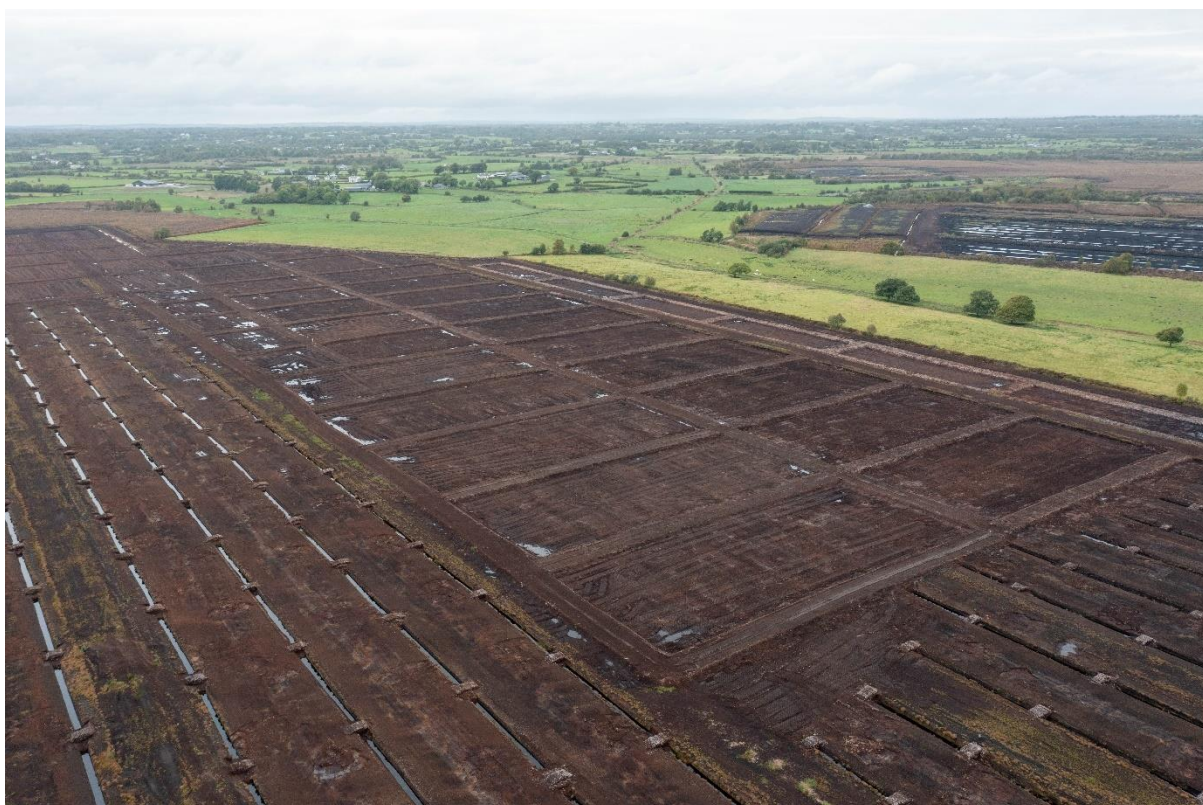
Plate B20.1: Clooniff Bog rehabilitation measures - October 2022

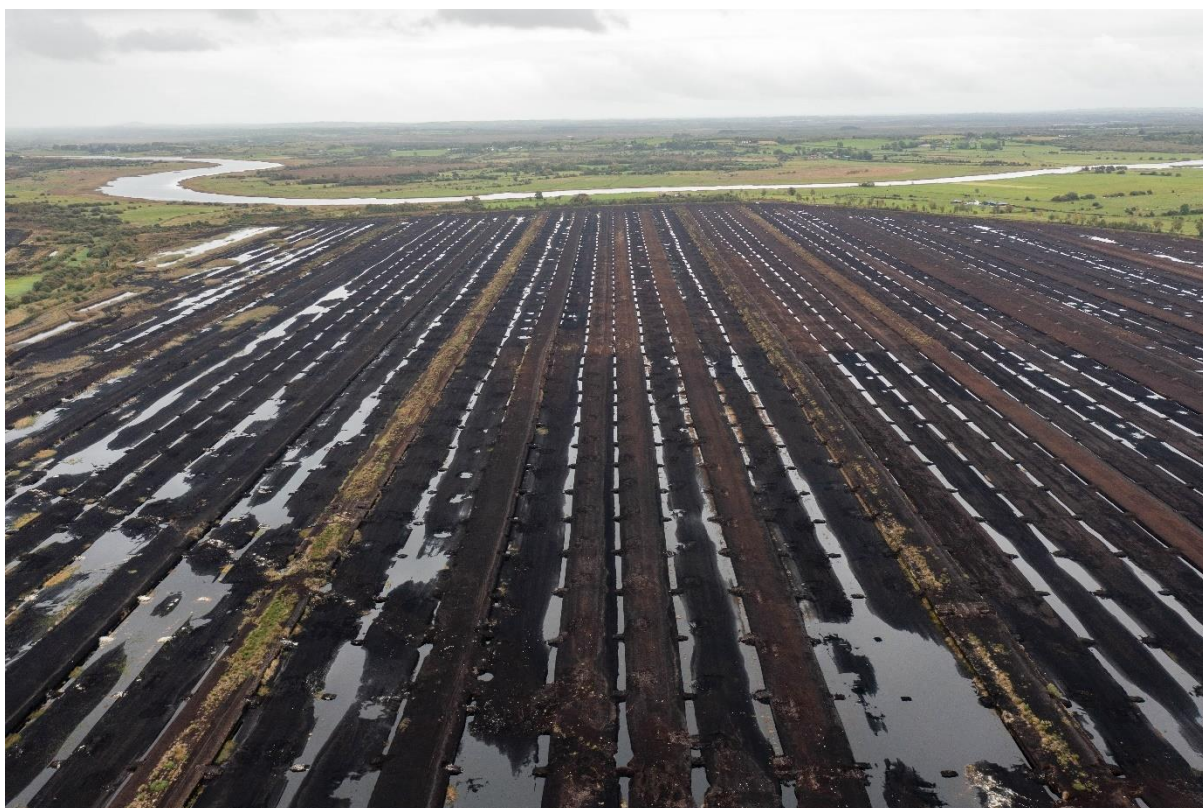
Plate B20.2: Clooniff Bog rehabilitation measures - October 2022
