# Bord na Móna

**Clongawney Bog**

# Draft Cutaway Bog Decommissioning and Rehabilitation Plan 2024

This document seeks to address the requirements of Condition 10.2 of IPC Licence Ref. P0500-01:

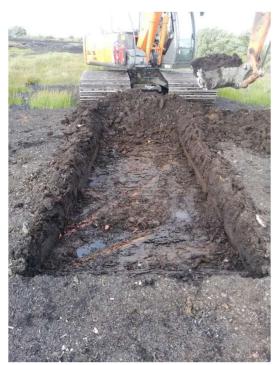
Plate 1. Timbers identified during monitoring in Clongawney Bog in 2019 at compound 2.

identified as of archaeological significance were noted in compounds 2 and 3 in Clongawney Bog at a depth of 0.38m and 2.8m (see Plates 1 and 2). The timbers were preserved *in situ*. However, no coordinates are provided in the monitoring report for these trial pits (Carroll 2020).

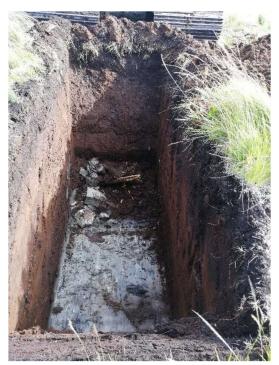
Plate 2. Timber identified during monitoring in Clongawney Bog in 2019 at compound 3.
