Bord na Móna

Cloonboley Bog

**Cutaway Bog Decommissioning and
Rehabilitation Plan**

2024

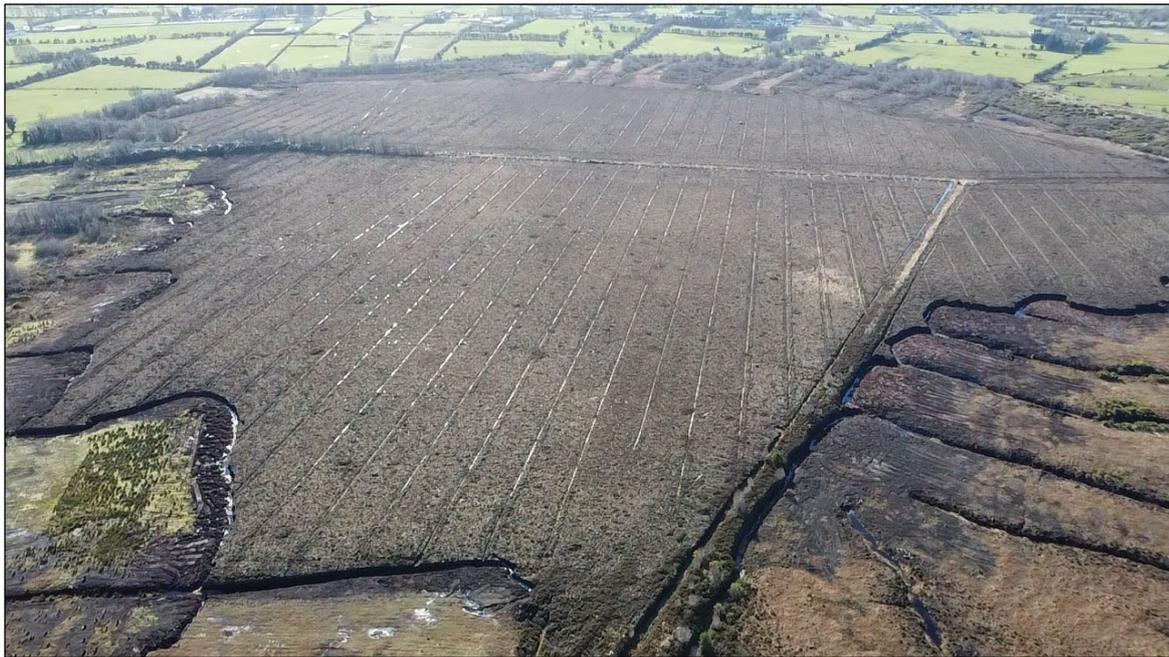
Plate 3.1 Raised bog at Tonalig South Bog. Note the cutover bog fringes the high bog.

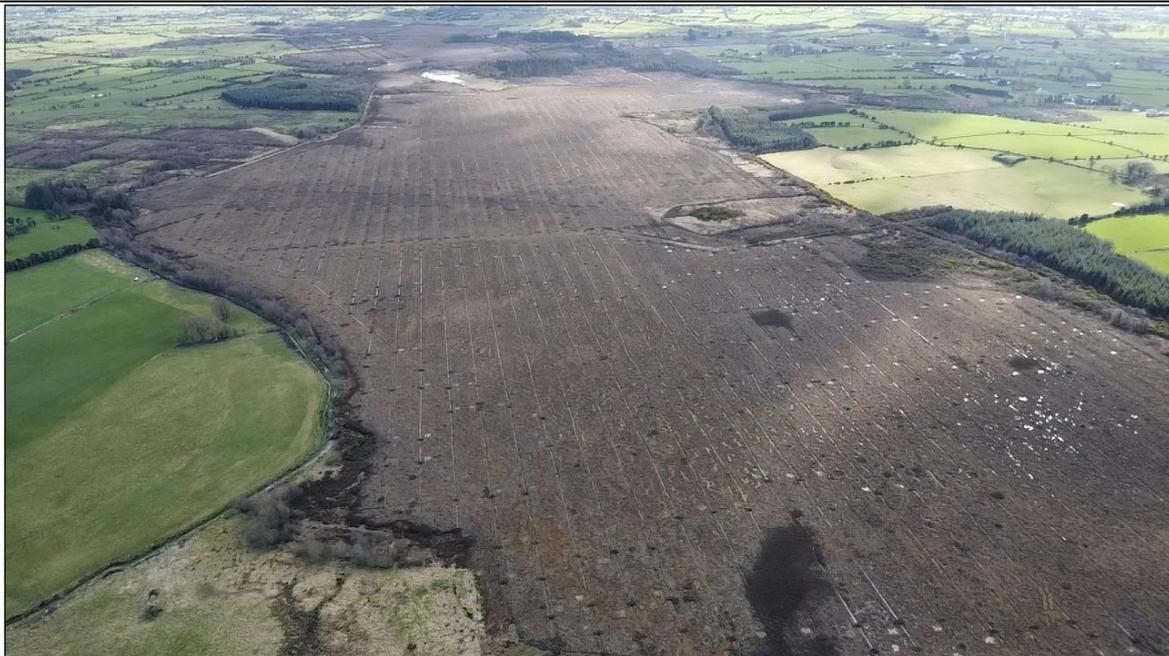
Plate 3.2 Cranberry Lough Raised bog, view looking south.

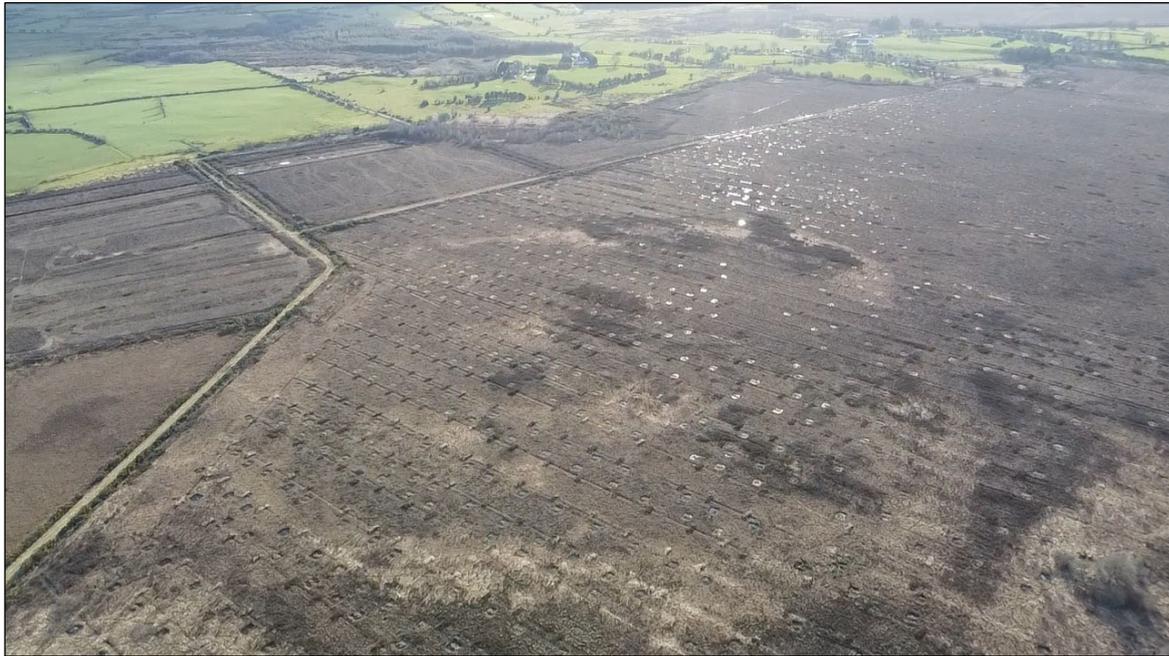
Plate 3.3 Ballydangan South Bog, southern section, view looking west.

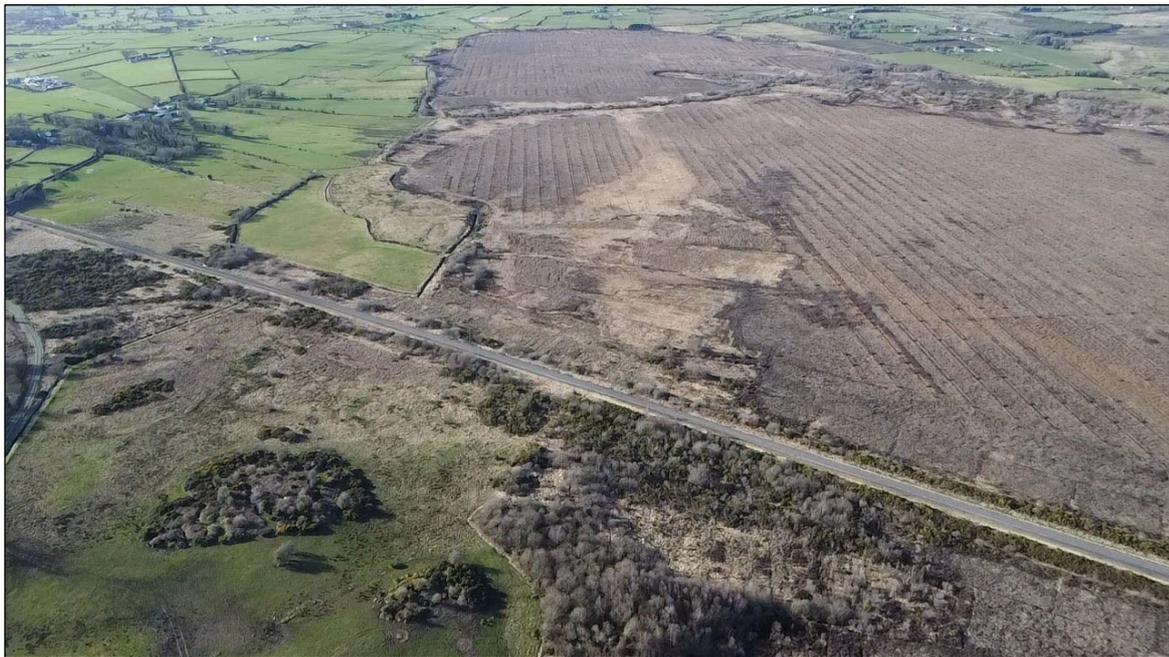
Plate 3.4 Ballydangan North Bog, view looking northwest.

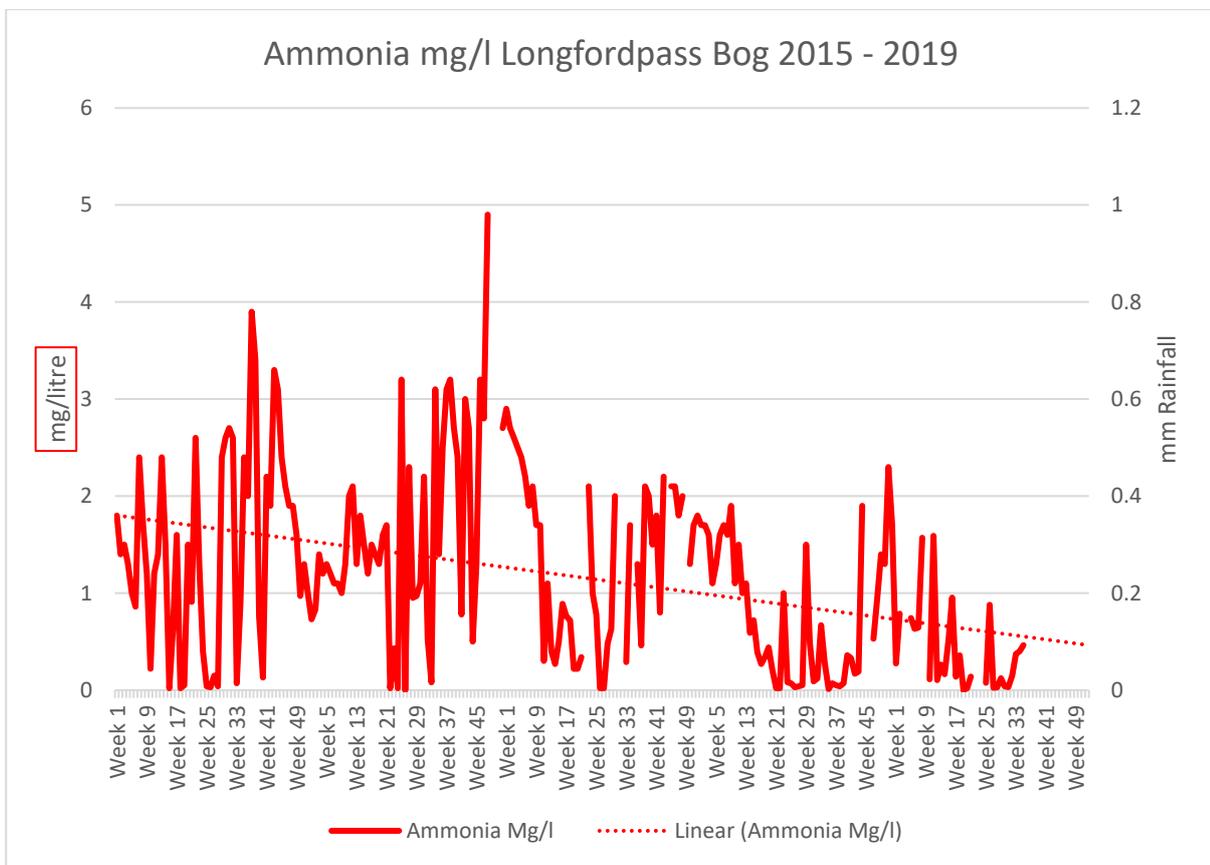
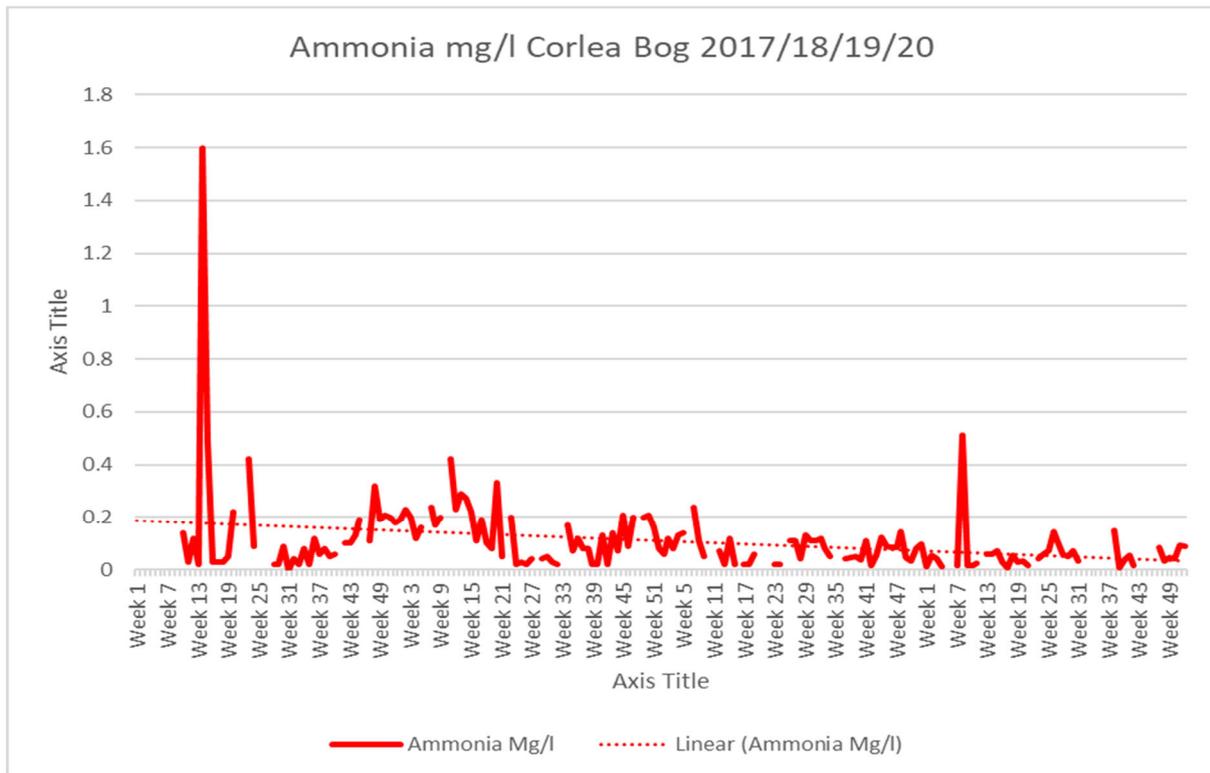
Figure 7.1. Ammonia levels over the period 2015-2019/2020 at Longfordpass and Corlea.

Similarly monitoring of surface water ammonia emissions from a Corlea bog in Mountdillon over the past 4 years post cessation of peat extraction with ongoing rehabilitation, indicate downward trends.

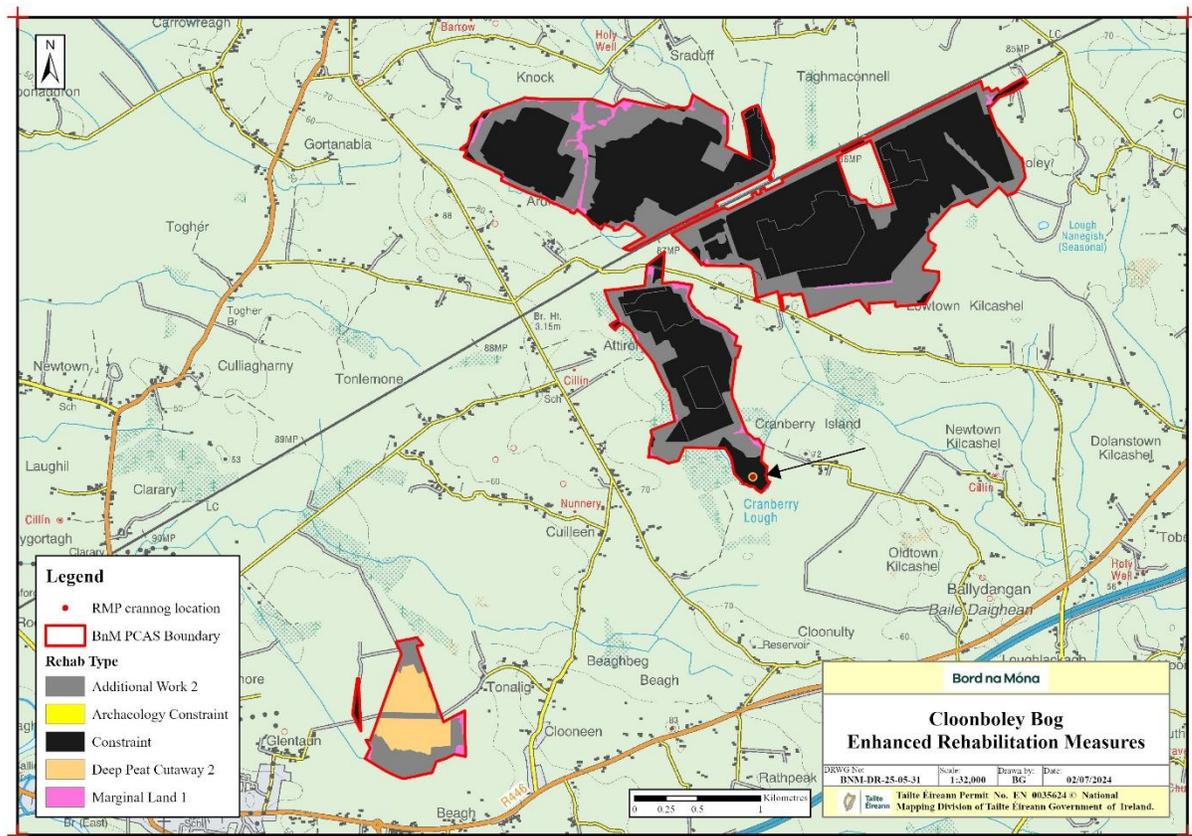
Fig. 1. Cloonboley Bog, Co. Roscommon, the proposed rehabilitation measures and known archaeology.

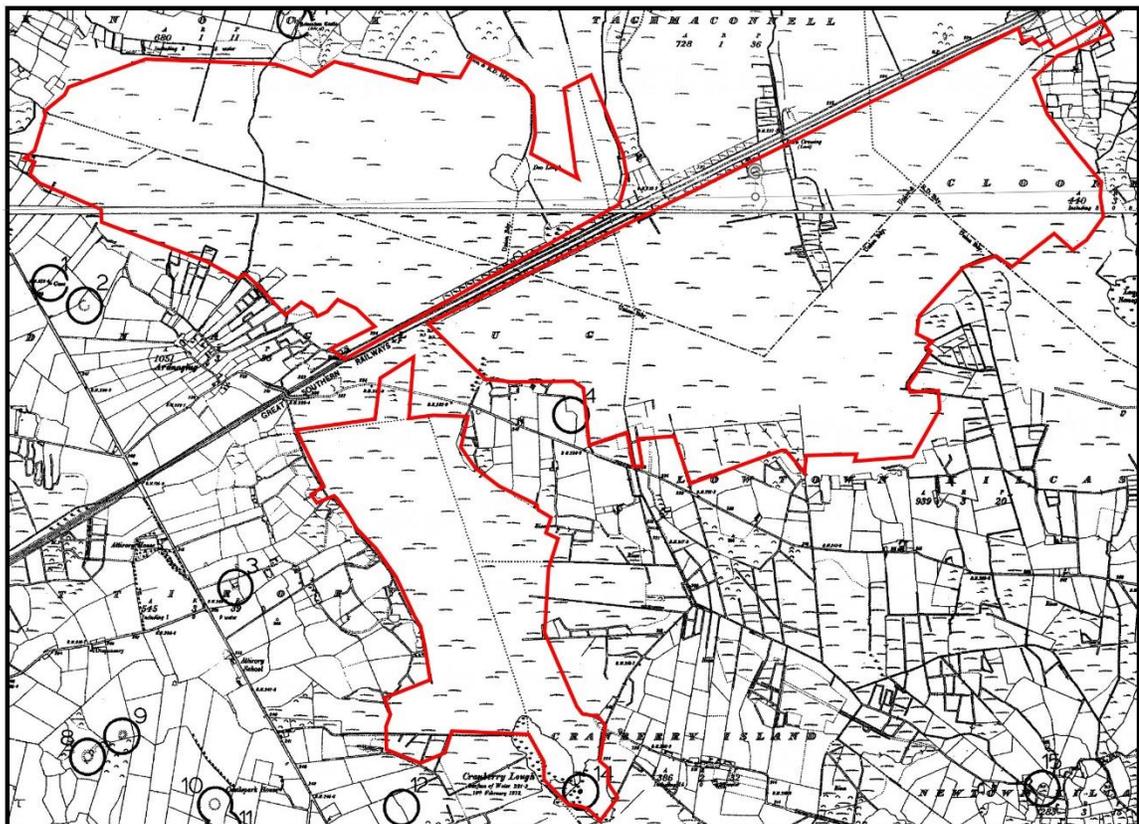
Fig. 2. Cloonboley Bog, Co. Roscommon, detail of the Record of Monuments and Places map sheet Roscommon Nos. 51 and 54. The proposed rehabilitation area is outlined with the red line.

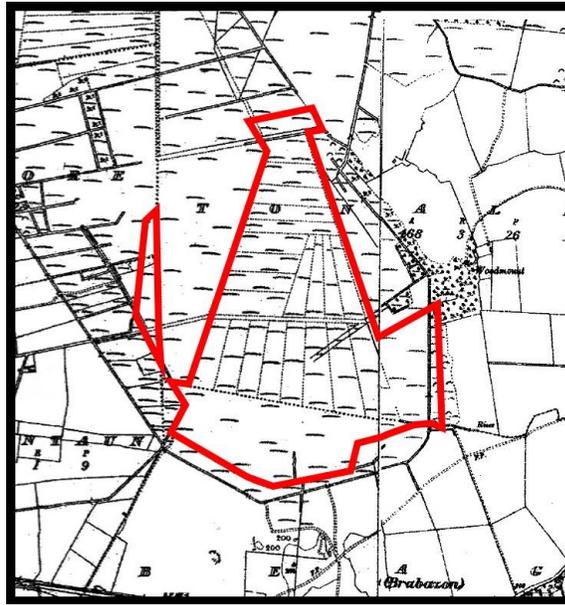
Fig. 2. Cloonboley Bog, Co. Roscommon, detail of the Record of Monuments and Places map sheet Roscommon Nos. 53 and 54, Beagh (Brabazon) and Tonalig townlands. The proposed rehabilitation area is outlined with the red line.

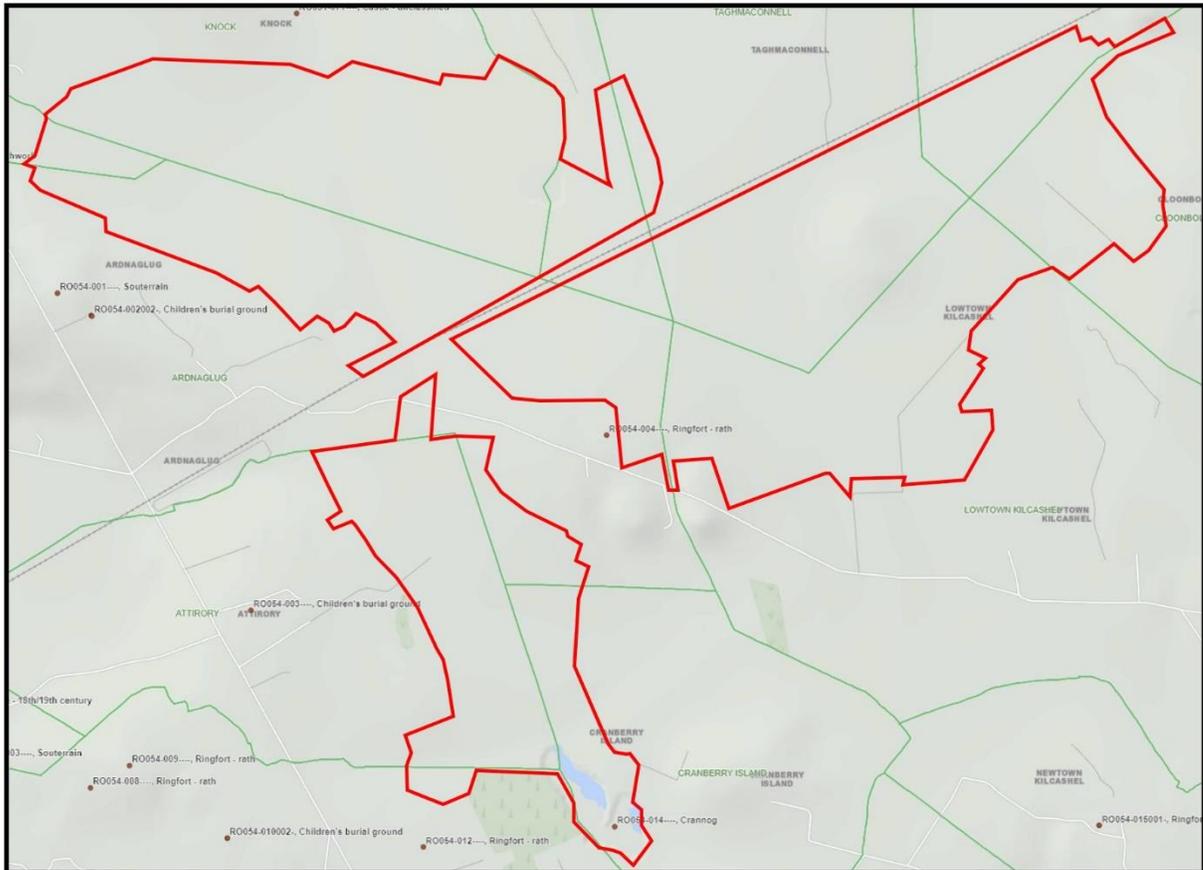
Fig. 4. Cloonboley Bog, Co. Roscommon, detail of the Sites and Monuments Record. The proposed rehabilitation area is outlined with the red line.

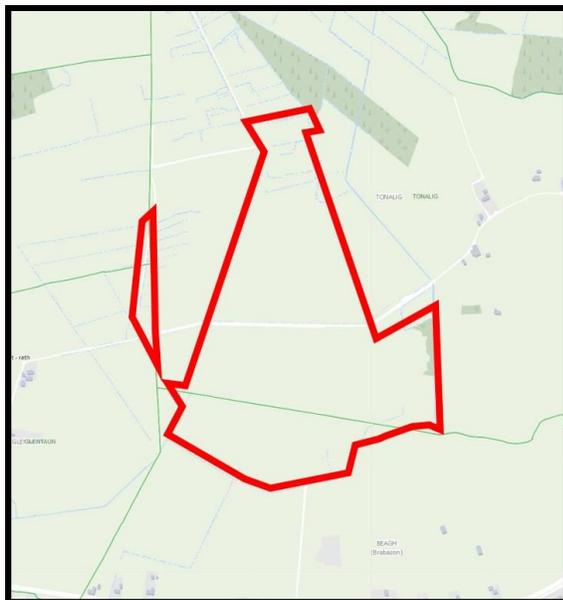
Fig. 5. Cloonboley Bog, Co. Roscommon, detail of the Sites and Monuments Record, Beagh (Brabazon) and Tonalig townlands. The proposed rehabilitation area is outlined with the red line.
