Mountdillon Bog

Cutaway Bog Draft Decommissioning and Rehabilitation Plan 2025

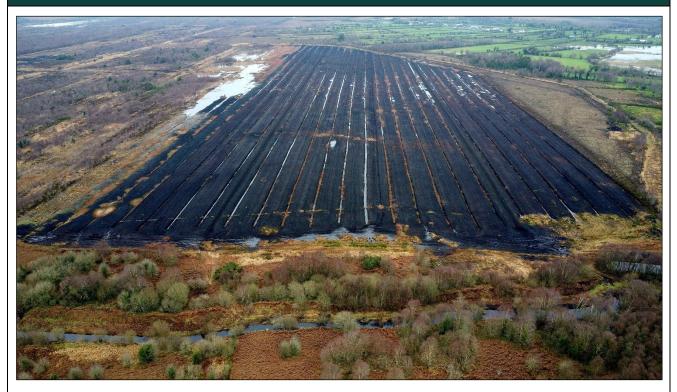
Plate 3-1 Eastern section of the PCAS rehab footprint (view looking north), dominated by bare peat (0-50% cover) (BP).

- Bare peat (0-50% cover) (BP) (Plate 3-1)
- Pioneer *Juncus effusus* community (pJeff) also containing pioneer *Eriophorum angustifolium* (pEang) and pioneer *Carex rostrata* (pRos) (Plate 3-3)
- Birch scrub emergent Birch (eBir), open Birch (oBir) and closed Birch (cBir)
- Pioneer Willow-dominated scrub (eWill)
- Birch woodland (BrWD)
- Exposed gravel
- Mosaics of wetlands with Phragmites-dominated community (Reedbed) (pPhrag), pioneer Juncus effusus (pJeff), Typha-dominated community (Reedbed) (pTyph) and Eriophorum angustifolium (pEang), open water (OW) and scrub of Birch and Willow (Plate 3-2)
- Purple Moorgrass-dominated vegetation (gMol)
- Heather dominated vegetation (dHeath)
- Pioneer dry calcareous grassland (gCal) (with emergent Birch scrub)

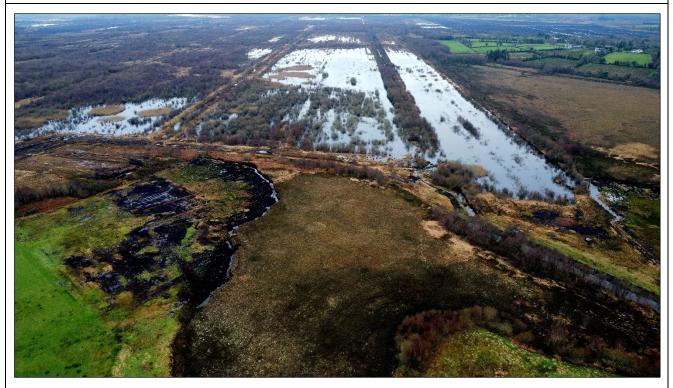
Plate 3-2 Northern section of PCAS rehab footprint (view looking south). Mosaics of wetlands with Phragmites-dominated community (Reedbed) (pPhrag), pioneer Juncus effusus (pJeff), Typha-dominated community (Reedbed) (pTyph) and Eriophorum angustifolium (pEang) and open water (OW).

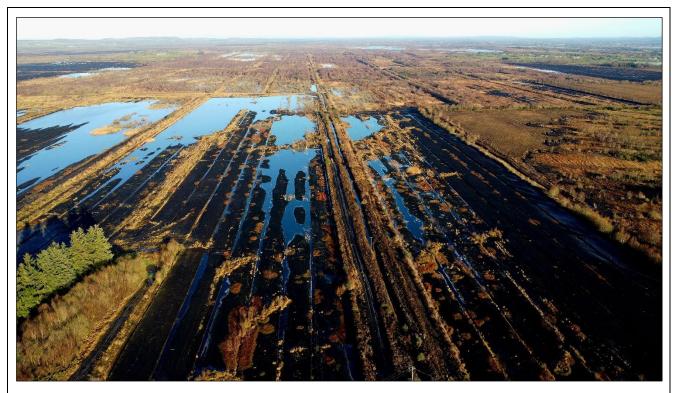
Plate 3-3 Southern Section of PCAS footprint (view looking north), with bare peat, open water and pioneer vegetation beginning to develop along the drains.

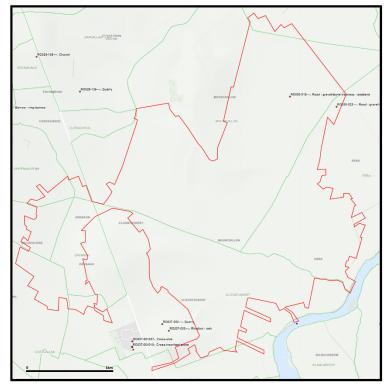
Fig. 3. Erenagh and Mountdillon Bogs, Co. Roscommon, detail of the Sites and Monuments Record with OS Discovery map. The proposed rehabilitation area is outlined with the red line.

The Sites and Monuments Record (SMR) which is maintained by the Department of Housing, Local Government and Heritage was examined as part of the assessment on the 6th of March 2025. The SMR consists of records included in the RMP and sites and monuments notified to the Dept. since the publication of the RMP. This review established that there are no additional entries in the SMR in the proposed rehabilitation area (see Fig. 3).
