Esker Bog

Cutaway Bog Decommissioning and Rehabilitation Plan 2021

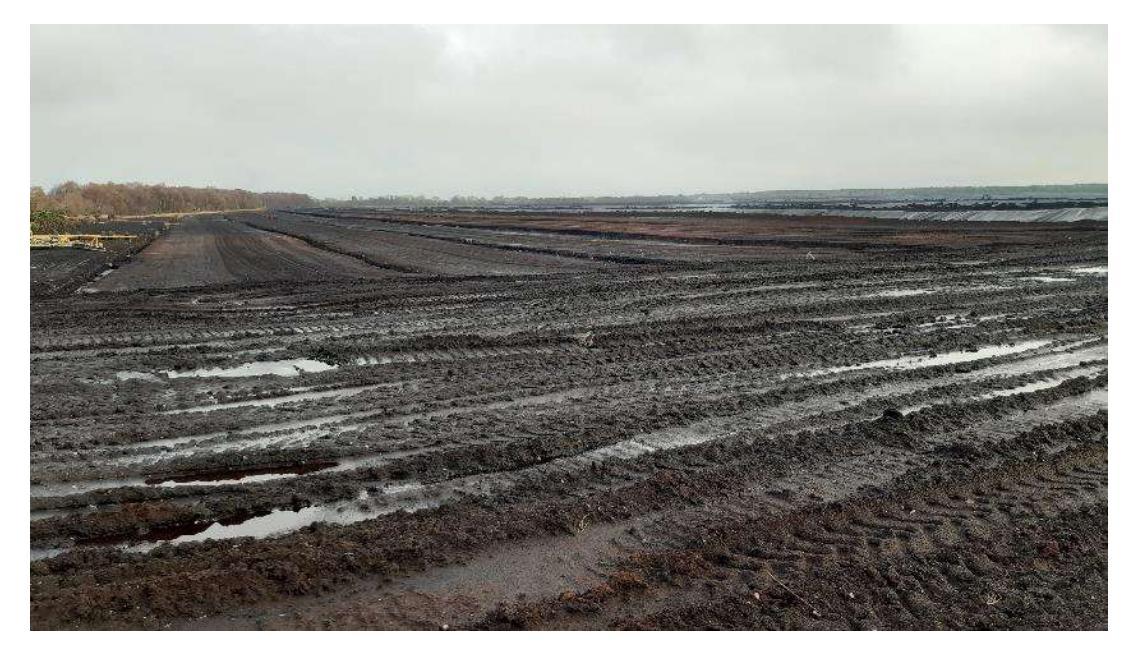
Figure 3.2 Bare peat of former production area at Esker Bog (western end)

The majority of the large area in the west of Esker Bog within the Bord na Móna boundary is dominated by bare peat (Figure 3.2) and the eastern section is largely cutaway (Figure 3.3). The Esker Stream flows along the southern side of the bog and forms a natural boundary. The Dogen River, a tributary of the Esker River, flows north to south and separates the eastern from the western side of the site. A third watercourse flows along the western boundary of the site and is also a tributary of the Esker Stream.

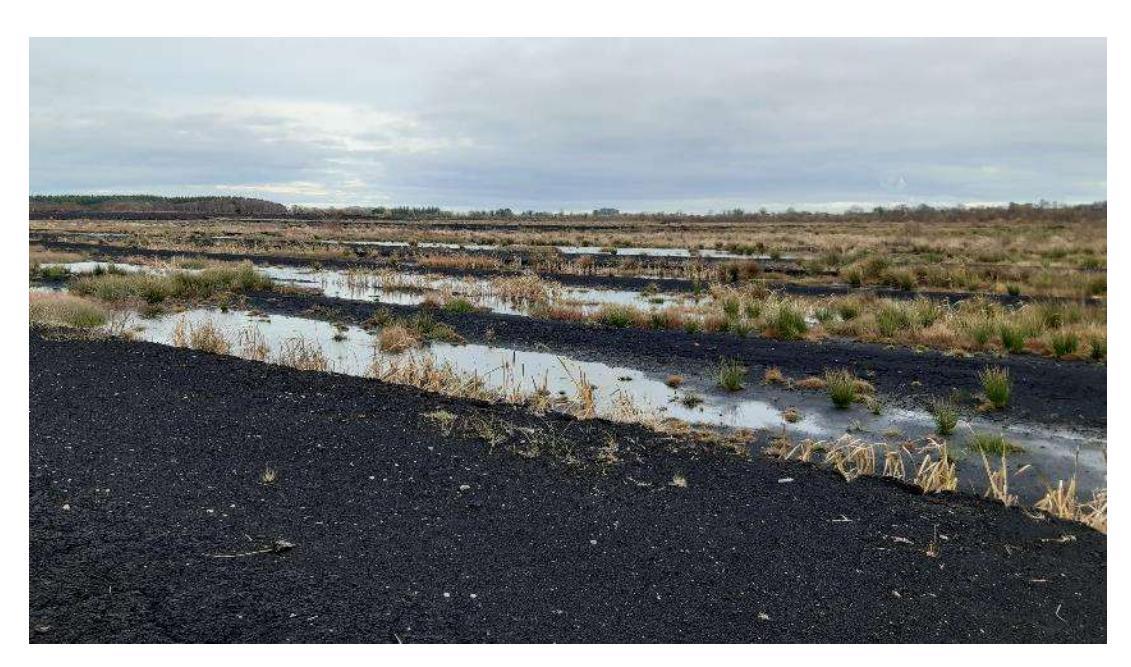
Figure 3.3 Area of cutaway peatlands at Esker Bog (eastern end).

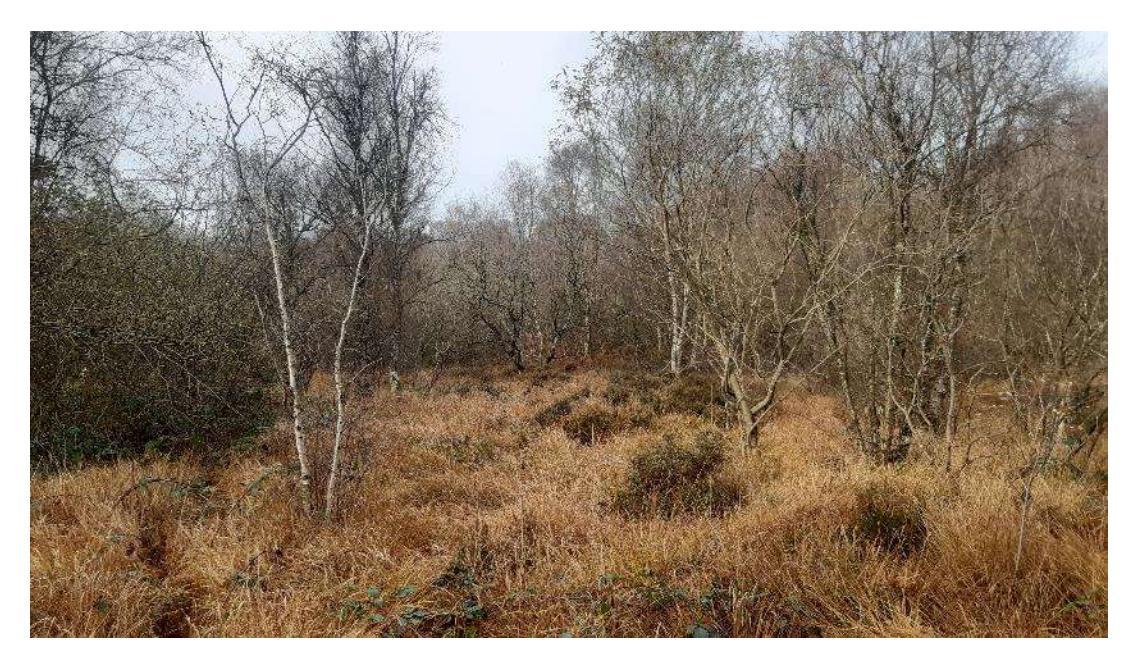
Figure 3.4 Area of bog woodland in the south east of the site.

woodland is developing, with a mosaic of rush-dominated poor fen and bare peat over much of the remainder of this area (see Figure 3.4). The drainage system in this area has been maintained so it has remained relatively dry.

The small area of Esker Bog in the south-east of the area (Figure 3.4) that has never been in production is dominated by mature Birch woodland (WN7) and also contains small patches of active and old cutover bog (PB4), wet grassland (GS4) that has developed on cutover peat and Bracken (HD1).

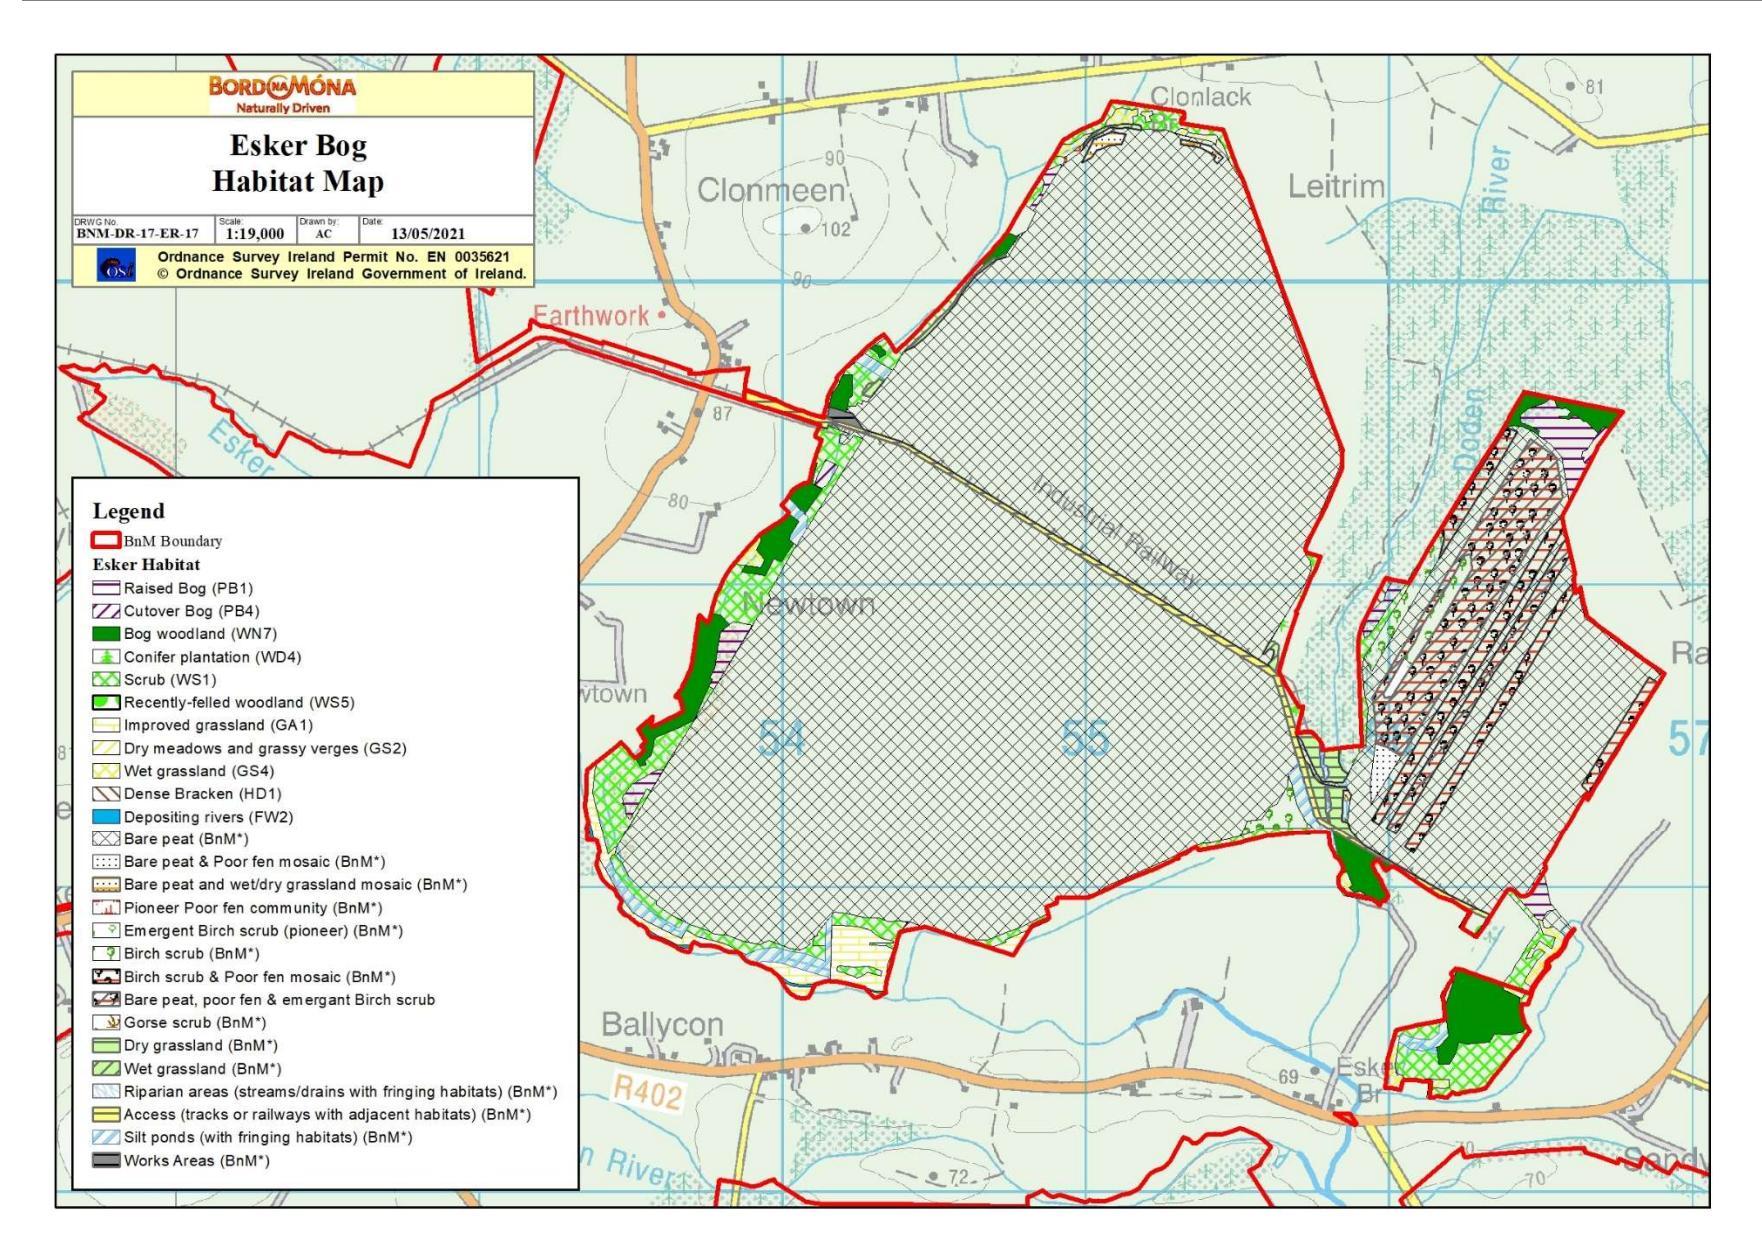
Figure 3.5 Habitat map of Esker Bog showing Bord na Móna habitat categorisation

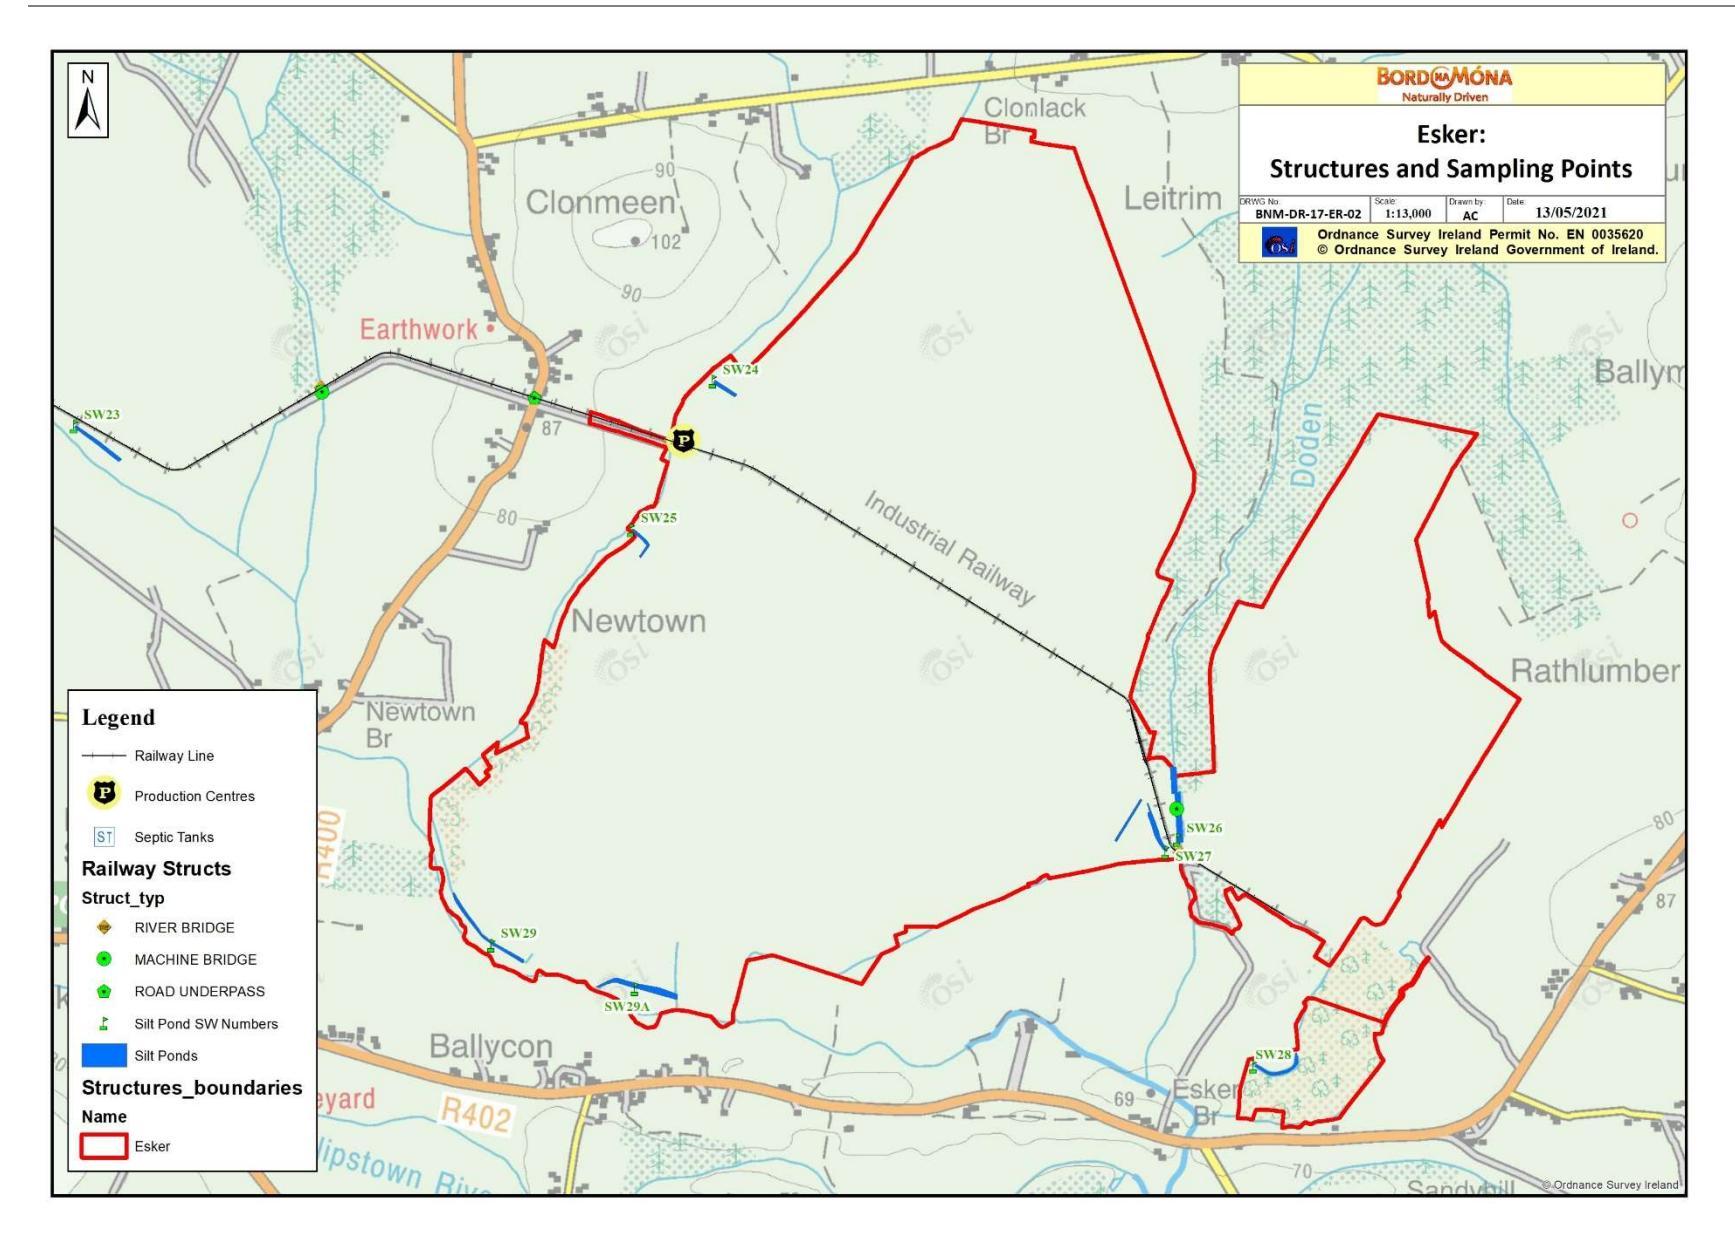
Figure 3.6. Map of Esker Bog showing structures and designated emission points.

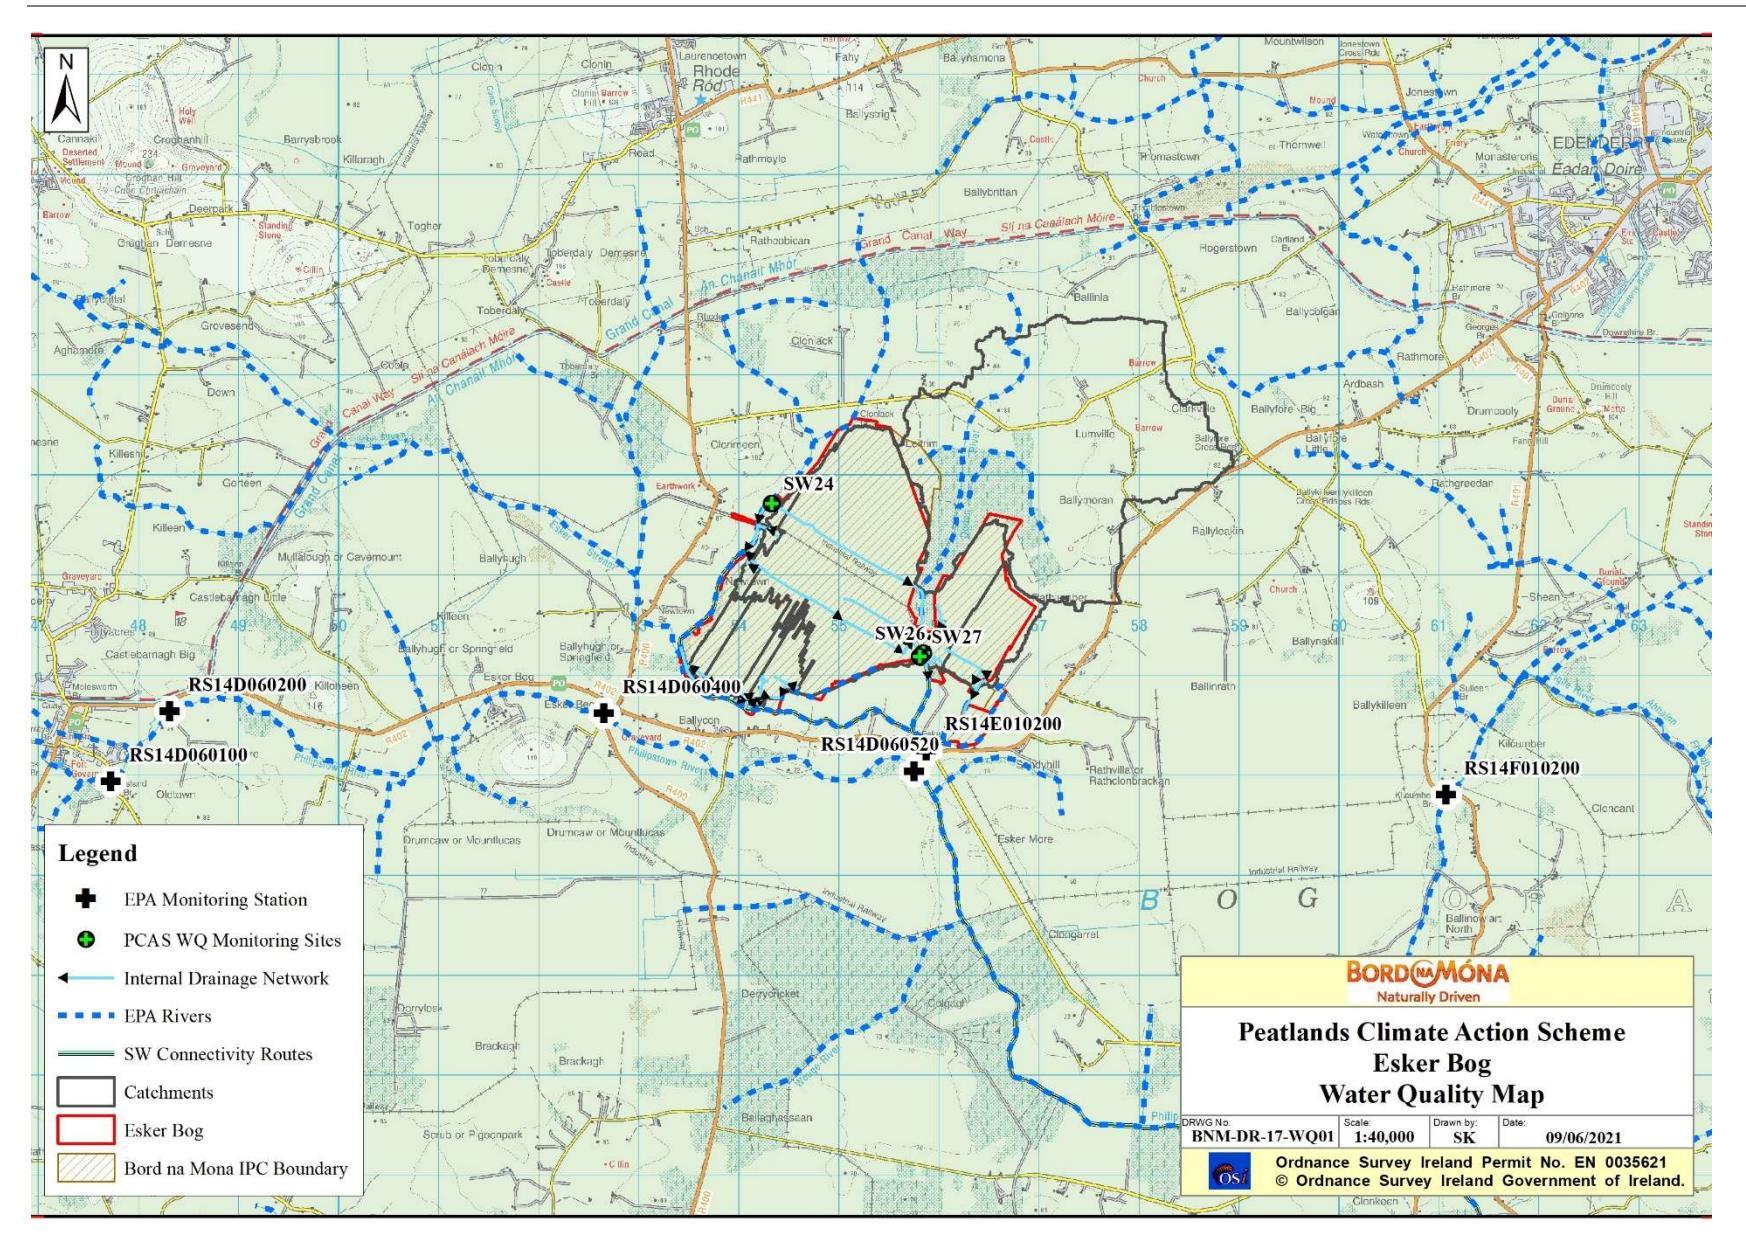
Figure 3.7. Water Quality map.

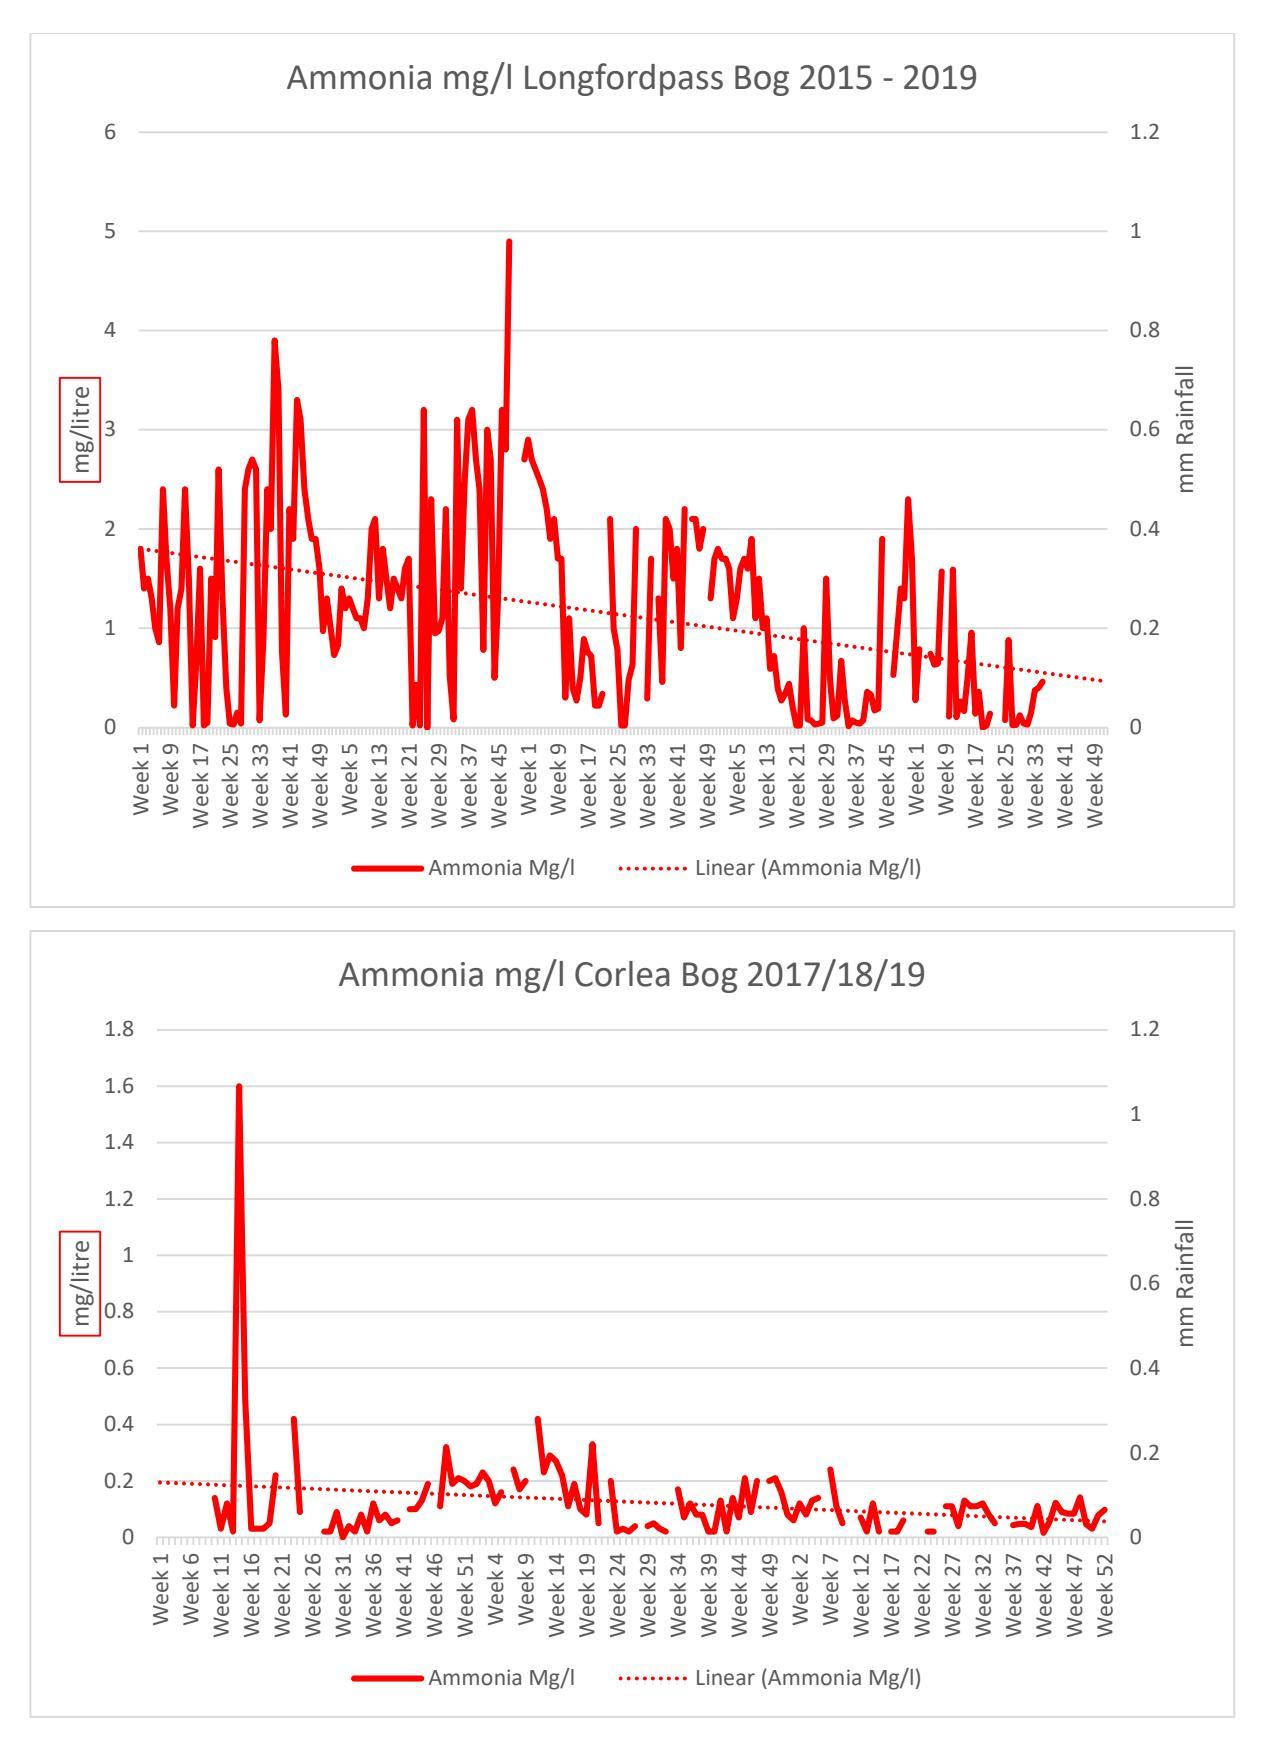
Figure 7.1. Ammonia levels over the period 2015-2019 at Longfordpass and Corlea.

With regard to predicting and estimating likely trends that might materialize or could be considered as a target, monitoring of surface water ammonia emissions from an adjoining Corlea bog in Mountdillon over the past 3 yrs., post cessation of peat extraction with ongoing rehabilitation, were considered. These are indicating a downward trend in Ammonia concentrations. As the monthly monitoring program at Derrycolumb continues in 2021 during the rehabilitation works, and data from the 2020 monitoring program is compiled, further trending will be produced to verify any ongoing trends (Figure 7.1).

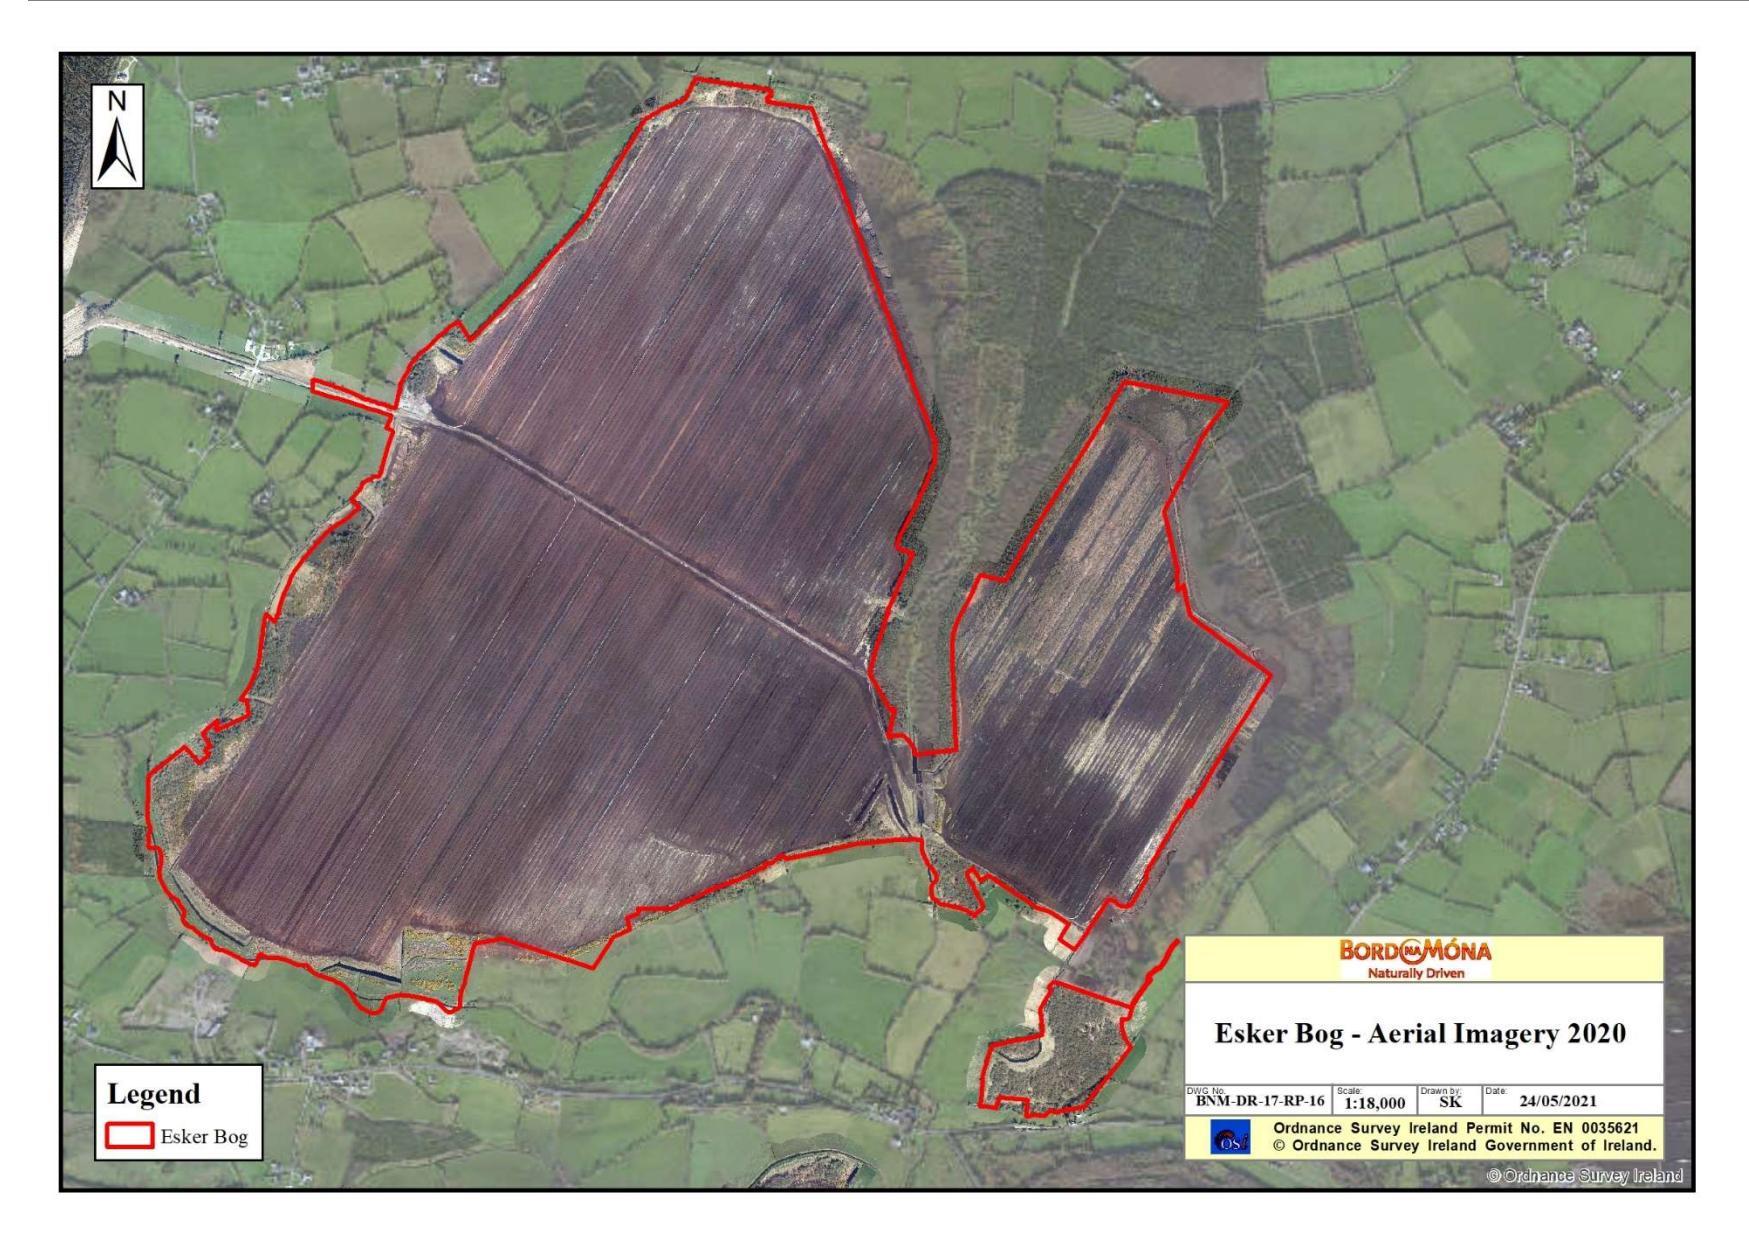
Figure 8.1. Aerial photo of Esker Bog. The majority of the bog is bare peat, with areas of vegetation at the northern end of the eastern side.

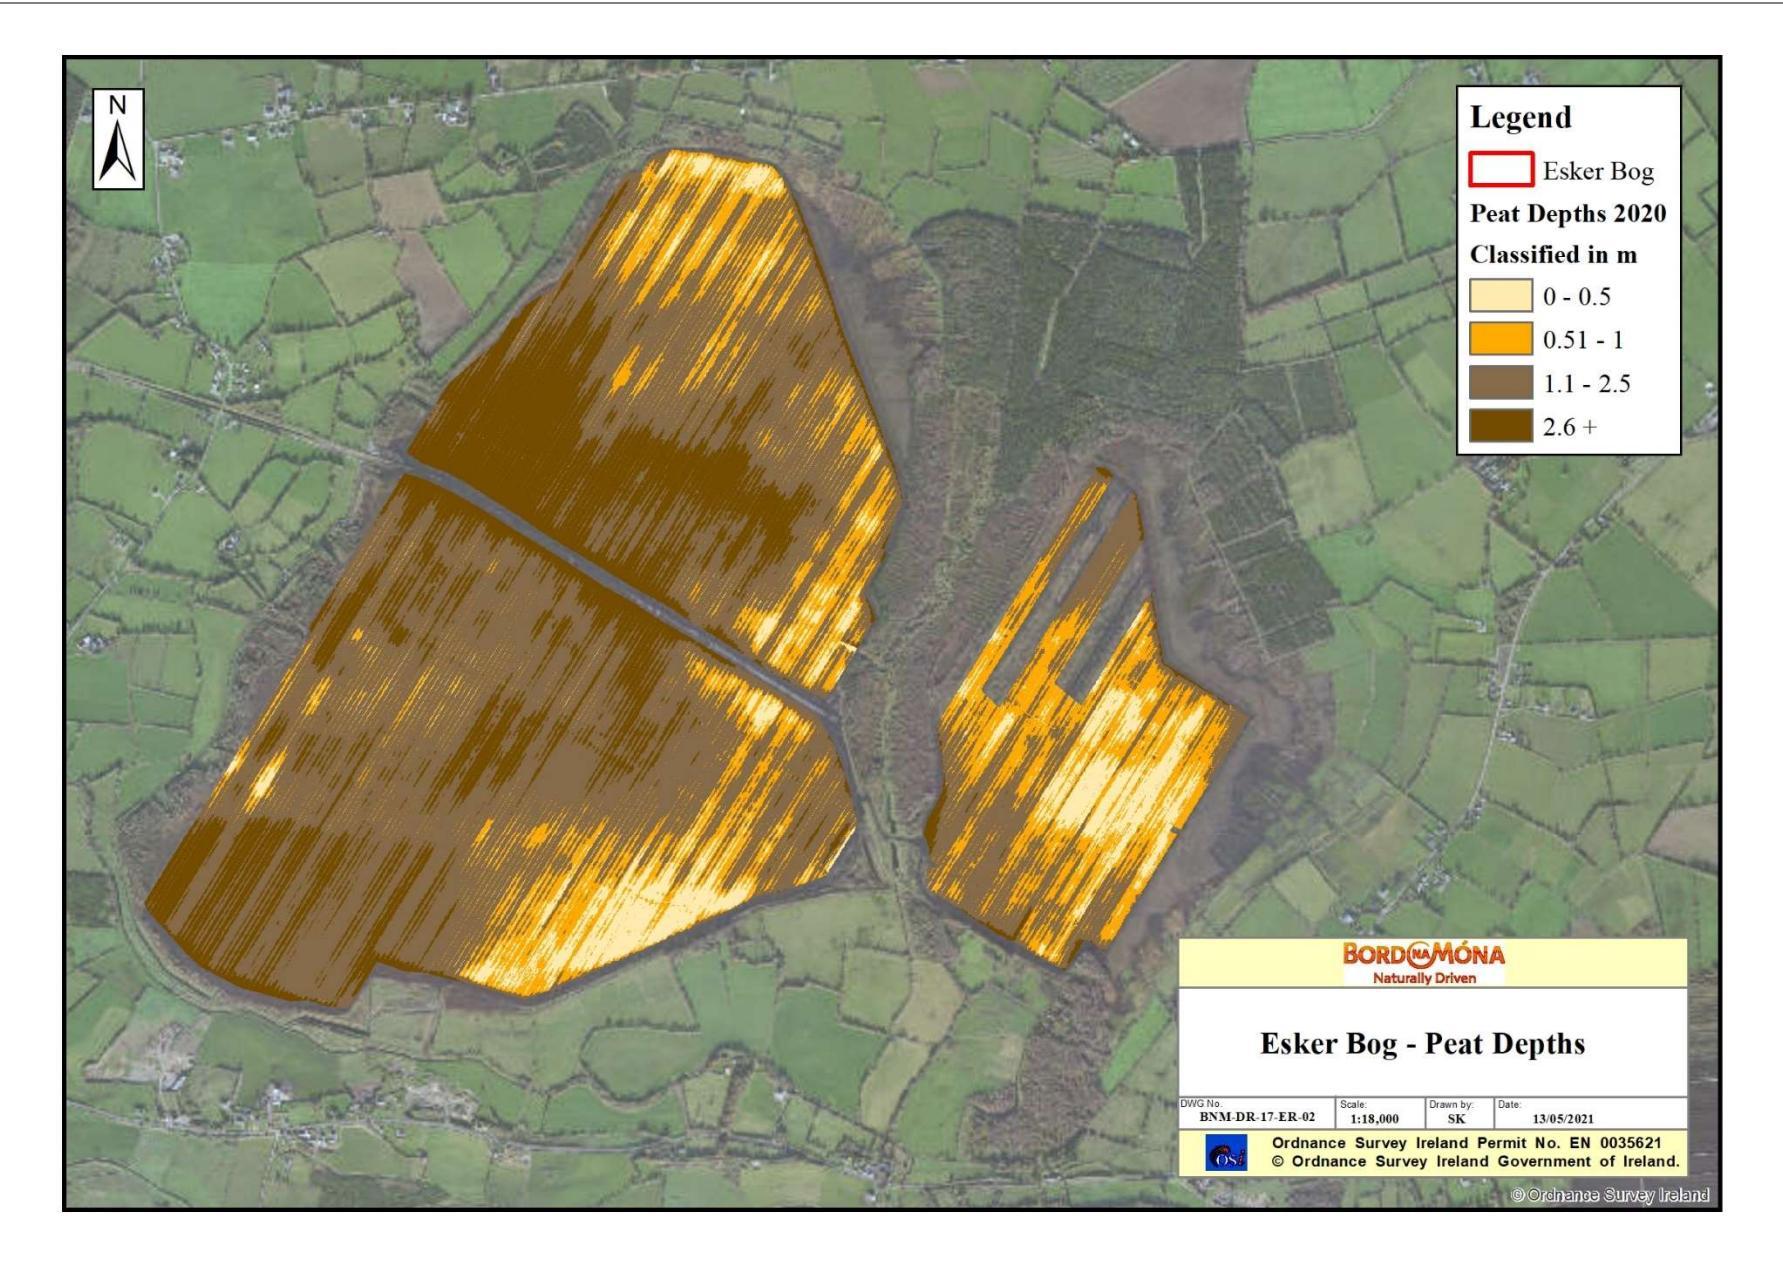
Figure 8.2. Peat Depth Map for Esker Bog (2020). There are pockets of deep residual peat (western area); the remainder is shallow cutaway.

- At Esker Bog, remnant peat depths are in excess of 2.5m in the western section. By contrast, the smaller
 eastern section contains shallower residual peat and is partly cutaway. These two areas will therefore
 require different approaches to rehabilitation. There are local factors that will influence the future
 trajectory of this site (hydrological and underlying geological conditions) which need to be considered as
 part of the wider rehabilitation work.

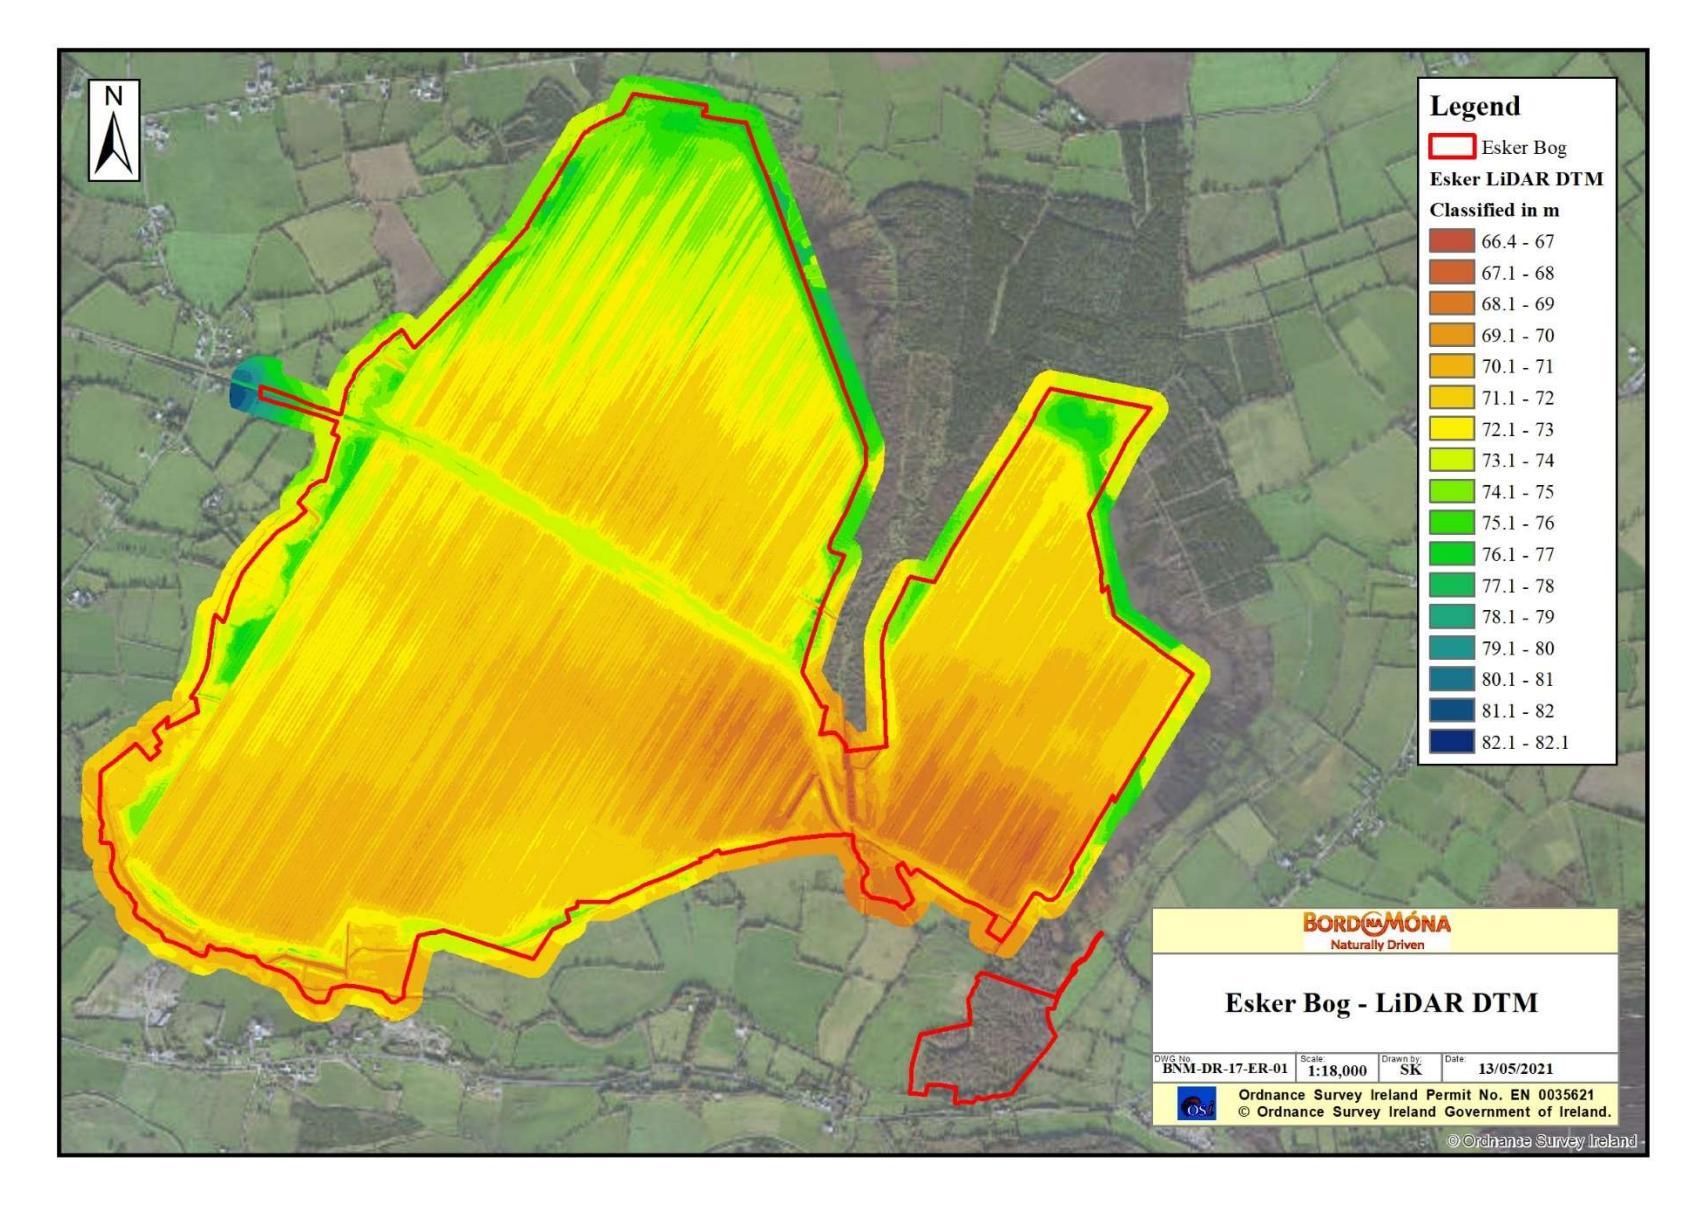
Figure 8.3. LIDAR topography map of Esker Bog. Low areas and basins are orange-yellow; more elevated areas are blue-green.

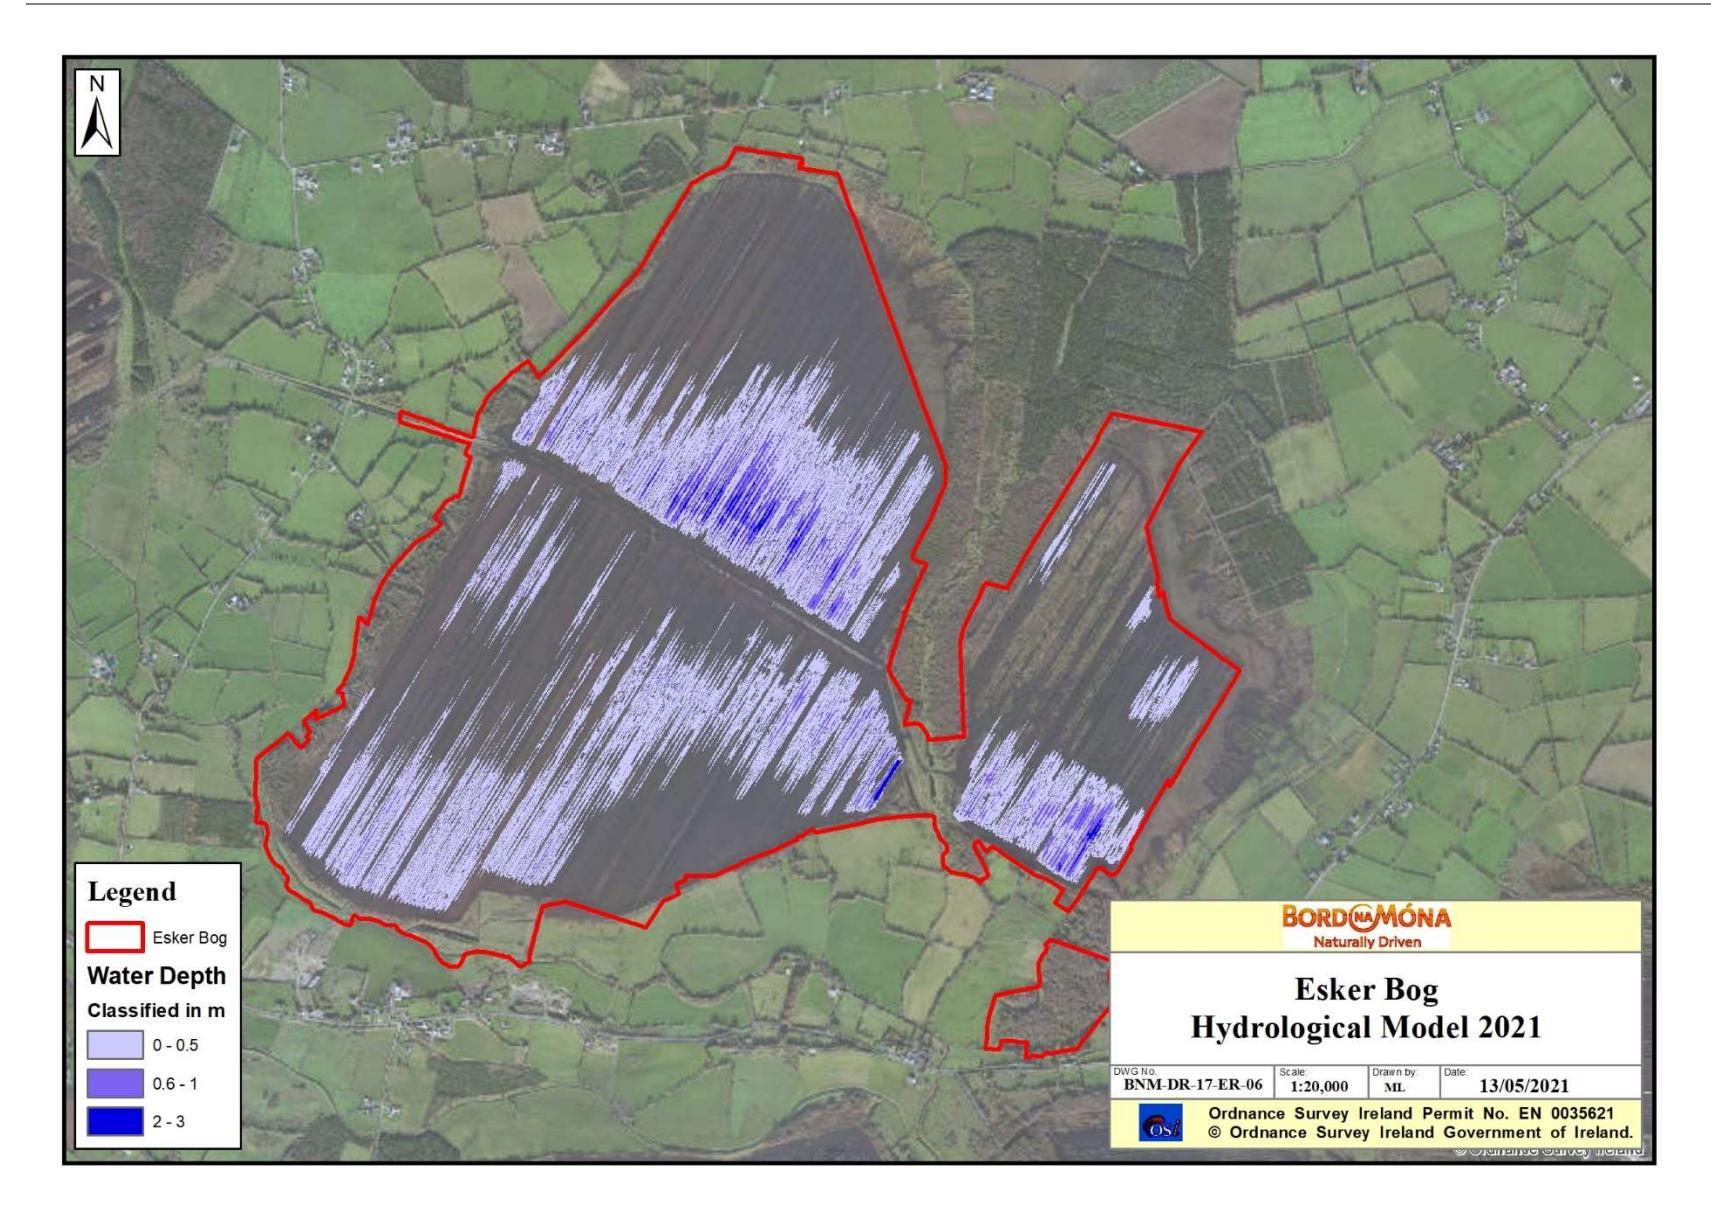
Figure 8.4. Hydrological modelling for Esker Bog showing range of expected water depths based on current topography. Small areas of both Esker East and West are modelled as basins that have the potential to develop wetland habitats.

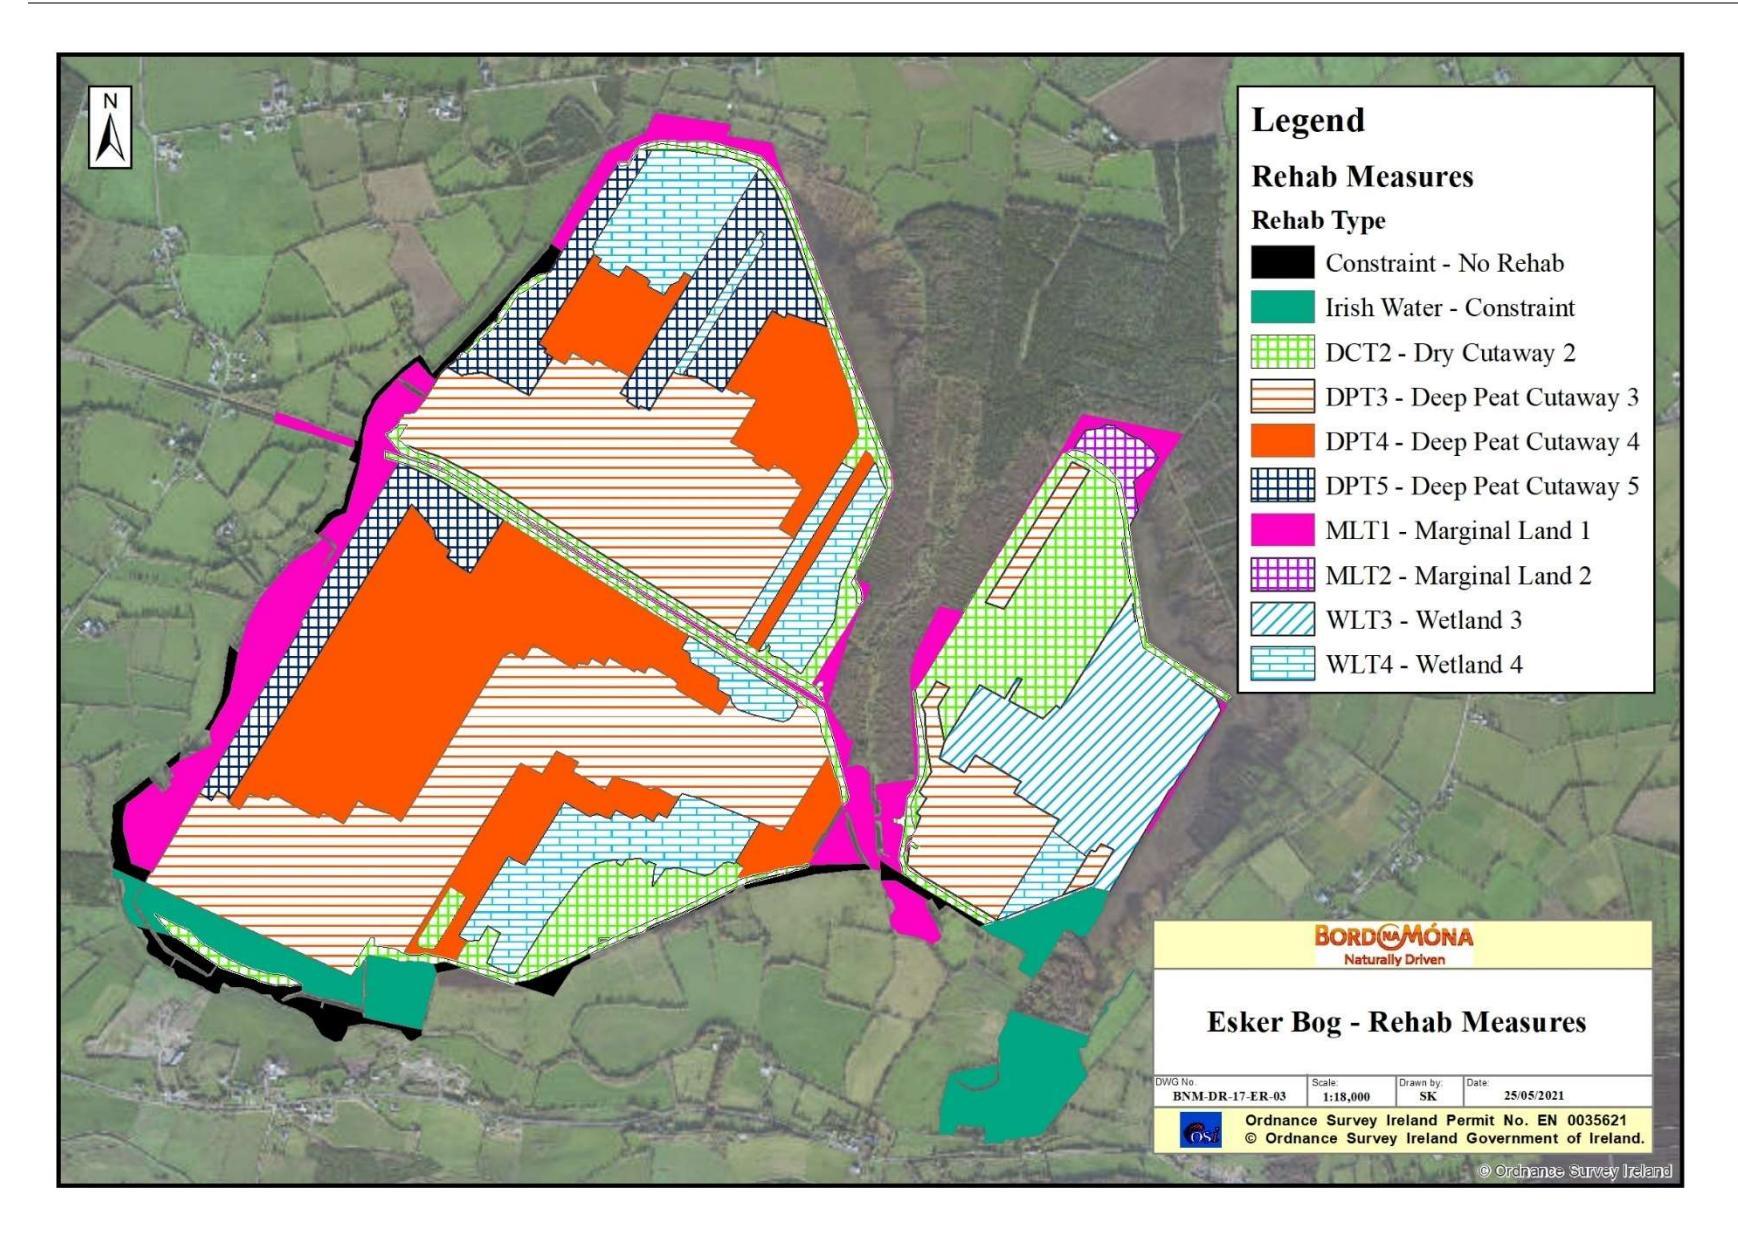
Figure 8.5 Indicative Enhanced Rehabilitation Plan. Note that the types of rehab and areas of rehab may change in response to stakeholder consultation and refinement of the enhanced rehabilitation measures.

An indication of the areas for these various measures is shown in Table 8.1 and in Figure 8.5.
