Esker Bog

Cutaway Bog Decommissioning and Rehabilitation Plan 2021

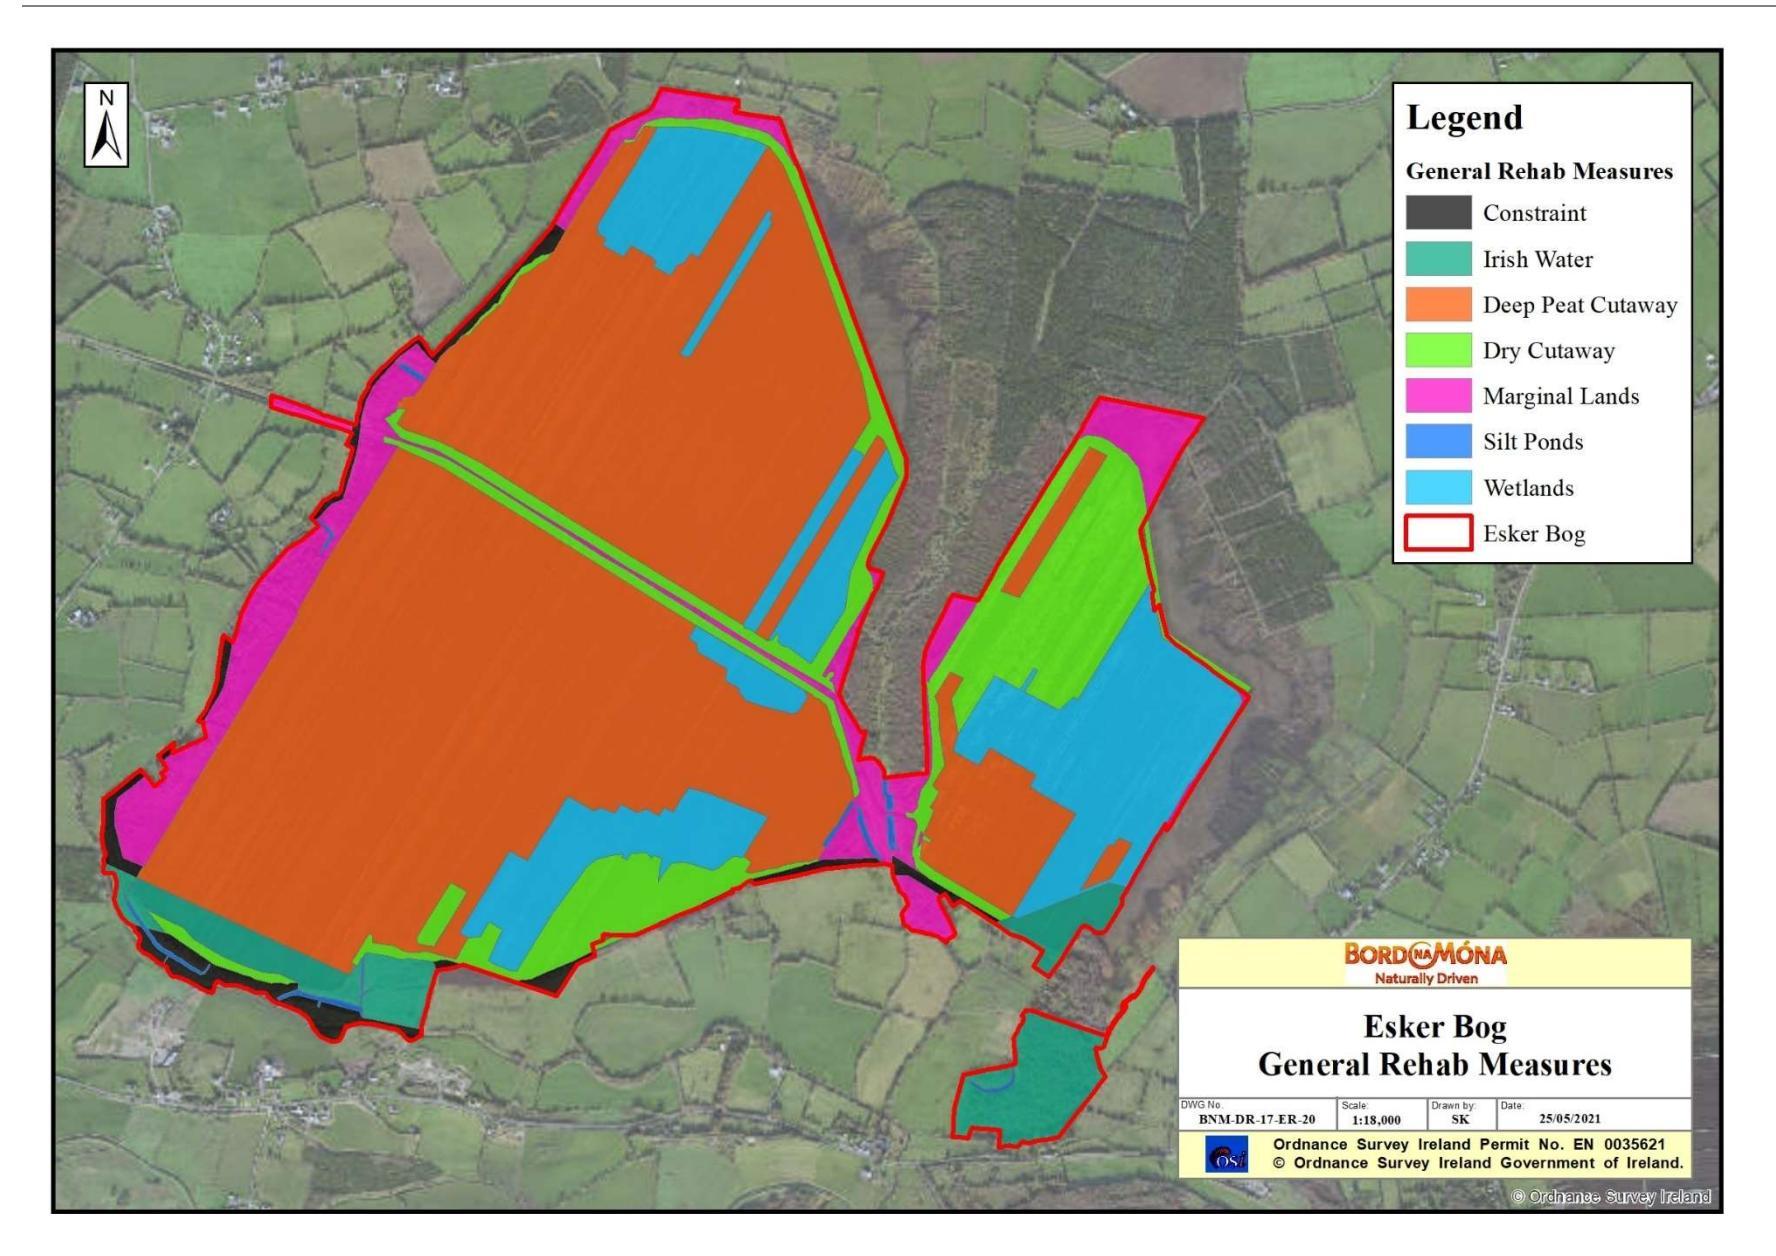
Figure Ap-1. Indicative Standard rehabilitation plan for Esker Bog.

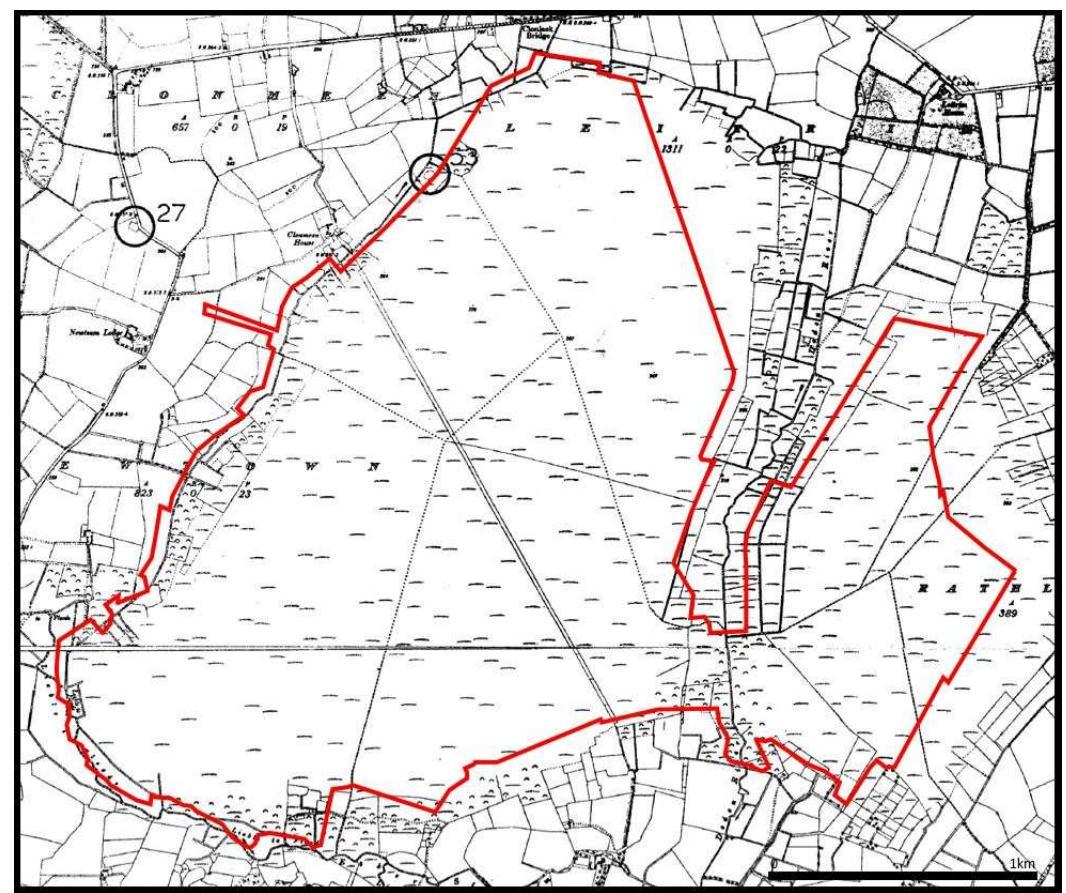
Fig. 1. Esker Bog, Co. Offaly, detail of the Record of Monuments and Places map sheets Nos. 11 and 19. The proposed rehabilitation area is outlined with the red line. There are no Recorded Monuments in the rehabilitation area.

rehabilitation area or vicinity (see Fig. 1). The closest RMP to the rehabilitation area, OF011-053----, is the site of an enclosure located on dryland in Clonmeen townland more than c.36m north-west of the rehabilitation area.

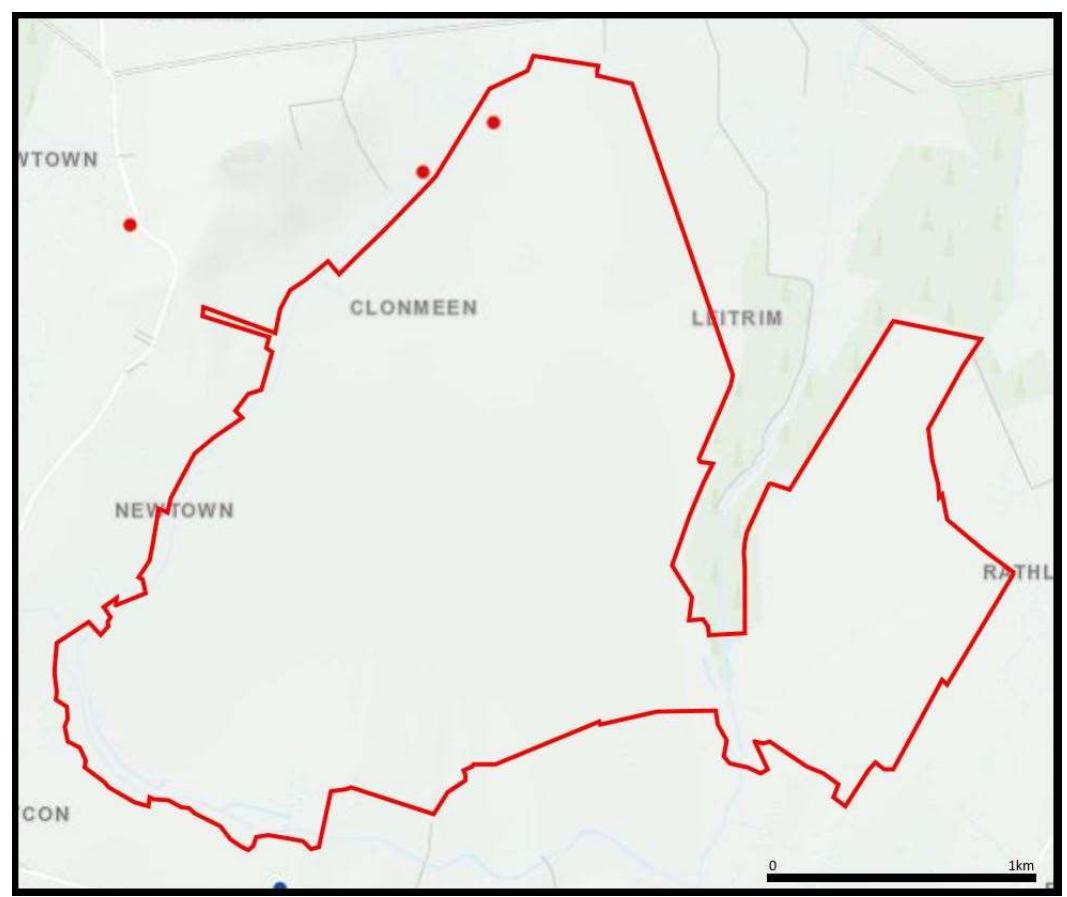
Fig. 2. Esker Bog, Co. Offaly, detail of the Sites and Monuments Record. The proposed rehabilitation area is outlined with the red line. There is one SMR redundant record in the rehabilitation area.
