Ummeras Bog

Cutaway Bog Decommissioning and Rehabilitation Plan 2020

This document seeks to address the requirements of Condition 10.2 of IPC License Ref. P0506-01:

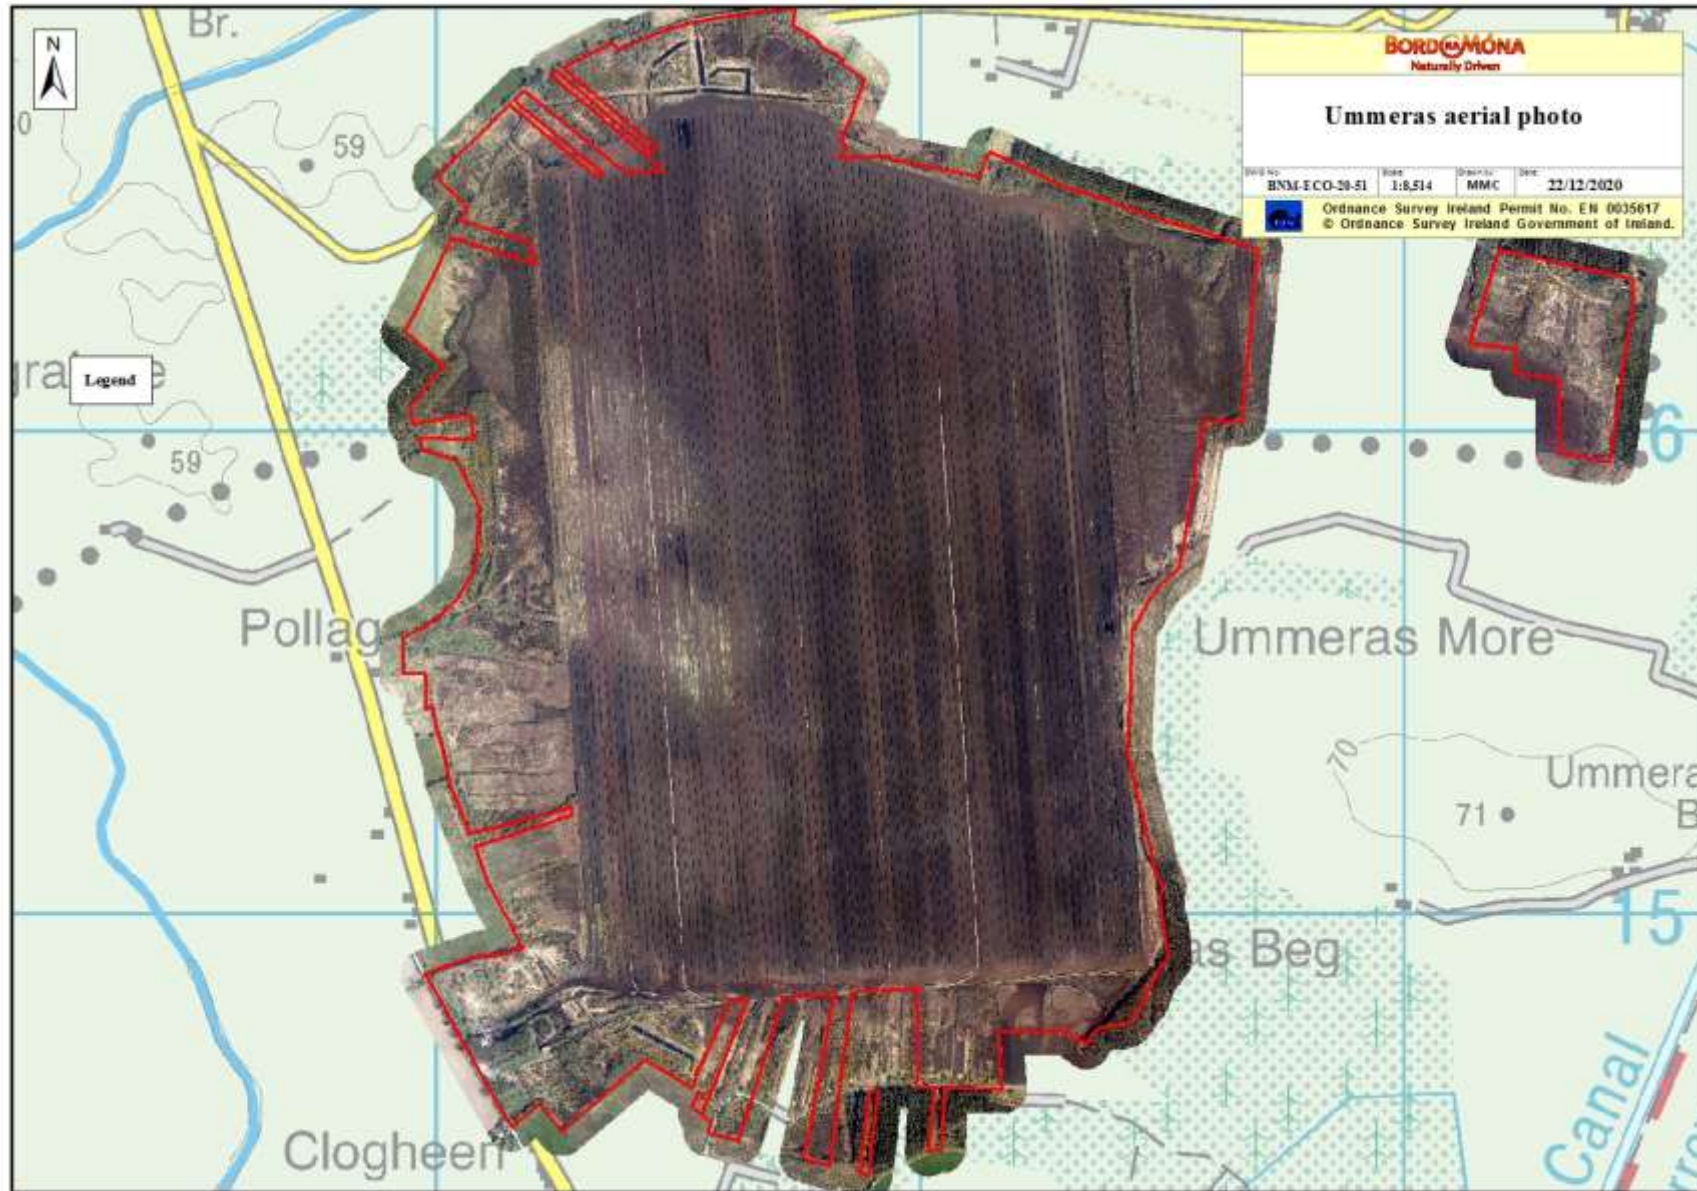
Figure 3.2 Aerial photo of Ummeras Bog (2015).

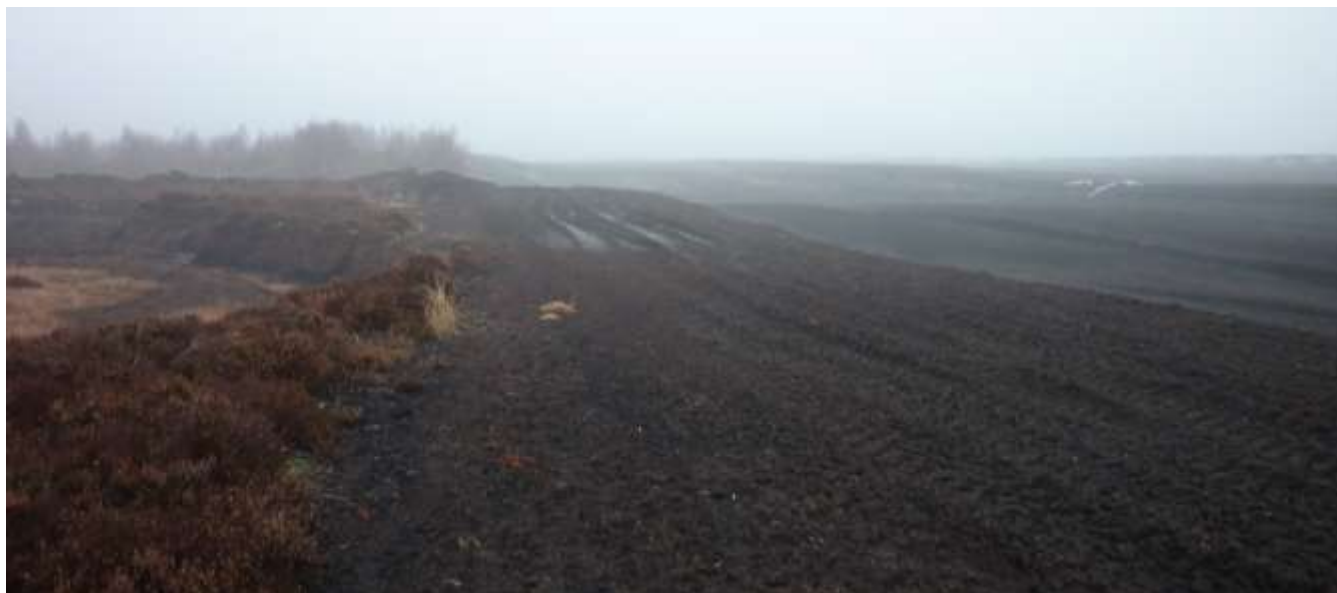
Figure 3.3. View of the interface between high bog and cutover peatland landscape at Ummeras Bog.

The majority of Ummeras Bog within the Bord na Móna boundary is dominated by bare peat (Figure 3.3). The Grand Canal is located to the east of the site, the Slate River flows to the north of the site and meets the Figile River, where it then flows south to meet the River Barrow.

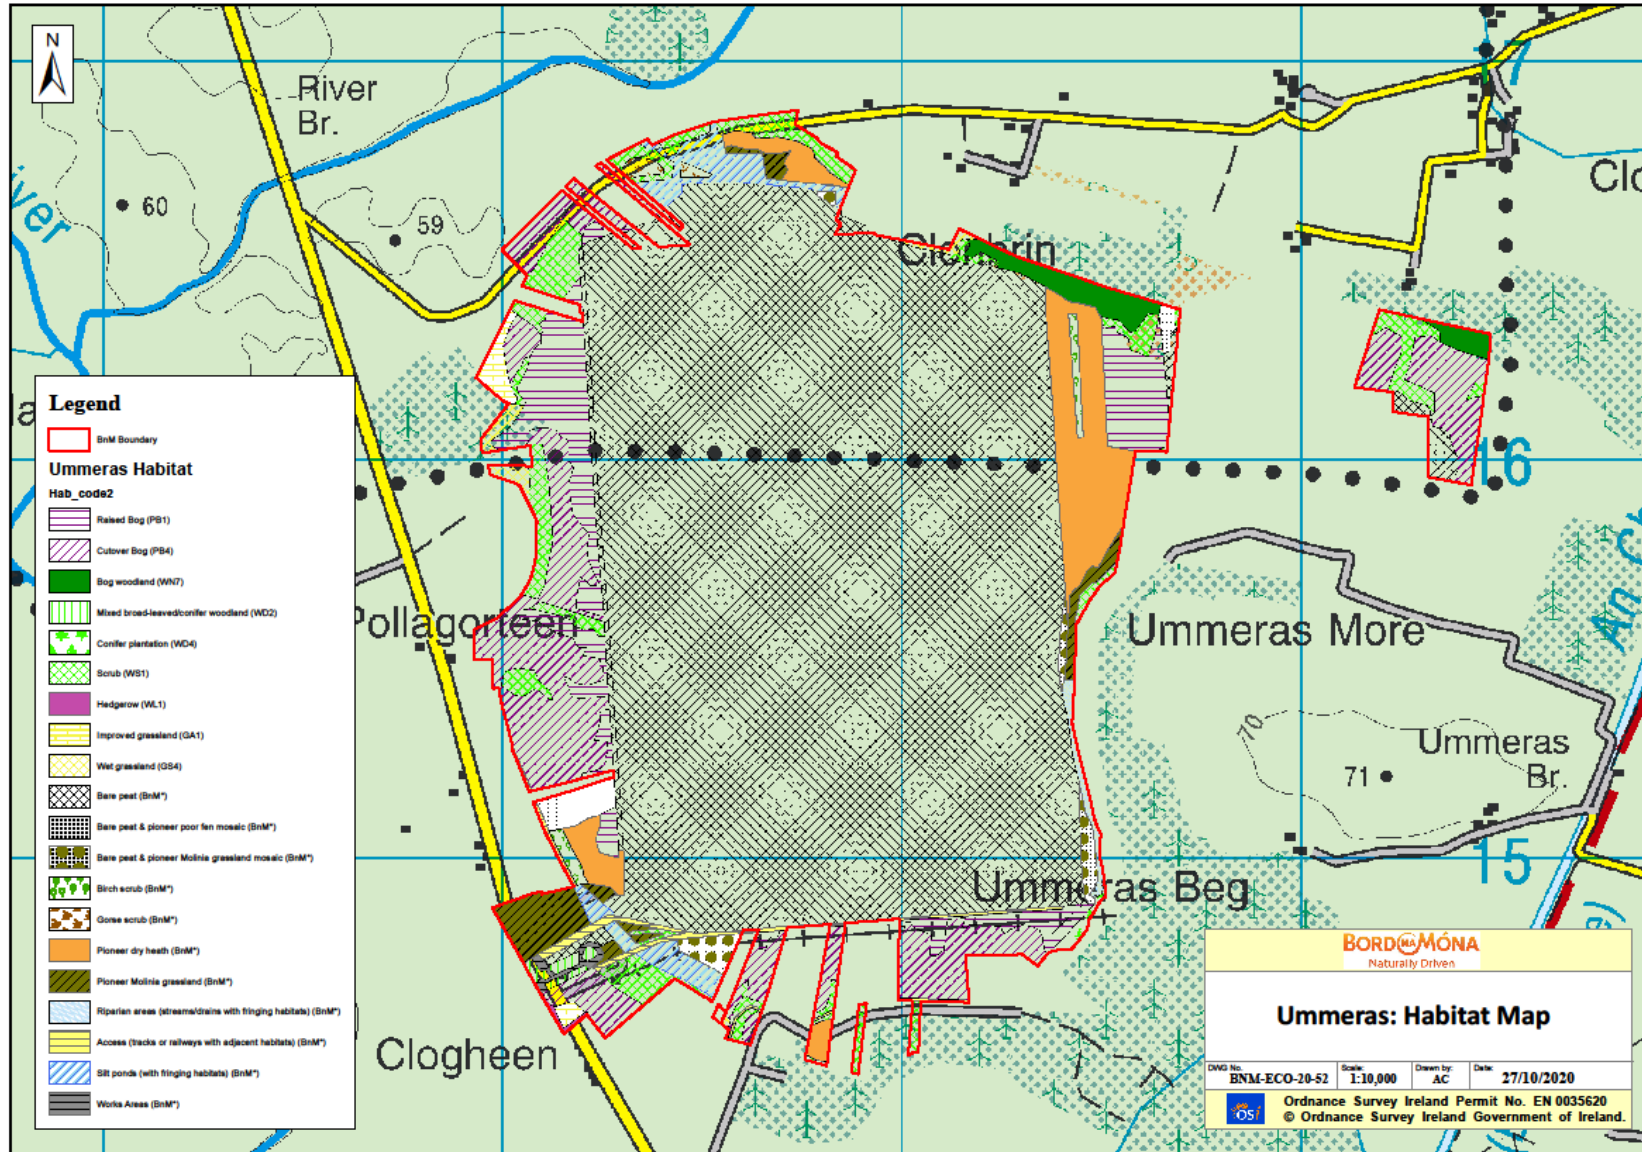
Figure 3.4 Habitat map of Ummeras Bog showing Bord na M6na habitat categorisation

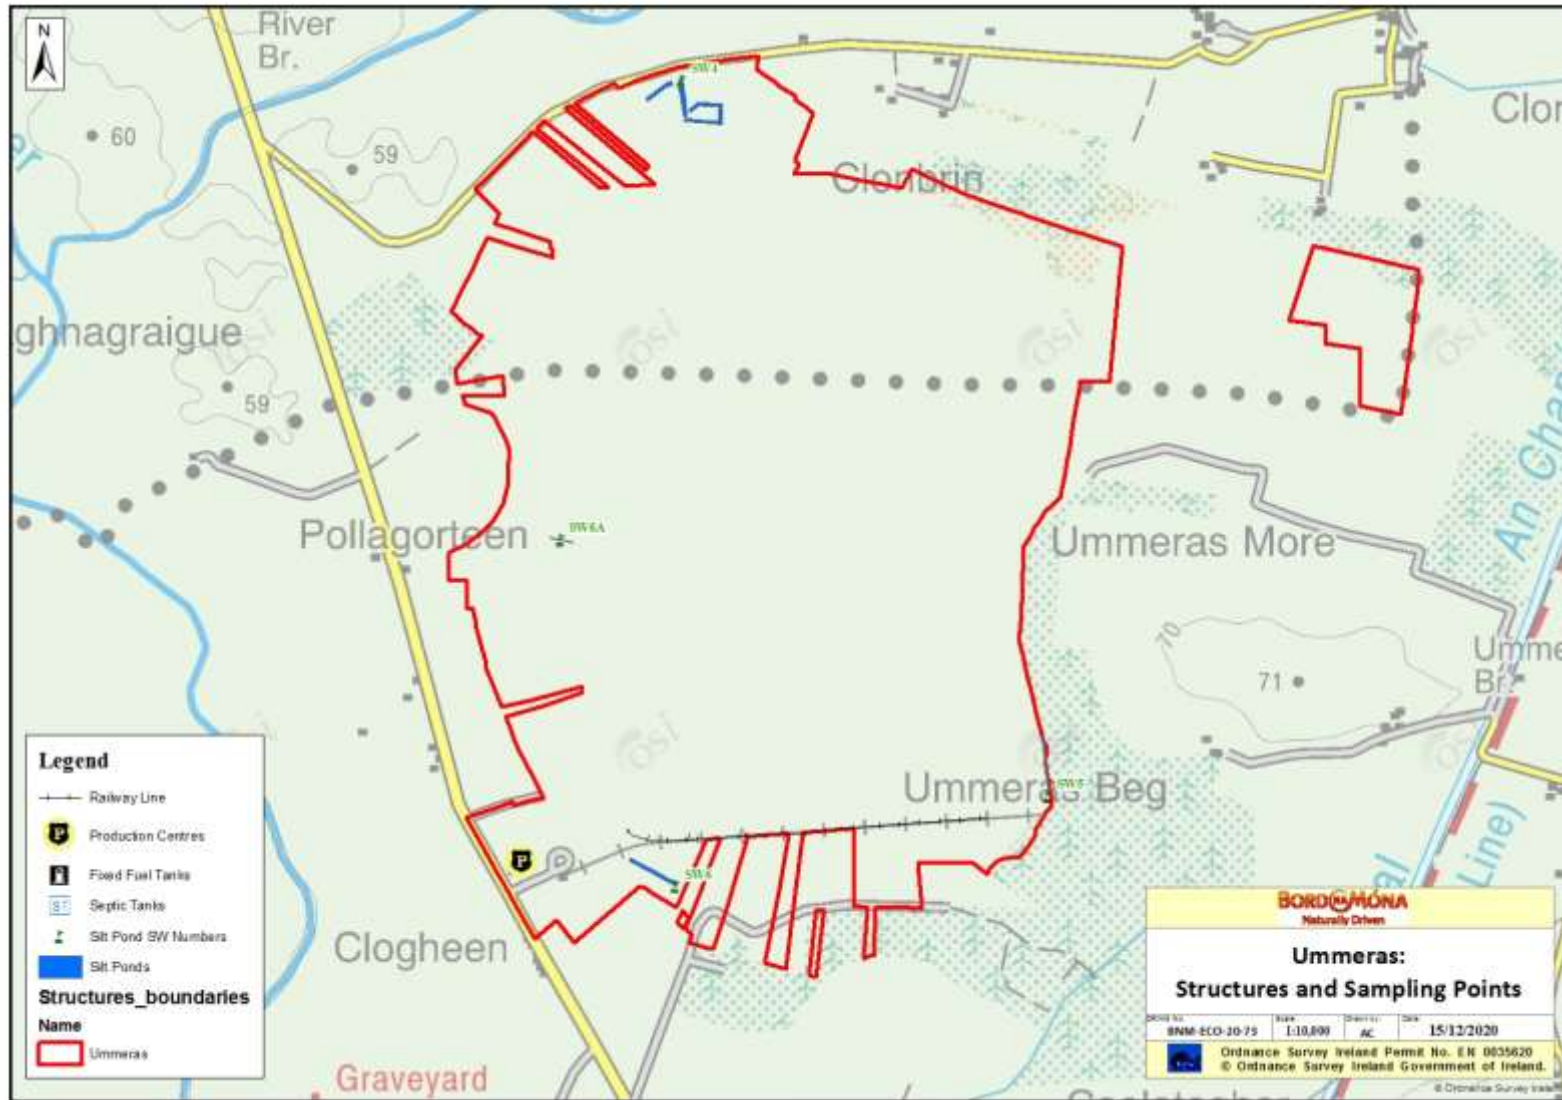
Figure 3.5. Map of Ummeras Bog showing structures and designated emission points.

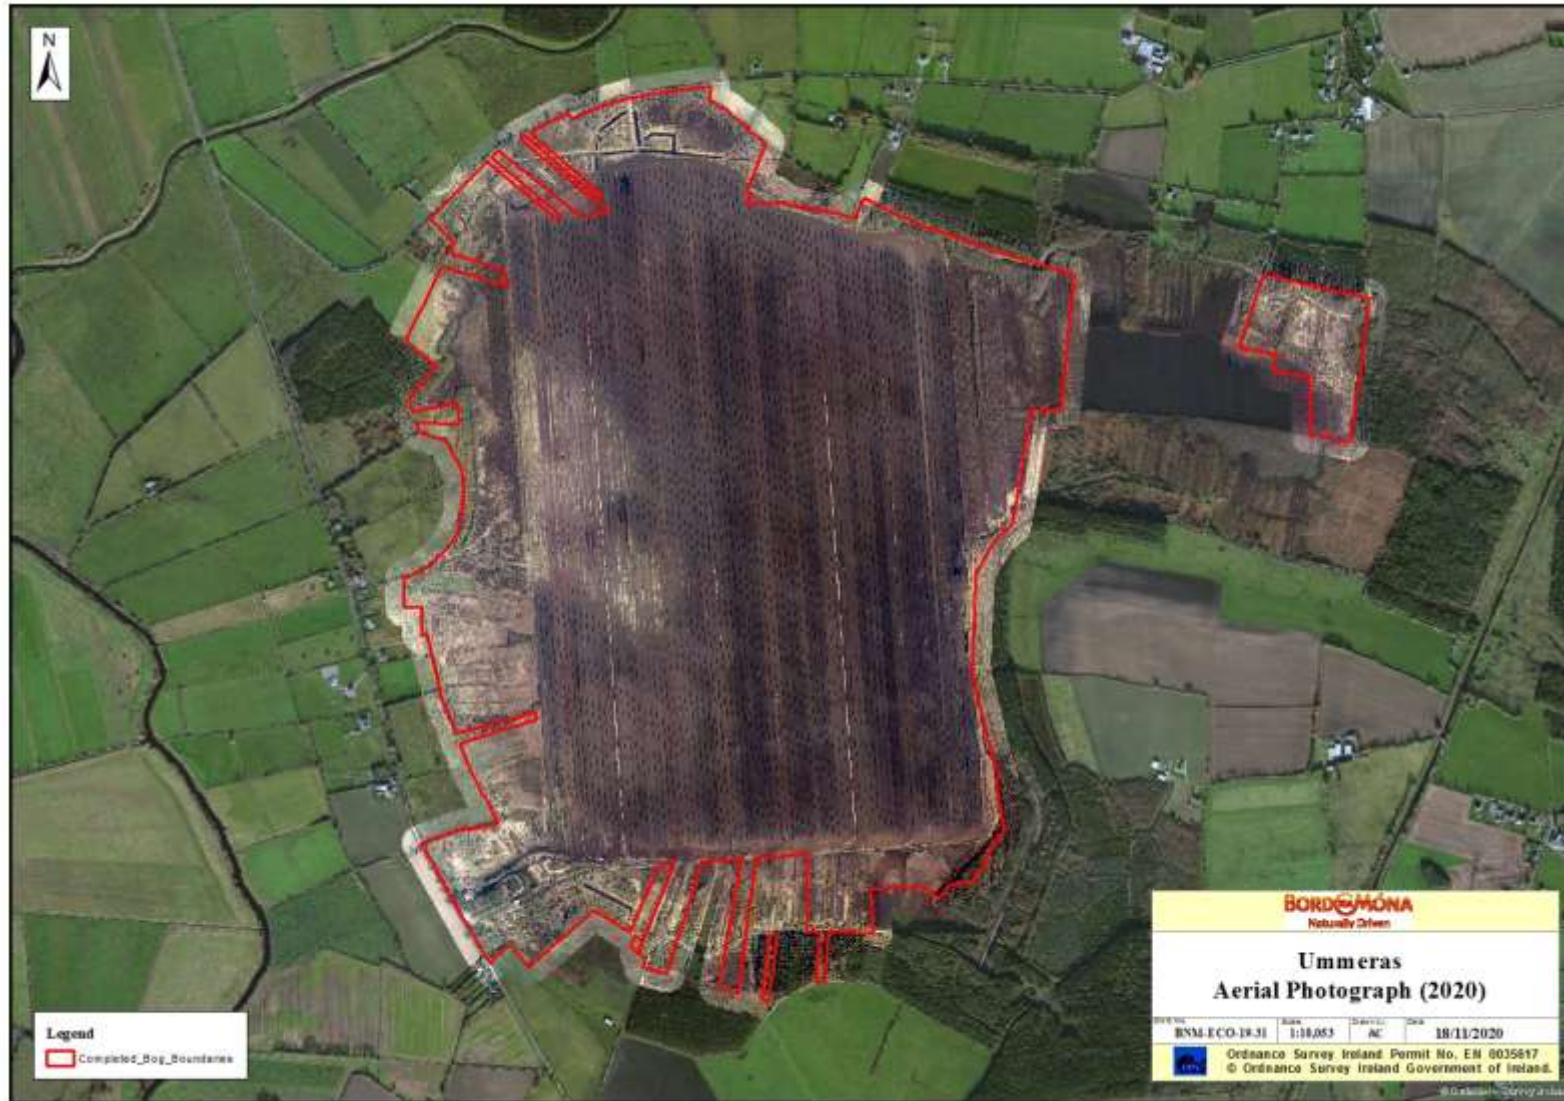
Figure 8.1. Aerial photo of Ummeras Bog. The vegetating ridge on the western side of the bog is visible.

Much of the site comprises extensive areas dominated by bare peat, although there is some emerging pioneer poor fen vegetation and some small areas of Birch woodland (See Figure 8.1). Some of the habitats present around the margins of the site such as remnant high bog (PB1), cutover bog and scrub (WS1) have moderate-high local ecological value as a refuge for local fauna. One more significant area is the ditched degraded raised bog in the north-east corner. This section has intact vegetation and still has some remnant Sphagnum cover and newer Sphagnum cover developing in depressions. Patches of Birch woodland and wet grassland are located along the margins of the site.

- The local environmental conditions of Ummeras Bog identify residual peat re-wetting as the most suitable rehabilitation approach for different part of this site. Ummeras Bog has a gravity drainage regime (See Figures 8.1-8.4).

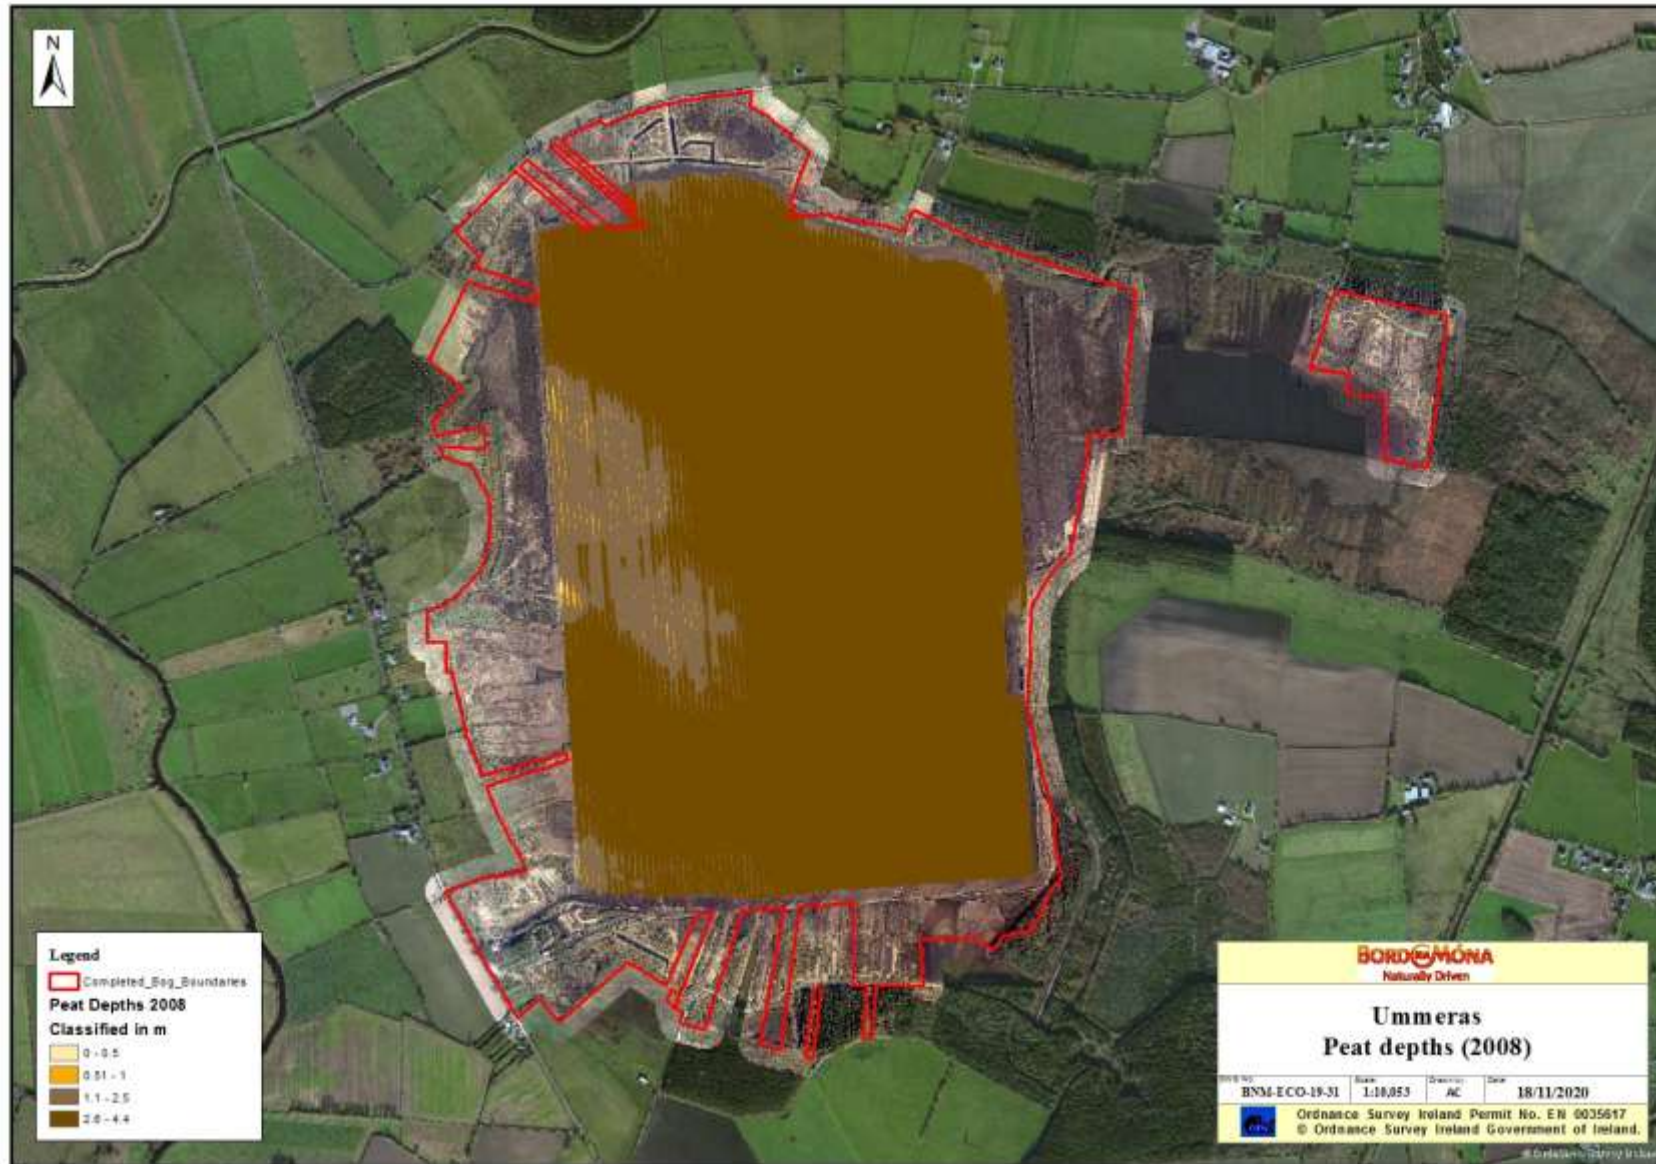
Figure 8.2. Peat depth map for Ummeras Bog. The majority of the bog is characterised as deep peat cutover bog.

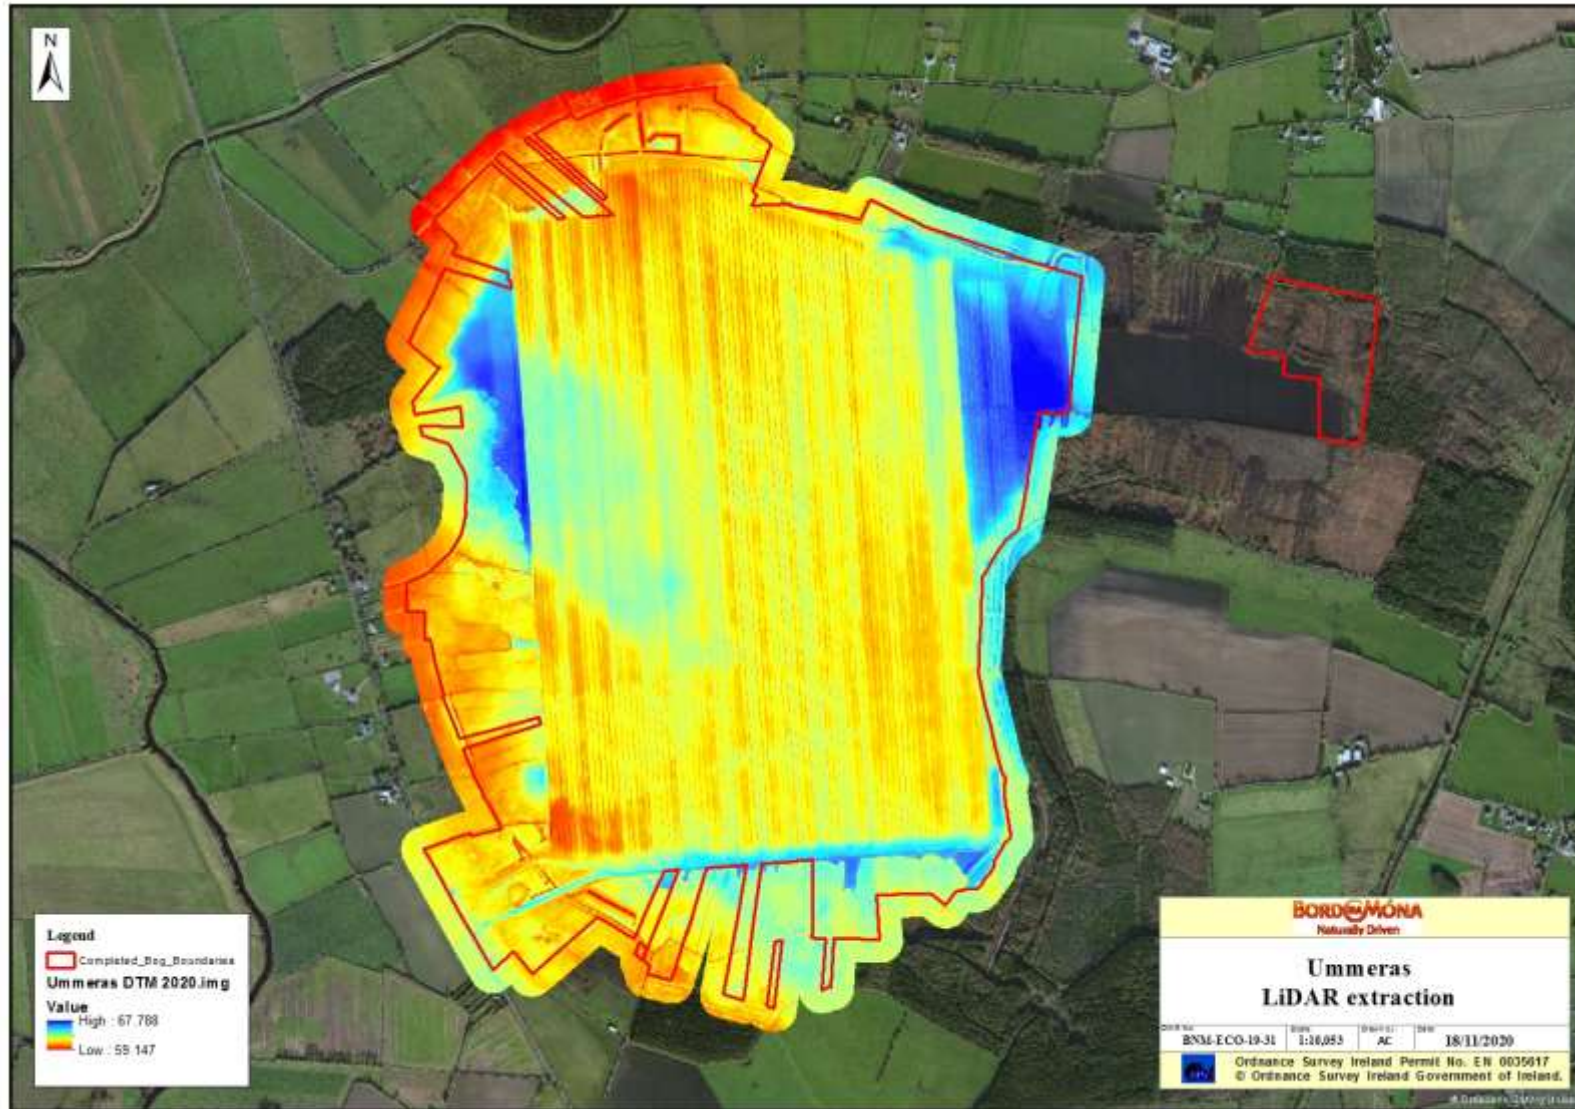
Figure 8.3. LIDAR topography map of Ummeras Bog. Low areas and basins are orange-yellow, more elevated areas are blue. The ridge present on the western side of the bog is visible.

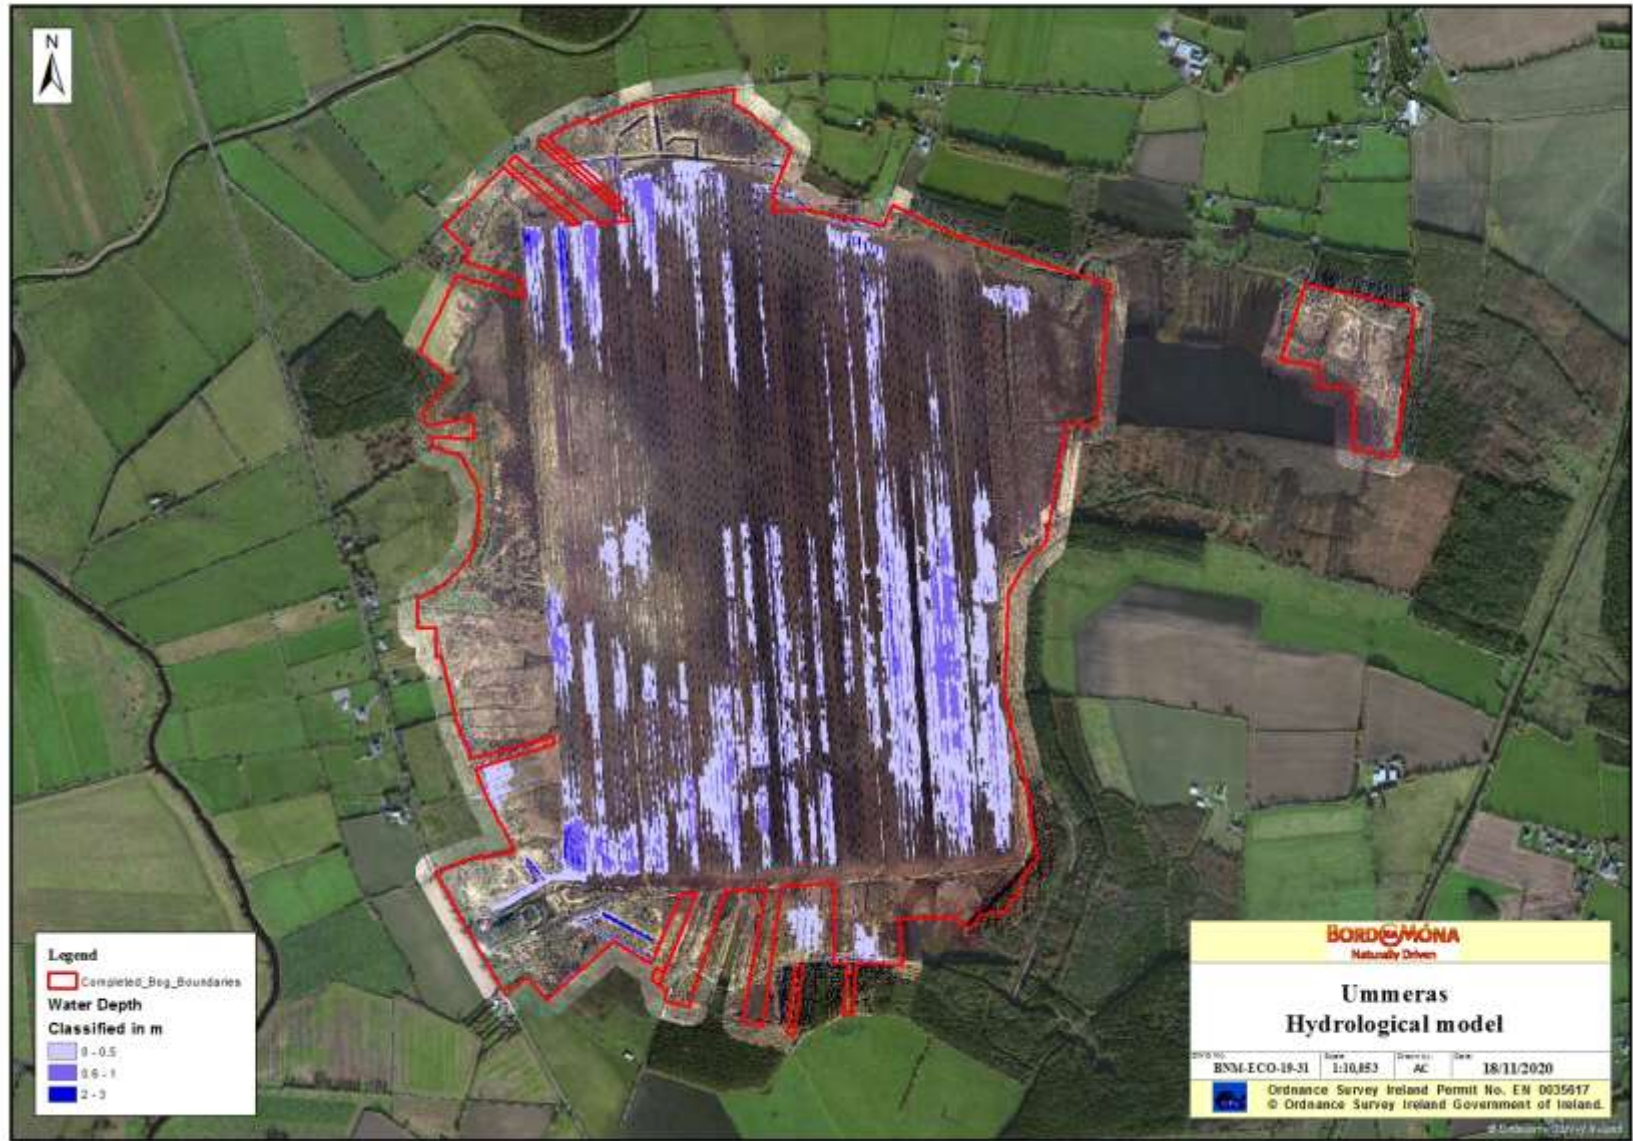
Figure 8.4. Hydrological modelling for Ummeras Bog showing range of expected water depths based on current topography.

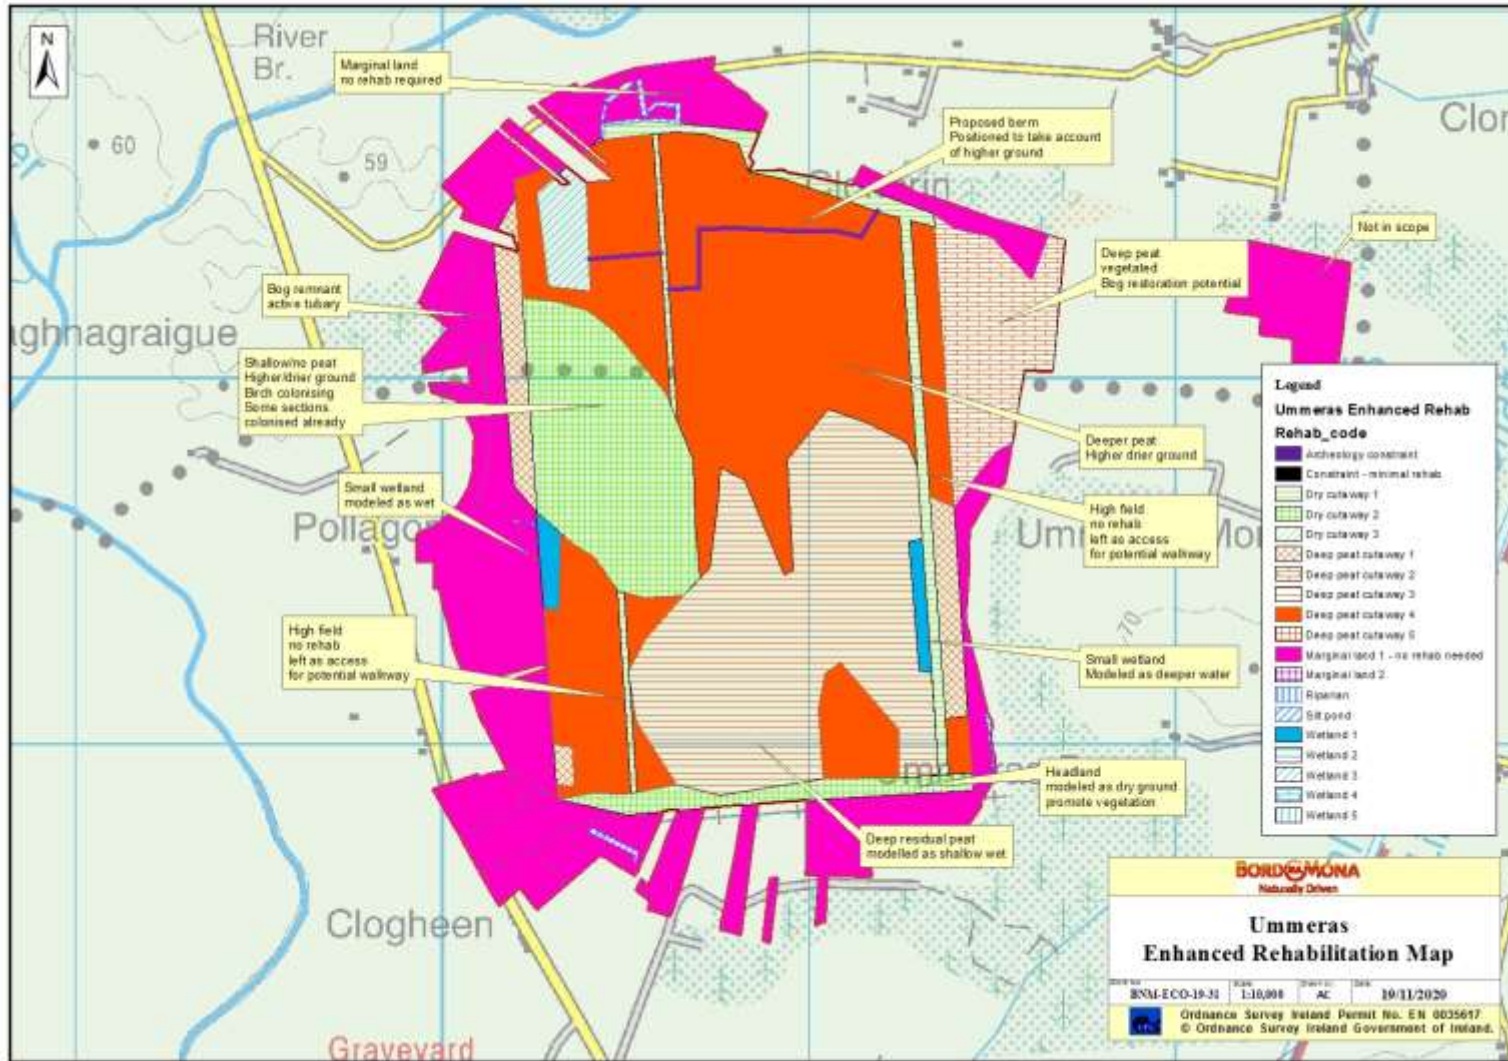
Figure 8.5. Indicative Enhanced Rehabilitation Plan for Ummeras Bog. Note that the actual distribution of these measures may be subject to change in response to stakeholder consultation and refinement of the enhanced rehabilitation measures. *Note that the types of rehab and areas of rehab may change in response to stakeholder consultation and refinement of the enhanced rehabilitation measures.*

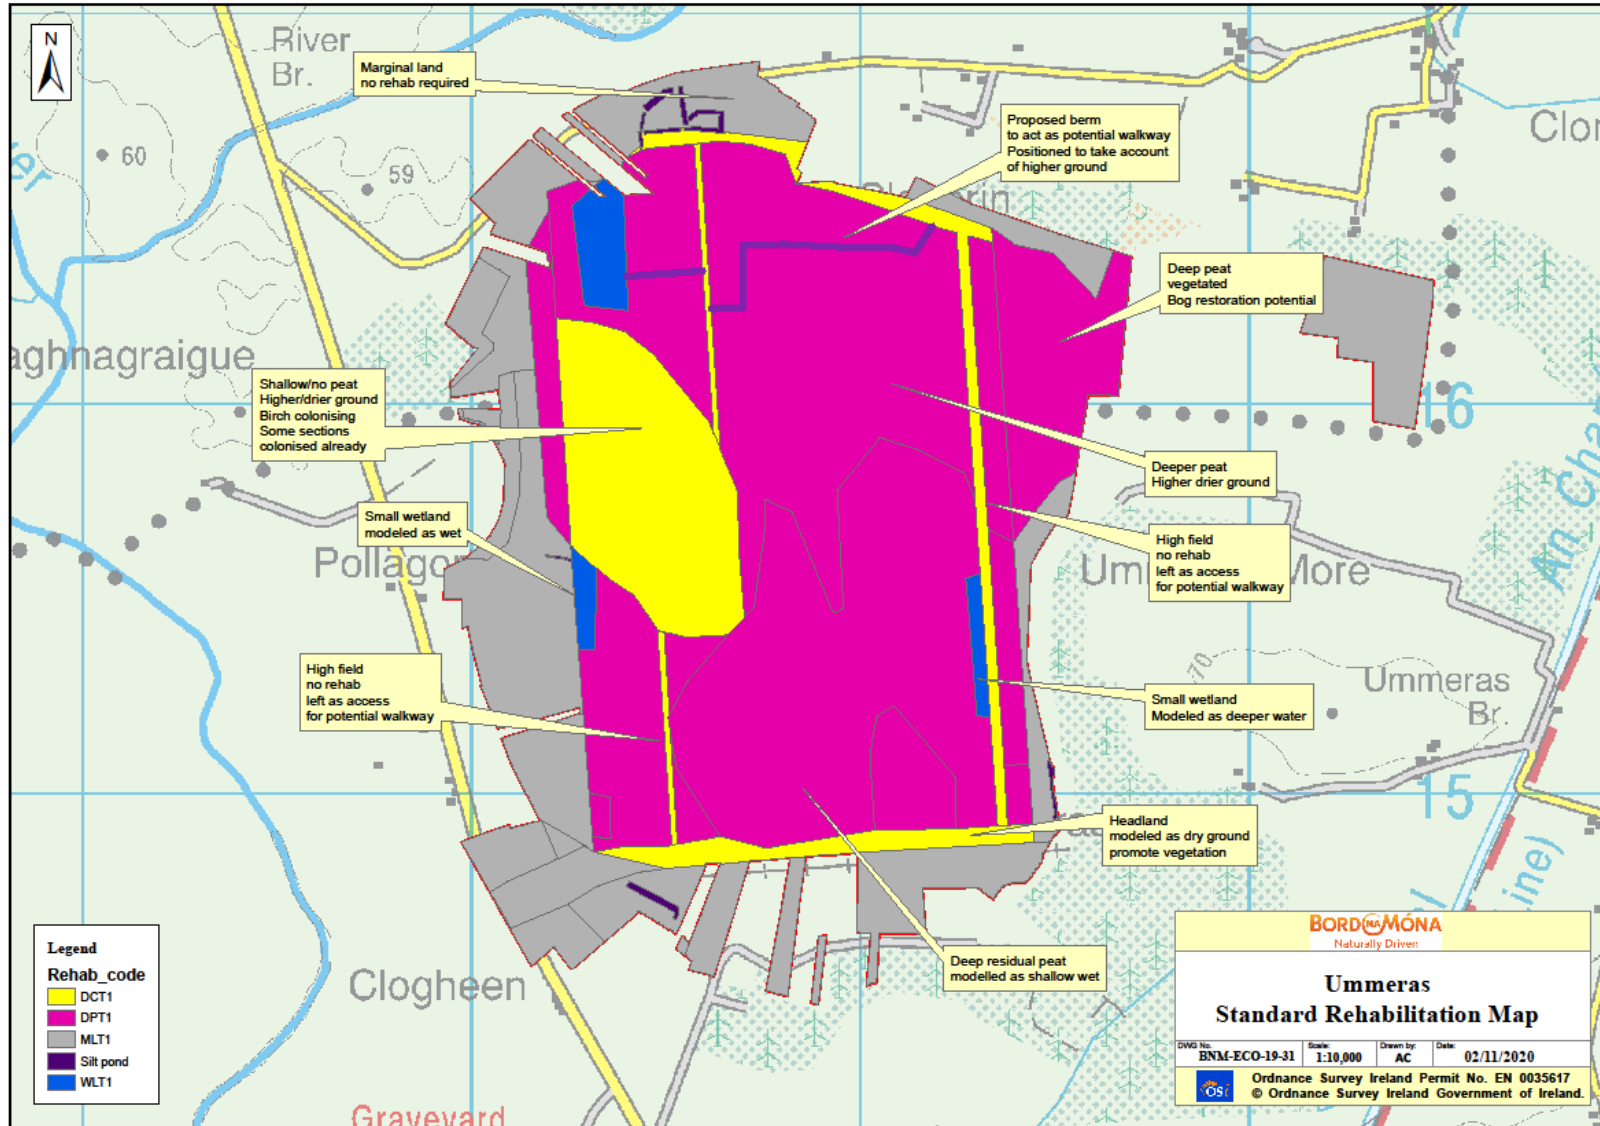
Figure Ap-1. Indicative adapted standard rehabilitation plan for Ummeras Bog.
