## **Edera Bog**

### **Cutaway Bog Decommissioning and Rehabilitation Plan 2020**

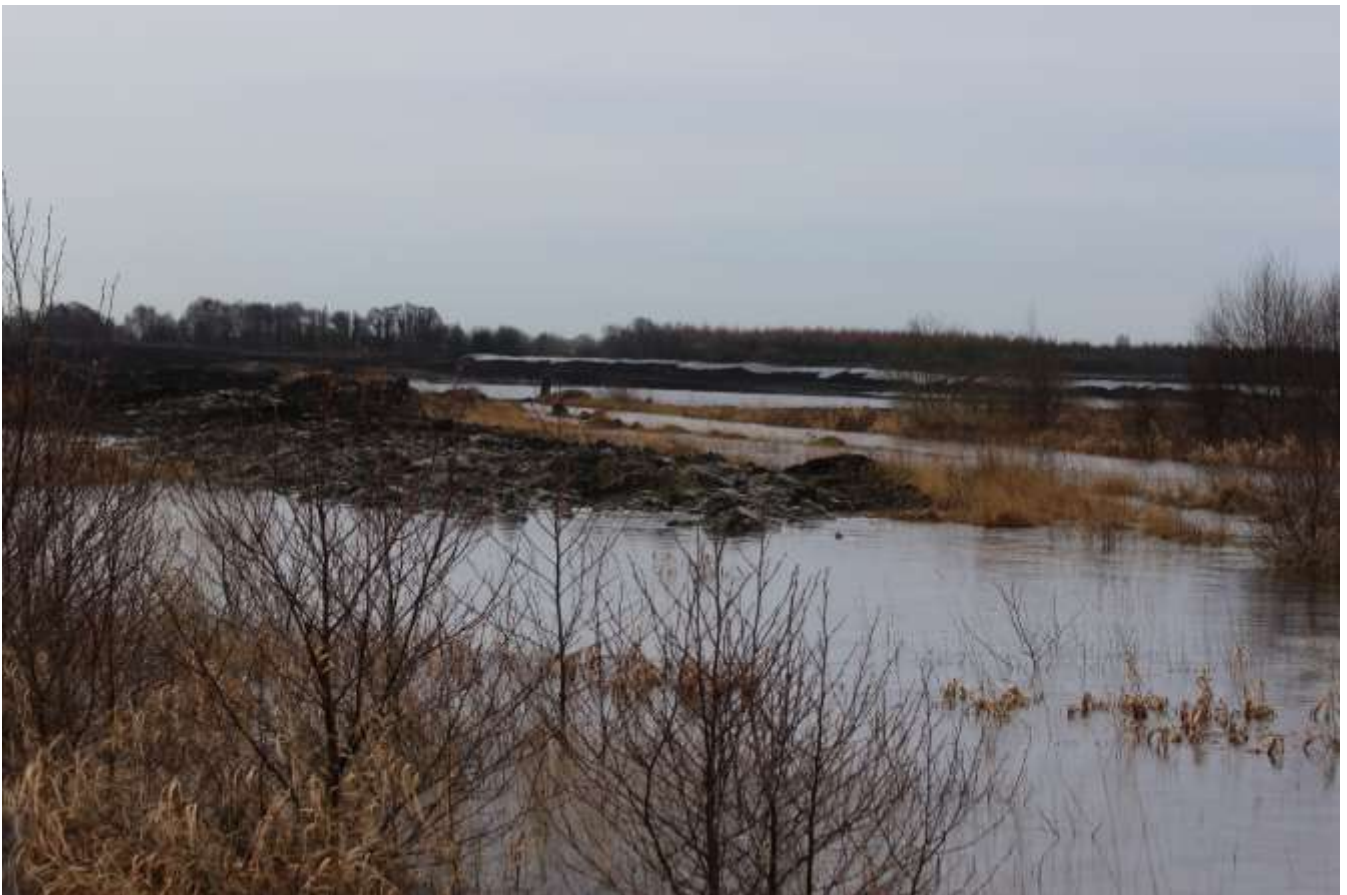
Figure 3.3 View of the flooded habitats in south-western part of the site (January 2015)

A significant area of scrub, raised bog and wet grassland is located in the west of the site. Purple Moorgrass is dominant across much of this section of raised bog along with species such as Bog Asphodel, Sundew, Yellow Rattle, Willow, Bog Myrtle, Devil's Bit-Scabious, Gorse, Bog Cotton, Heather, *Sphagnum papillosum*, *S. subnitens*, *S. squarrosum* and *Aulacomnium palustre*. Occasional tufts of Black Bog Rush are located along the edges of this habitat. This area, immediately adjacent to Lough Ree, can flood in winter if lake water levels are high (See Figure 3.3).
