**Article 6(3)
Appropriate
Assessment Screening
Report**

Kilmacshane Bog, Co
Galway
Decommissioning and
Rehabilitation 2021

Client: Bord na Móna

Project Number: 201008

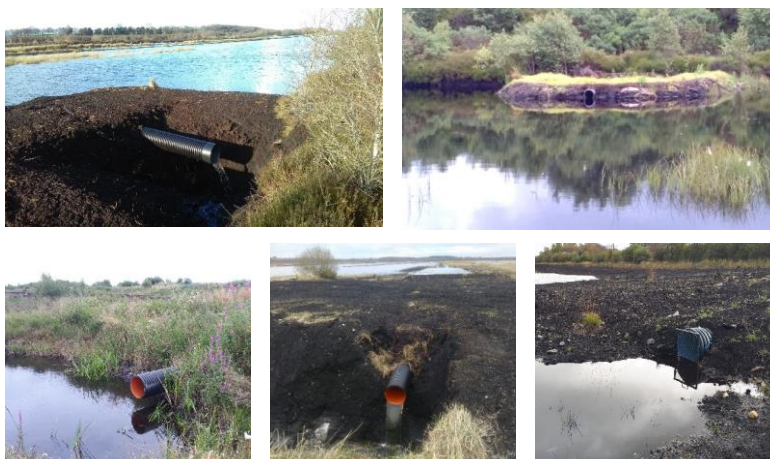
Plate 2-2: Examples of installed overflow pipes

The first step is to block the existing drain where the pipe exits to stop flows. A new transverse field drain and pipe is then placed above the route of the previously blocked and now redundant pipe, to a specified invert level. The drain holding the new, raised pipe, is filled in using an excavator or bulldozer as appropriate.

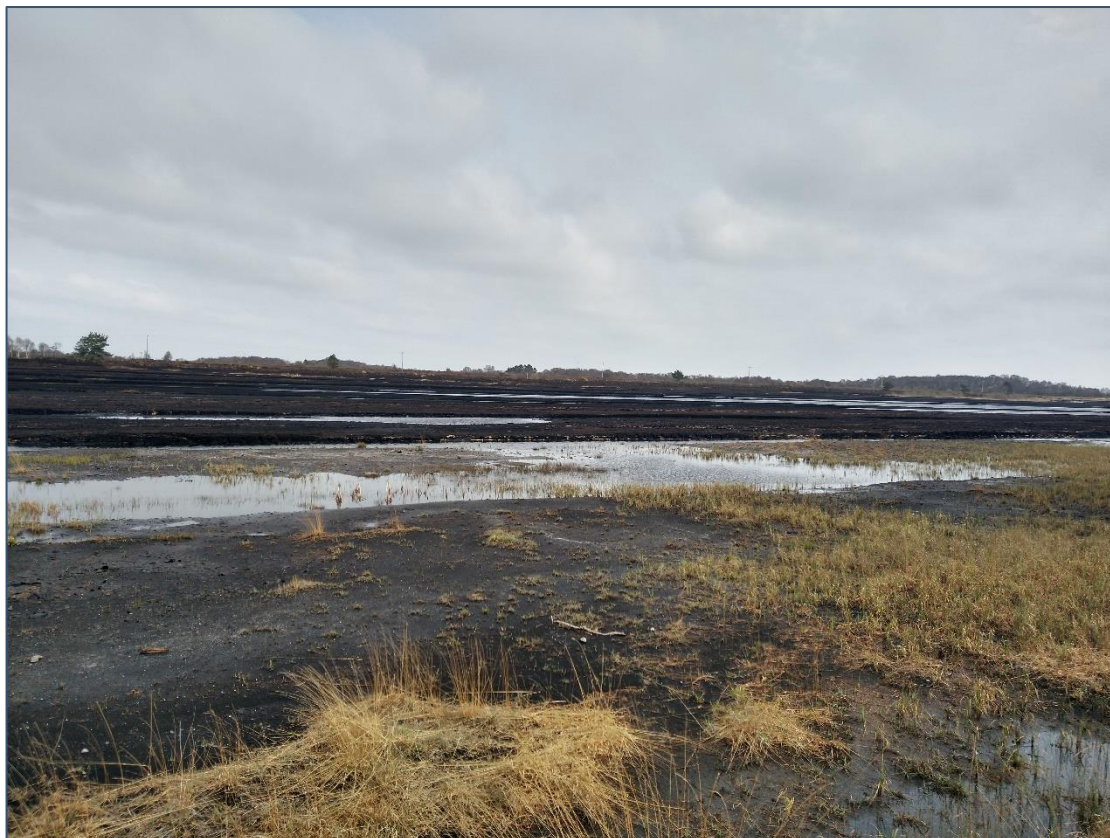
Plate 2-3 View of partially flooded bare peat with early pioneering vegetation communities in the west of Kilmacshane Bog (April 2021).

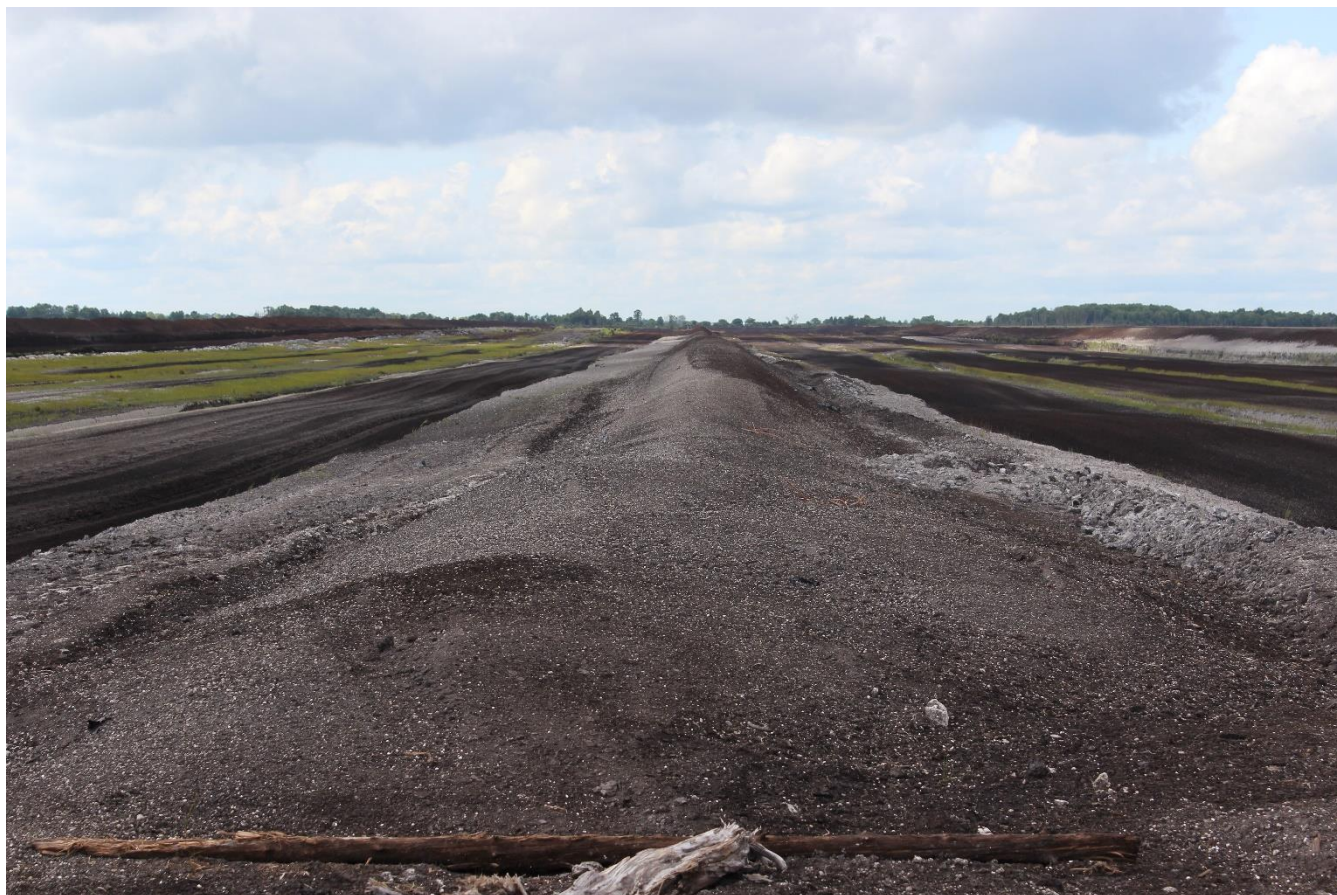
Figure 3.3. View of the typical peat surface with existing drainage and early pioneering vegetation communities across Kilmacshane Bog

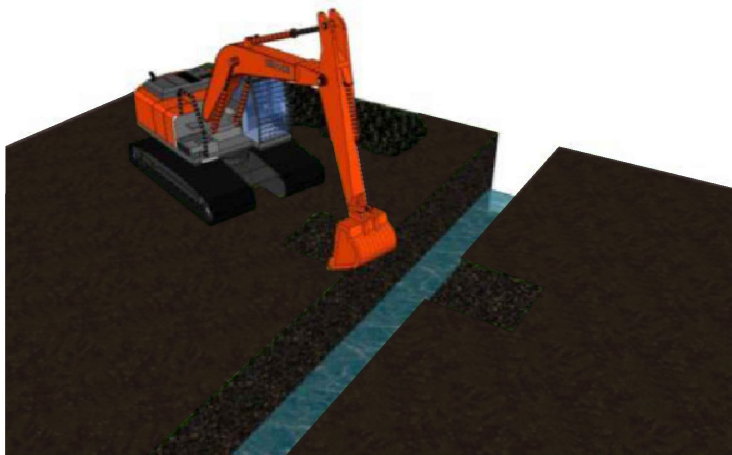
1. Before building drain block, the sides and bottom of the ditch is cleaned using the excavator to remove dry degraded peat, to ensure a good peat-to-peat contact.
(If any vegetation present, it should be carefully removed and left aside for replacement at the end of the process.)

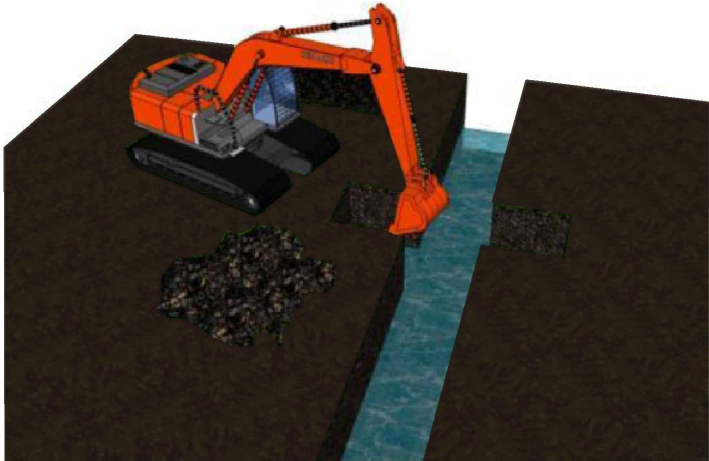
2. Cut key in either side of the drain approximately 500mm deep, and ensure that it is wider than the actual drain. Remove 500mm of peat from bottom of the drain also and place behind the machine for replacement later.

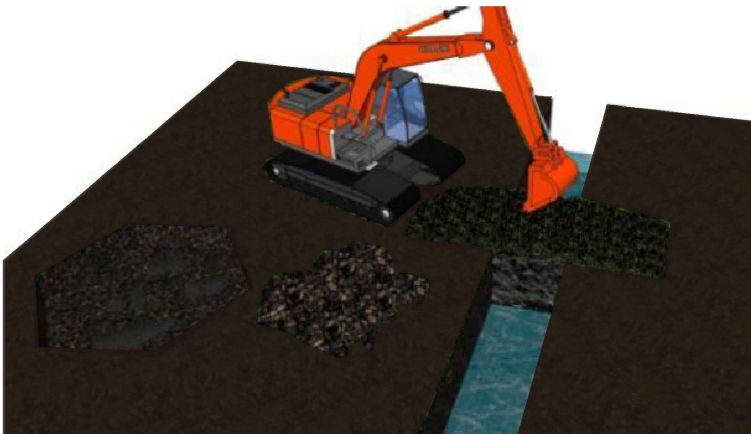
5. Build the drain block up at least 300mm-500mm above the ground level of the bog to allow for subsequent shrinkage of the peat as it dries.
(Take any vegetation removed in step 1 and step 3 and place on the top of the dam, to help bind and stabilise the drain block.)
