Article 6(3) Appropriate Assessment Screening Report

Kellysgrove Bog, Co Galway
Decommissioning and
Rehabilitation 2021

Project Title: **Kellysgrove Bog, Co Galway Decommissioning and Rehabilitation 2021**

Document Title: **Article 6(3) Appropriate Assessment Screening Report**

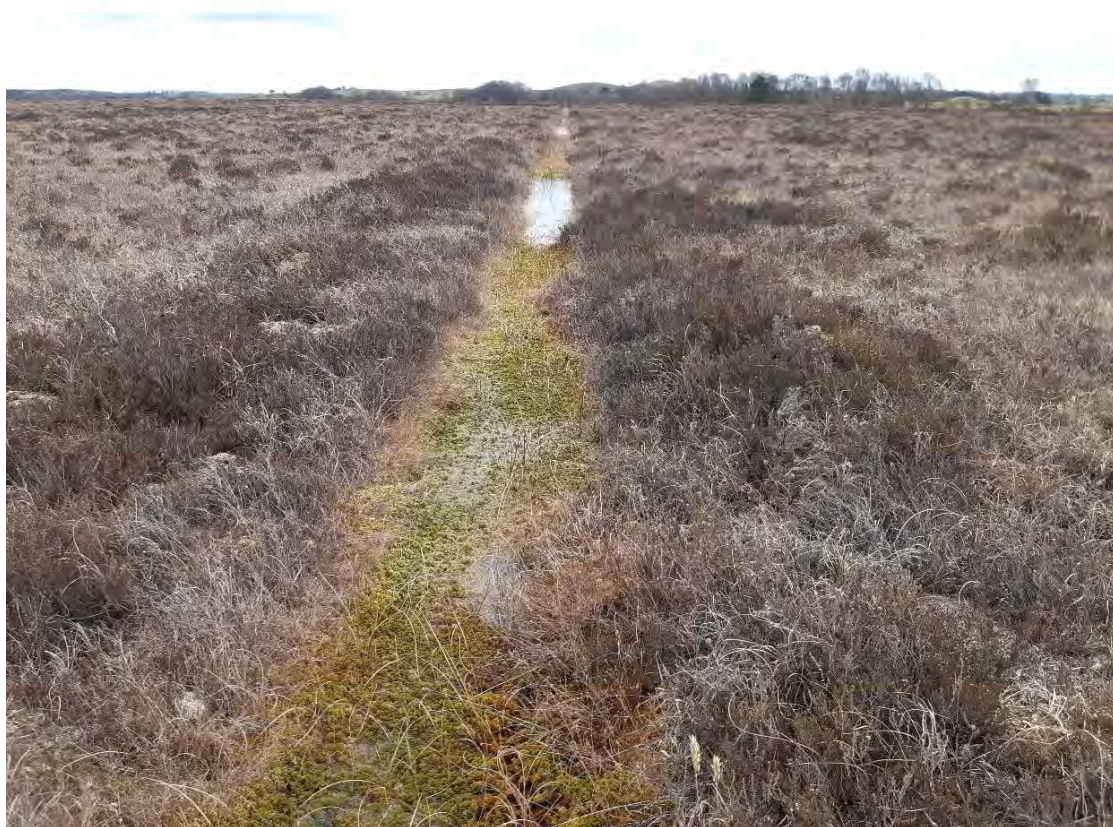
Plate 2-2 View of the typical high bog vegetation with existing drainage across Kellysgrove Bog (April 2020, extracted from Appendix 1)

The largest section of the site is made up of intact **raised bog (PB1)**. It supports 'marginal', 'sub-marginal' and 'facebank' ecotopes that are typical indicators of more degraded raised bog while active areas are characterised by the presence of 'sub-central' ecotope. Some of the drainage ditches on the high bog have started to infill with *Sphagnum* mosses and there is a small wet quaking area with abundant *Sphagnum* cover in the central part of the bog where drainage features have been rendered to reduced functional drainage systems. Some of the wettest sections contain species such as white beak-sedge (*Rhynchospora alba*), common cotton-grass (*Eriophorum angustifolium*), hares-tail cotton-grass (*Eriophorum vaginatum*) and great sundew (*Drosera anglica*). The *Sphagnum* cover in 'sub-central' zones is dominated by lawns of *Sphagnum cuspidatum*, *S. papillosum*, *S. capillifolium* and *S. subnitens*.

The micro-topography supports remnant hummocks of *Sphagnum fuscum* and *S. austini*. However, such hummocks are rare, and the bog hydrology has been impacted as a result of commercial drainage operations. Hollows and pools are absent although *Sphagnum* lawns occur in wetter areas of 'active bog'. Conditions are progressively drier towards much of the western section of the bog and along the bog margins where 'marginal' ecotope dominates.

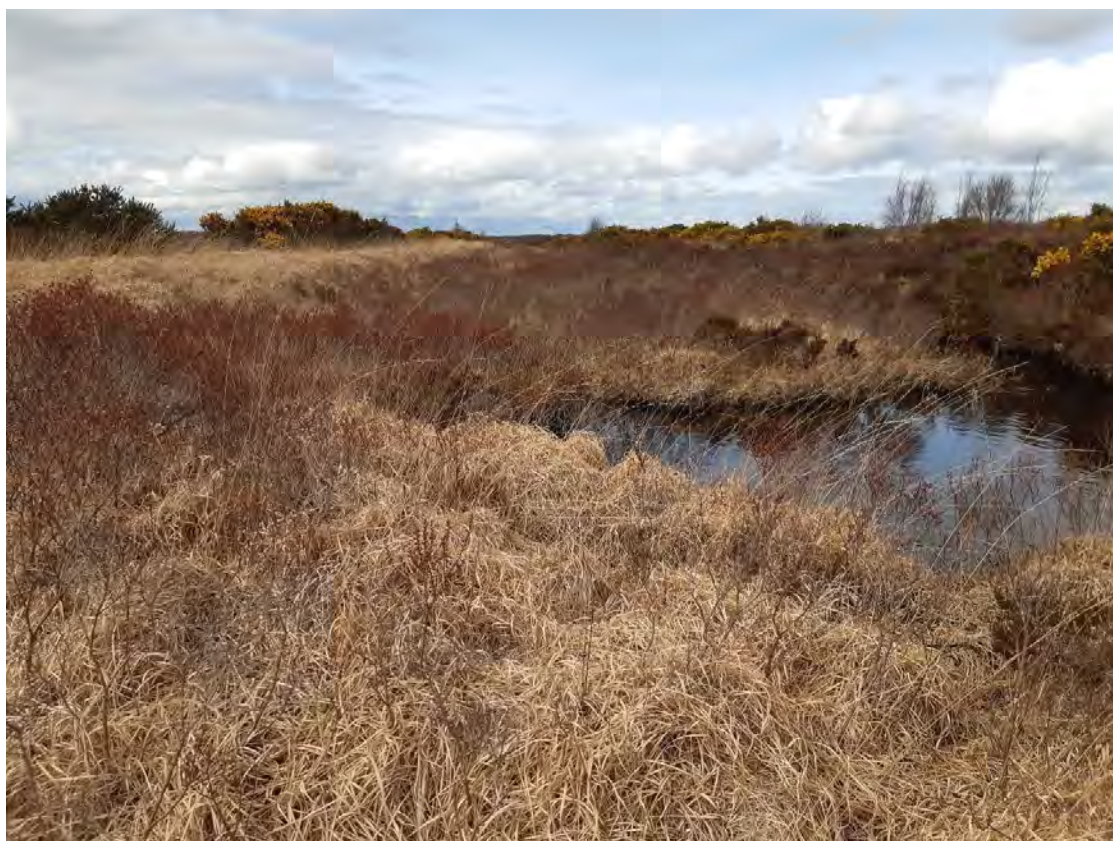
Plate 2-3 View of the old Ballinasloe Canal that runs through the site with the Hymany Way on the bank on the left side in the picture (April 2020, extracted from Appendix 1)

The old Ballinasloe **canal (FW3)** (Plate 2-3) runs through the site separating a linear section of **raised bog (PB1)** to the north-east from the remainder of the site. The canal itself has largely infilled with vegetation dominated by purple moor-grass (*Molinia caerulea*), with large stands of bog myrtle (*Myrica gale*). The bog in this section of the site is characterised by remnant areas of **raised bog (PB1)** that were formerly subject to turf cutting operations. Much of these areas have suffered erosion to some extent, however the cutover areas support some *Sphagnum*-rich communities comprising *Sphagnum papillosum*, *S. capillifolium*, *S. cuspidatum*, *S. palustre* and *S. magellanicum* (surveyed November 2016). This section of raised bog has not been ditched for commercial purposes. Several small sections of **scrub (WS1)** and **bog woodland (WN7)** have also developed in this area.

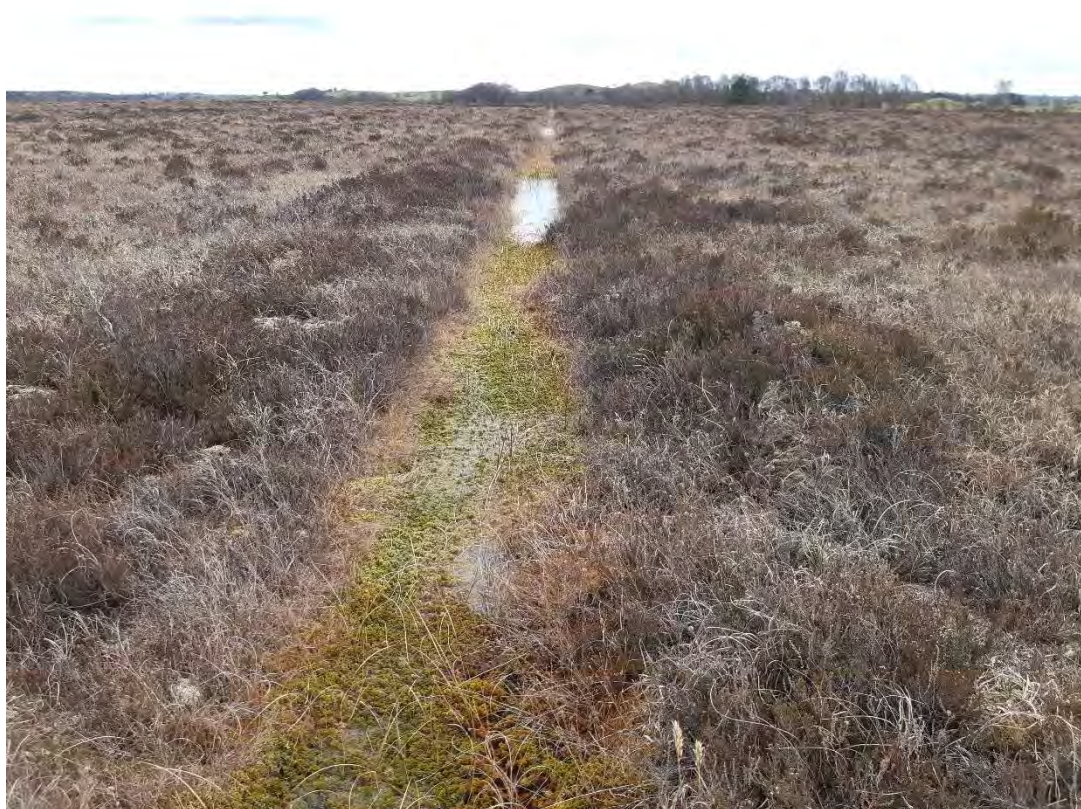
Figure 3.3 View of the typical high bog vegetation with existing drainage across Kellysgrove Bog (Apr 2020)

has never been harvested for peat despite this section having been ditched in the early 1980's. Some of the drainage ditches on the high bog have started to infill with *Sphagnum* mosses (see Figure 3.3) and there is a small wet quaking area with abundant *Sphagnum* cover in the central part of the bog where drainage features have been rendered to reduced functional drainage systems. This area comprises sub-central ecotope dominated by *Sphagnum* mosses. Some of the wettest sections contain species such as White Beak-sedge (*Rhynchospora alba*), Common Cotton-grass (*Eriophorum angustifolium*), Hares-tail Cotton-grass (*Eriophorum vaginatum*) and Great Sundew (*Drosera anglica*), which is typical of flushed (or sub-central ecotope) raised bog areas. The *Sphagnum* cover in sub-central zones is dominated by lawns of *Sphagnum cuspidatum*, *S. papillosum*, *S. capillifolium* and *S. subnitens*.

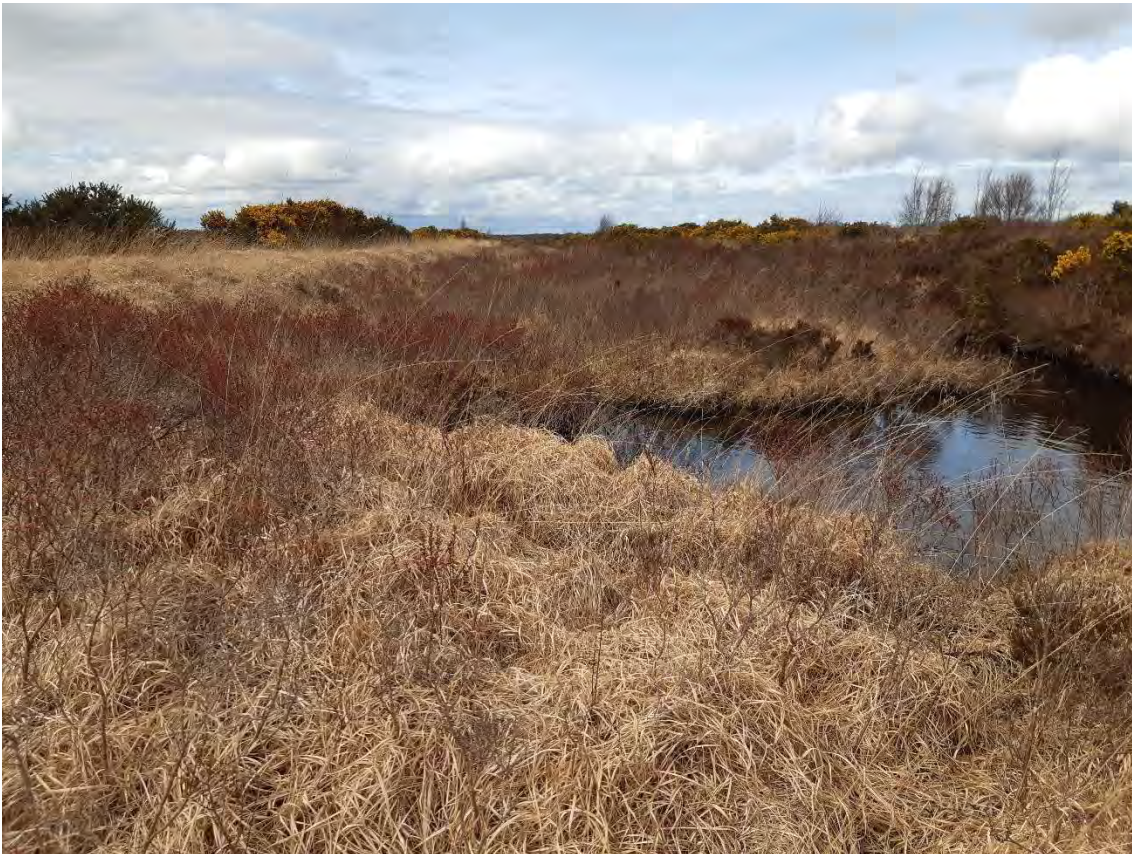
Figure 3.4 View of the old Ballinasloe Canal that runs through the site with the Hymany Way on the bank on the left side in the picture (Apr 2020)

The old Ballinasloe canal (see Figure 3.4) runs through the site separating a linear section of raised bog to the north-east from the remainder of the site. The canal itself has largely infilled. The canal vegetation is dominated by Purple Moor Grass, with large stands of Bog Myrtle.

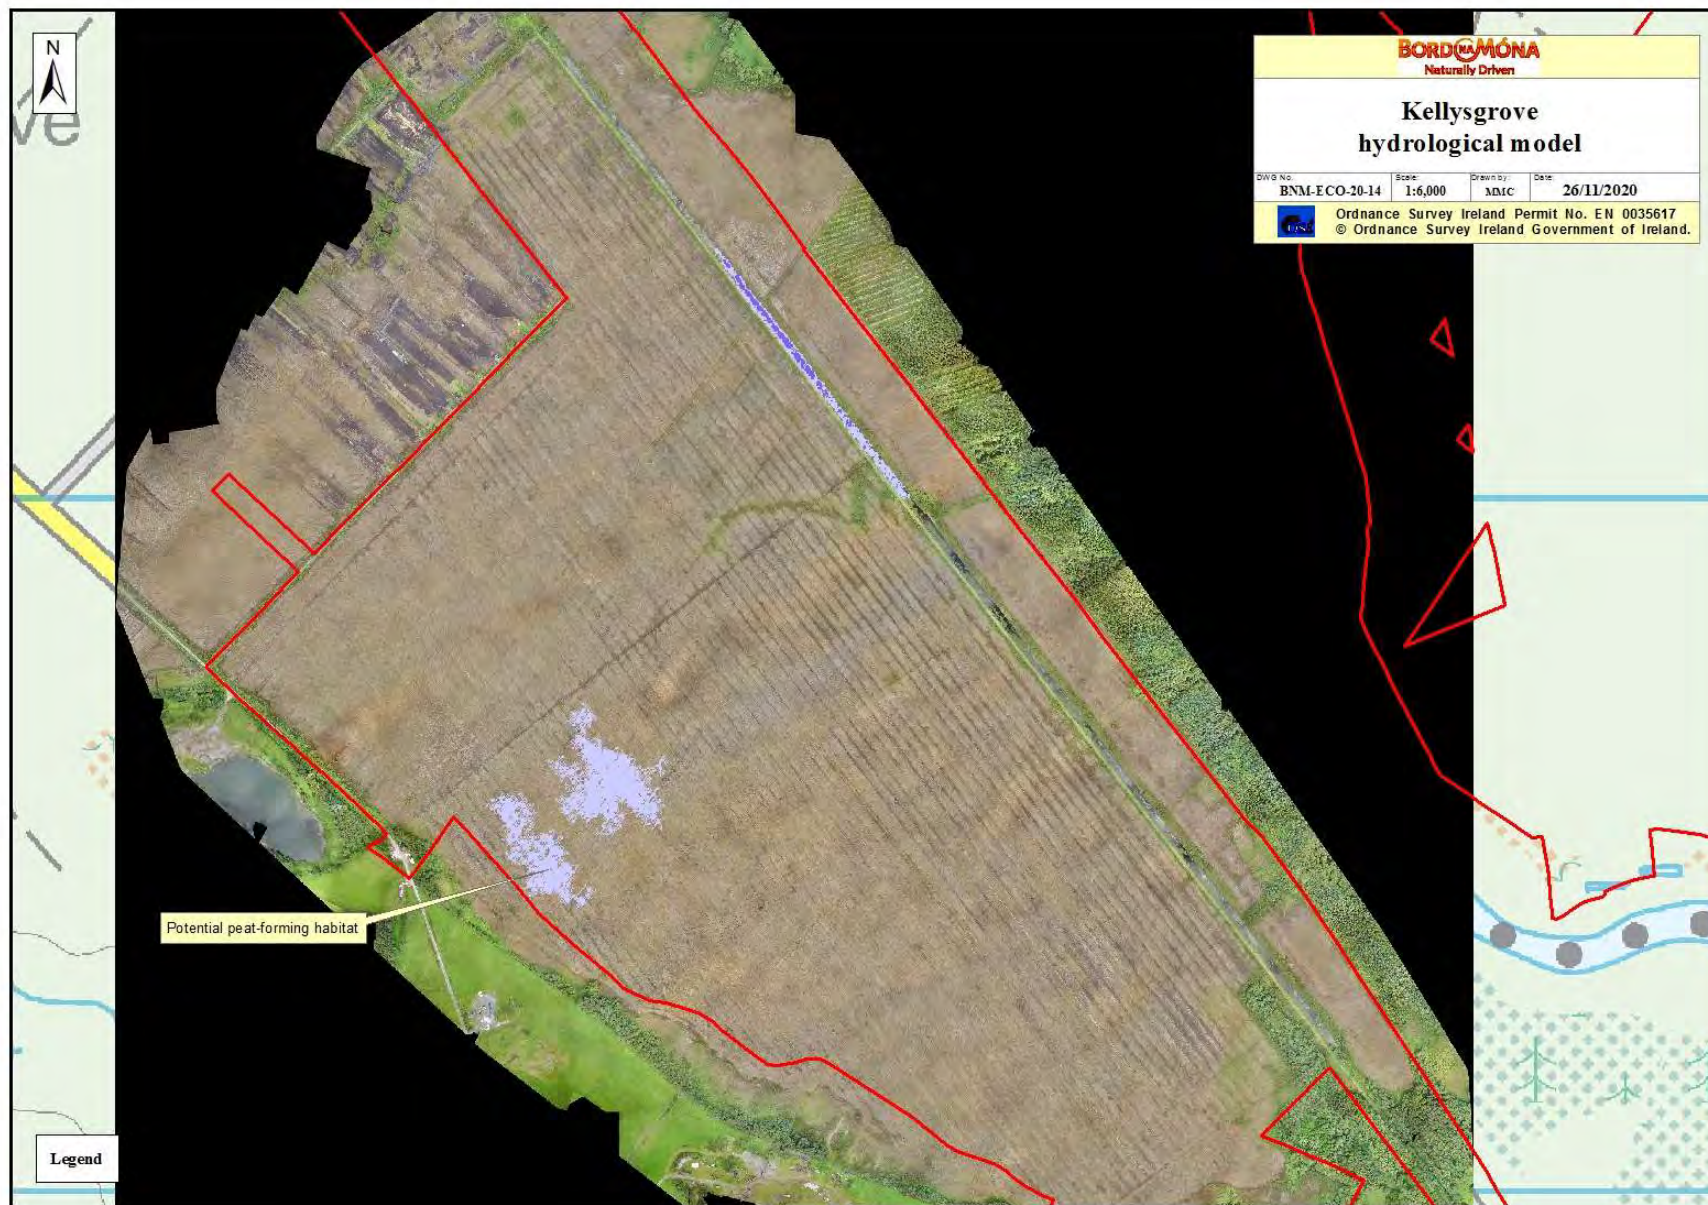
Figure 8.3. Hydrological model for Kellysgrove Bog. This models the potential peat-forming habitat when drains are blocked (2 ha).
