Belmont Bog

Cutaway Bog Decommissioning and Rehabilitation Plan 2021

This document seeks to address the requirements of Condition 10.2 of IPC Licence Ref. P0502-01:

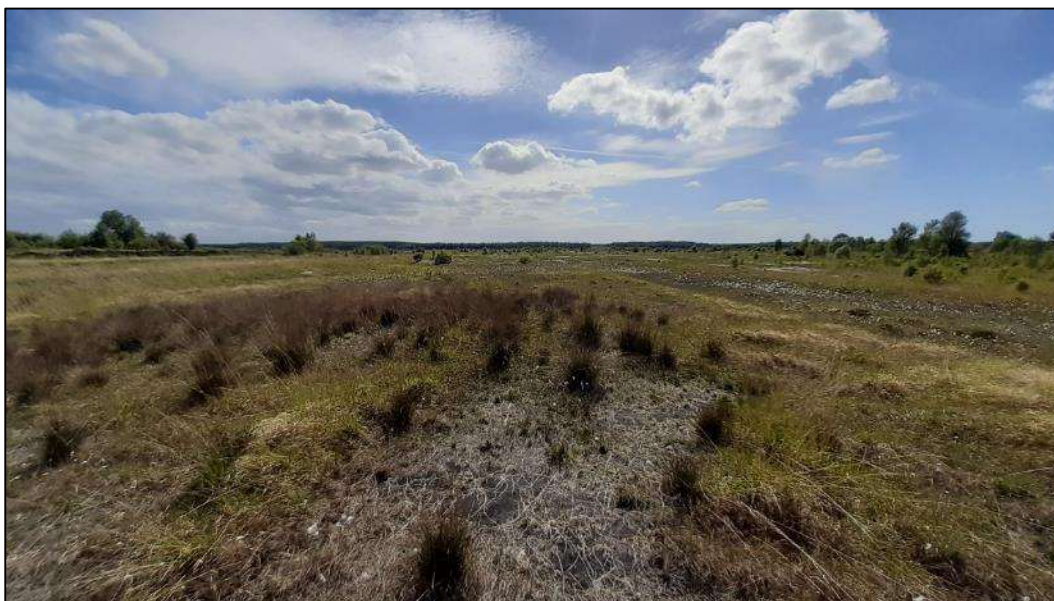
Figure 3.3 View of Pioneering habitat at Belmont Bog (2020)

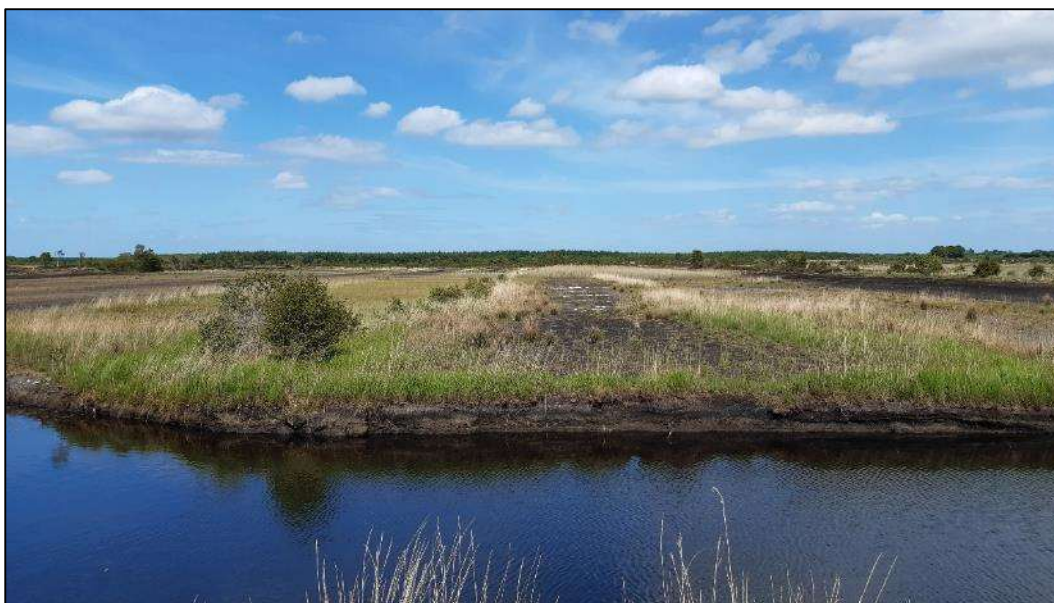
Figure 3.4 View of Pioneering Habitat and existing Silt Pond (foreground) at Belmont Bog (2020)

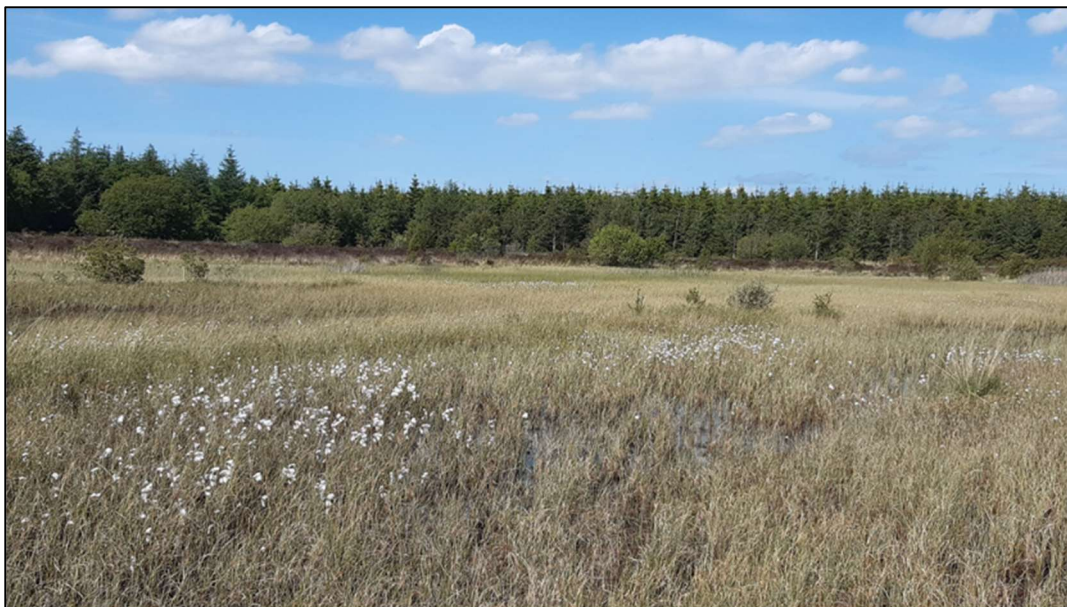
Figure 3.5 View of Pioneering Fen forming Habitat Belmont Bog (2020)

In May 2020, a site visit by BNM ecologists confirmed the presence of fen-forming habitats in the NW section of Belmont, with indicator species such as Black Bog Rush *Schoenus nigricans*, Common Butterwort *Pinguicula vulgaris* and Lustrous Bog-moss *Sphagnum subnitens* present.

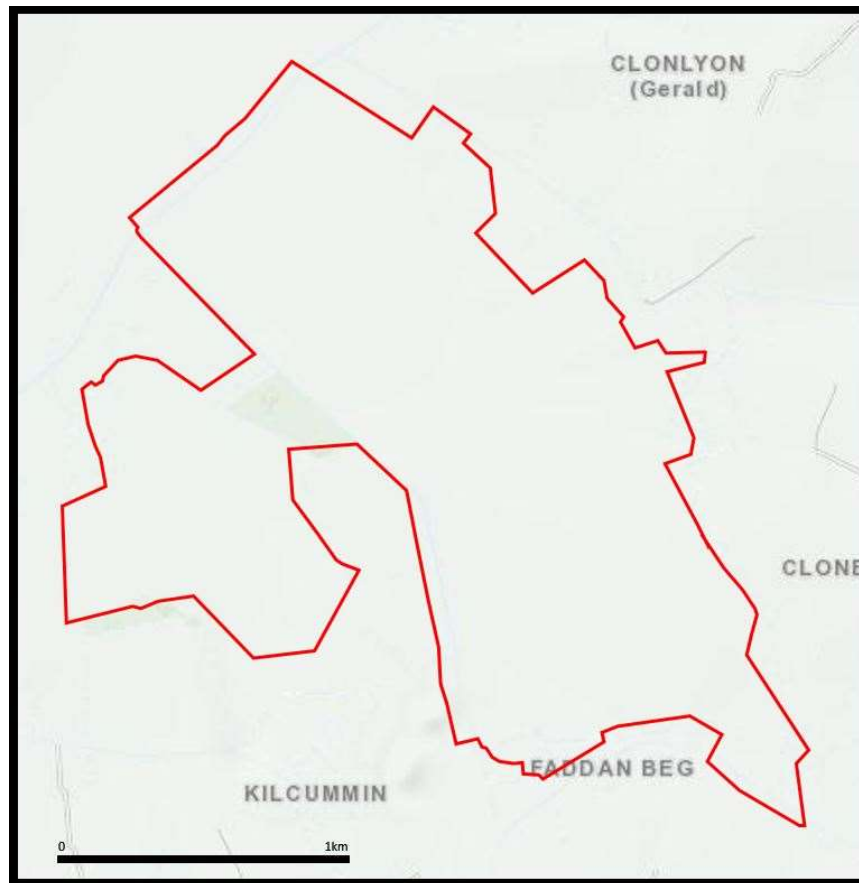
Fig. 2. Belmont Bog, Co. Offaly, detail of the Sites and Monuments Record. The proposed rehabilitation area is outlined with the red line. There is one SMR (now destroyed) in the rehabilitation area but its original location was not recorded and it is not marked on the SMR mapping.

The Sites and Monuments Record (SMR) which is maintained by the Department of Housing, Local Government and Heritage was examined as part of the assessment on the 28th of April 2021. The SMR consists of records included in the RMP and sites and monuments notified to the Dept. since the publication of the RMP. This review established that there is one sighting in the SMR in the proposed rehabilitation area. SMR OF014-051---- is a Road - class 3 togher identified by the IAWU in 1992 but destroyed before its location could be surveyed (see table 1). There were no locational coordinates recorded and the location of the siting is not marked on the SMR mapping.
