Garryduff Bog

Cutaway Bog Decommissioning and Rehabilitation Plan 2021

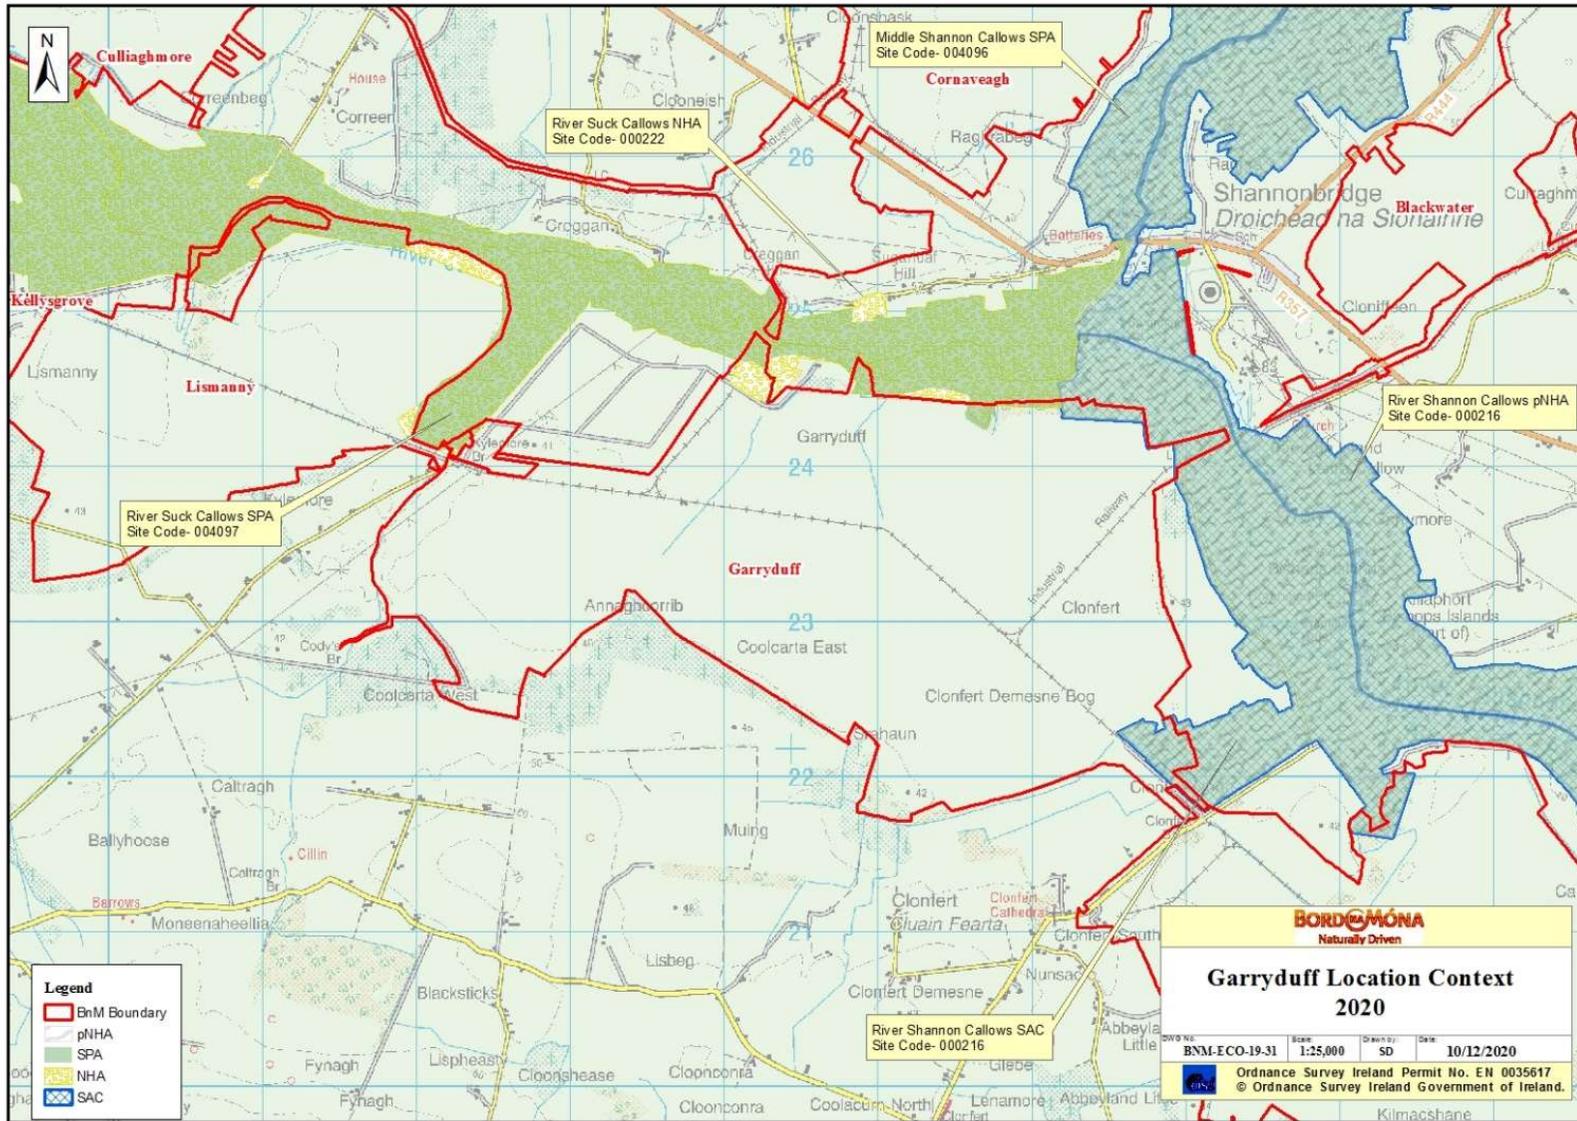
Figure 3.1 Location of Garryduff Bog in context to other Bord na Móna bogs and surrounding area

- The area of Garryduff Bog (Figure 3.1).
- EPA IPC Licence - Ref. P0502-01. As part of Condition 10.2 of this license, a rehabilitation plan must be prepared for permanent rehabilitation of the boglands within the licensed area. Garryduff Bog is part of the Blackwater Bog group.

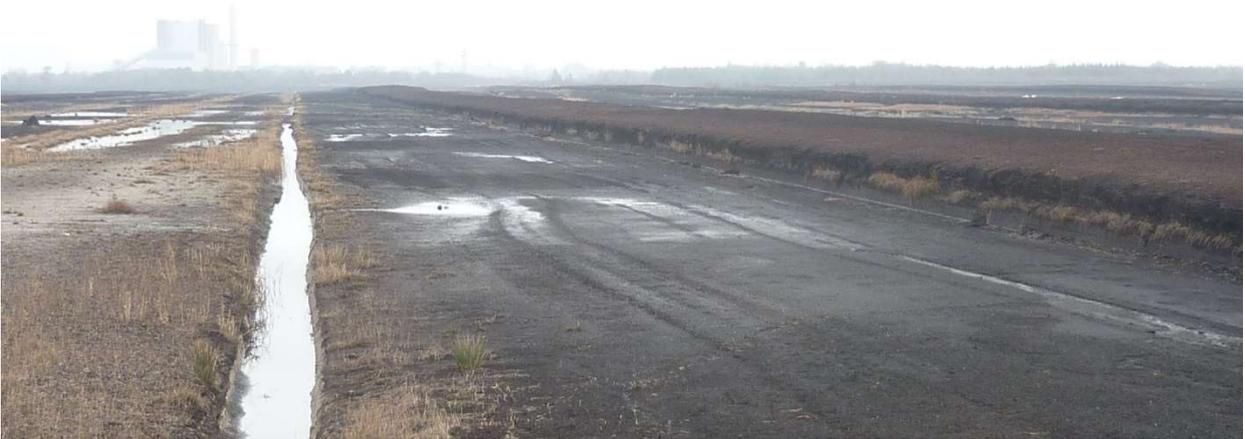
Figure 3.2. View of the typical peat surface with existing drainage and early pioneering vegetation communities across Garryduff Bog

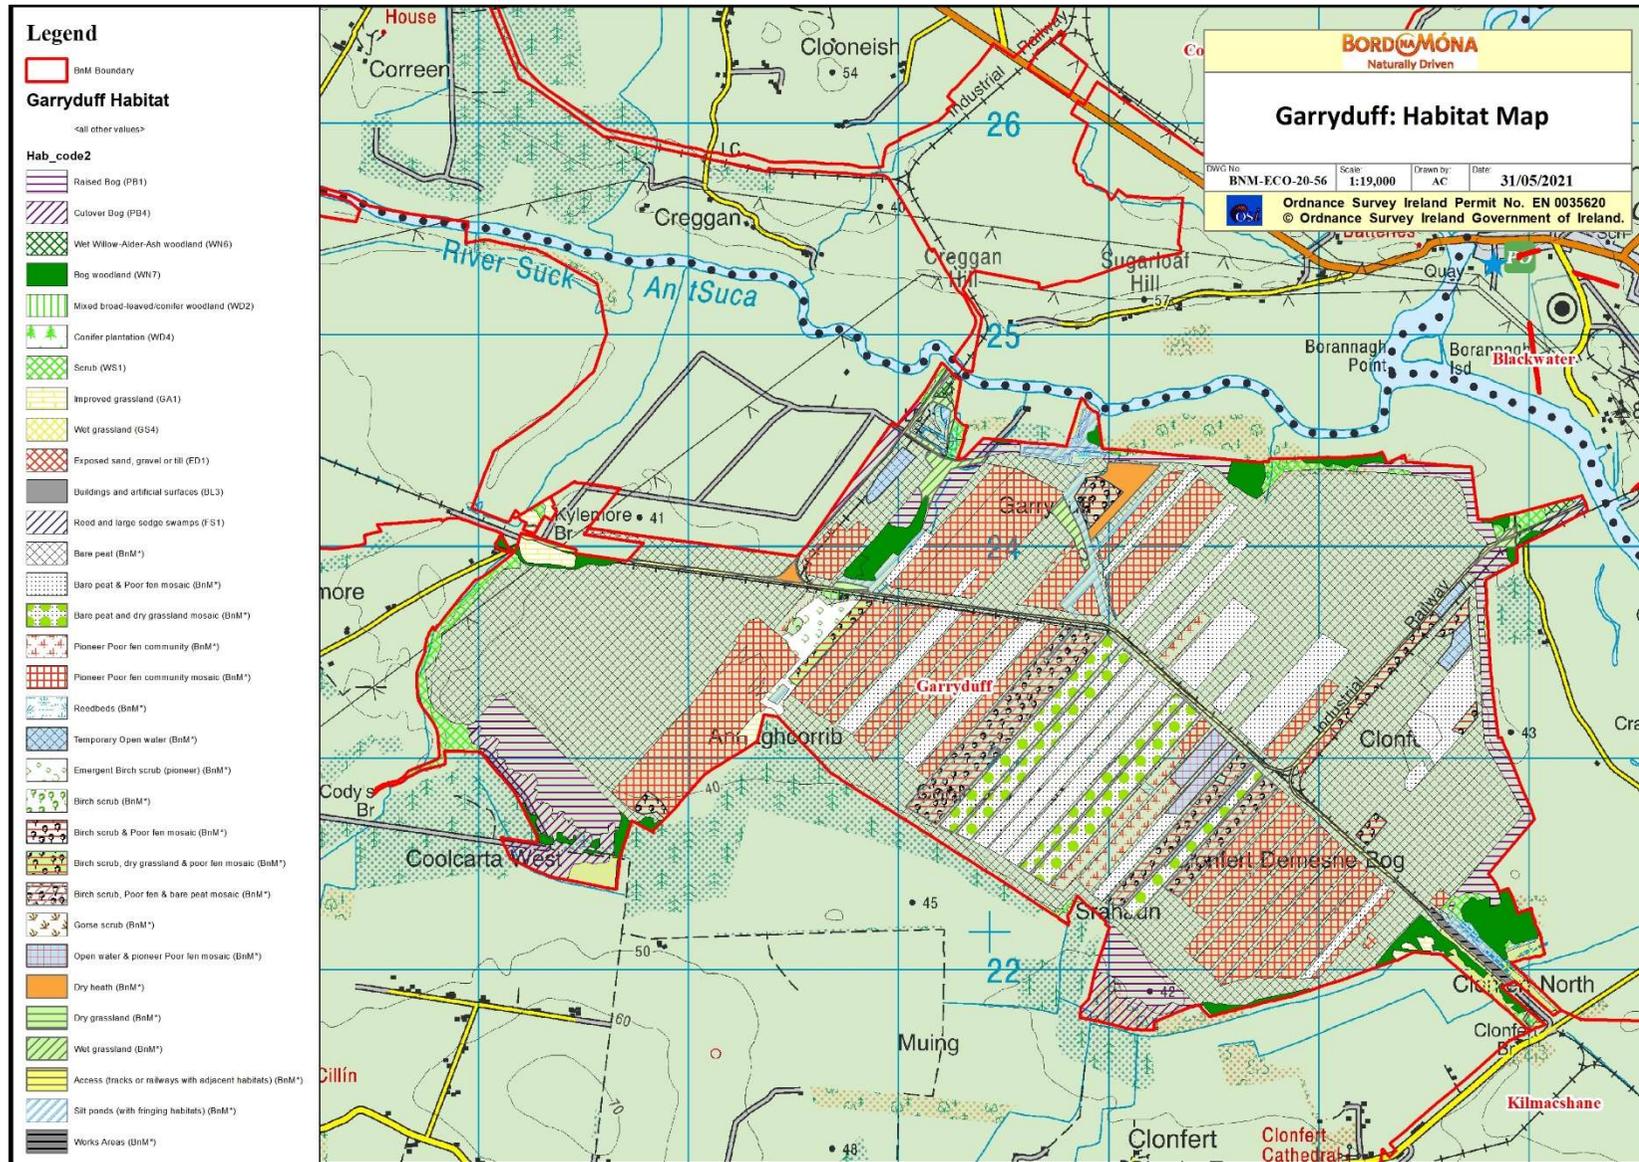
Figure 3.3 Habitat map of Garryduff Bog showing Bord na Móna habitat categorisation.

Much of the site comprises extensive areas dominated by bare peat but with emerging pioneer vegetation (see Figure 3.3). Parts of the cutaway now have well developed wetland and scrub vegetation. Garryduff includes several undeveloped or partially-developed sections around the margin of the production bog that have been designated as part of a nature conservation site (River Shannon Callows cSAC and SPA & Suck River Callows SPA and NHA). Some of the remnant high bog is within the designated boundary, although it is quite degraded. These designated areas also include other typical marginal habitats such as wet grassland, scrub and bog woodland. They also act as part of a buffer between the former production bog and the main channels of both rivers. Small undeveloped sections within the production bog include patches of Birch woodland (WN7), scrub (WS1) and disturbed raised bog (high bog PB1) in poor condition.

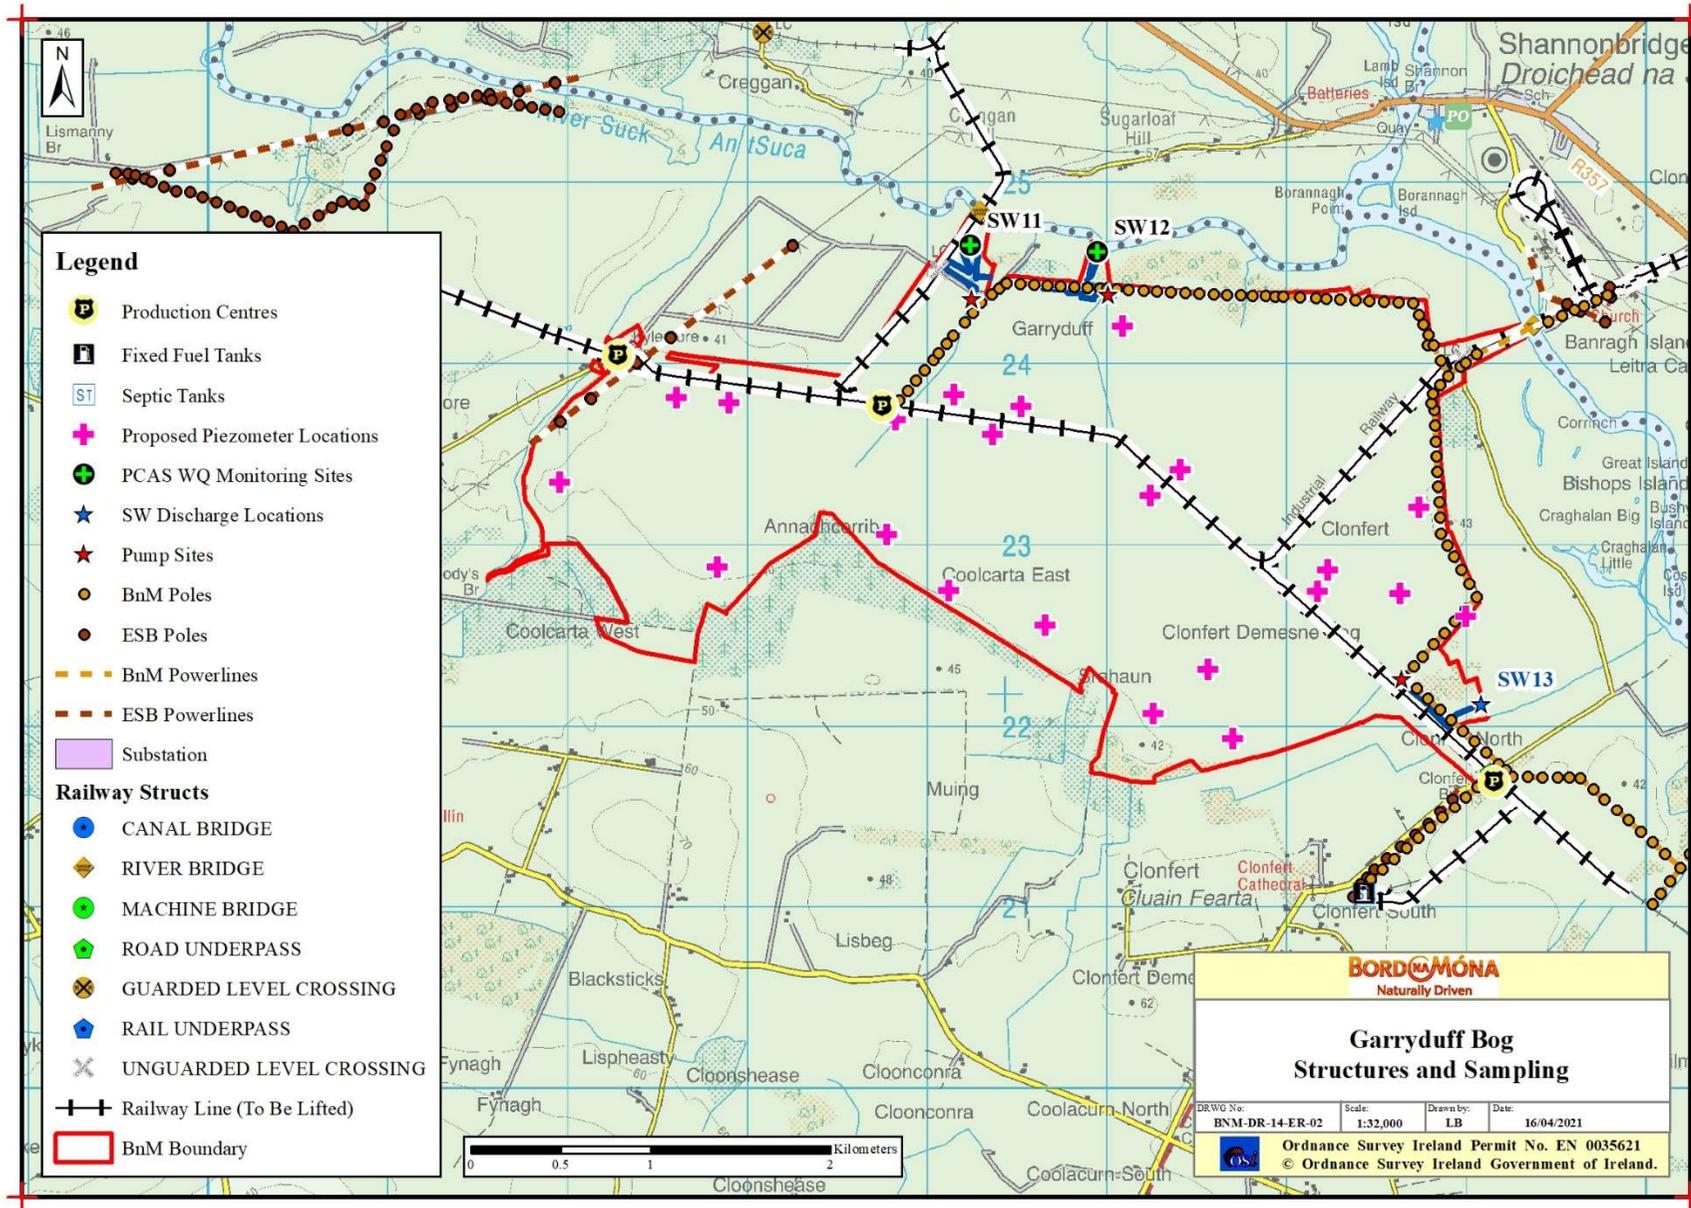
Figure 3.4. Map of Garryduff Bog showing structures and designated emission points.

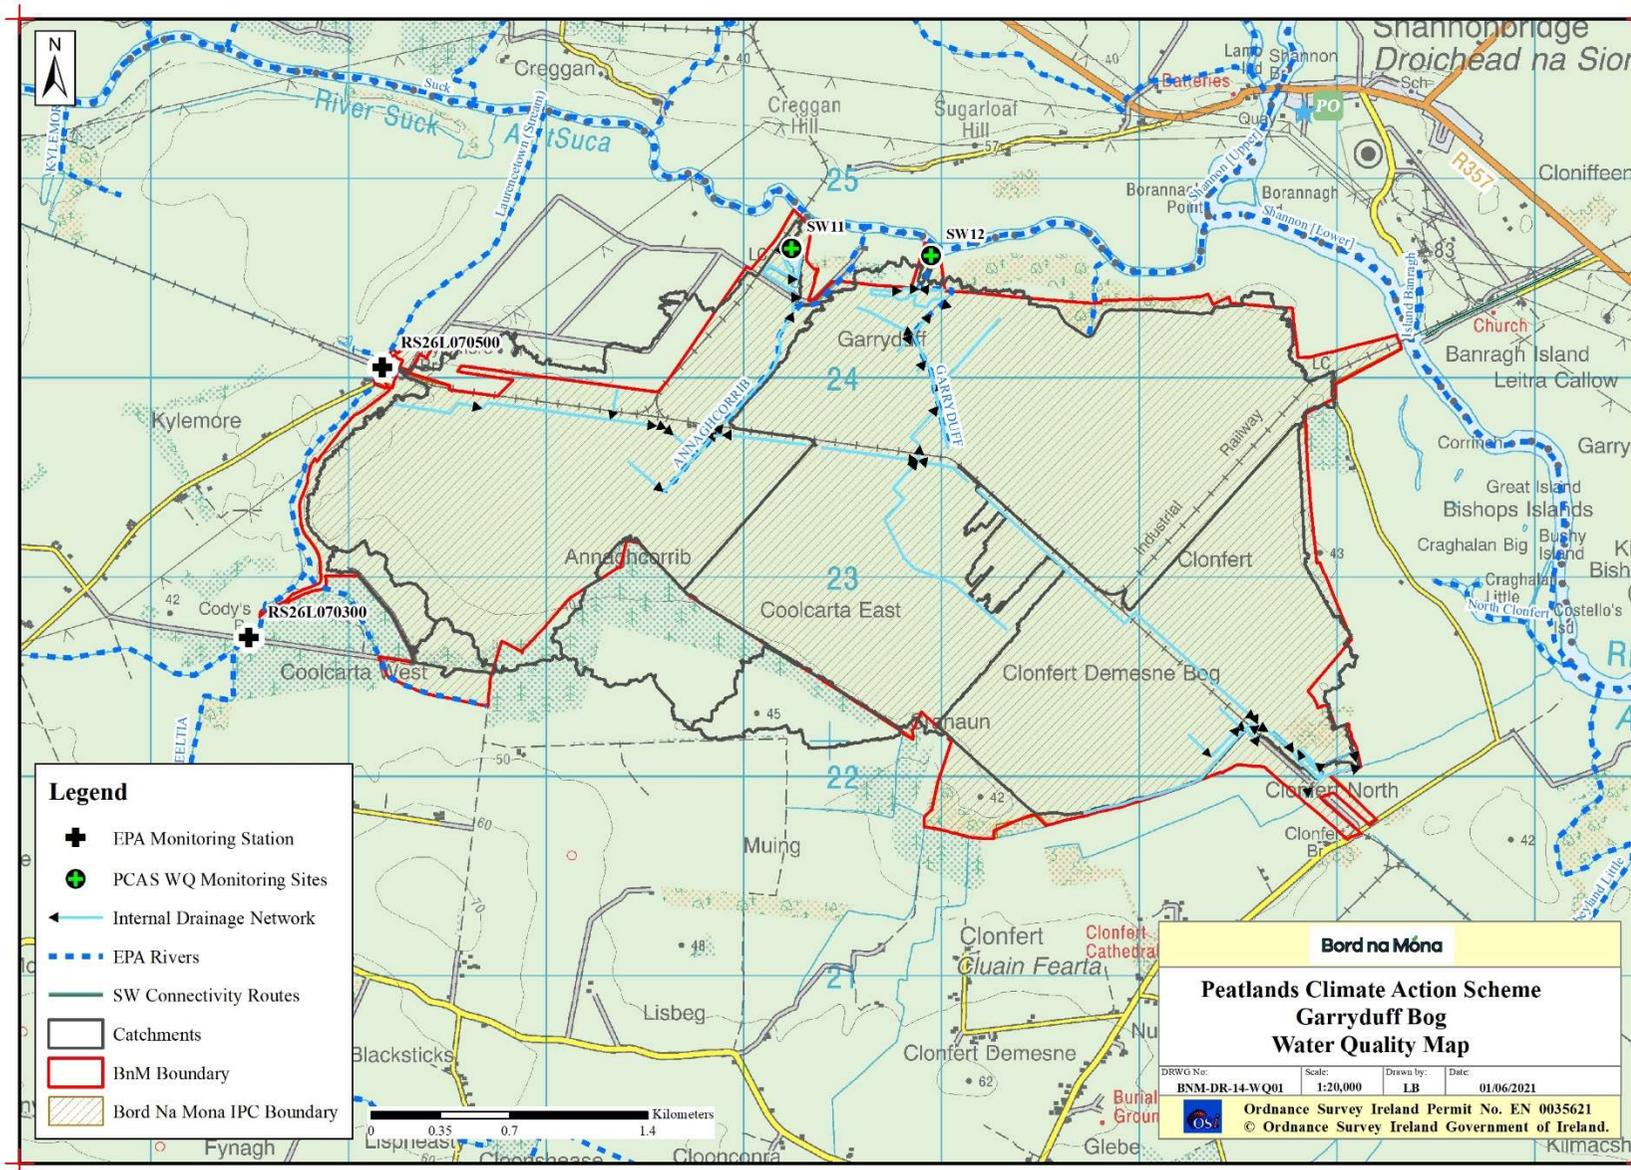
Figure 3.5. Map of Garryduff Bog showing water management features and water quality monitoring points.

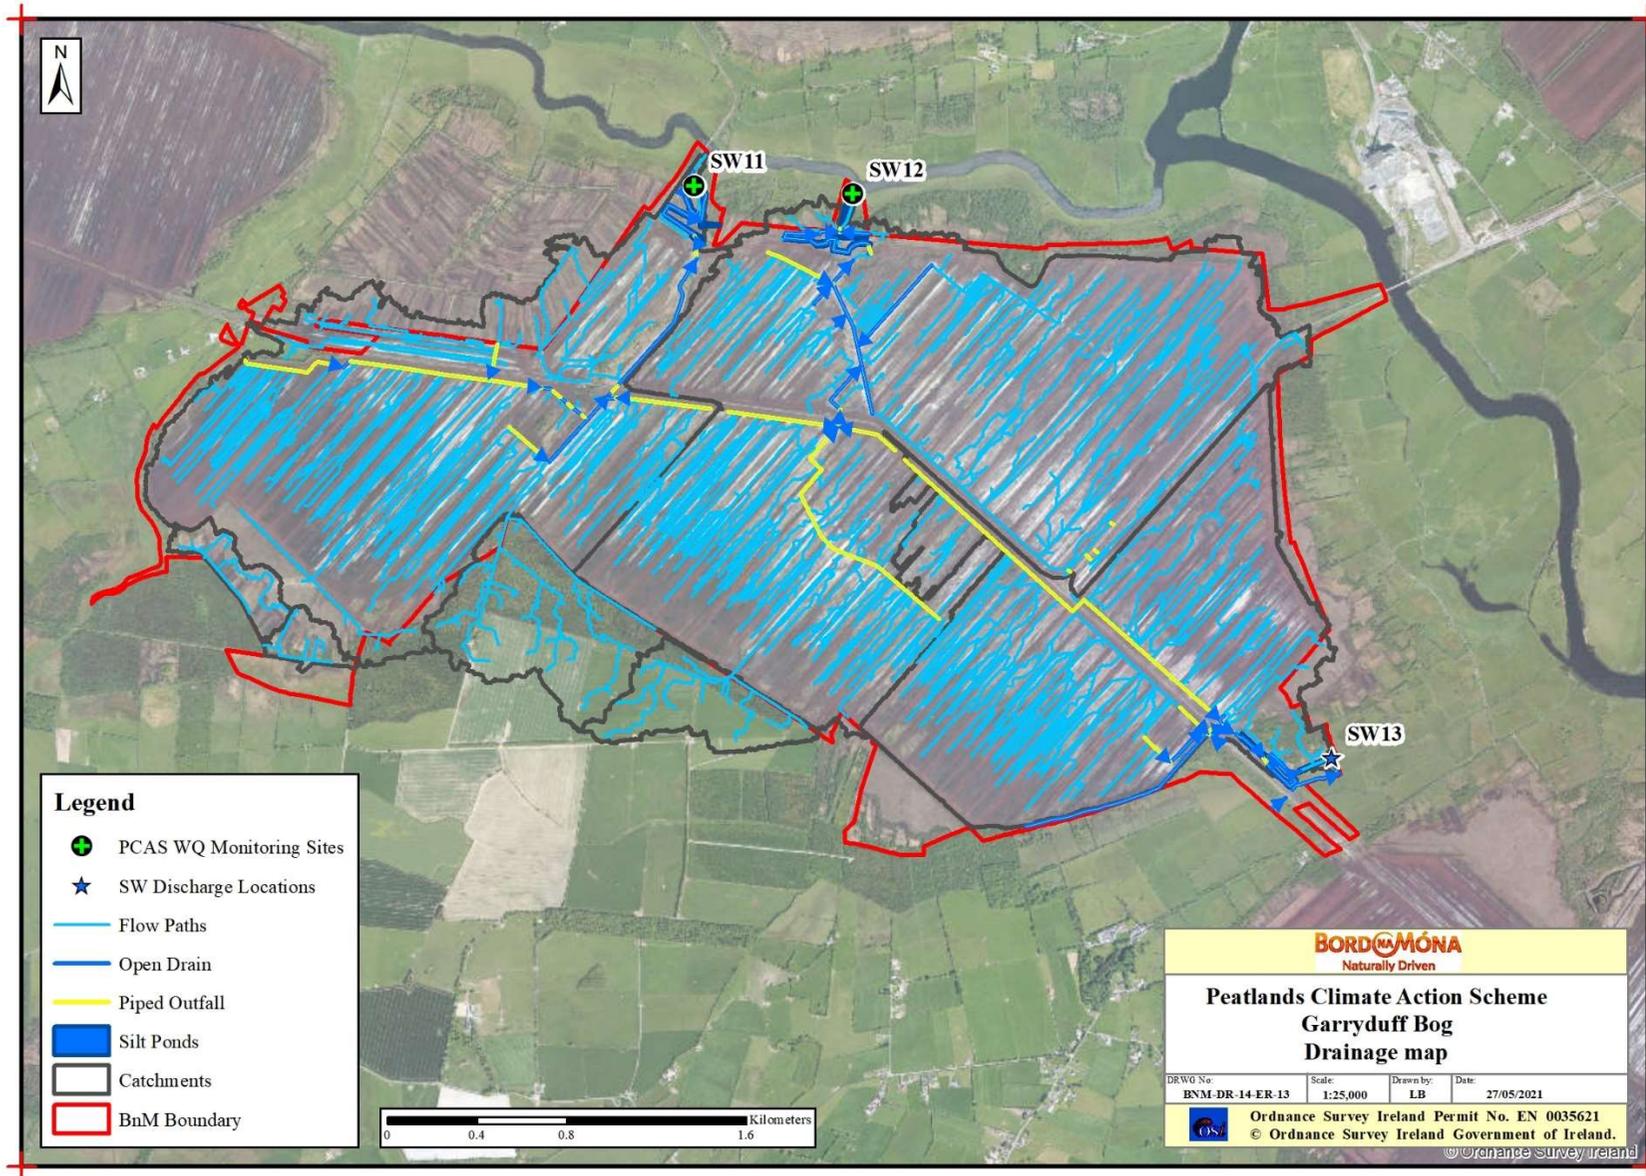
Figure 3.5a. Map of Garryduff Bog showing water management features and water quality monitoring points.

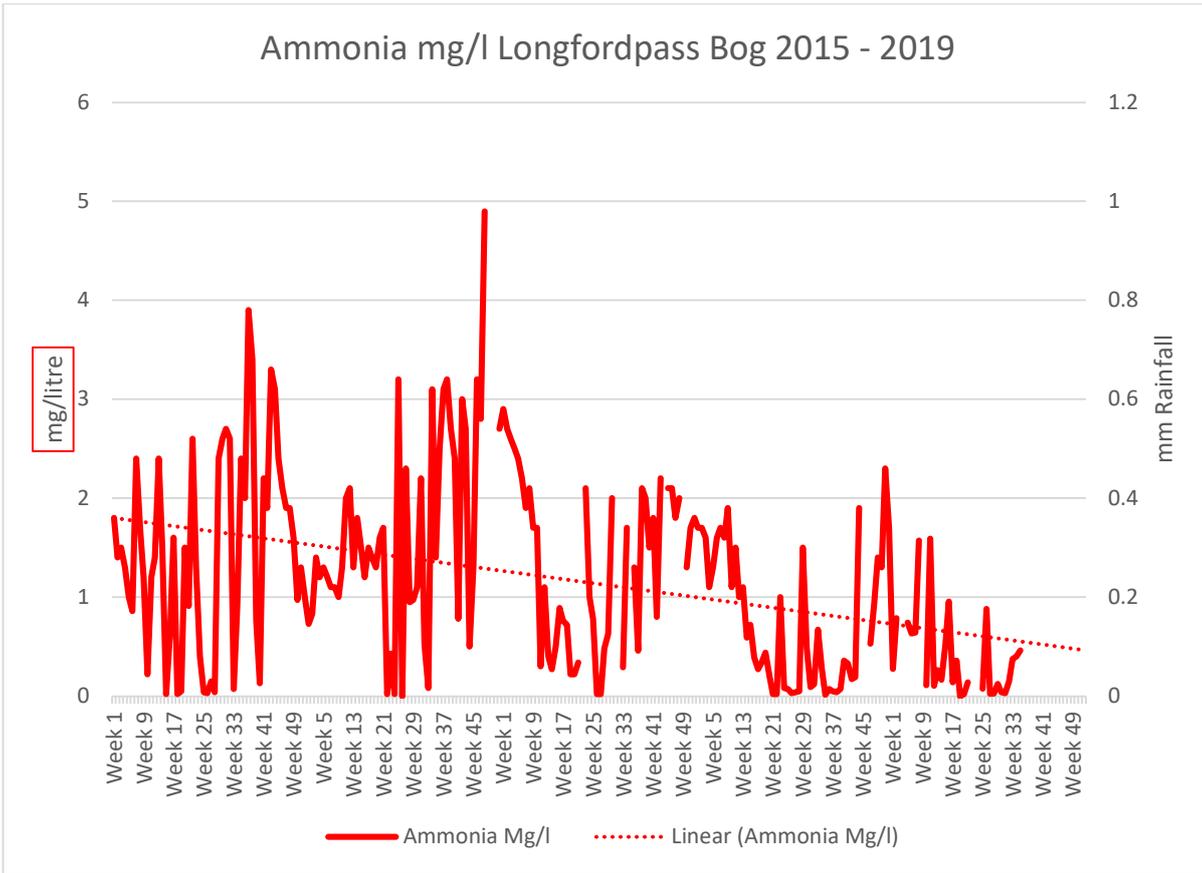
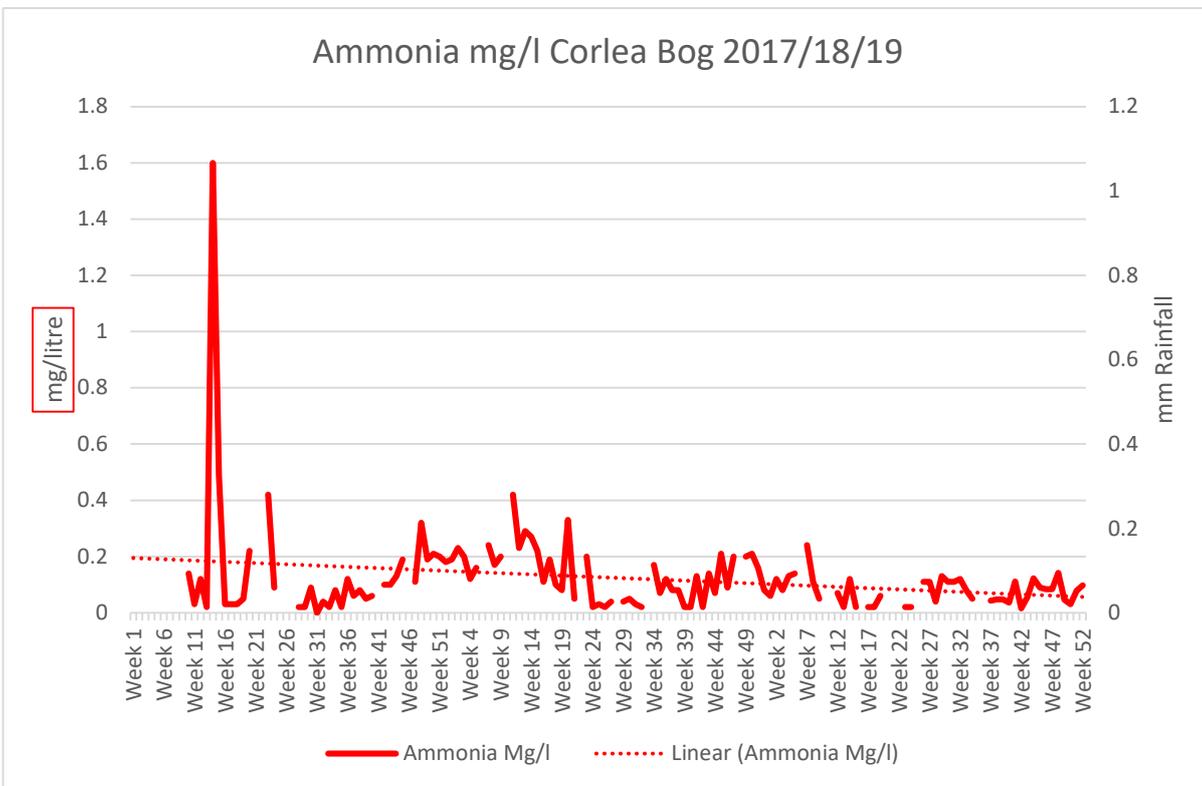
Figure 7.1. Ammonia levels at Longfordpass and Corlea Bogs.

Similarly monitoring of surface water ammonia emissions from a Corlea bog in Mountdillon over the past 3 yrs. post cessation of peat extraction with ongoing rehabilitation, indicate downward trends.

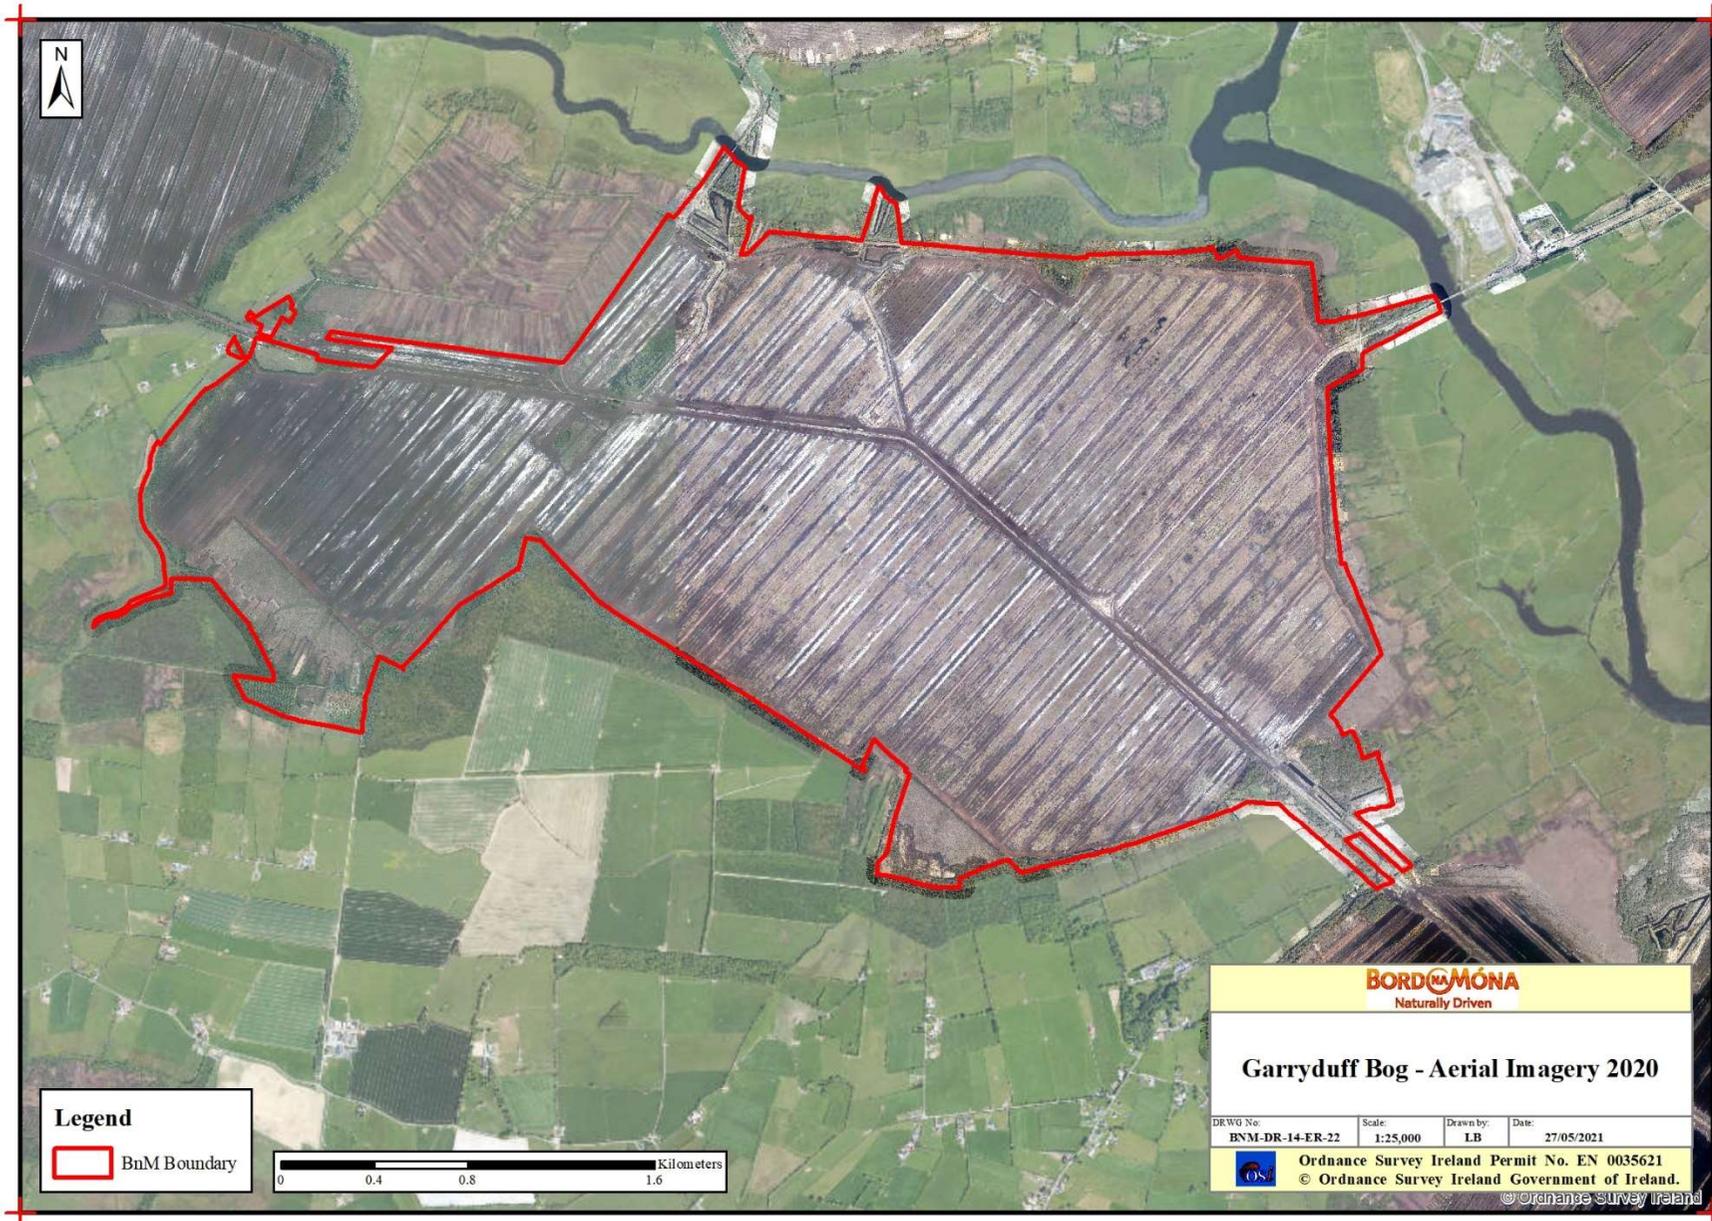
Figure 8.1 Aerial photo of Garryduff Bog. The whiteness present in the aerial photo north of the railway is exposed calcareous marls.

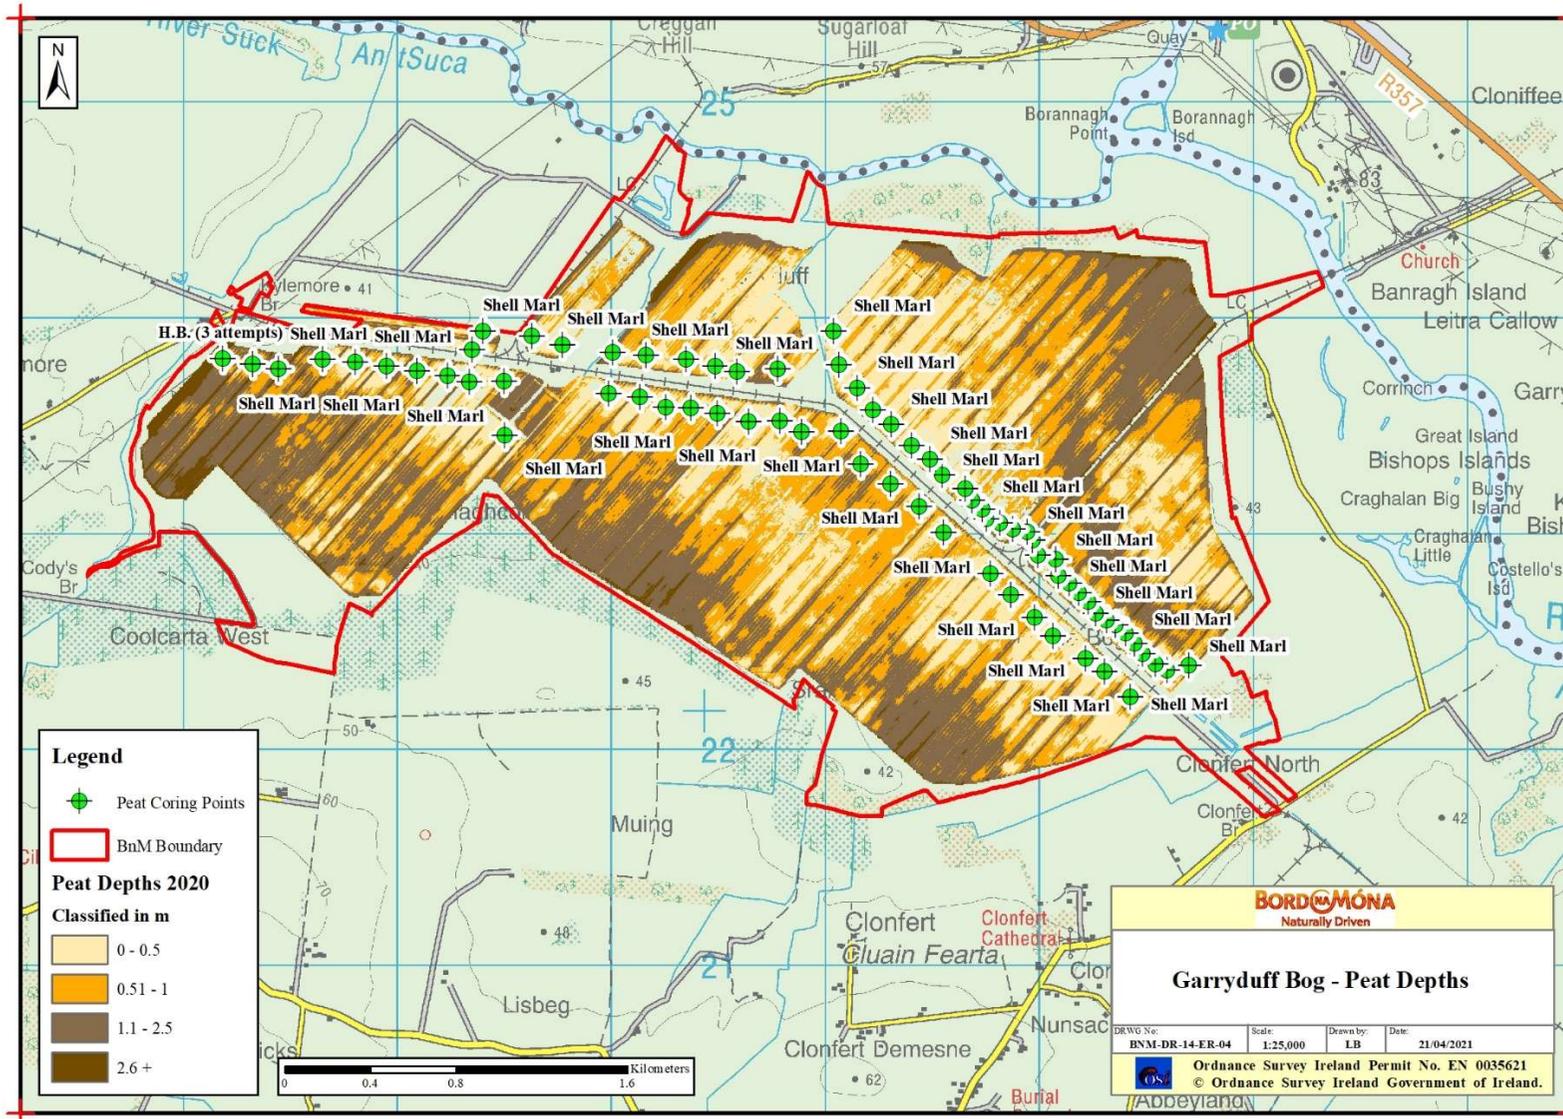
Figure 8.2. Peat Depth Map for Garryduff Bog. Deep peat reserves remain in the west of the bog areas, the peat over the remainder of the site has been harvested resulting in shallower peat reserves.

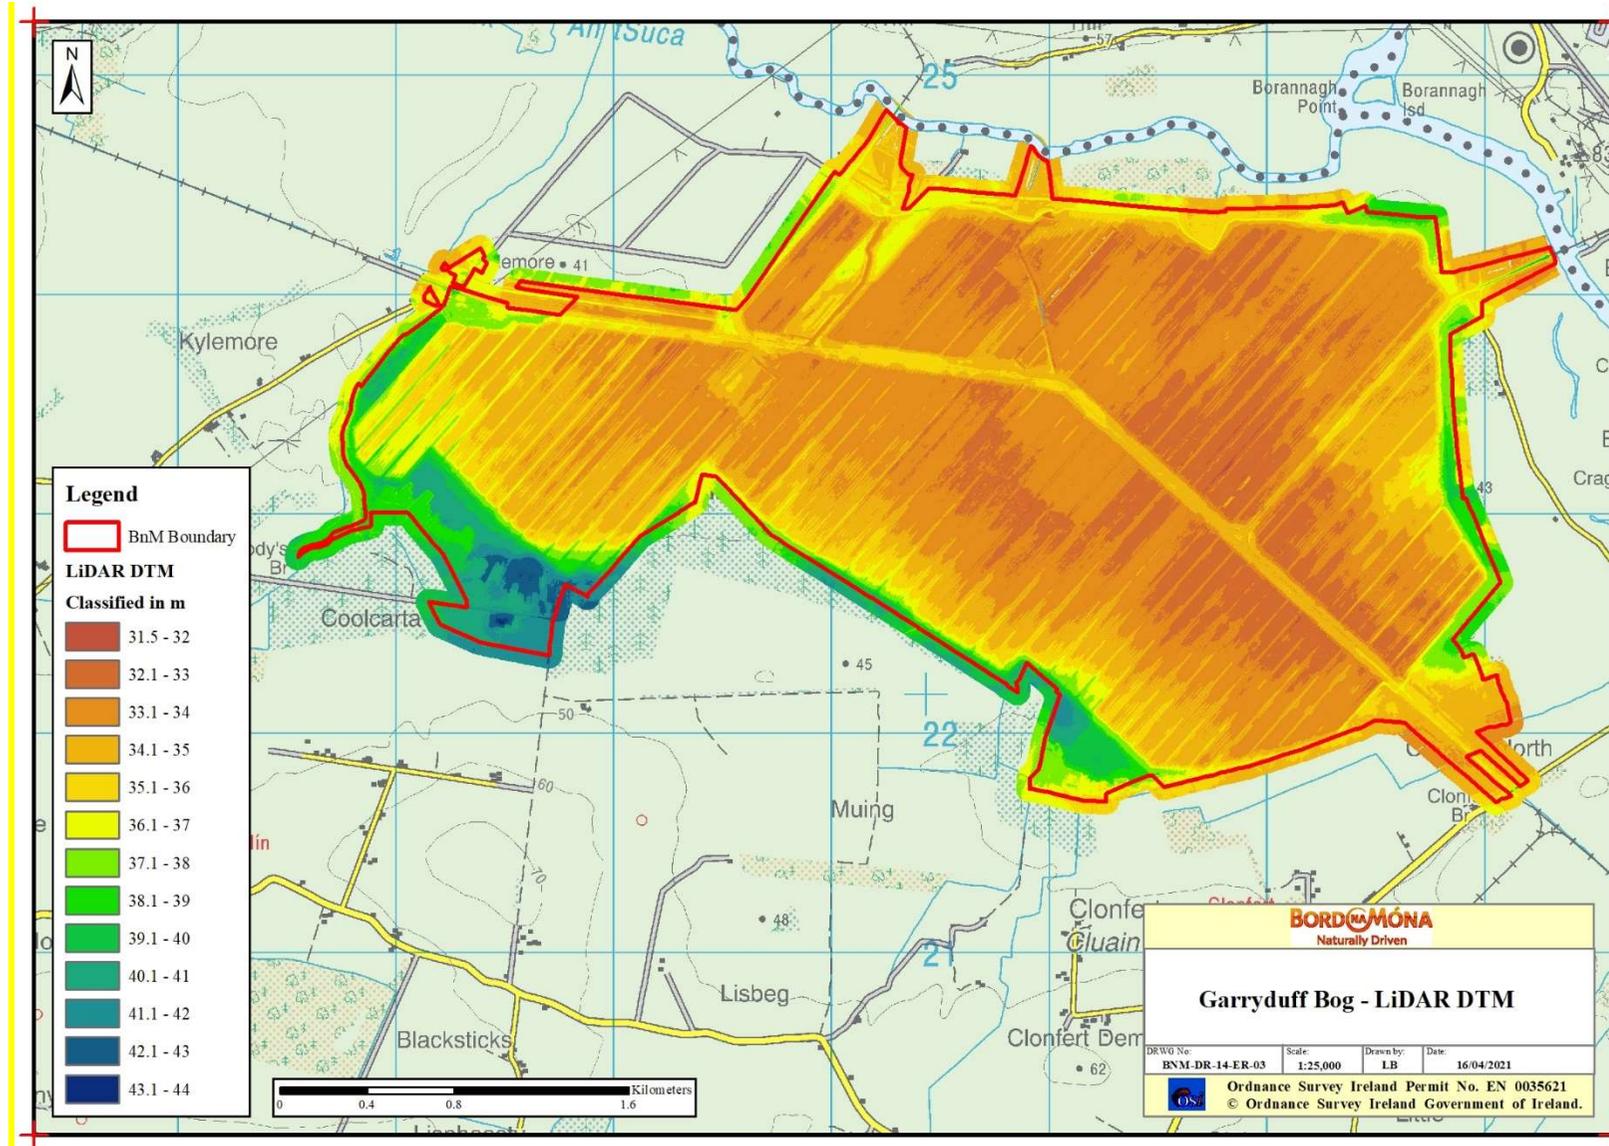
Figure 8.3. LIDAR topography map of Garryduff Bog. Low areas and basins are orange-yellow, more elevated areas are blue-green.

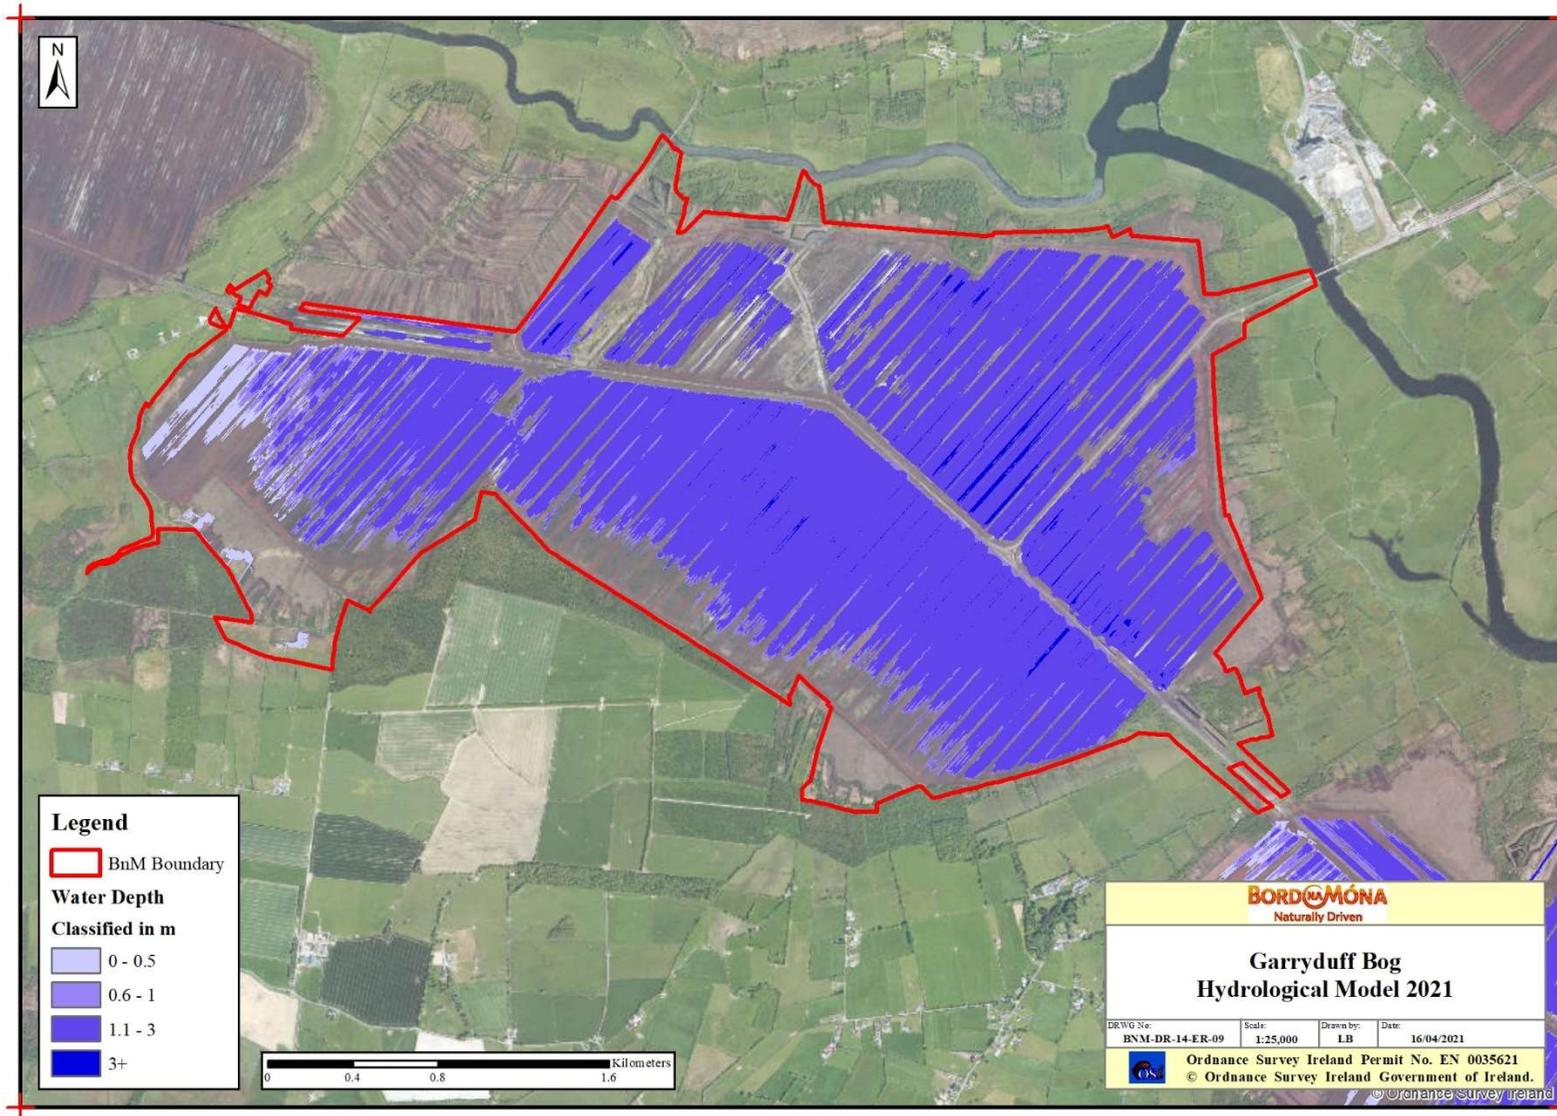
Figure 8.4. Hydrological model of Garryduff Bog. This shows expected water depths showing range of expected water depths based on current topography in the winter if pumps are turned off.

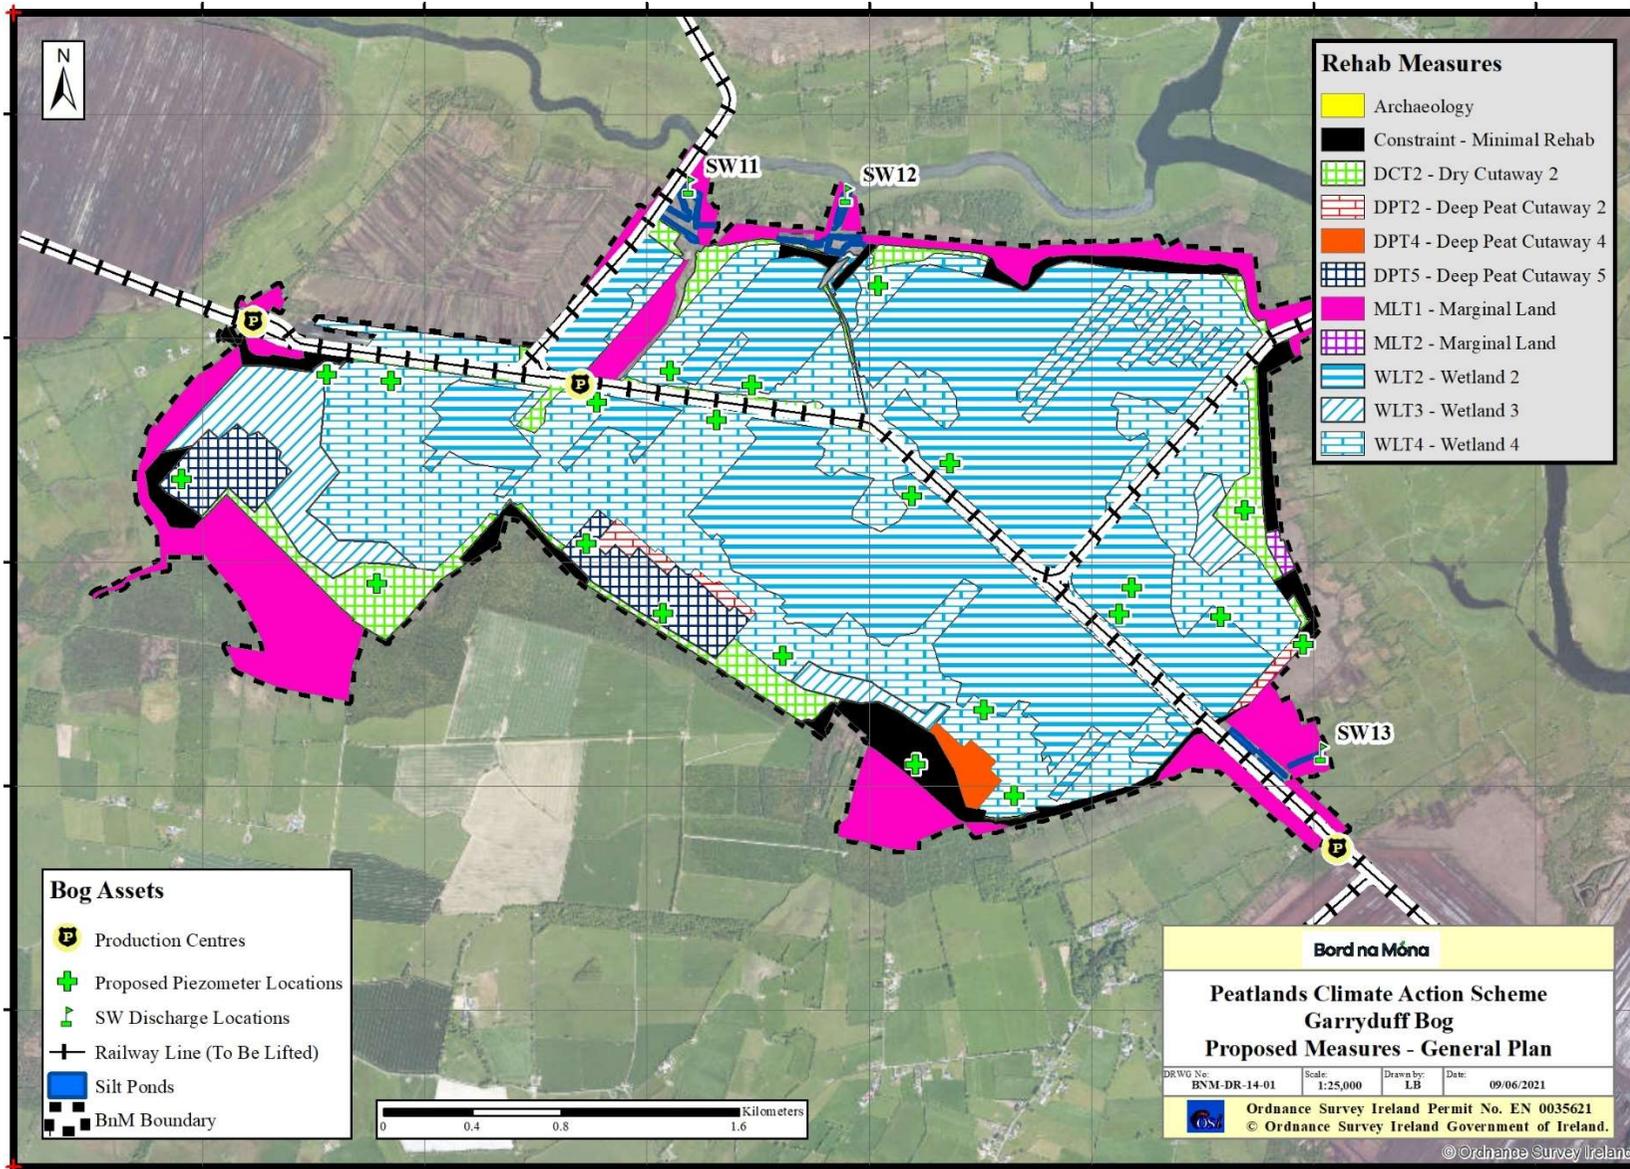
Figure 8.5. Indicative Enhanced Rehabilitation Plan for Garryduff Bog. Note that the types of rehab and areas of rehab may change in response to stakeholder consultation and refinement of the enhanced rehabilitation measures.
