Garryduff Bog

Cutaway Bog Decommissioning and Rehabilitation Plan 2021

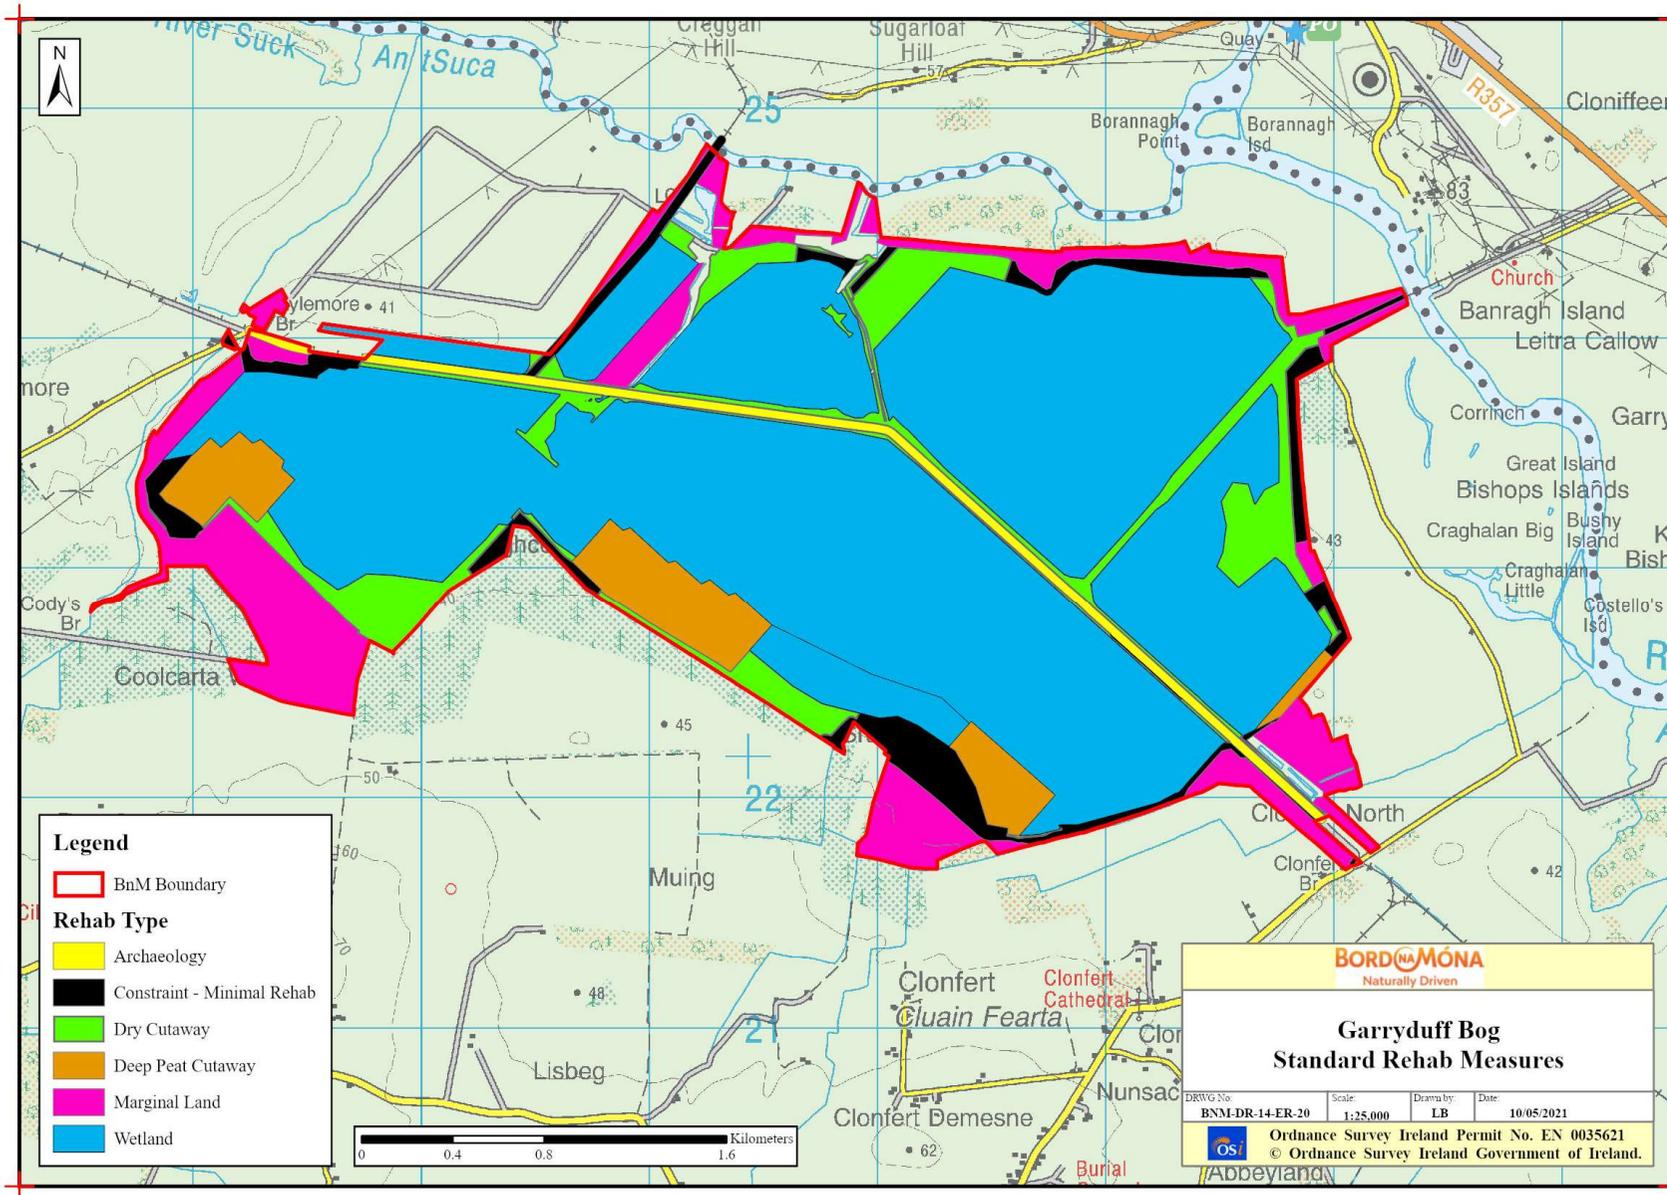
Figure Ap-1. Indicative adapted standard rehabilitation plan for Garryduff Bog.

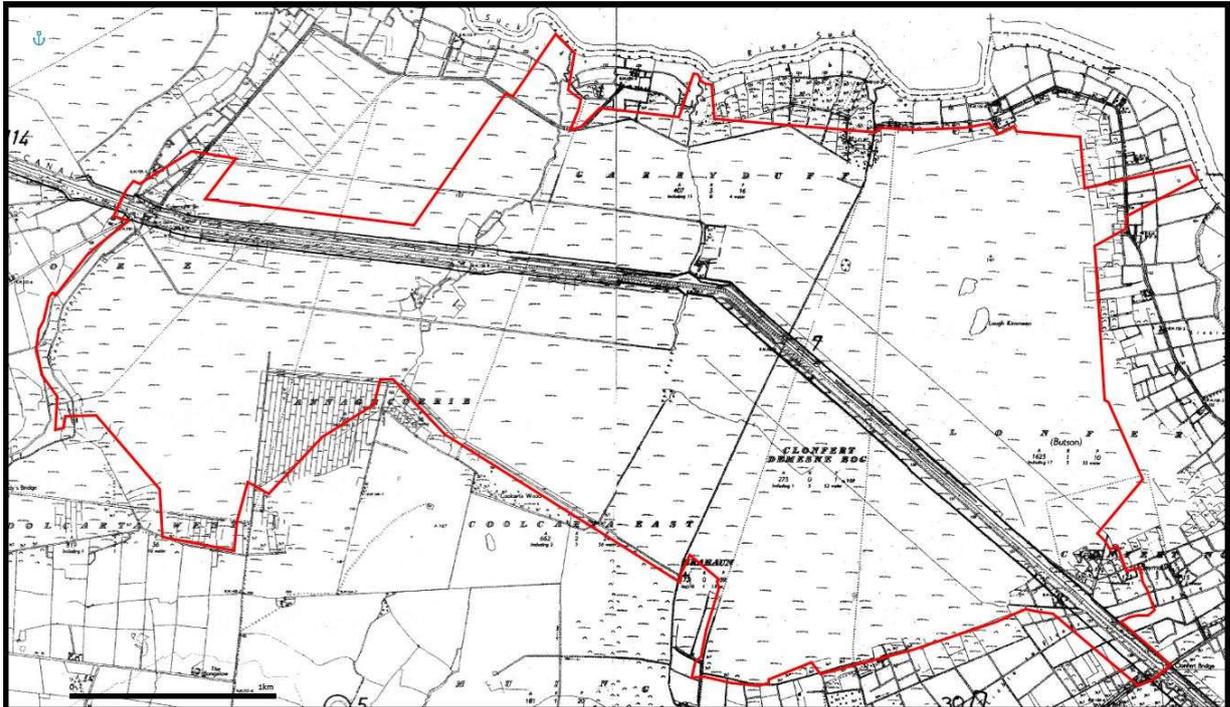
Fig. 1. Garryduff Bog, Co. Galway, detail of the Record of Monuments and Places map sheets Nos. 100 and 101. The proposed rehabilitation area is outlined with the red line. There is one Recorded Monument in the area.

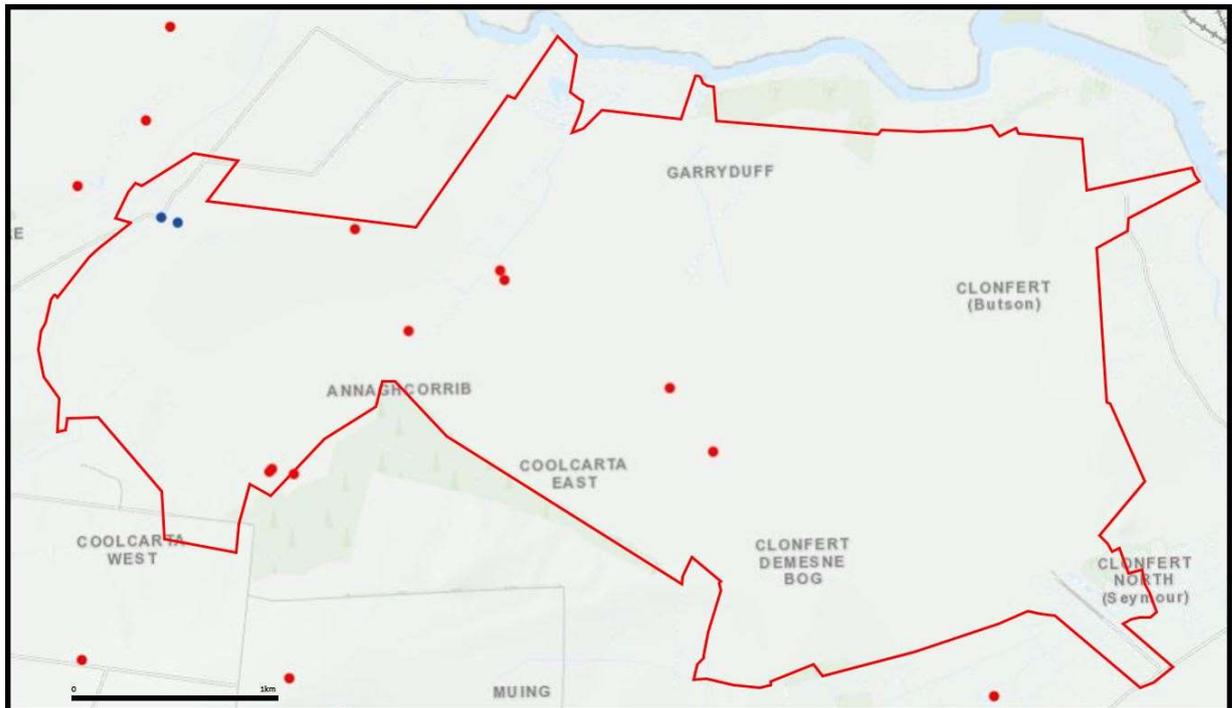
Fig. 2. Garryduff Bog, Co. Galway, detail of the Sites and Monuments Record. The proposed rehabilitation area is outlined with the red line. There are 10 SMRs in the area.
