# **Castlegar Bog**

## **Cutaway Bog Decommissioning and Rehabilitation Plan 2021**

This document seeks to address the requirements of Condition 10.2 of IPC License Ref. P0502-01:

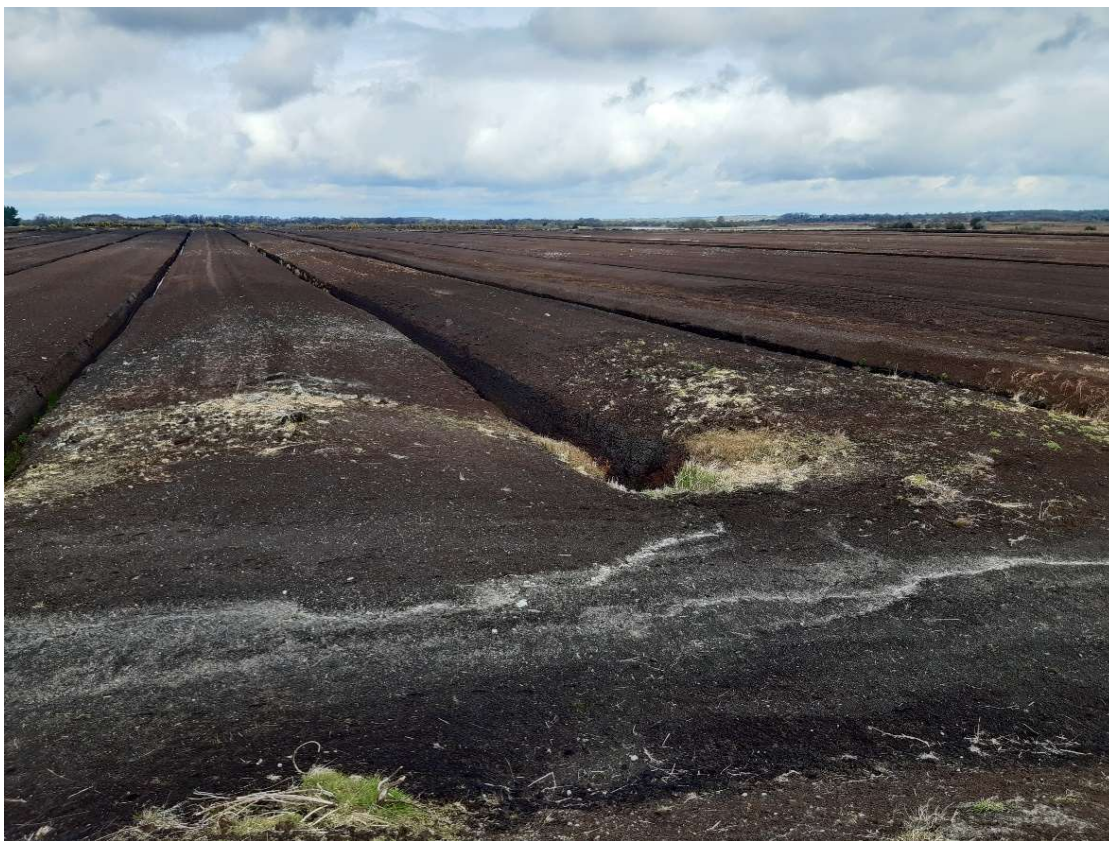
*Figure 3.3. View of the typical milled peat surface with existing drainage across Castlegar Bog*

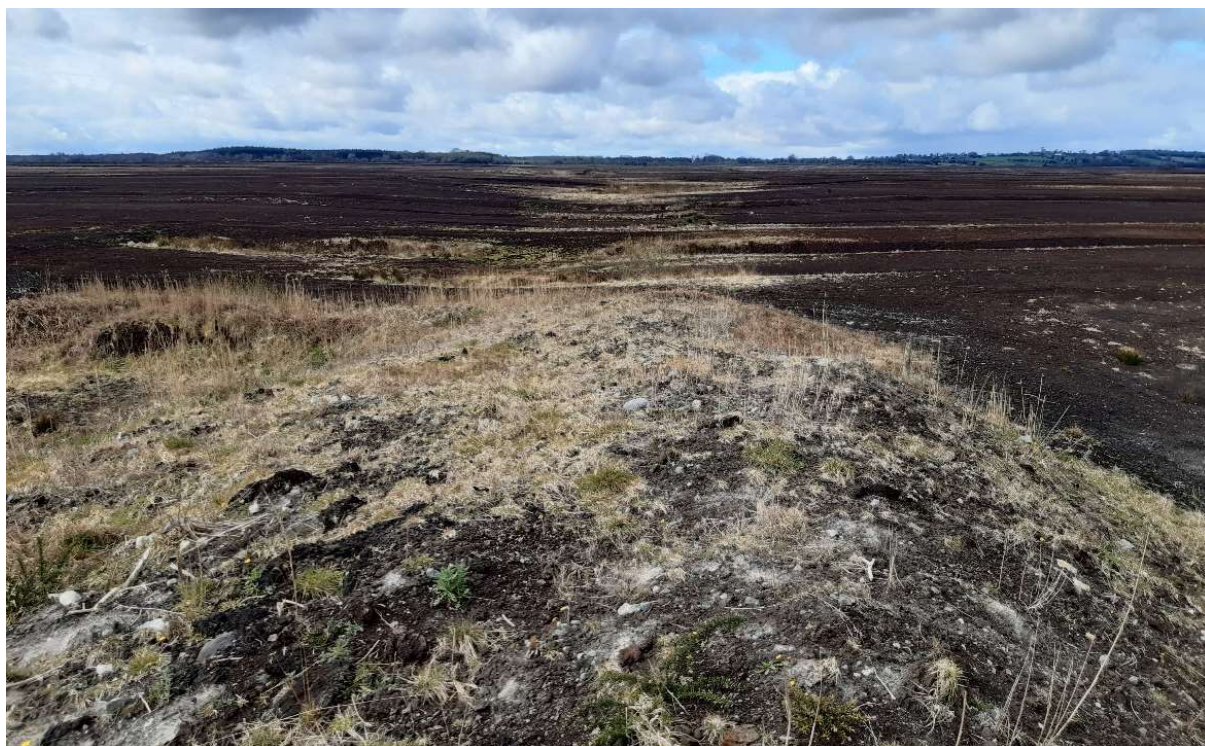
Figure 3.4 View of former water-course (now piped); course still indicated by vegetation patterns
