Clooniff Bog

Cutaway Bog Decommissioning and Rehabilitation Plan 2021

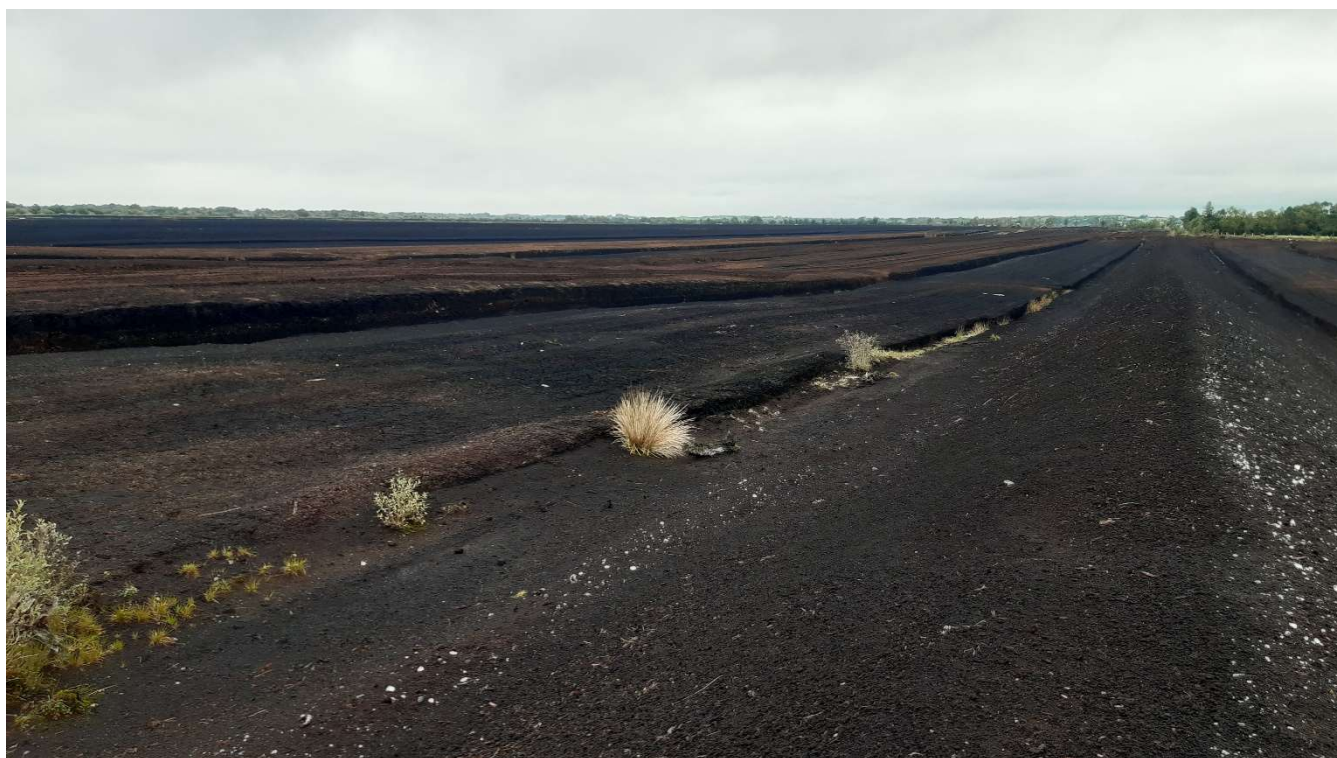
Figure 3.3. View of the typical milled peat surface with existing drainage across Clooniff Bog

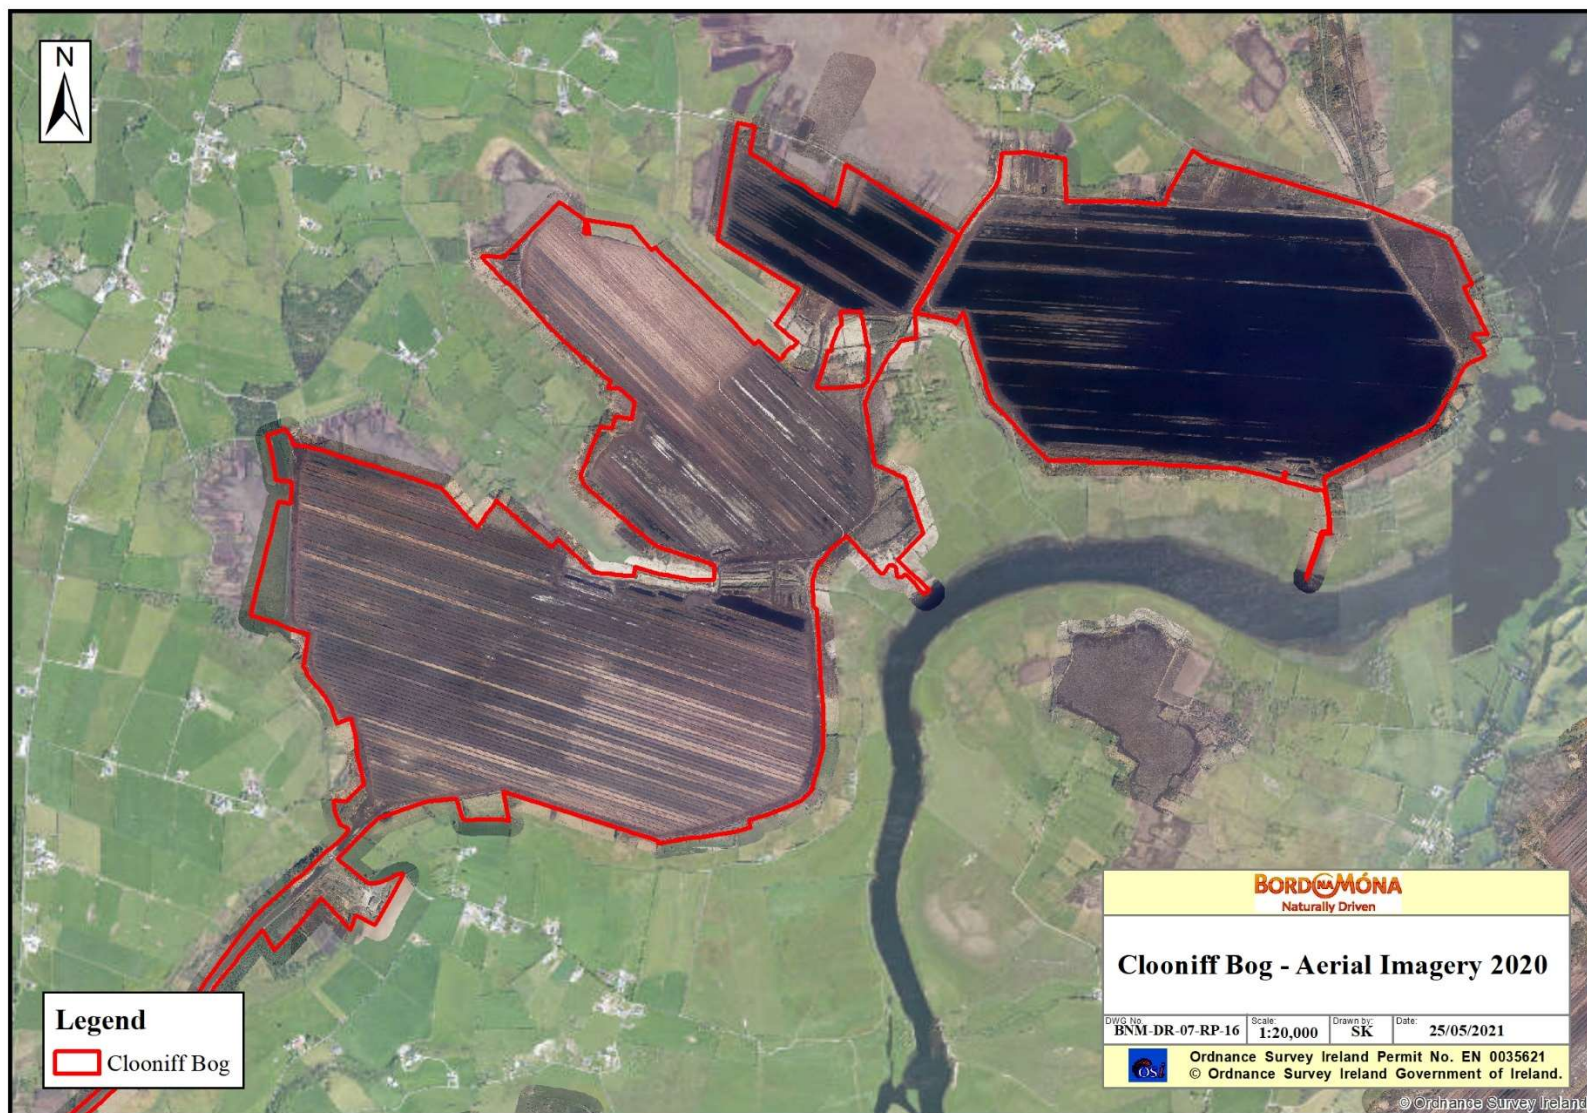
Figure 8.1. Aerial photo of Clooniff Bog. The majority of the bog is bare peat. The northern bog (Coolumber) has already re-wetted and water levels reflect winter conditions.
