# Bord na Móna

## Bloomhill Bog

**Cutaway Bog Draft Decommissioning and Rehabilitation Plan  
2021**

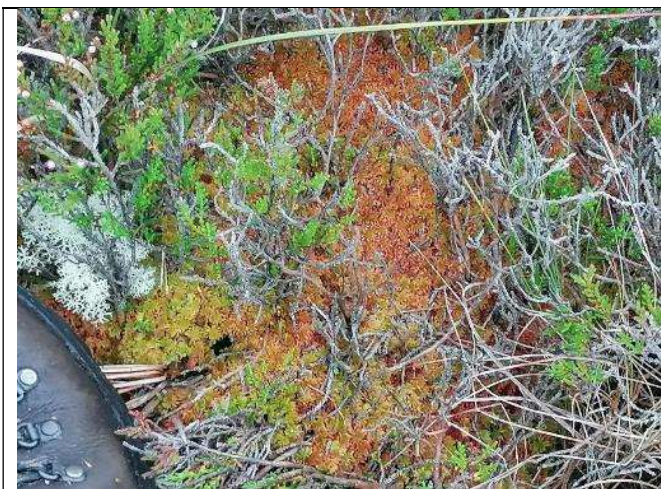
*Sphagnum mounds present in remnant high bog in Bloomhill*

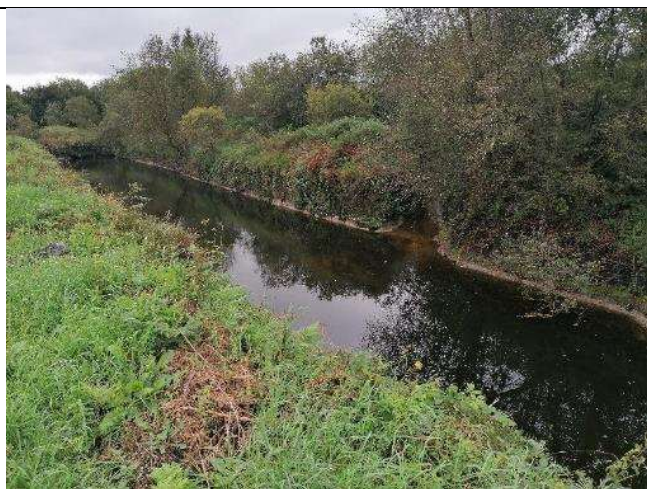
*View of typical silt ponds in Bloomhill*

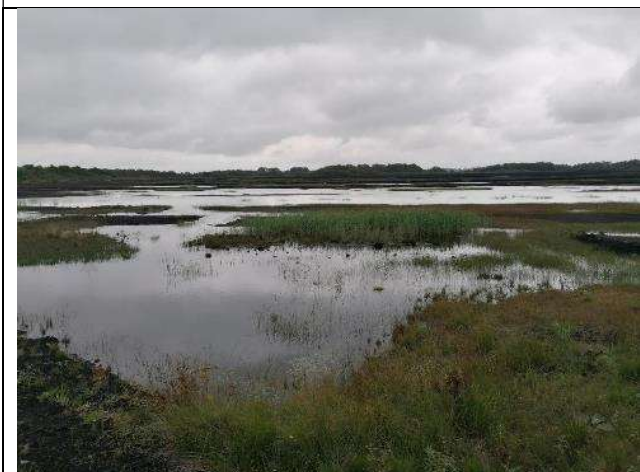
*View of wetland at Bloomhill*

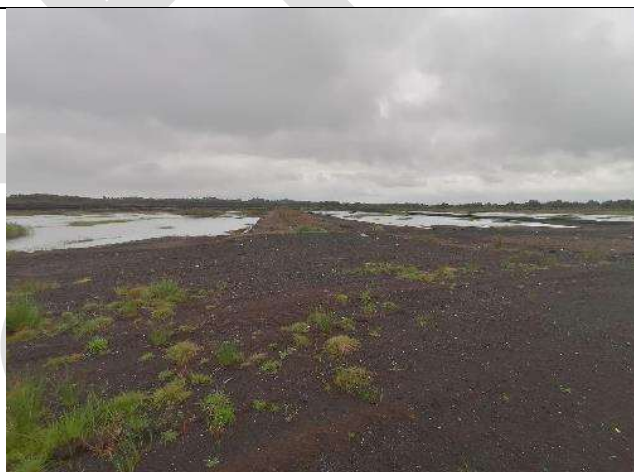
*Bare peat and wetland habitat at Bloomhill former production area*

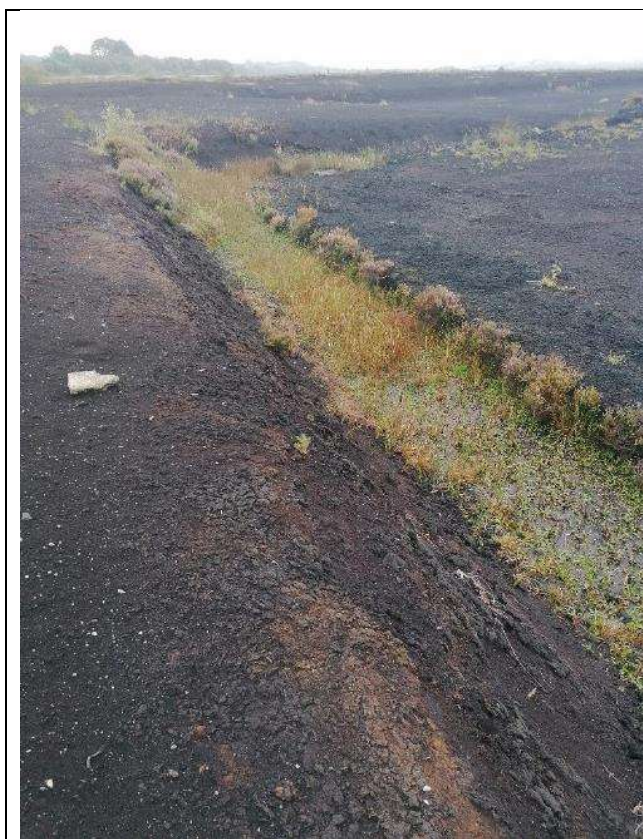
*Bloomhill Bog drain in-filling with wetland vegetation*

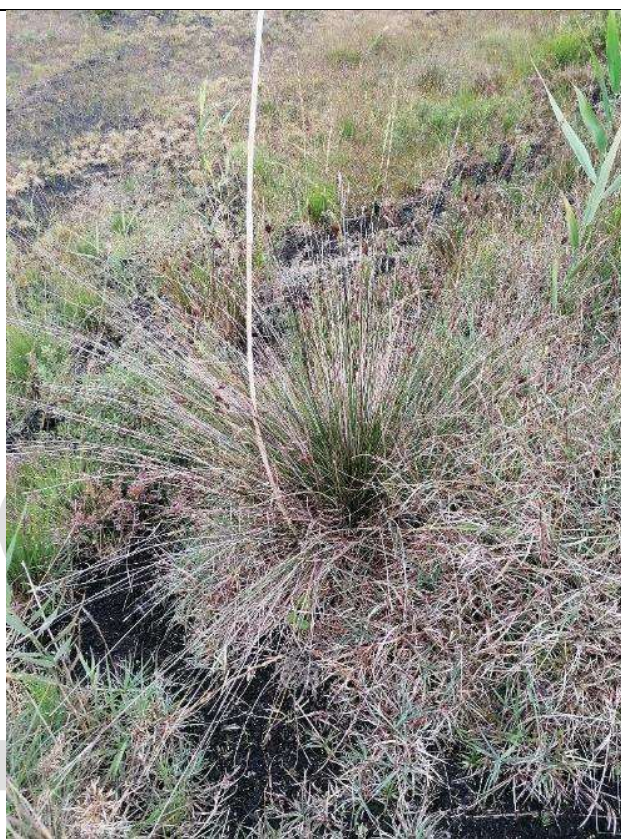
*Black Bog Rush in wetlands in Bloomhill*
