Bord na Móna

Bunahinly-Kilgarvan Bog

**Cutaway Bog Decommissioning and
Rehabilitation Plan
2021**

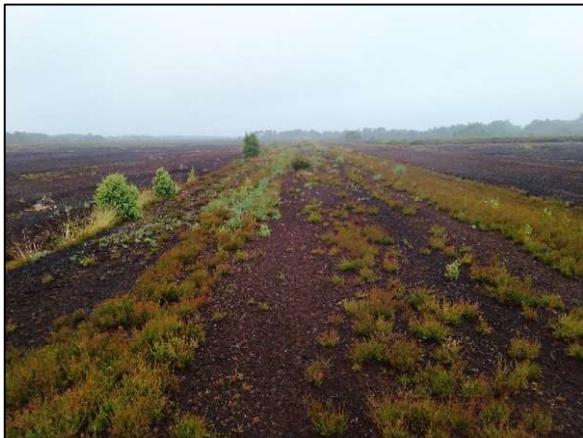
Pioneering vegetation on Cutover Bog at Bunahinly

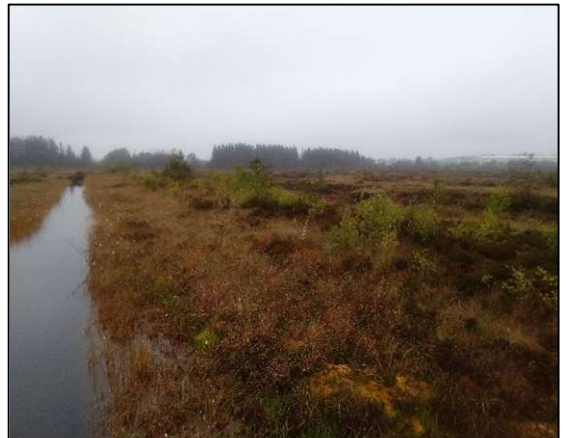
Rehabilitated cutover Bog at Bunahinly

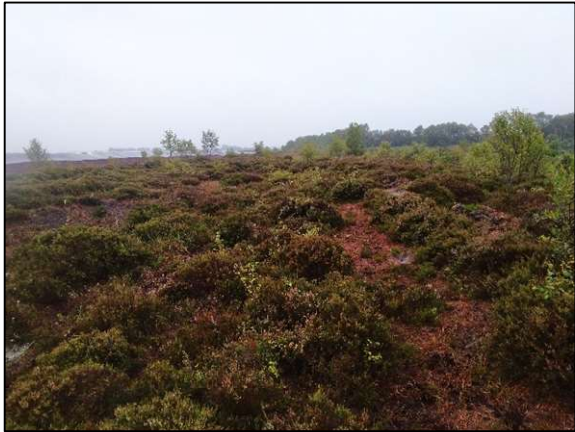
Pioneering Heath along margin of former production area at Kilgarvan

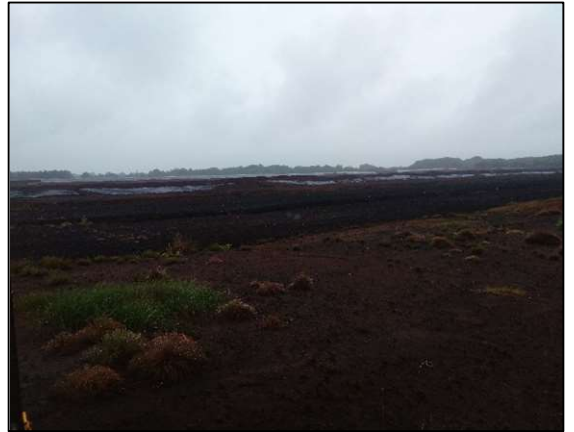
Bare Peat and extant stock at Kilgarvan
