Bord na Móna

Carranstown Bog

Cutaway Bog Decommissioning and Rehabilitation Plan 2021

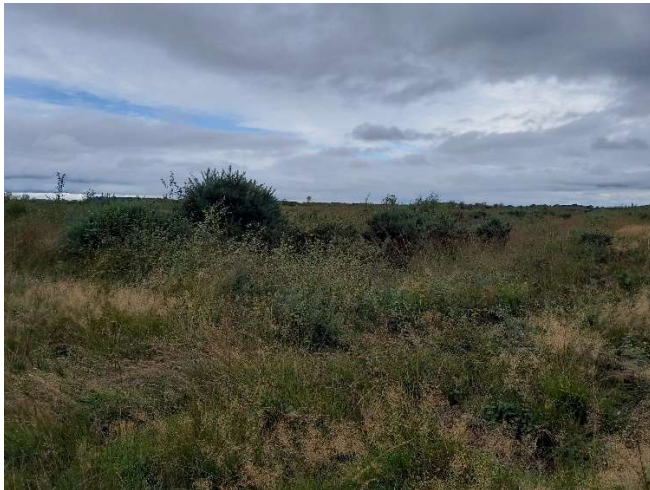
Pioneering vegetation on cutaway including Scrub and Soft Rush dominated Poor fen (Sept 2021)

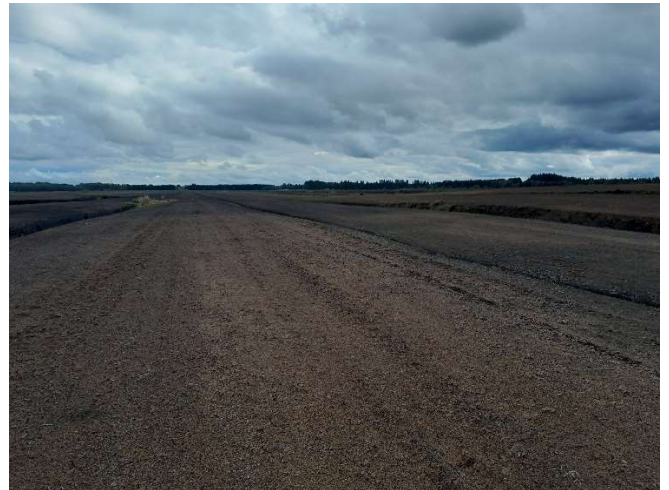
Bare Peat at Carranstown (Sept 2021)

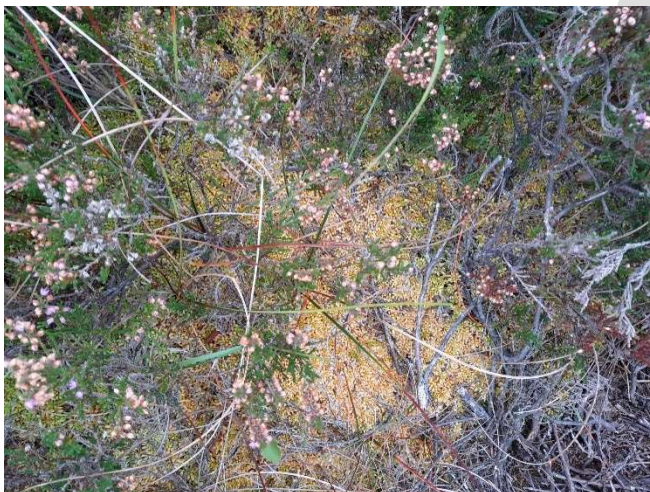
Sphagnum recolonization within Dry Heath at Carranstown (Sept 2021)

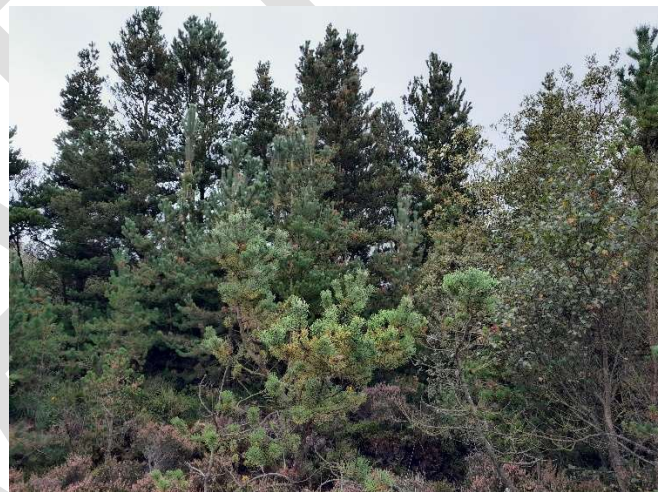
Birch woodland (WN7) (on cutover bog dominated by Birch and/or Scot's Pine) at Carranstown Bog (Sept 2021)
