# Bord na Móna

## Kilaranny Bog

# Cutaway Bog Decommissioning and Rehabilitation Plan 2021

This document seeks to address the requirements of Condition 10.2 of IPC License Ref. P0500-01:

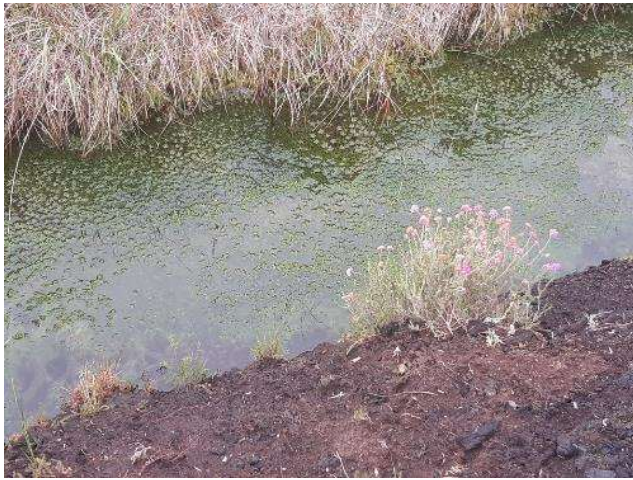
*Sphagnum cuspidatum* present in drains in Kilaranny East

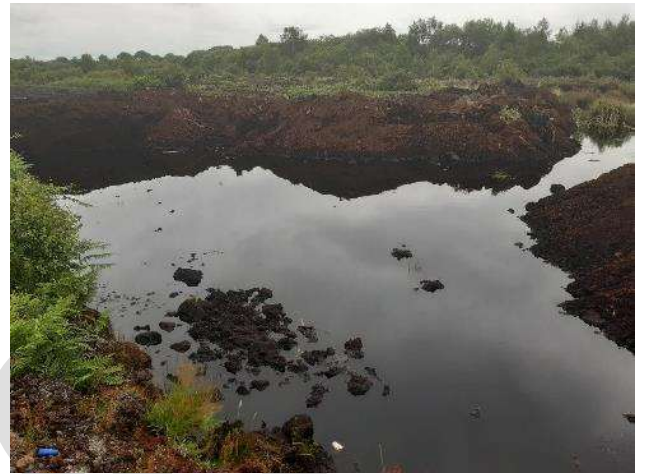
View of large drains in Kilaranny East

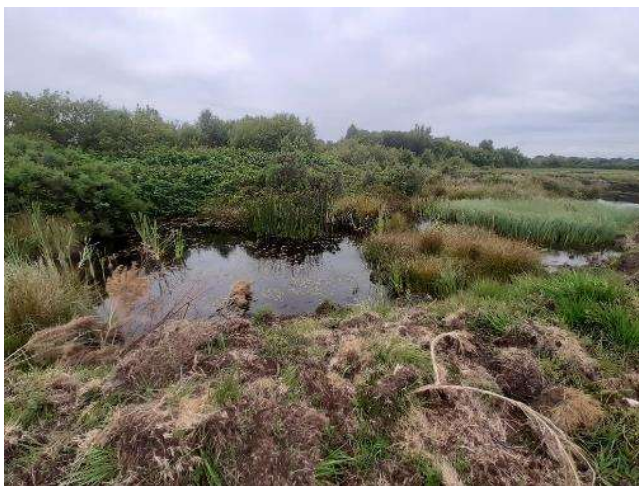
View of wetland at Kilaranny west

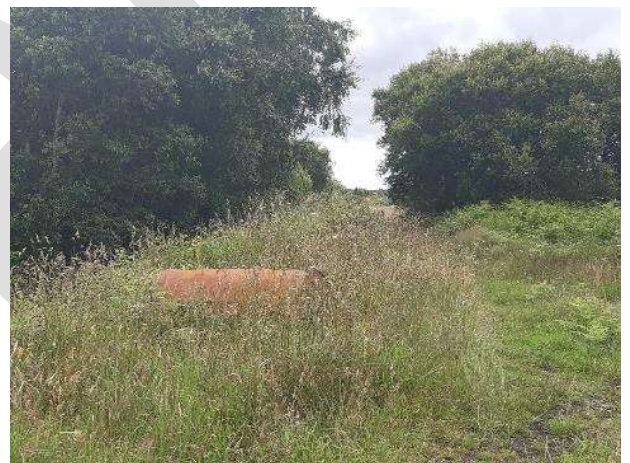
Stream surrounded by grassland and scrub, central area Kilaranny bog

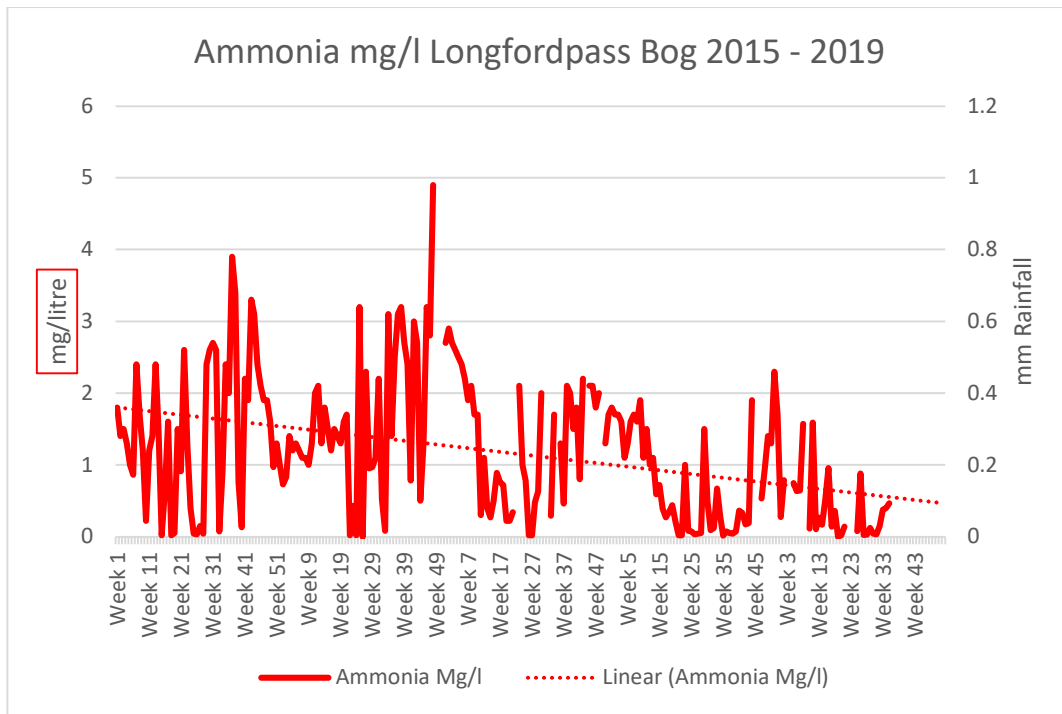
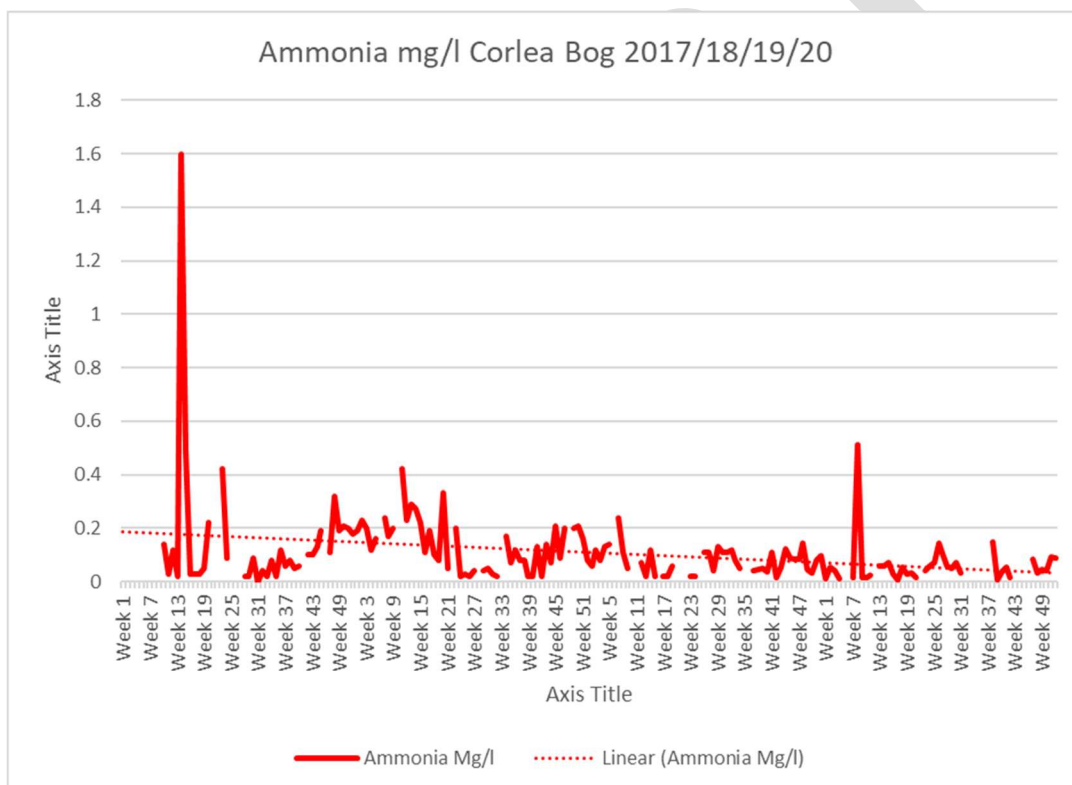
Similarly monitoring of surface water ammonia emissions from a Corlea bog in Mountdillon over the past 3 yrs. post cessation of peat extraction with ongoing rehabilitation, indicate downward trends.

Figure 7.1. Ammonia trends at Longfordpass and Corela 2015-2019.

As the monthly monitoring program at Kilaranny continues in 2021 during the rehabilitation works, and data from the 2020 monitoring program is compiled, further trending will be produced to verify any ongoing trends.
