Bord na Móna

Derraghan Bog

Cutaway Bog Decommissioning and Rehabilitation Plan 2022

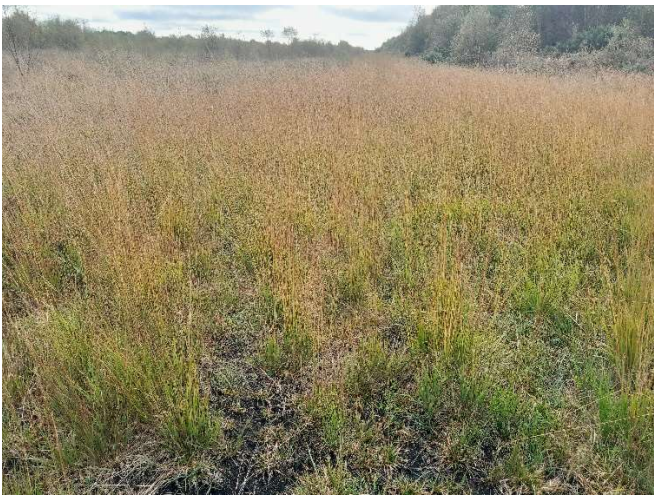
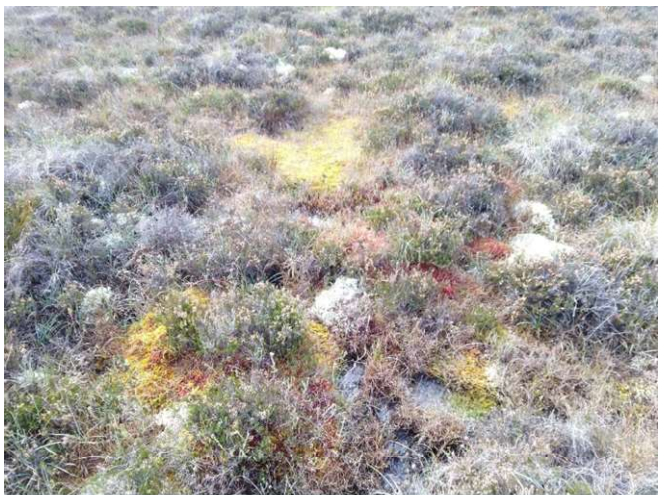
<p><i>Pioneering vegetation on cutaway including Scrub and Soft Rush dominated Poor fen (Oct 2021)</i></p>	<p><i>Sphagnum within north western Raised Bog remnant at Derraghan (Sept 2021)</i></p>

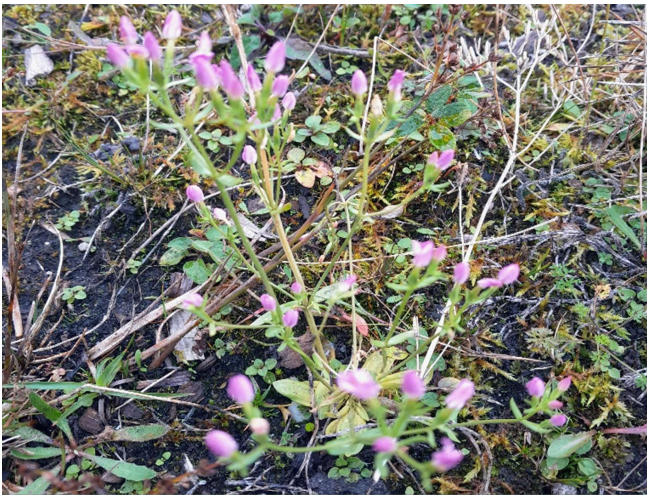
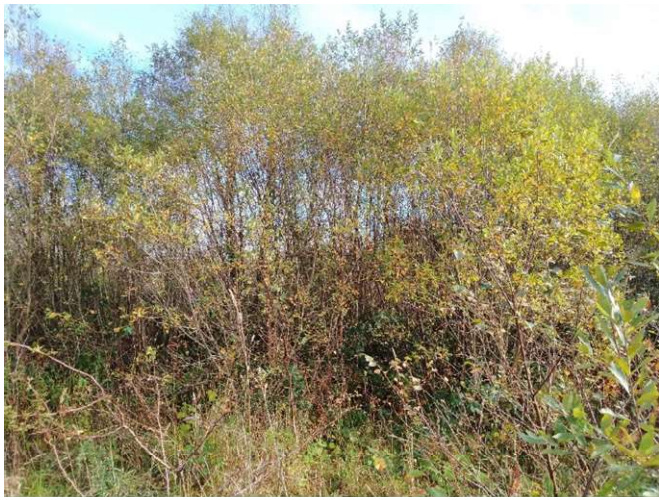
Table 1: Photos from Derraghan Bog

<p><i>Common centaury on cutaway (Oct 2021)</i></p>	<p><i>Pioneering scrub and Birch woodland (WN7) at Derraghan Bog (Sept 2021)</i></p>
