Bord na Móna

Gilltown Bog

Cutaway Bog Decommissioning and Rehabilitation Plan 2022

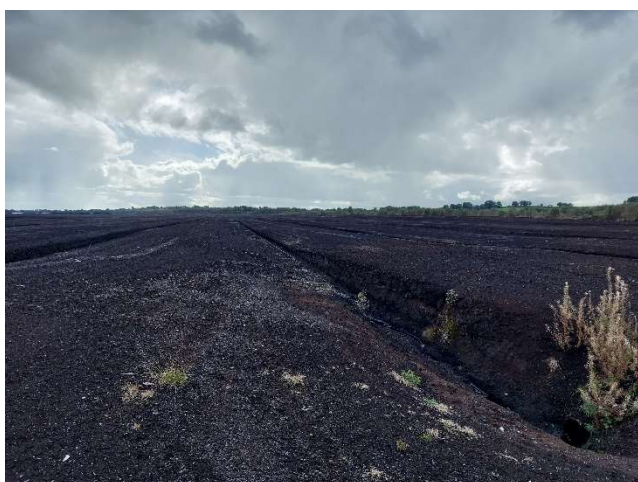
Bare Peat is the main habitat at Gilltown Bog.

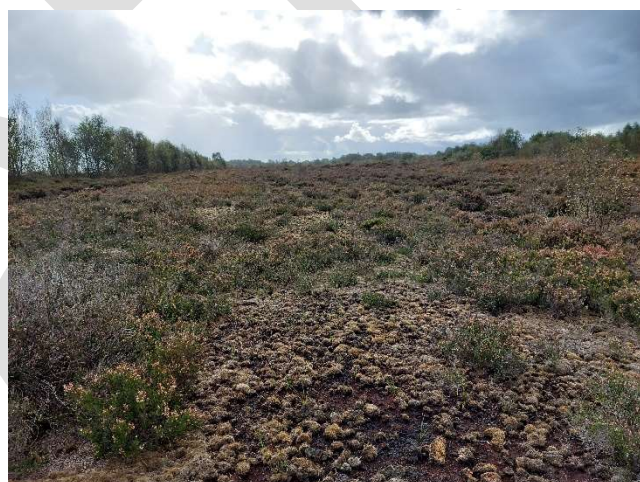
Pioneer dry Heather-dominated habitat in the western section of Gilltown Bog.

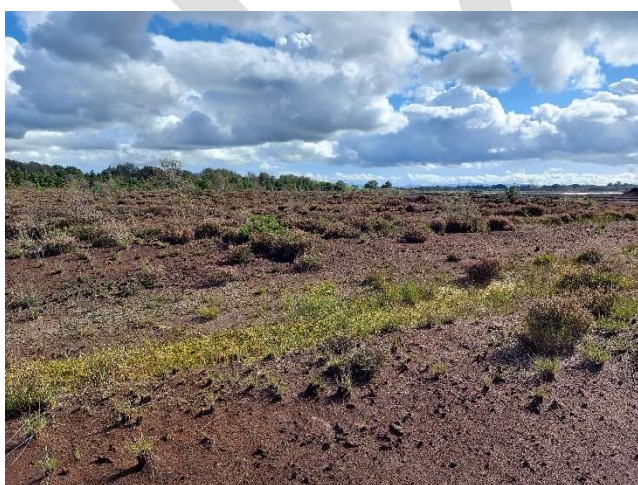
Mosaic of bare peat and Heather in the northern section of Gilltown Bog.

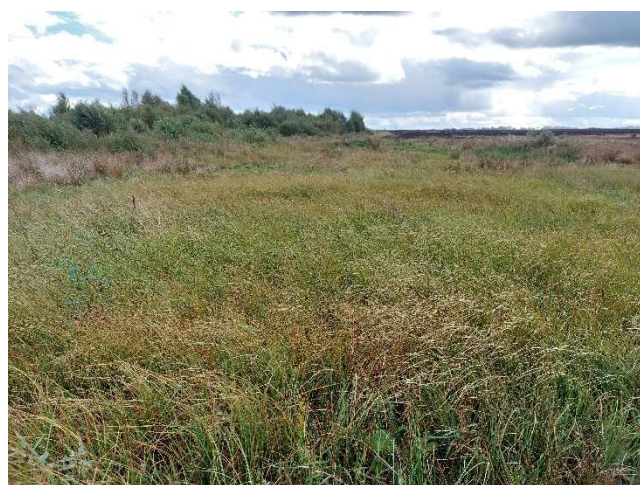
Pioneer bottle sedge dominated community in the central section of the site.

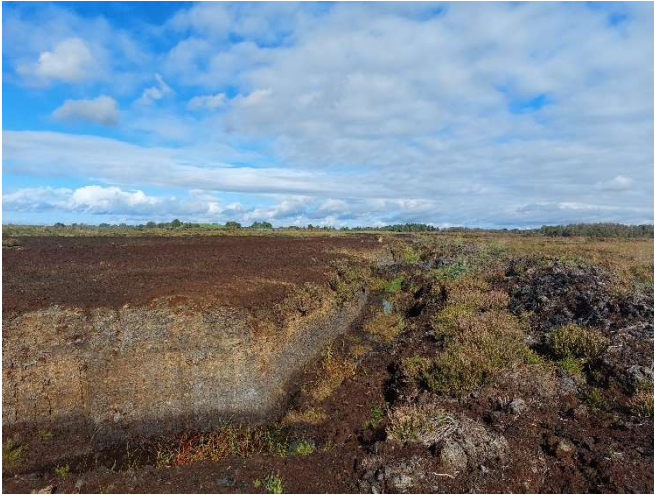
Cutover bog habitat in the north-eastern section of the site.

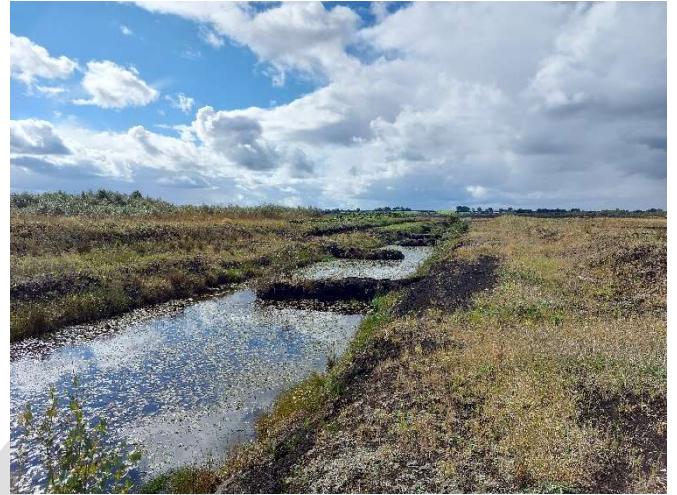
Silt pond in the centre of the site.
