Bord na Móna

Noggusboy Bog

**Cutaway Bog Decommissioning and
Rehabilitation Plan**

2022

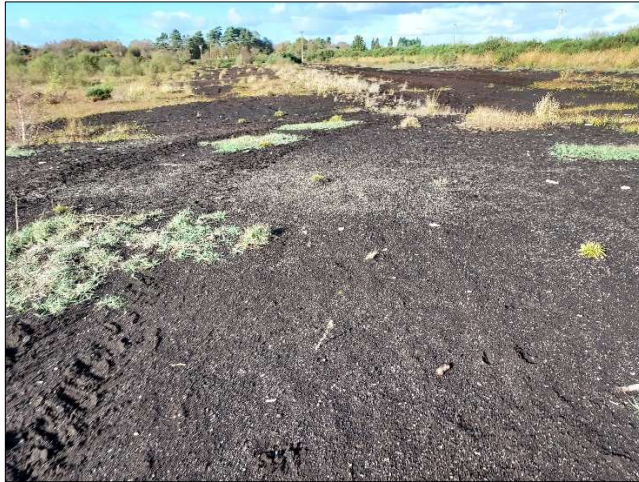
Plate 3.1 Example of cutaway bare peat and pioneering cutaway vegetation occurring within the west of the site.

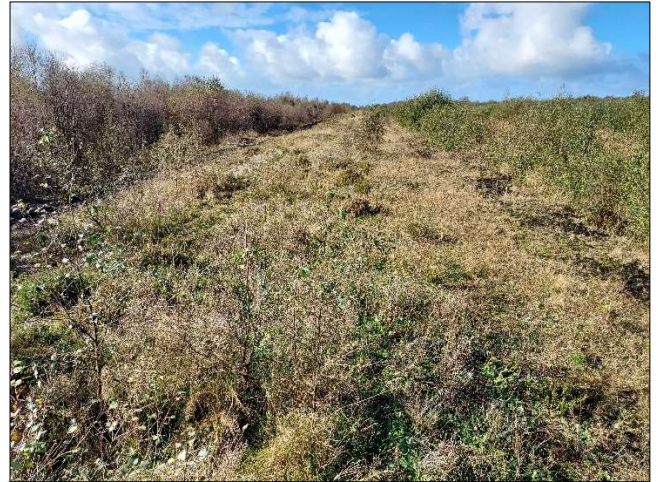
Plate 3.2 Example of developing pioneering cutaway vegetation on former cutaway production bog.

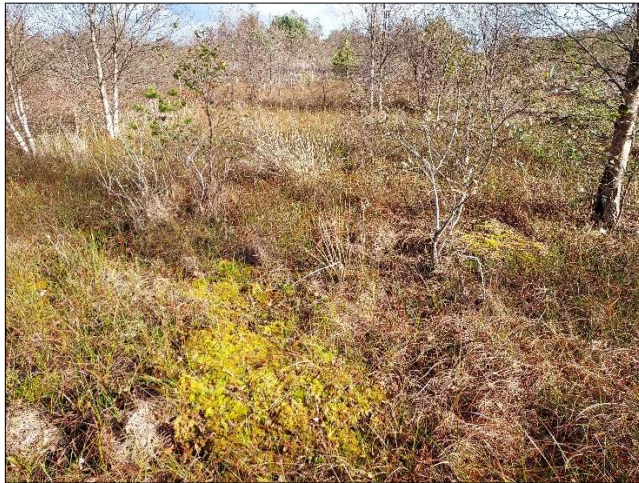
*Plate 3.3 Example of pioneering bog woodland (WN7) within the west of the site with *Sphagnum recurvum*, *S. palustre* and *S. capillifolium* occurring in the ground layer.*

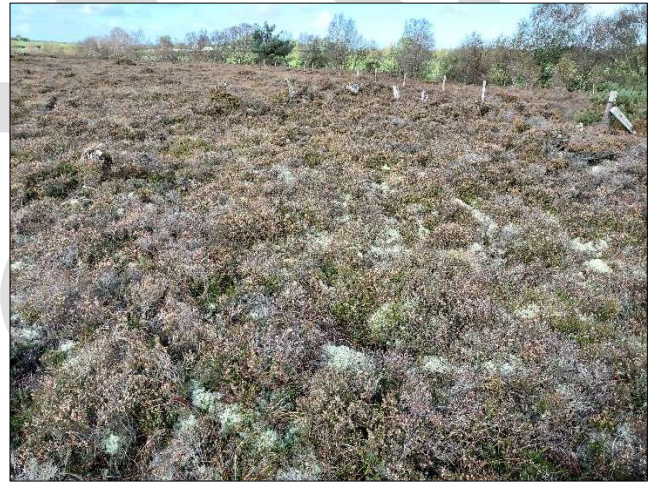
Plate 3.4 Example of remnant sections of raised bog occurring within the northwest of the site.

A number of small sections of remnant raised bog are located around this section of the site mainly along the western boundaries, see Plate 3.4. These sections are dry and degraded and dominated by heather, some of these raised bog remnants were being encroached upon by domestic turf cutters.

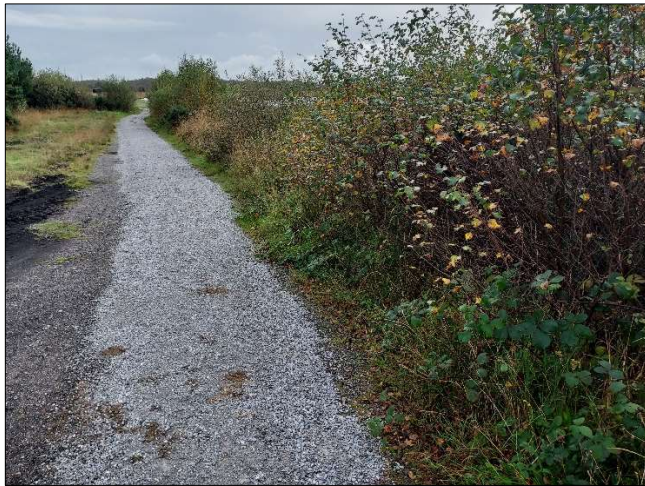
Plate 3.5 Example of public amenity path within the area leased by the Cloghan Community Development Association.

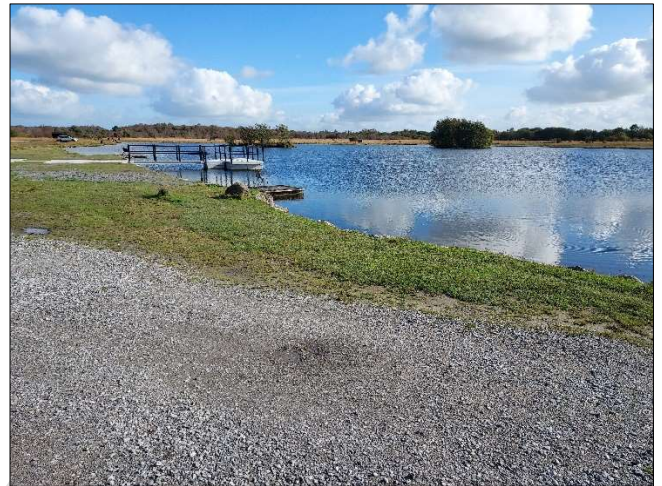
Plate 3.6 Cloghan fishing lake and public amenity area within the area leased by the Cloghan Community Development Association (southwest of the site).

The western side of Noggusboy bog has been out of peat production for some time and has thus begun to revegetate. The Cloghan Community Development Association have leased sections of the site, mainly in the south and mid-west of the site. The southern areas are used as an angling resource on the man-made lakes, Plate 3.6. This area also includes walking tracks (see Plate 3.6) and a pheasant viewing area where different species of pheasant are on display. Information signs are also displayed around this area relating to the flora and fauna of the site. Another area close to the mid-west boundary of the site is used to raise pheasants for release onto the site and sections of the cutaway had also been planted with game crops such as grasses and Brassica spp. Predator control has also been undertaken on the site.

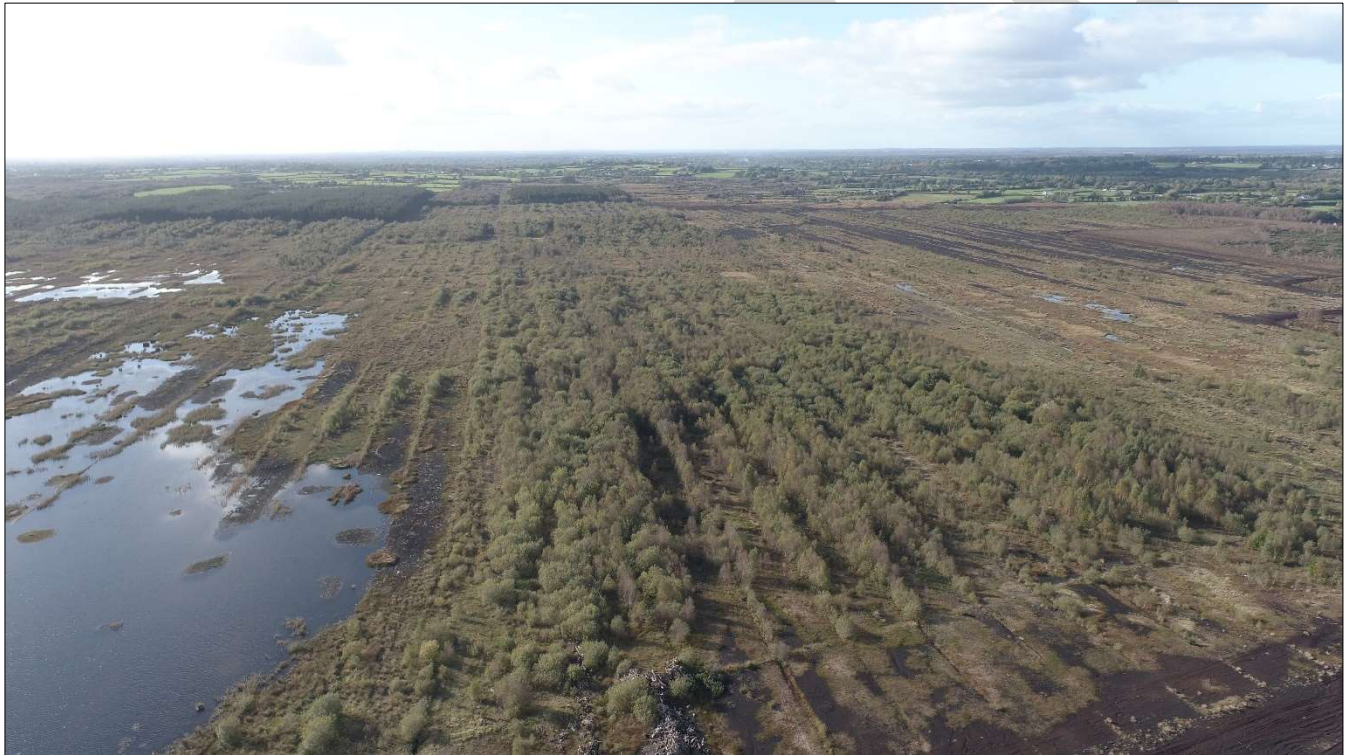
Plate 3.7 Example of developing pioneering cutaway vegetation (i.e. scrub, developing woodland, poor fen) and wetland habitats occurring on former cutaway production bog within the north east of the western portion of Noggusboy.
