# **Bord na Móna**

## **Begnagh Bog**

# **Cutaway Bog Decommissioning and Rehabilitation Plan 2022**

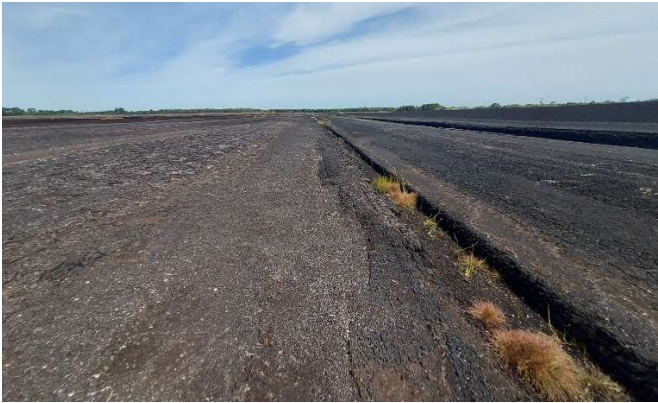
<p>View of the milled peat surface (2021) across the north of Begnagh bog.</p>

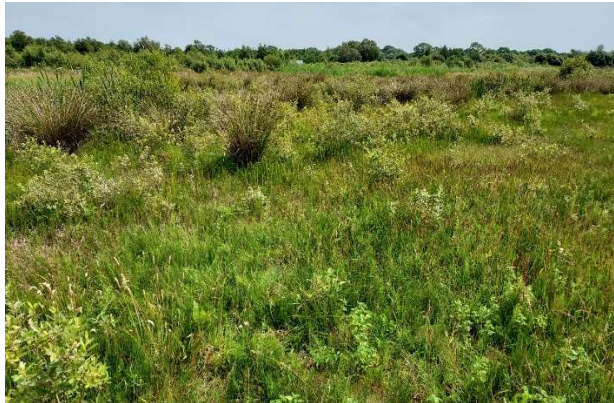
<p>View of wetland habitat and emergent vegetation within the south of Begnagh Bog (2021)</p>
---	---

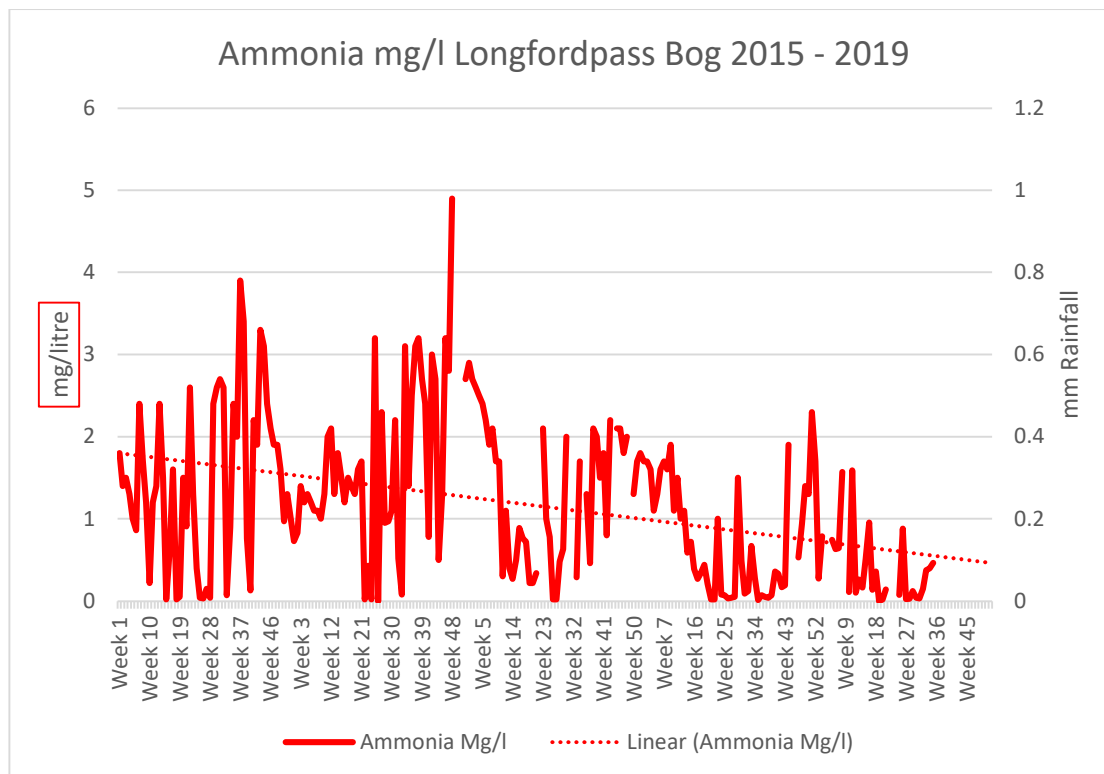
Plate 7.1 Example of decreasing ammonia emissions at Longfordpass bog following cessation of peat extraction and commencement of rehabilitation

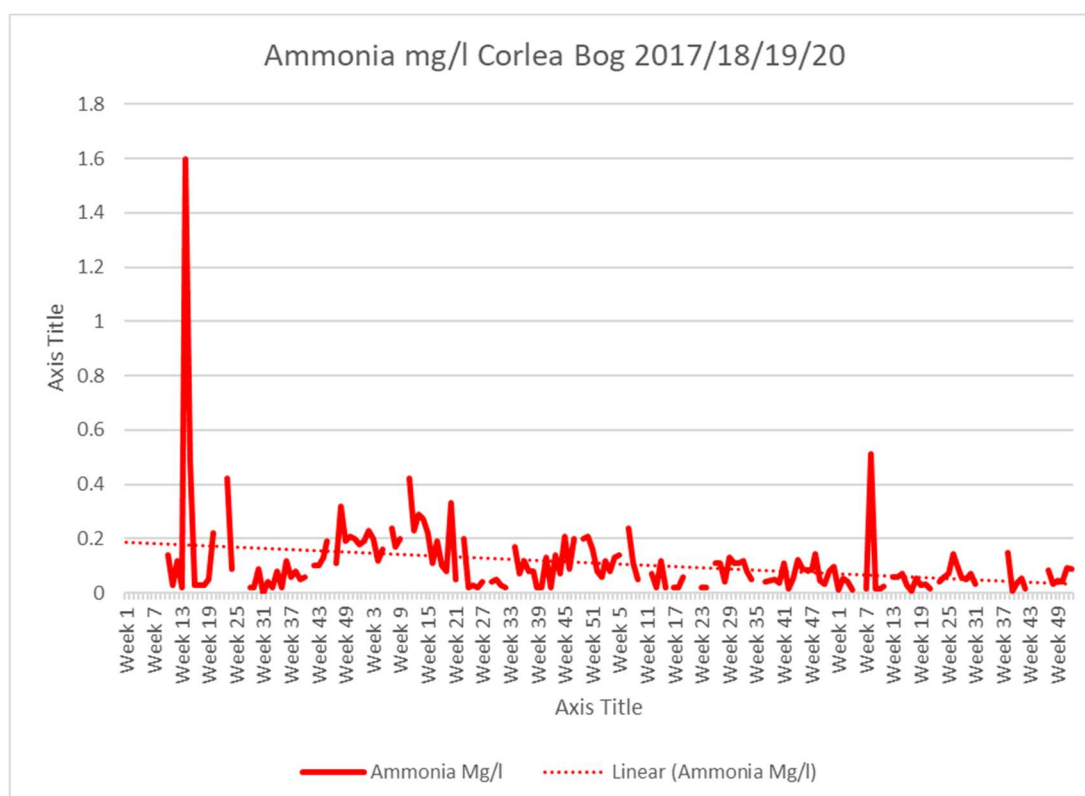
Plate 7.2 Example of decreasing ammonia emissions at Corlea bog following cessation of peat extraction and commencement of rehabilitation.

Similarly monitoring of surface water ammonia emissions from a Corlea bog in Mountdillon over 3 yrs. post cessation of peat extraction with ongoing rehabilitation, indicate downward trends, see Plate 7.2.

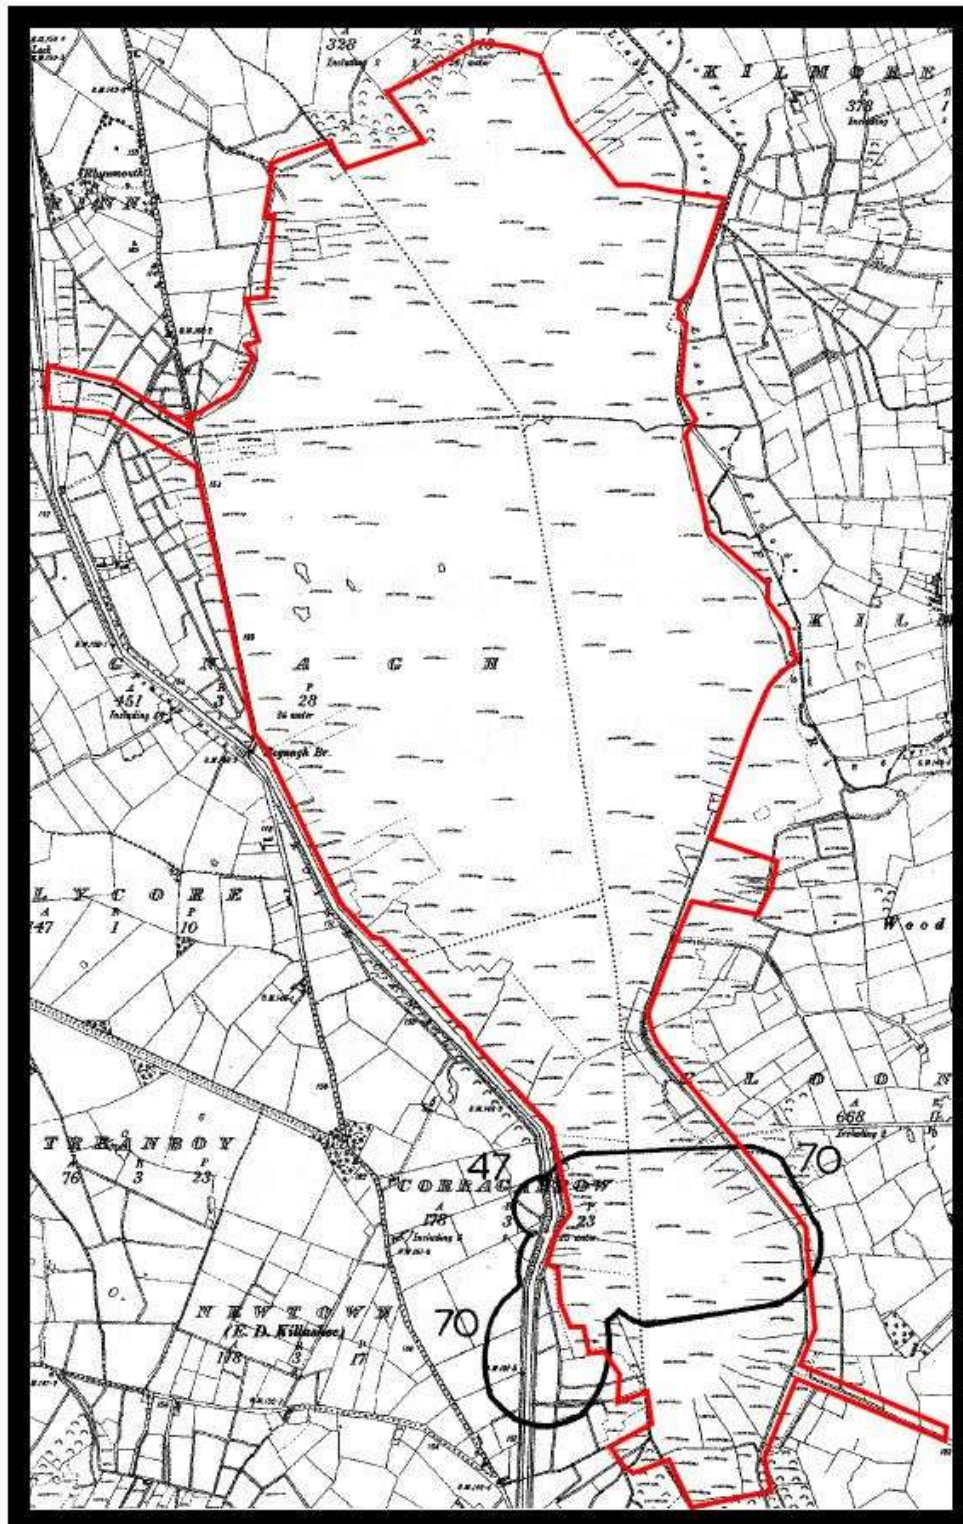
Fig. 1. Begnagh Bog, Co. Longford, detail of the Record of Monuments and Places map sheet No. 13. The proposed rehabilitation area is outlined with the red line. There are a large number of Recorded Monuments in the rehabilitation area.

RMP No.	NGR E	NGR N	Townland	RMP Classification
LF013-070---	20774	27220	Corragarrow/Cloonmore	Archaeological Complex
LF013-07001-	20762	27225	Corragarrow	Togher
LF013-07002-	20766	27209	Corragarrow	Worked Wood
LF013-07003-	20751	27195	Corragarrow	Post Row
LF013-07004-	20759	27211	Corragarrow	Worked Wood
LF013-07005-	20785	27219	Cloonmore	Togher
LF013-07006-	20797	27227	Cloonmore	Togher
LF013-07007-	20796	27221	Cloonmore	Togher
LF013-07008-	20787	27215	Cloonmore	Togher
LF013-07009-	20787	27216	Cloonmore	Togher
LF013-070010-	20778	27210	Cloonmore	Togher
LF013-070011-	20780	27210	Cloonmore	Worked Wood
LF013-070012-	20778	27212	Cloonmore	Togher
LF013-070013-	20786	27212	Cloonmore	Togher

Table 3. List of sites included in the Record of Monuments and Places in Begnagh Bog.

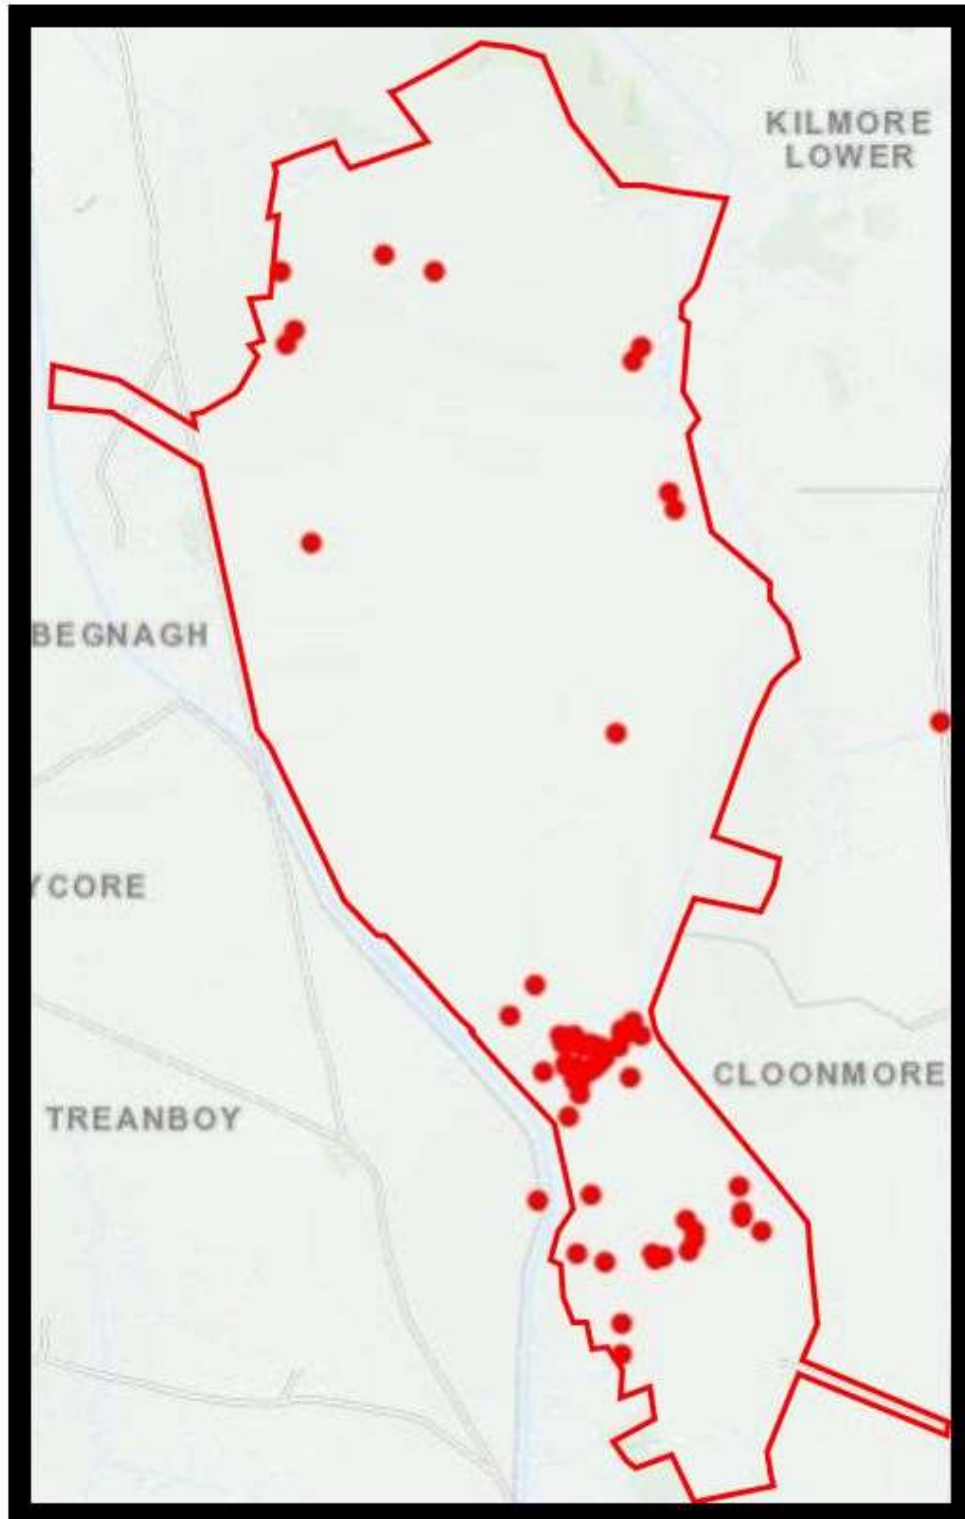
Fig. 2. Begnagh Bog, Co. Longford, detail of the Sites and Monuments Record. The proposed rehabilitation area is outlined with the red line. There are a large number of SMRs in the rehabilitation area.

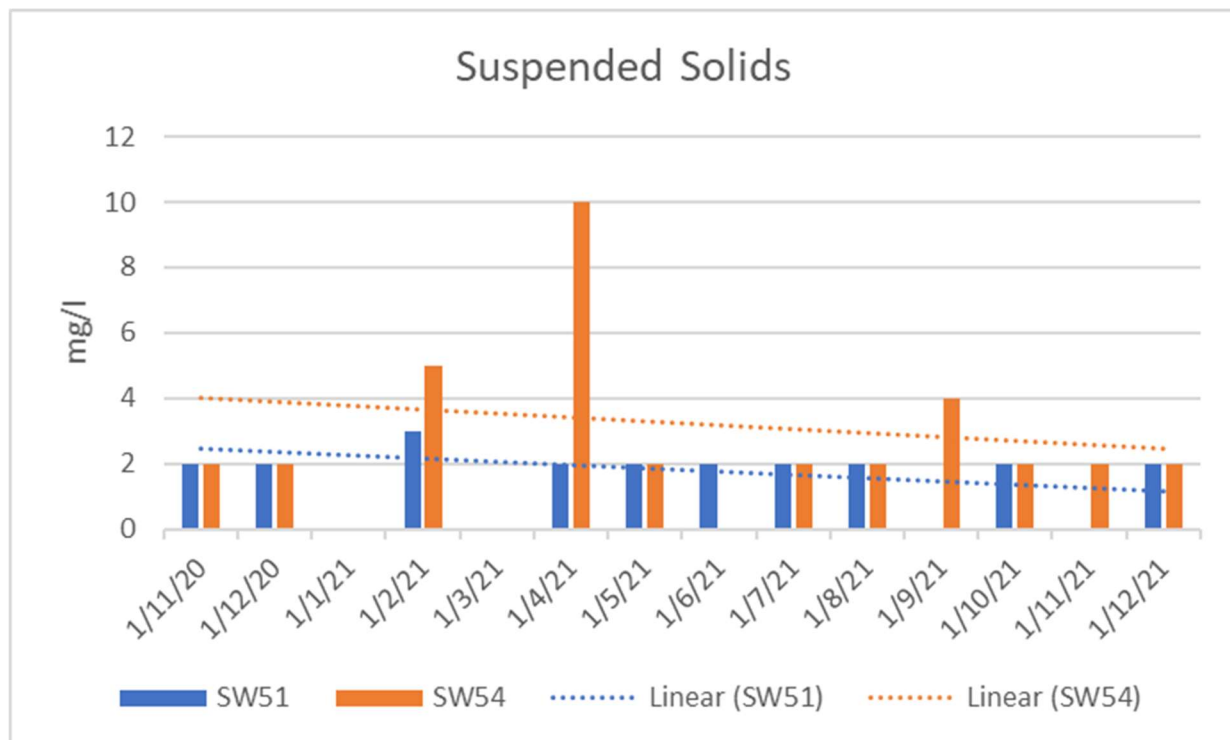
Figure AP13.1. Suspended solids in water sampling at Begnagh from different discharge points. 35 mg/l is the emission limit value.

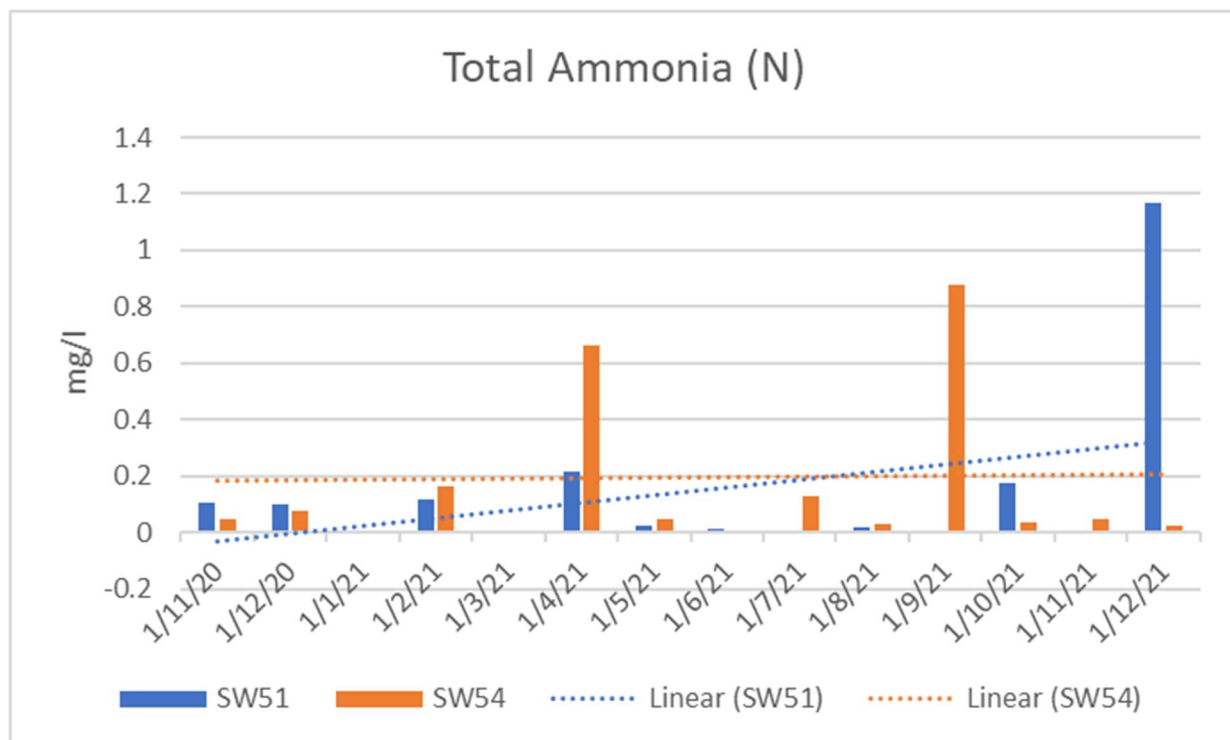
Figure AP13.2. Ammonia concentrations in water sampling from Begnagh from different discharge points. The main trigger level for ammonia is 1.42mg/l for reporting to EPA.
