Bord na Móna

Clooneeny Bog

Cutaway Bog Decommissioning and Rehabilitation Plan 2022

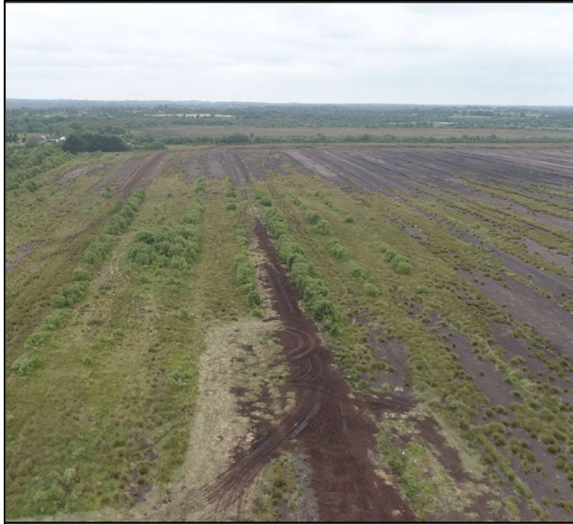
Pioneering vegetation on cutaway including Scrub and Soft Rush dominated Poor fen (July 2021)

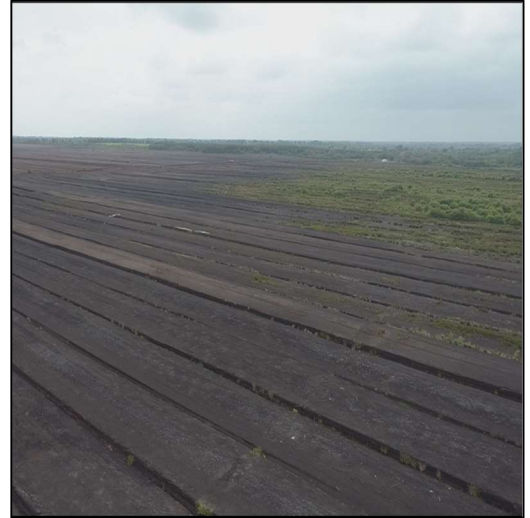
Bare Peat at Clooneeny (July 2021)

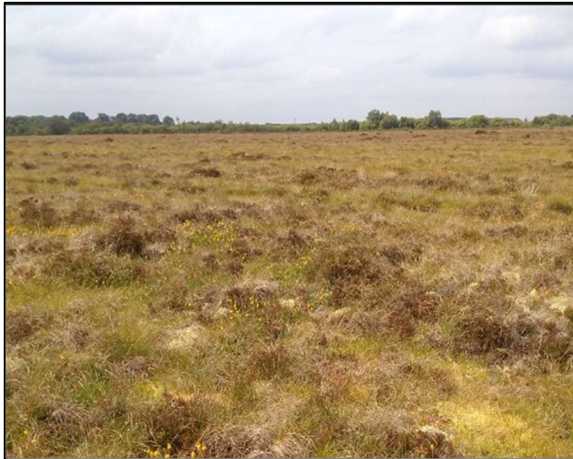
High Bog at Clooneeny (July 2021)

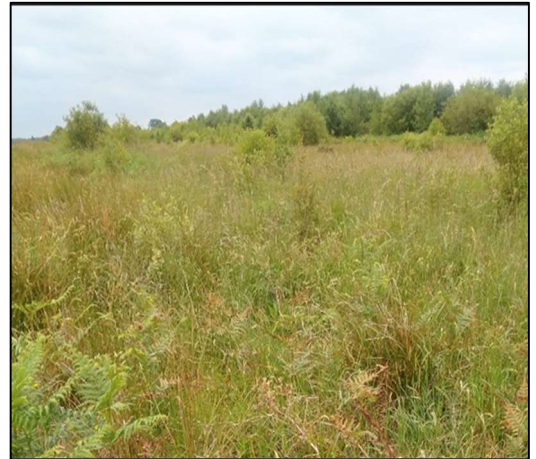
Mosaic of Pioneering Grassland and Birch Scrub at Clooneeny Bog (July 2021).
