# **Bord na Móna**

## **Derrinboy Bog**

# **Cutaway Bog Decommissioning and Rehabilitation Plan 2022**

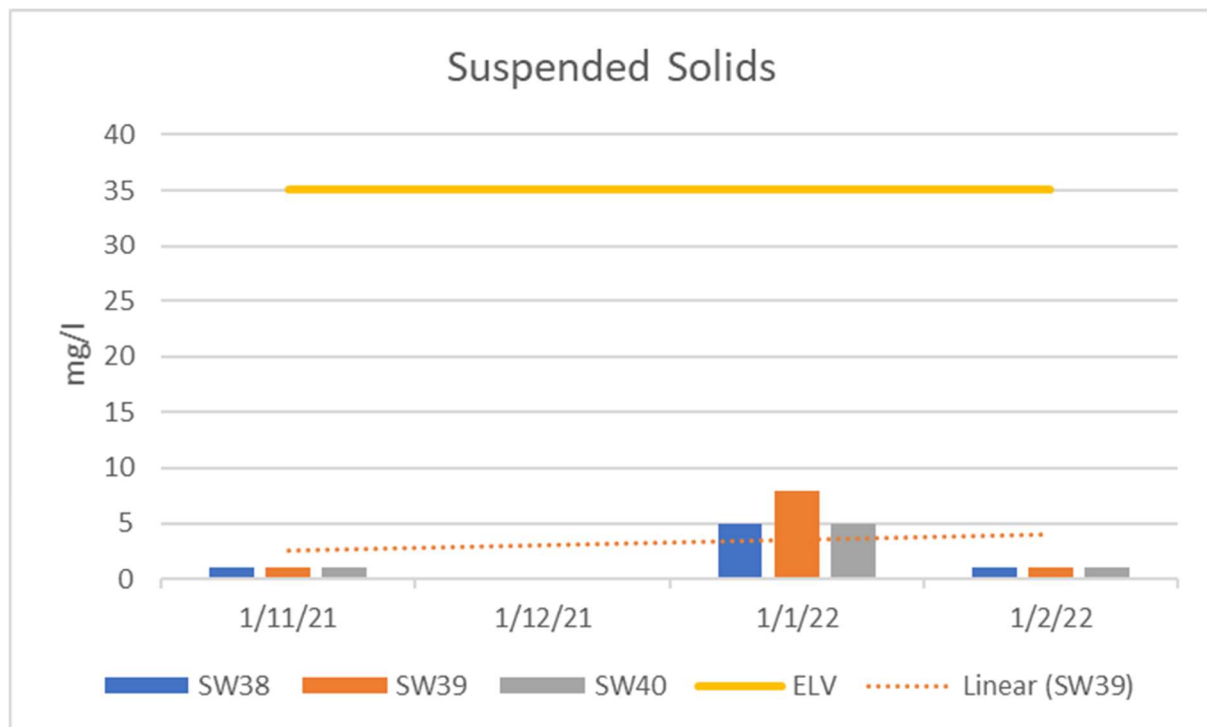
Figure AP13.1. Suspended solids in water sampling at Derrinboy from different discharge points. 35 mg/l is the emission limit value.

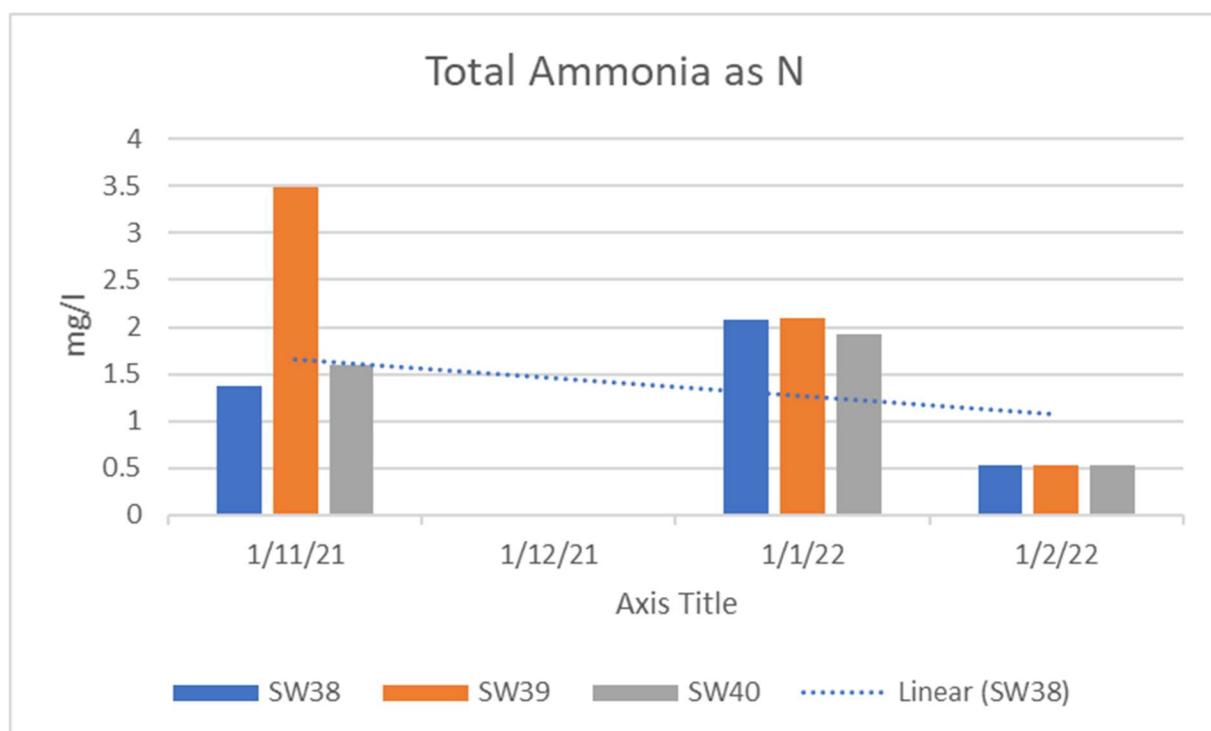
Figure AP13.2. Ammonia concentrations in water sampling from Derrinboy from different discharge points. The main trigger level for ammonia is 3.7 mg/l for reporting to EPA.
