Bord na Móna

Derraghan Bog

Cutaway Bog Decommissioning and Rehabilitation Plan 2022

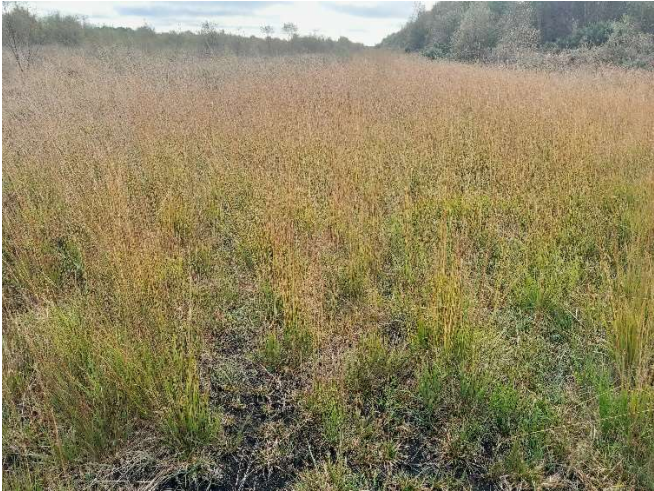
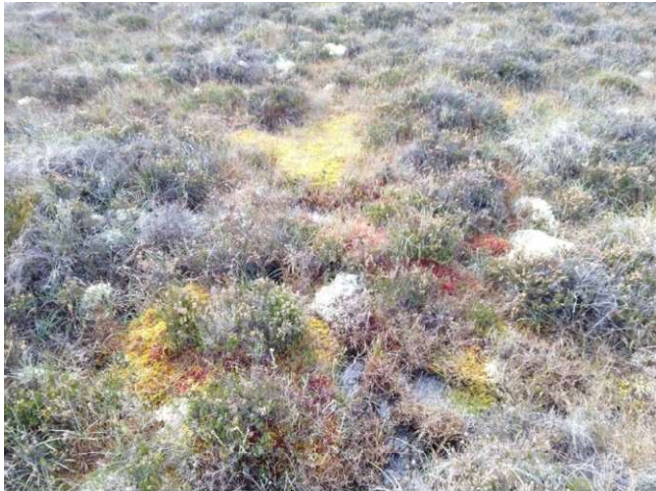
Table 1: Photos from Derraghan Bog

<p><i>Pioneering vegetation on cutaway including Scrub and Soft Rush dominated Poor fen (Oct 2021)</i></p>	<p><i>Sphagnum within north western Raised Bog remnant at Derraghan (Sept 2021)</i></p>

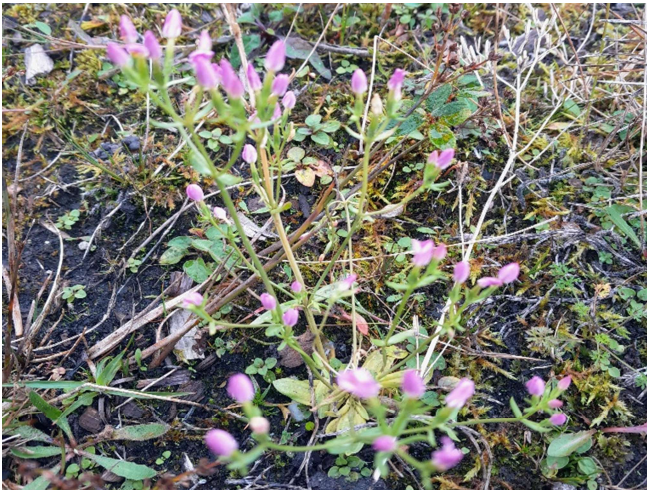
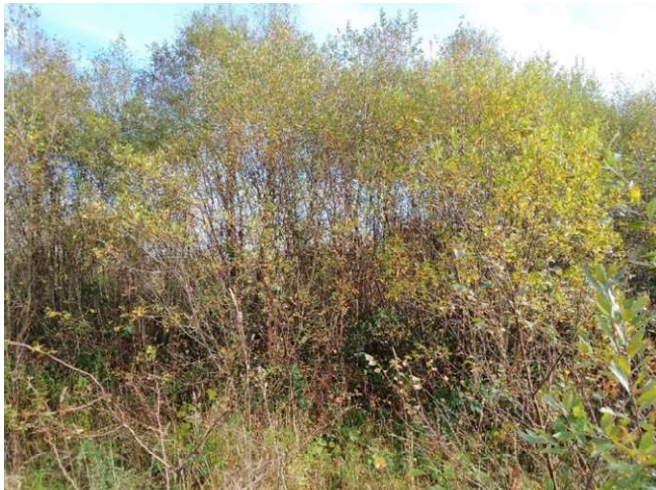
<p><i>Common centaury on cutaway (Oct 2021)</i></p>	<p><i>Pioneering scrub and Birch woodland (WN7) at Derraghan Bog (Sept 2021)</i></p>

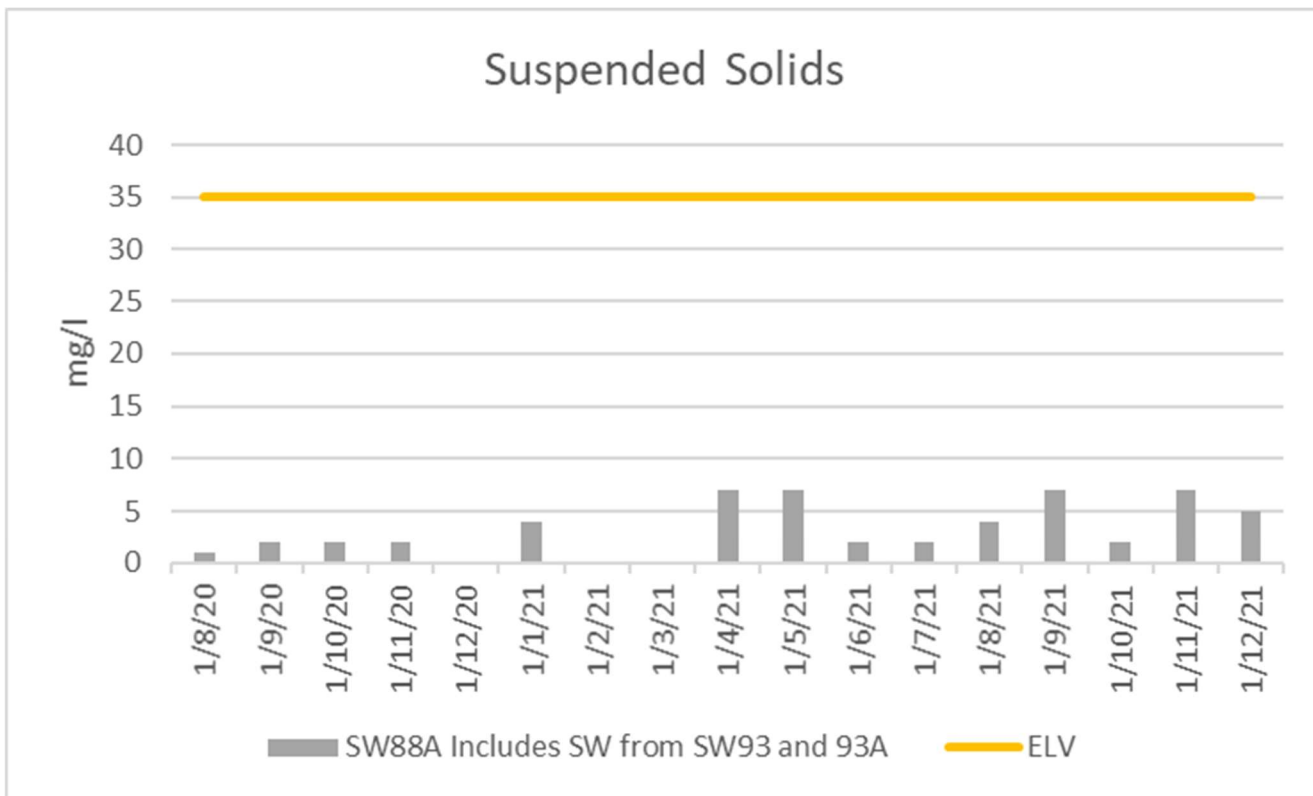
Figure AP13.1. Suspended solids in water sampling at Derraghan from different discharge points. 35 mg/l is the emission limit value.

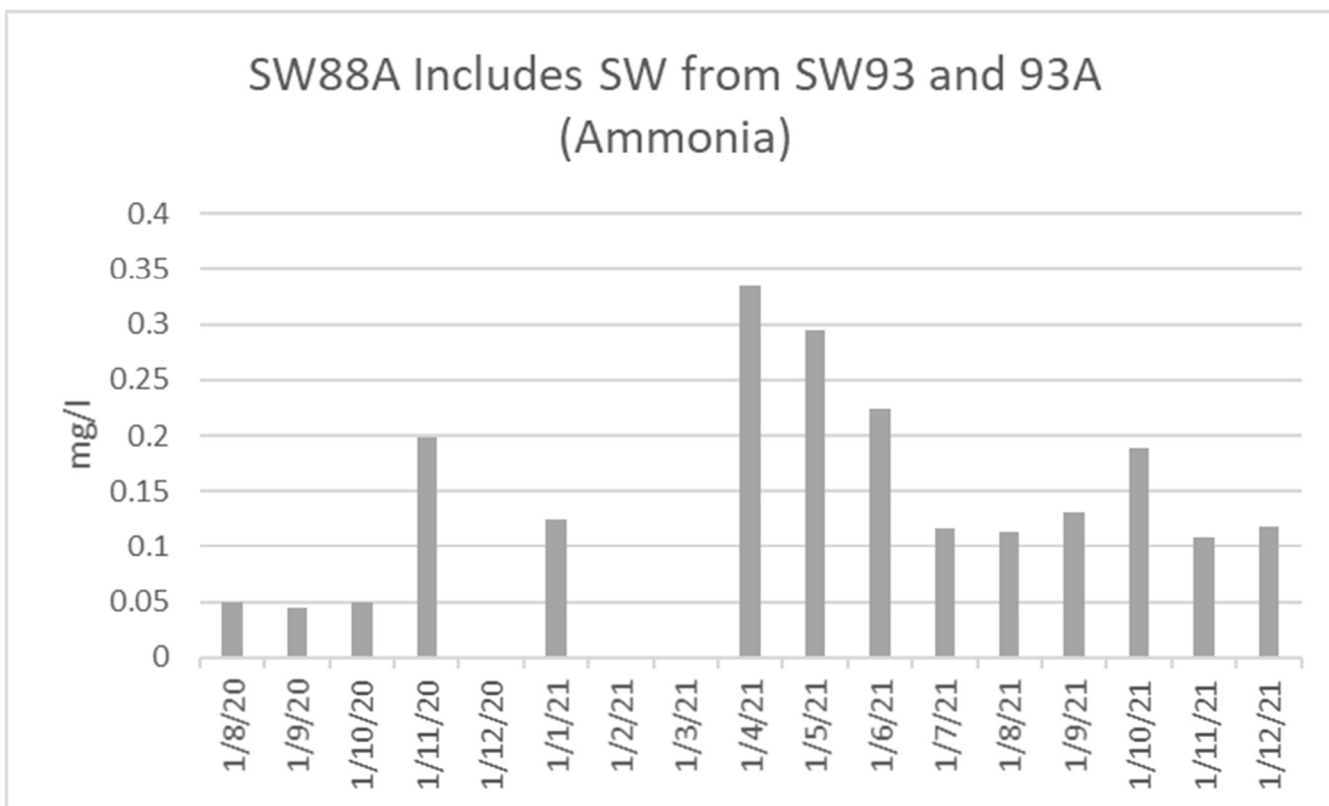
Figure AP13.2. Ammonia concentrations in water sampling from Derraghan from different discharge points. The main trigger level for ammonia is 1.42mg/l for reporting to EPA.
