Bord na Móna

Lodge Bog

Cutaway Bog Decommissioning and Rehabilitation Plan

2022

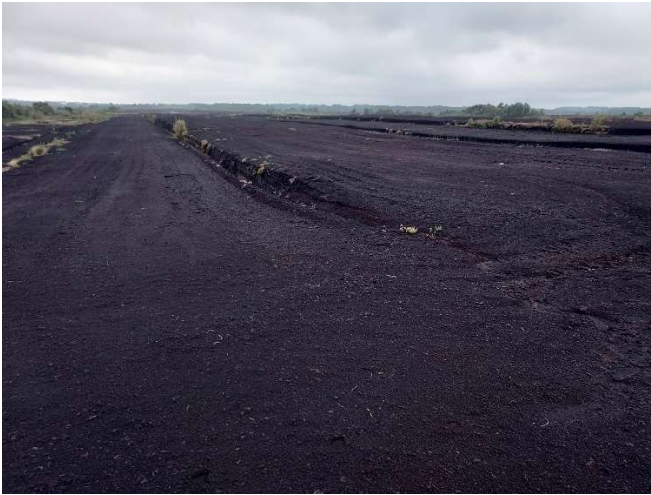
Plate 3.1 Example of cutaway bare peat occurring within the east of the site. This section contains large areas of deep peat.

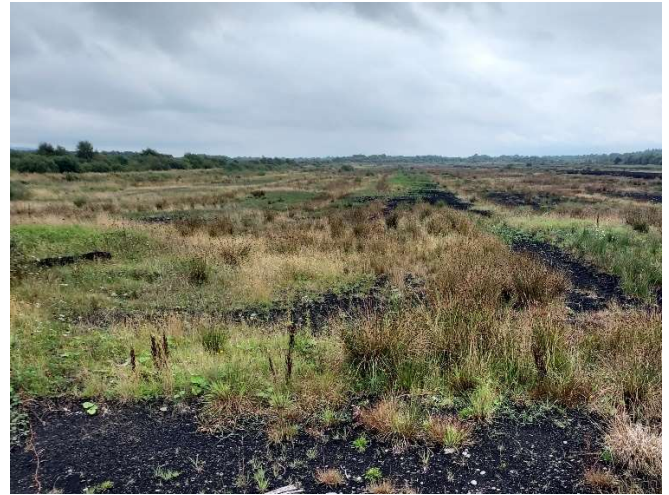
Plate 3.2 Example of developing pioneering cutaway vegetation on former cutaway production bog.

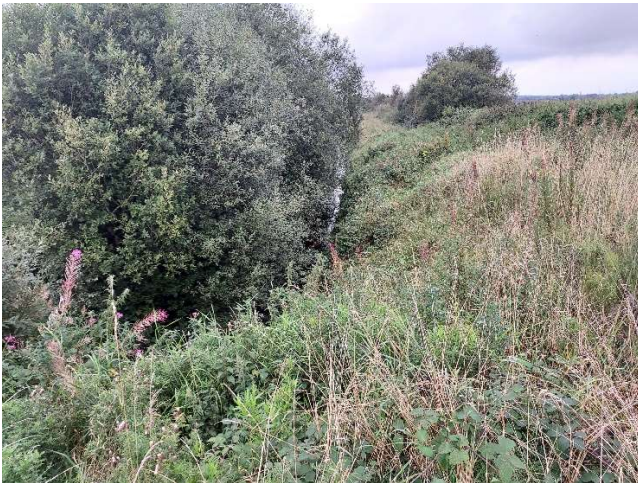
Plate 3.3 Example of large trench drains that run north-south through the site.

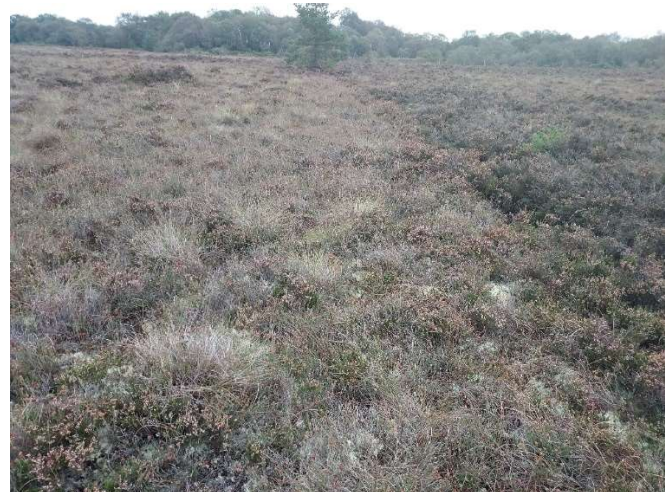
Plate 3.4 Example of remnant sections of raised bog occurring within the south and east of the site. Not old drainage network (right of photo).

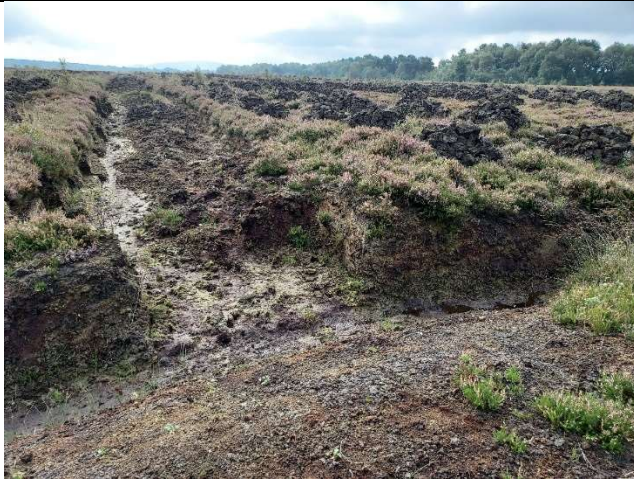
*Plate 3.5 Example of cutover bog associated with sod peat production. The vegetation comprises of a dry heath type vegetation community, with *Sphagnum papillosum* and *Sphagnum magellanicum* occurring in places.*

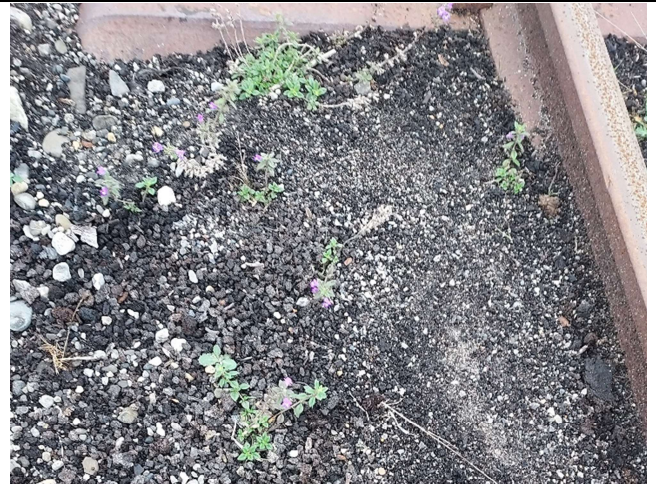
Plat3 3.6 Example of Basil thyme occurring along the old railway track on site.

Basil thyme was noted at a number of locations along the railway track that divides the site and at the southern end of the site, see Plate 3.6. This species is listed on the Flora Protection Order. Basil thyme would not be a typical species of cutaway bog. The exposed gravel along the railway embankments is a perfect habitat for this species.

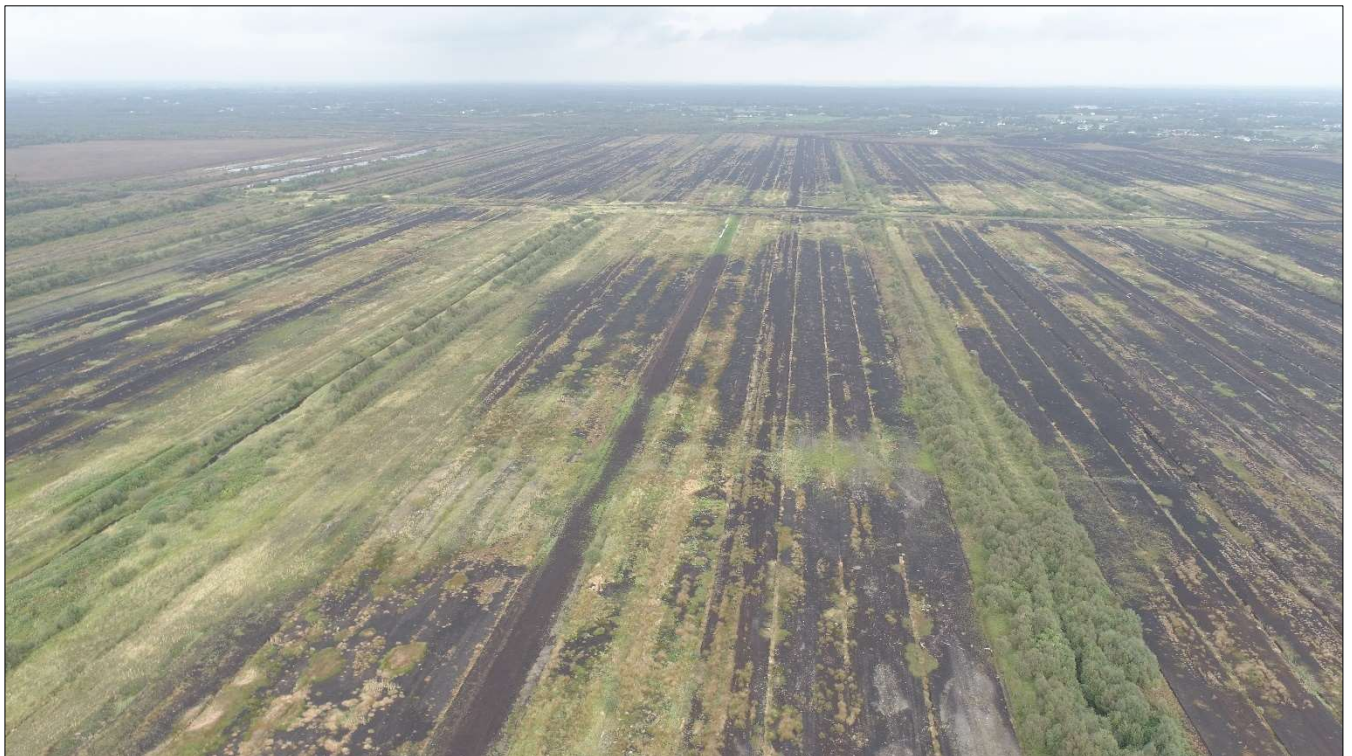
Plate 3.7 Example of developing pioneering cutaway vegetation on former cutaway production bog (Drone photography September 2021).
