Bord na Móna

Cloncreen Bog

Cutaway Bog Decommissioning and Rehabilitation Plan

2022

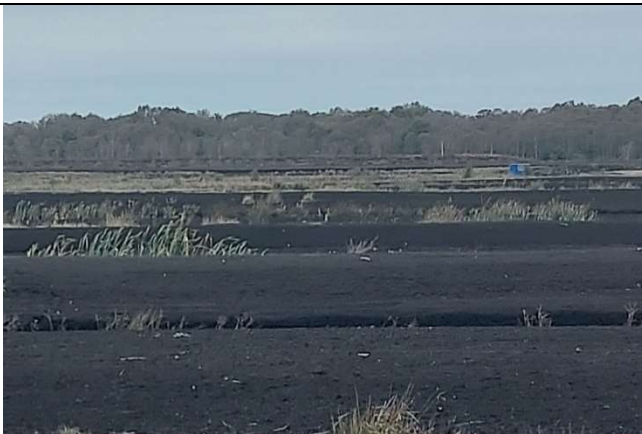
Plate 3.1 Example of cutaway bare peat occurring within the northeast of the site.

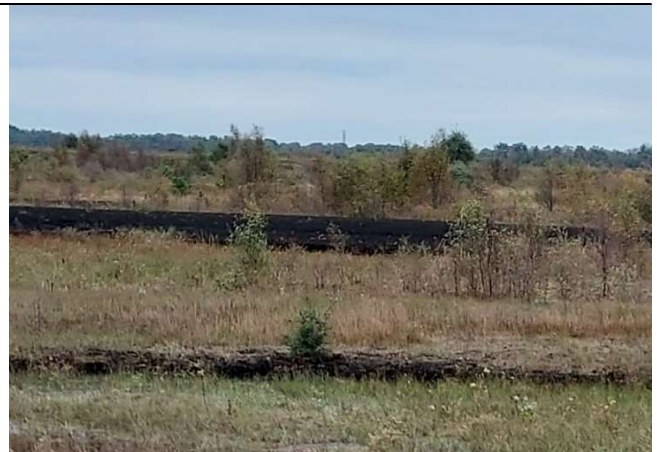
Plate 3.2 Example of developing pioneering dry cutaway vegetation on former cutaway production bog.
