Bord na Móna

Derrybrat Bog

Cutaway Bog Decommissioning and Rehabilitation Plan 2021

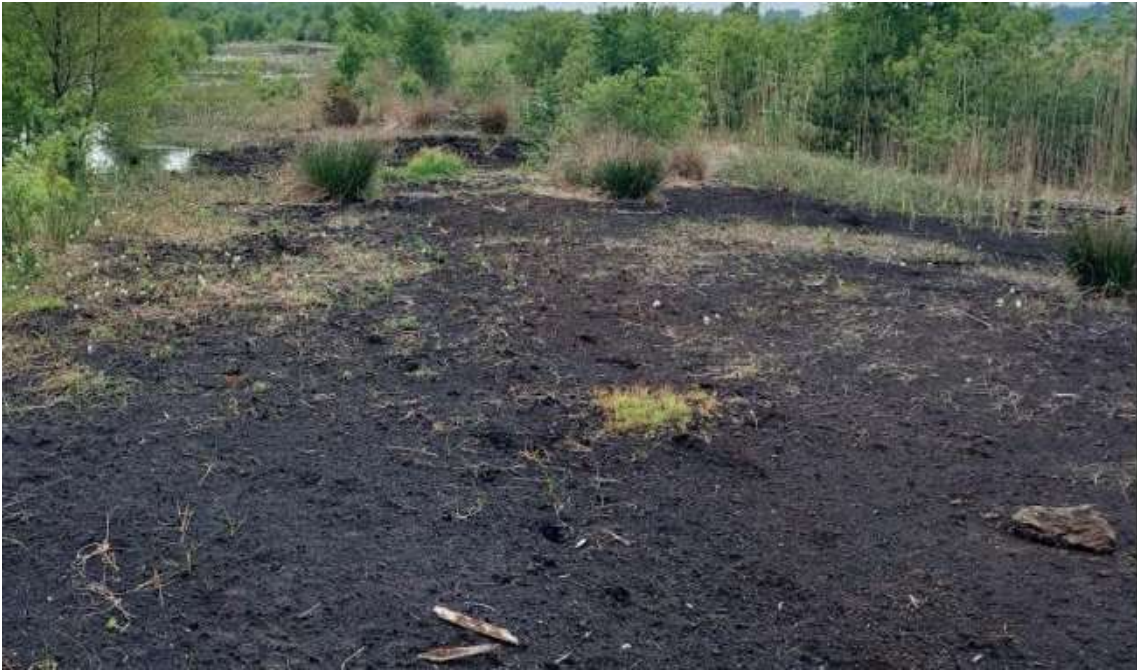
Figure 3.1. View of the revegetating milled peat surface (2021) across Derrybrat bog.

The bog is currently developing pioneer cutaway wetland habitats (poor fen, Reed swamp, Birch woodland) (Figure 3.1-3.2). Much of the site is re-vegetating or re-wetted and the area of bare peat has been reduced significantly. Some rehabilitation measures have previously been carried out on the southern section. The resultant environmental conditions in this section are therefore generally wetter and closer to optimal condition than the same in the northern section.

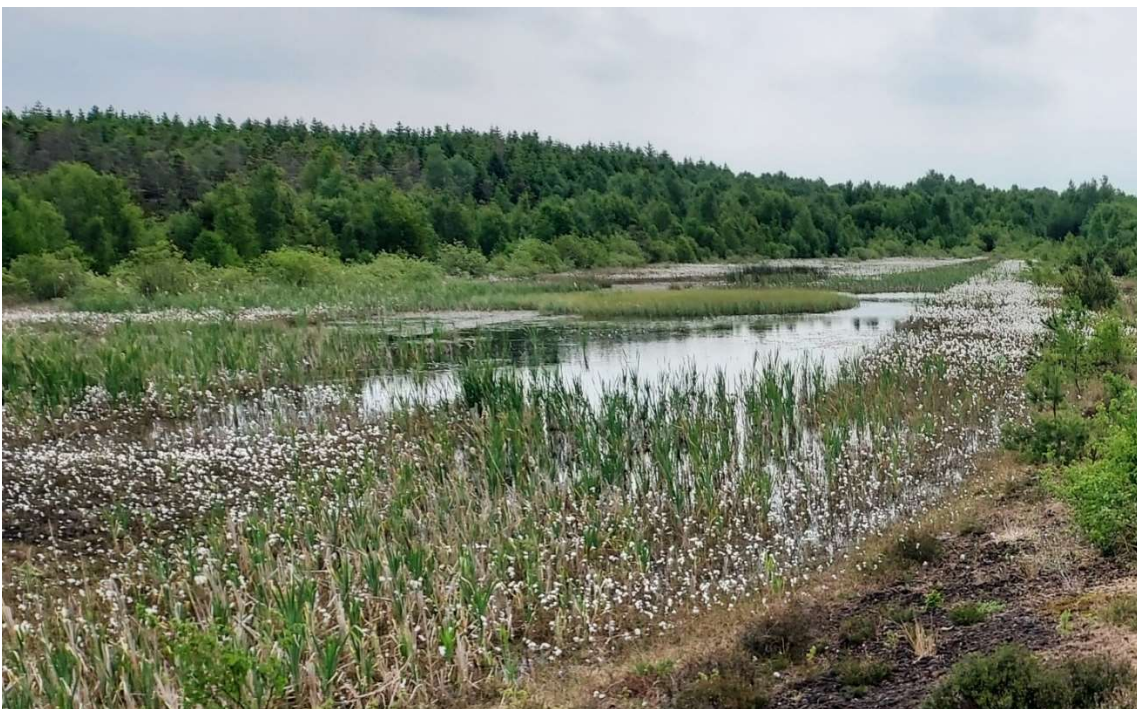
Figure 3.2 View of wetland habitat and emergent vegetation at Derrybrat Bog with the conifer plantation in the background(2021)
