Bord na Móna

Derryfadda Bog

Cutaway Bog Decommissioning and Rehabilitation Plan

2022

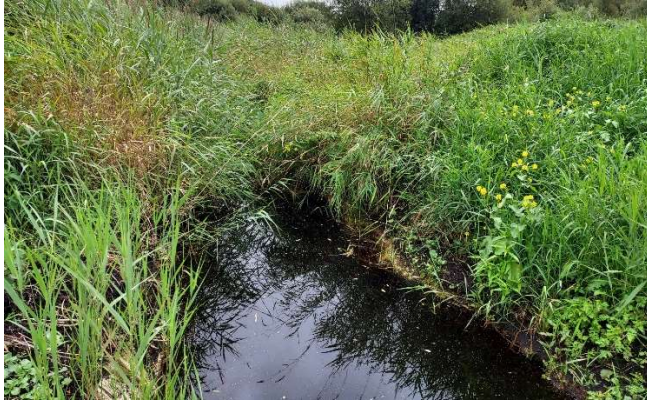
Plate 3.1 The Killaderry stream separates the southern sections of the site from the central and northern sections.

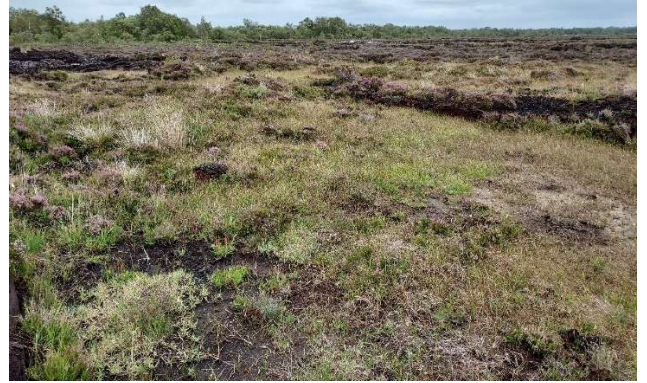
Plate 3.2 Example of remnant sections of raised bog, cutover bog, scrub and birch dominated woodland occurring both north and south of the Killaderry stream

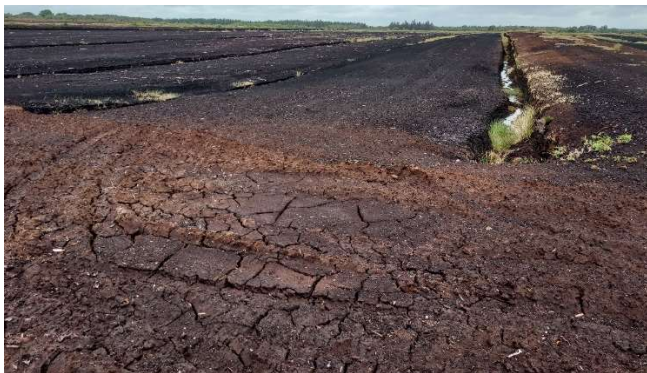
Plate 3.3 Example of the central section of the site dominated by bare peat.

The central section of the site is dominated by bare peat, see Plate 3.3. A mineral island is located in the centre of the site and is accessed by way of a bog track; a small works area is located on the mineral island.

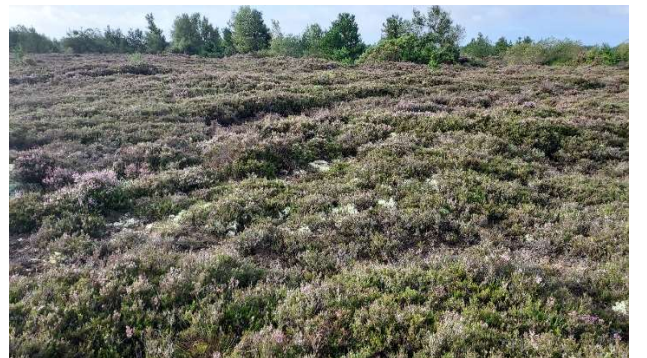
Plate 3.4 Example of cutover bog with dry heath type vegetation occurring within the north-eastern part of the site.

An area of cutover bog is located in the north-eastern part of this section, see Plate 3.4. This area consists of dry heath type vegetation with some scrub along the edges. Some areas of the scrub consisted of birch with an understory of bramble, bracken and bluebell. This area had been in peat production in the past.

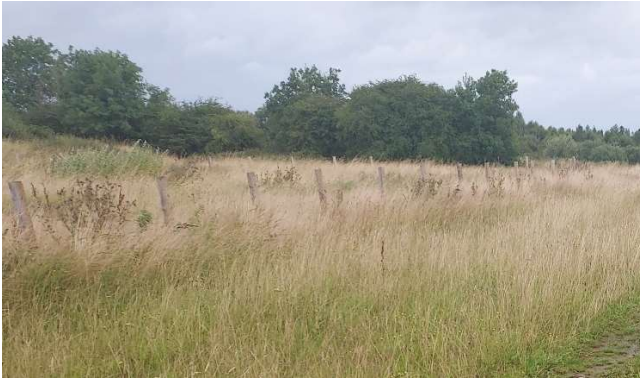
Plate 3.5 Example of dry grassland and scrub occurring on part of the mineral island that separates the central section from the most northern parcel.

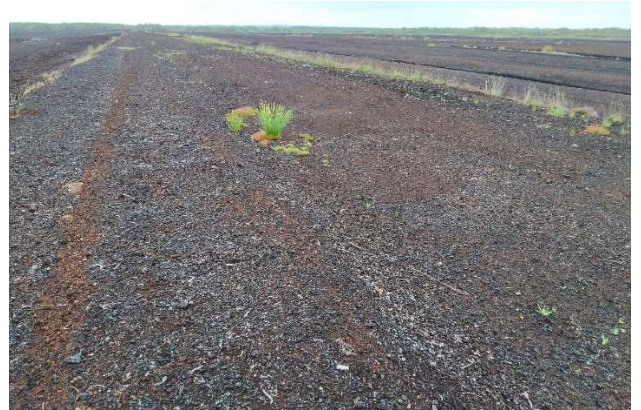
Plate 3.6 Example of cutaway bare peat occurring within the south of the site. This section contains large areas of deep sphagnum peat.
