# **Bord na Móna**

## **Glenlough Bog**

### **Cutaway Bog Draft Decommissioning and Rehabilitation Plan 2022**

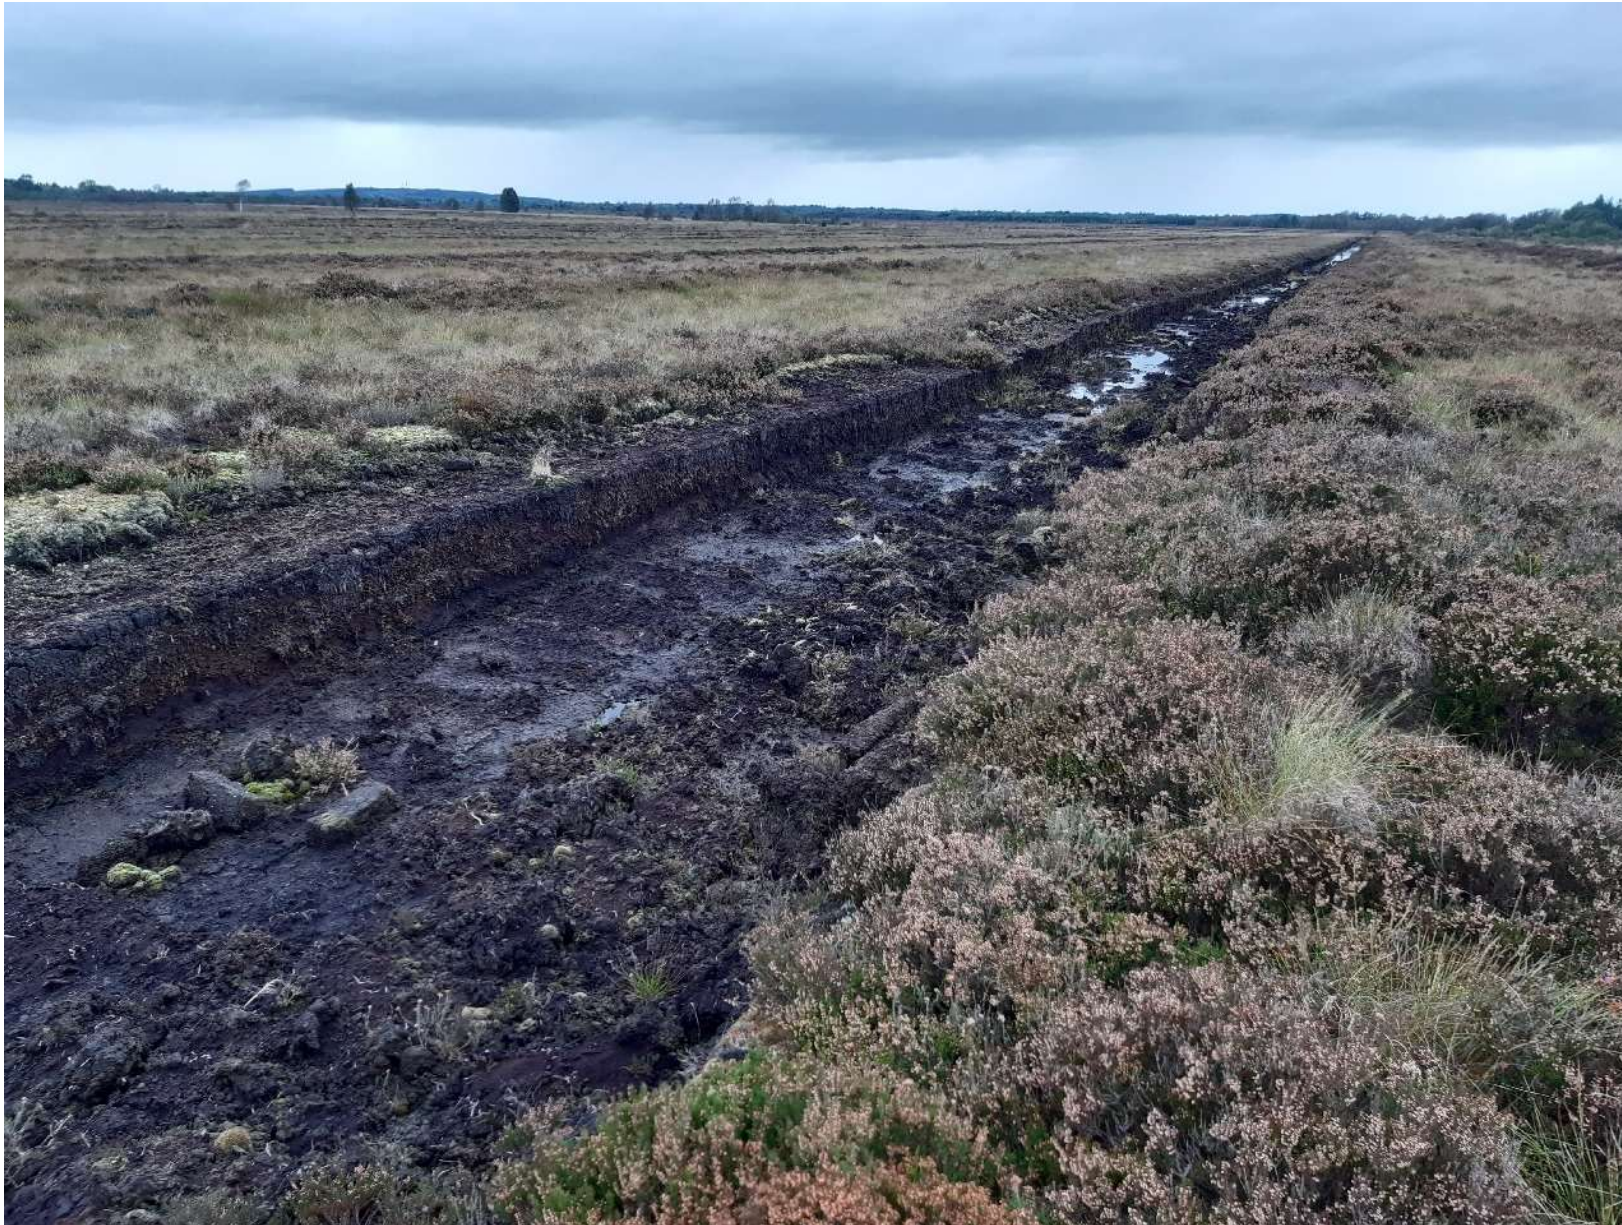
*Figure 3.1. View of large trench drain present in Glenlough*

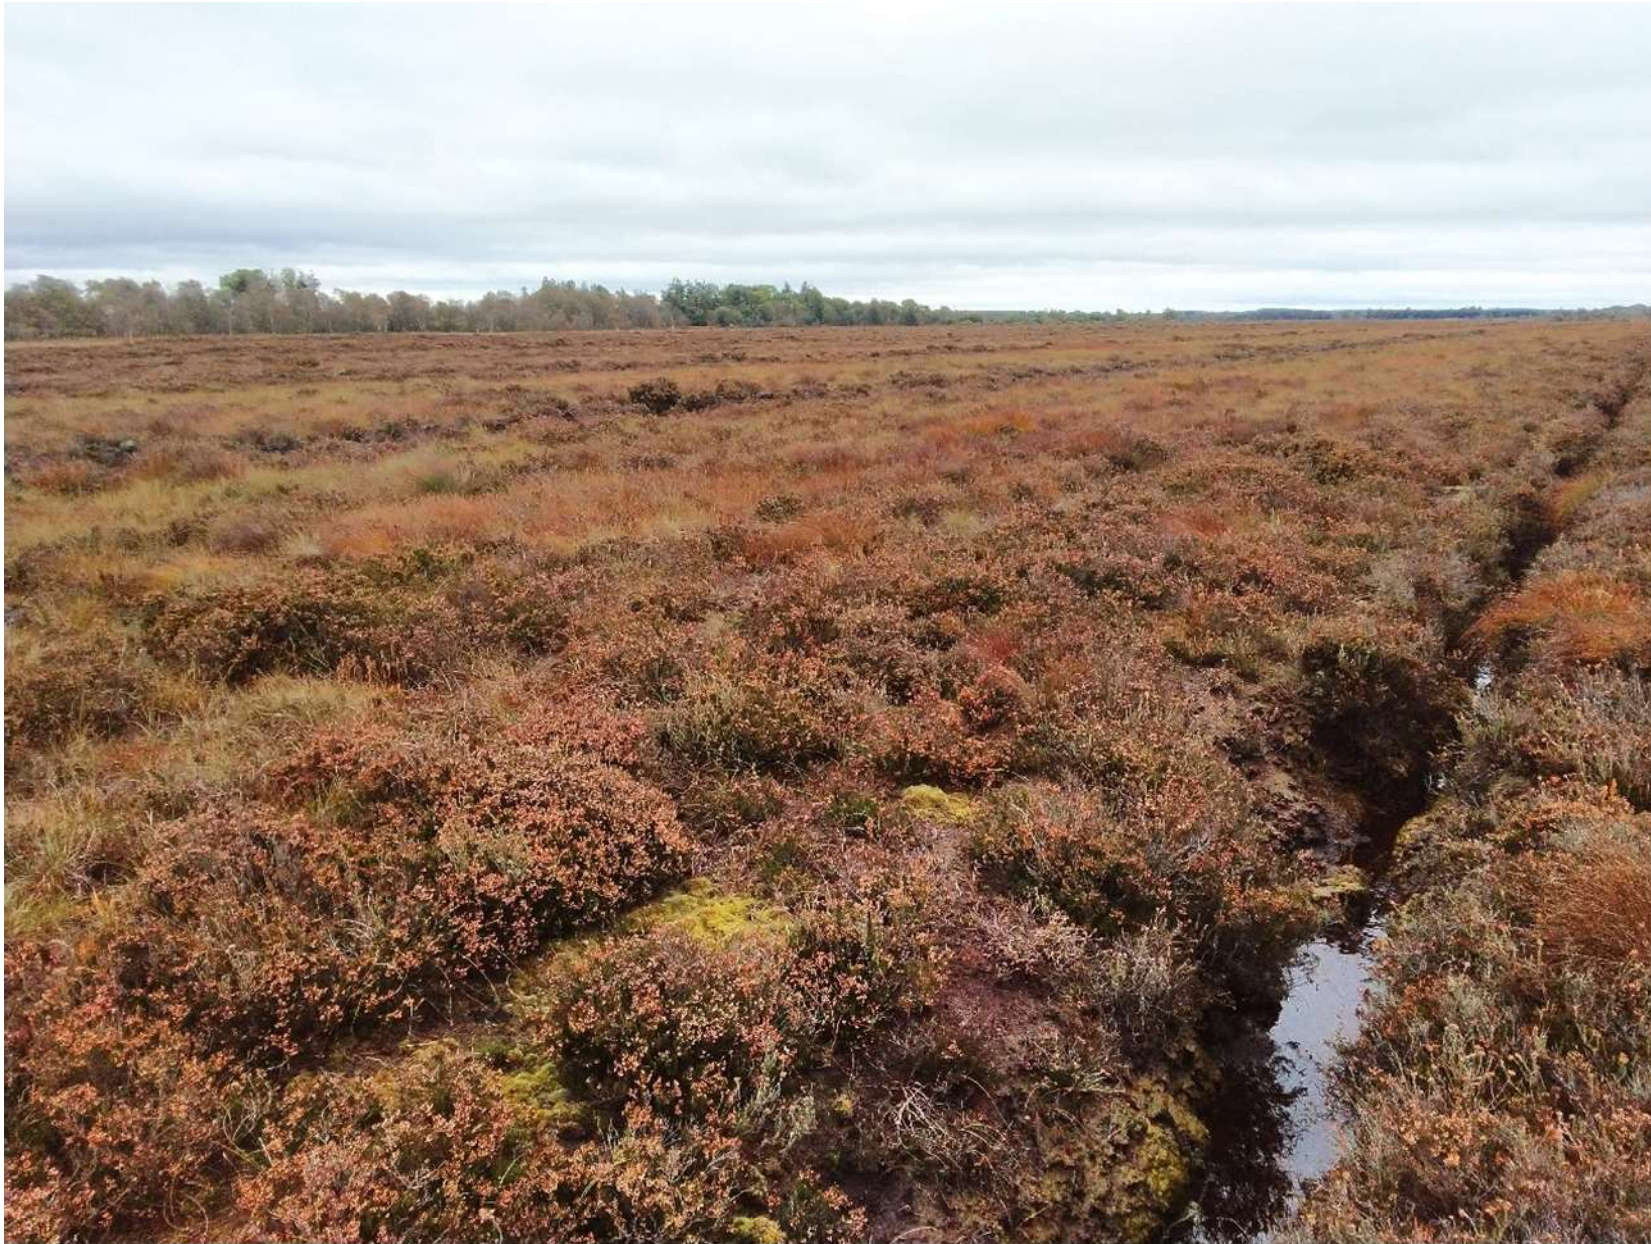
*Figure 3.3. View of drains and degraded raised bog habitat at Glenlough*

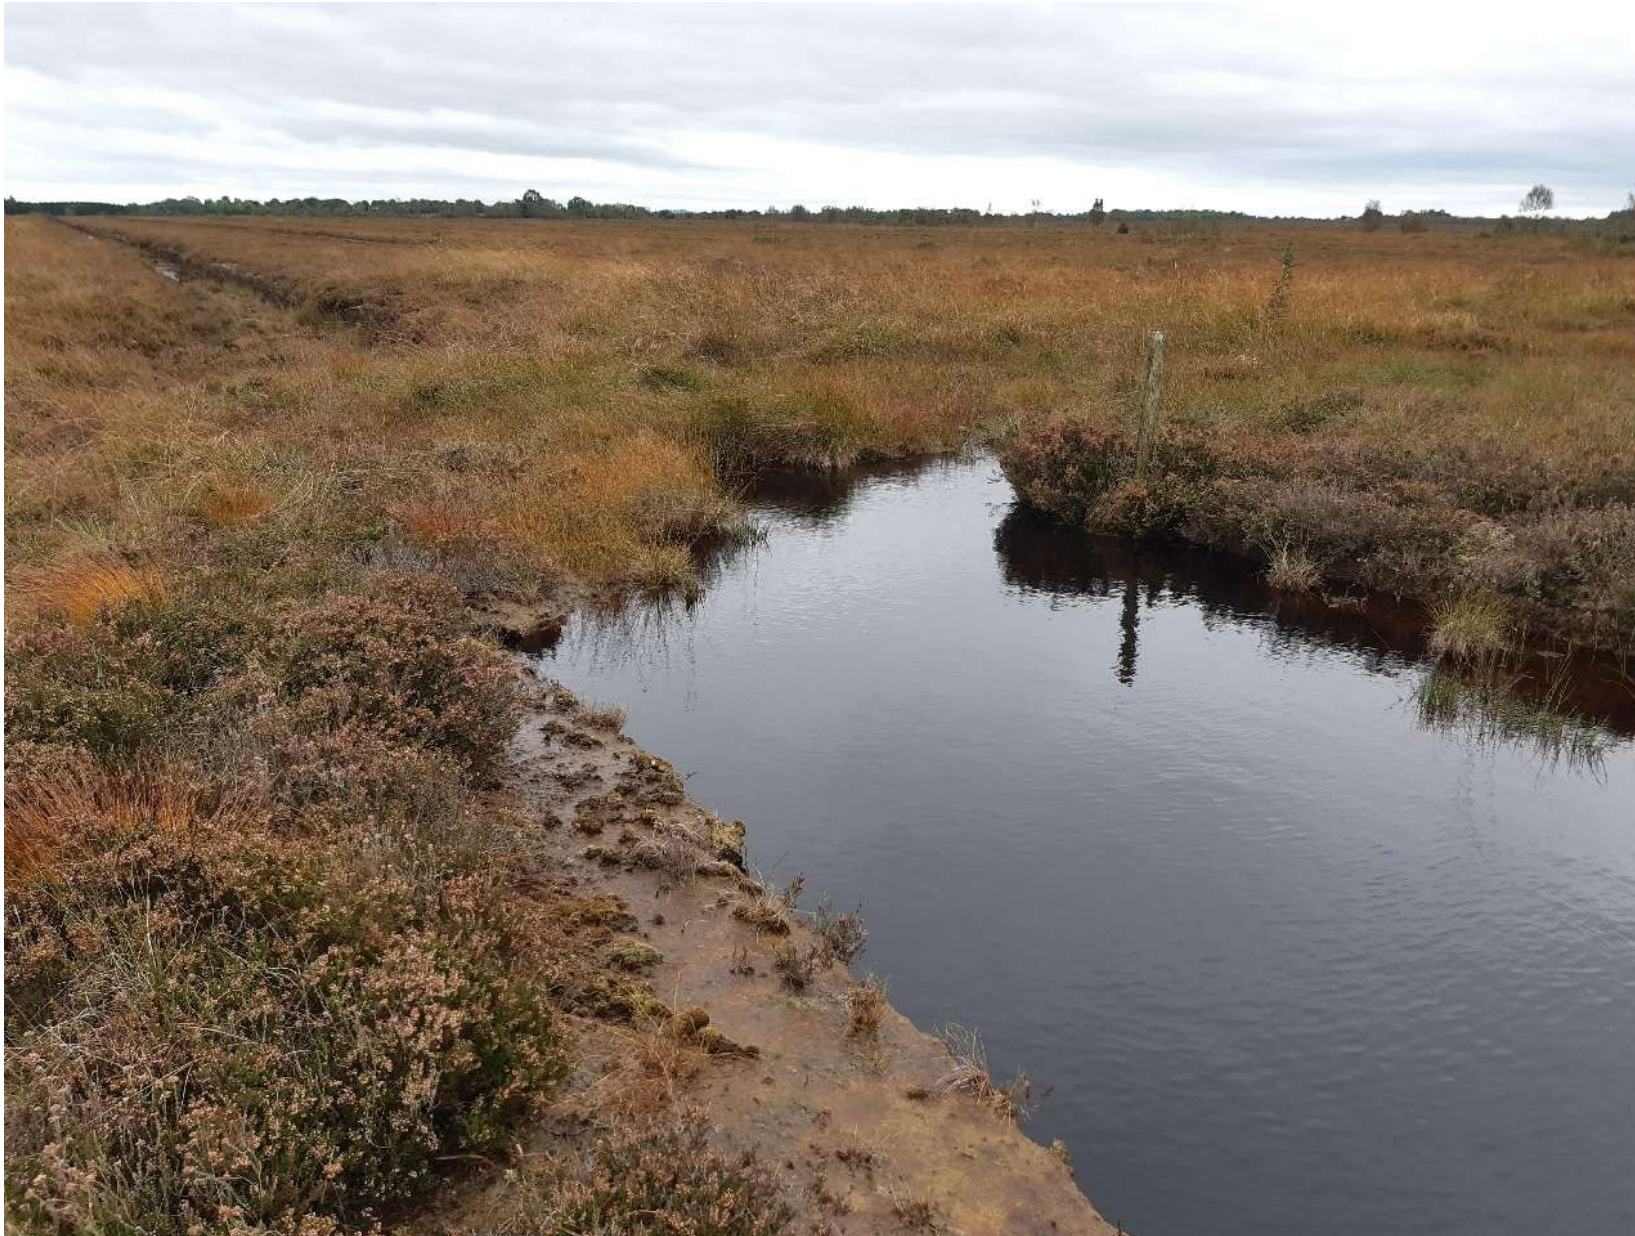
*Figure 3.4. View of trench drain blocked by machine pass, water flow has been reduced to a trickle that has overtopped the machine pass at Glenlough.*
