**Bord na Móna**

**Noggusboy Bog**

**Cutaway Bog Decommissioning and  
Rehabilitation Plan**

**2022**

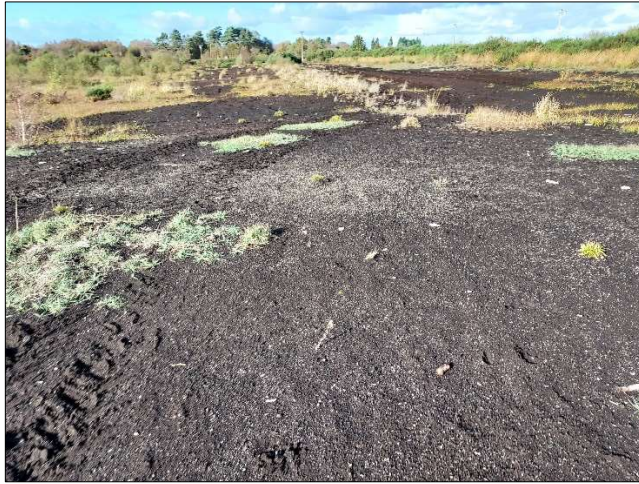
*Plate 3.1 Example of cutaway bare peat and pioneering cutaway vegetation occurring within the west of the site.*

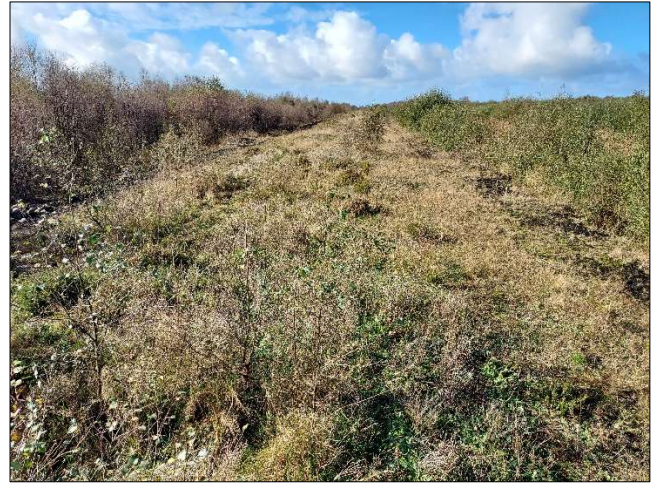
*Plate 3.2 Example of developing pioneering cutaway vegetation on former cutaway production bog.*

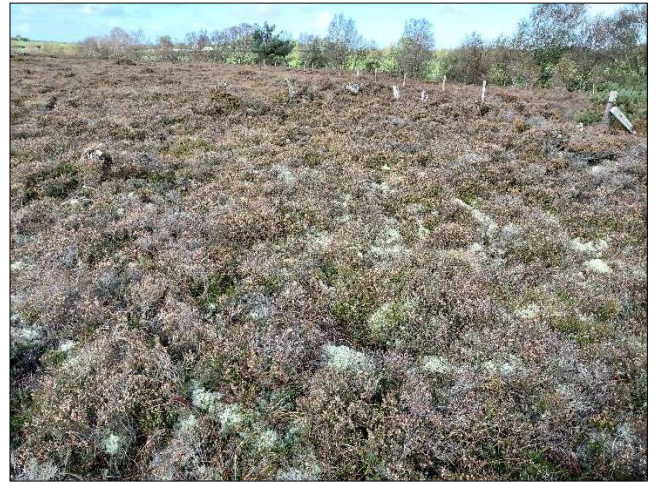
*Plate 3.4 Example of remnant sections of raised bog occurring within the northwest of the site.*

A number of small sections of remnant raised bog are located around this section of the site mainly along the western boundaries, see Plate 3.4. These sections are dry and degraded and dominated by heather, some of these raised bog remnants were being encroached upon by domestic turf cutters.

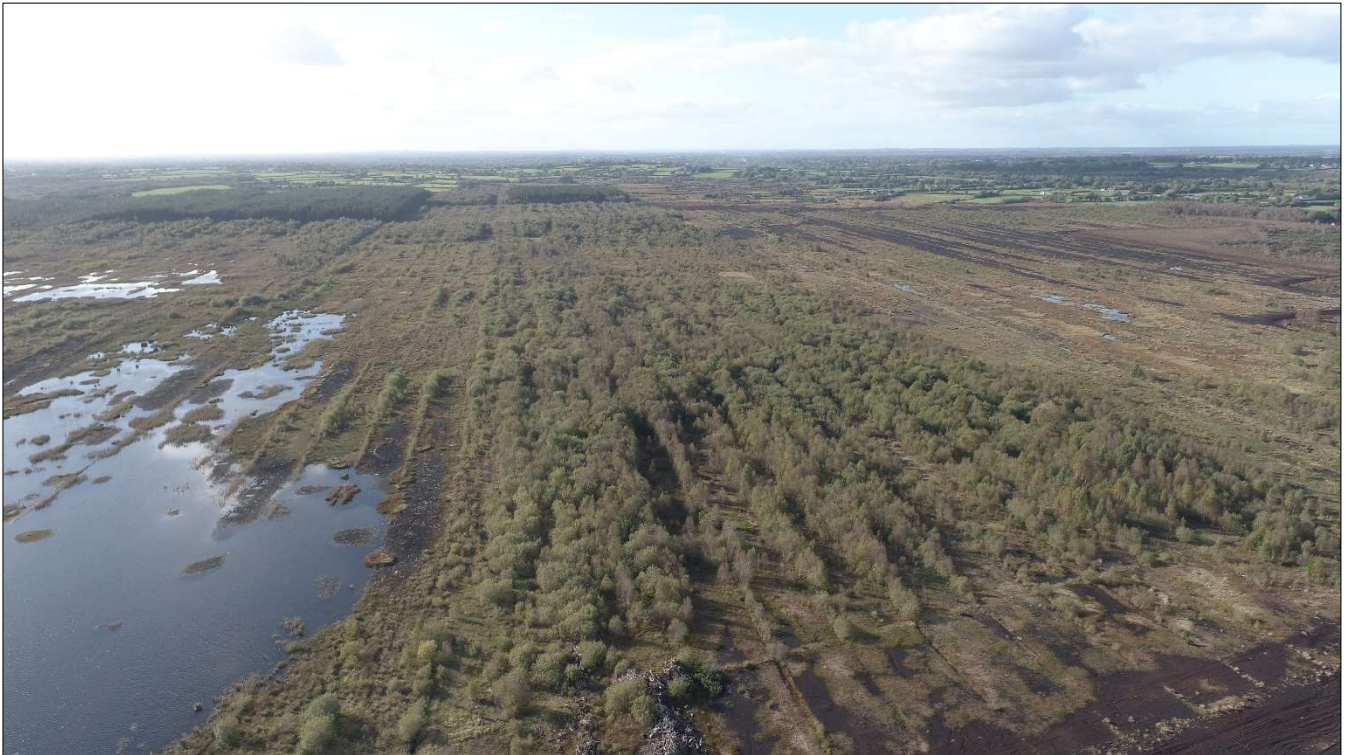
*Plate 3.7 Example of developing pioneering cutaway vegetation (i.e. scrub, developing woodland, poor fen) and wetland habitats occurring on former cutaway production bog within the north east of the western portion of Noggusboy.*

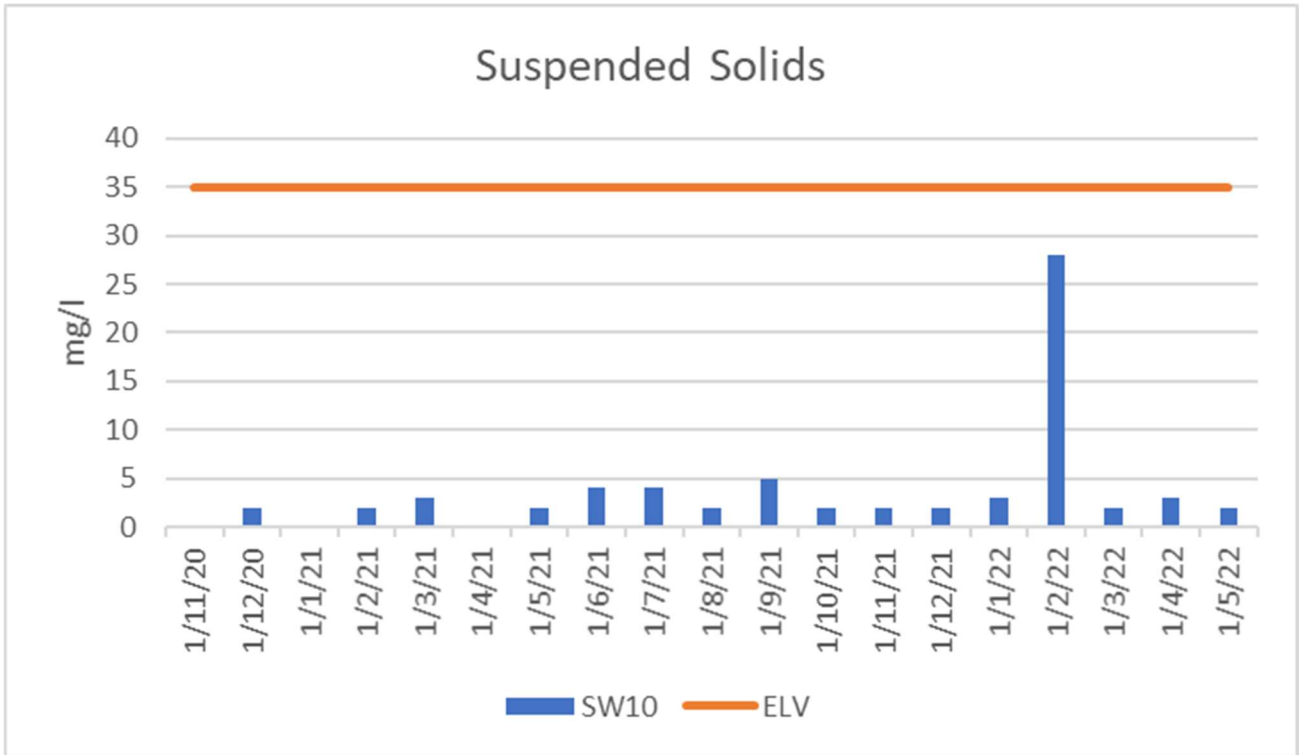
Figure AP13.1. Suspended solids in water sampling at Noggusboy from different discharge points. 35 mg/l is the emission limit value.

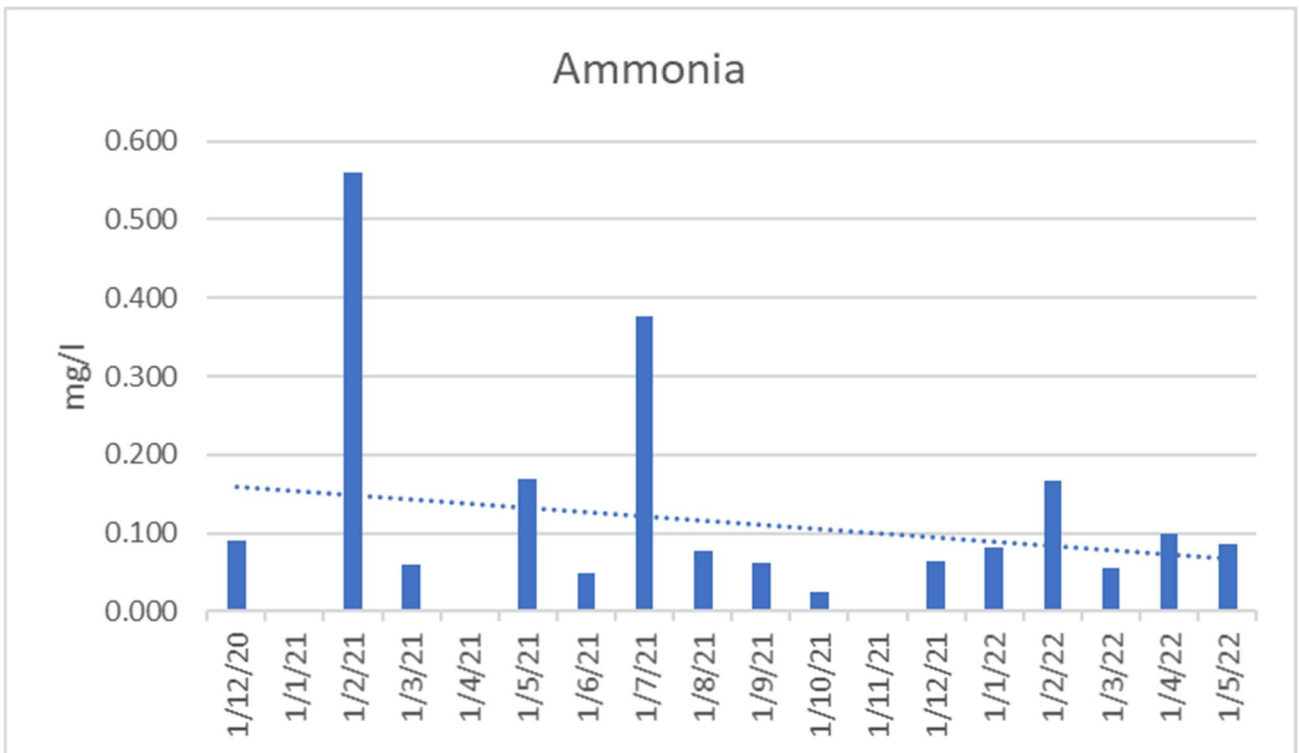
Figure AP13.2. Ammonia concentrations in water sampling from Noggusboy from different discharge points. The main trigger level for ammonia is 4.53mg/l for reporting to EPA.
