# **Bord na Móna**

## **Timahoe South Bog**

# **Cutaway Bog Decommissioning and Rehabilitation Plan 2022**

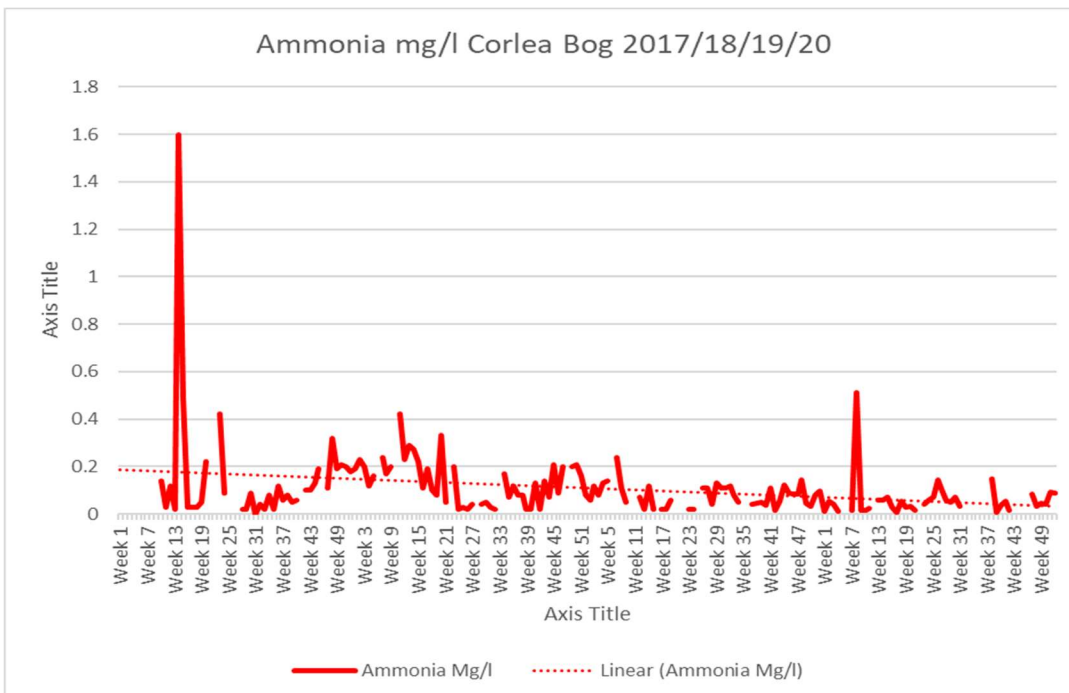
**Plate 7.2** Example of decreasing ammonia emissions at Corlea bog following cessation of peat extraction and commencement of rehabilitation

Similarly monitoring of surface water ammonia emissions from a Corlea bog in Mountdillon over the past 3 yrs. post cessation of peat extraction with ongoing rehabilitation, indicate downward trends.

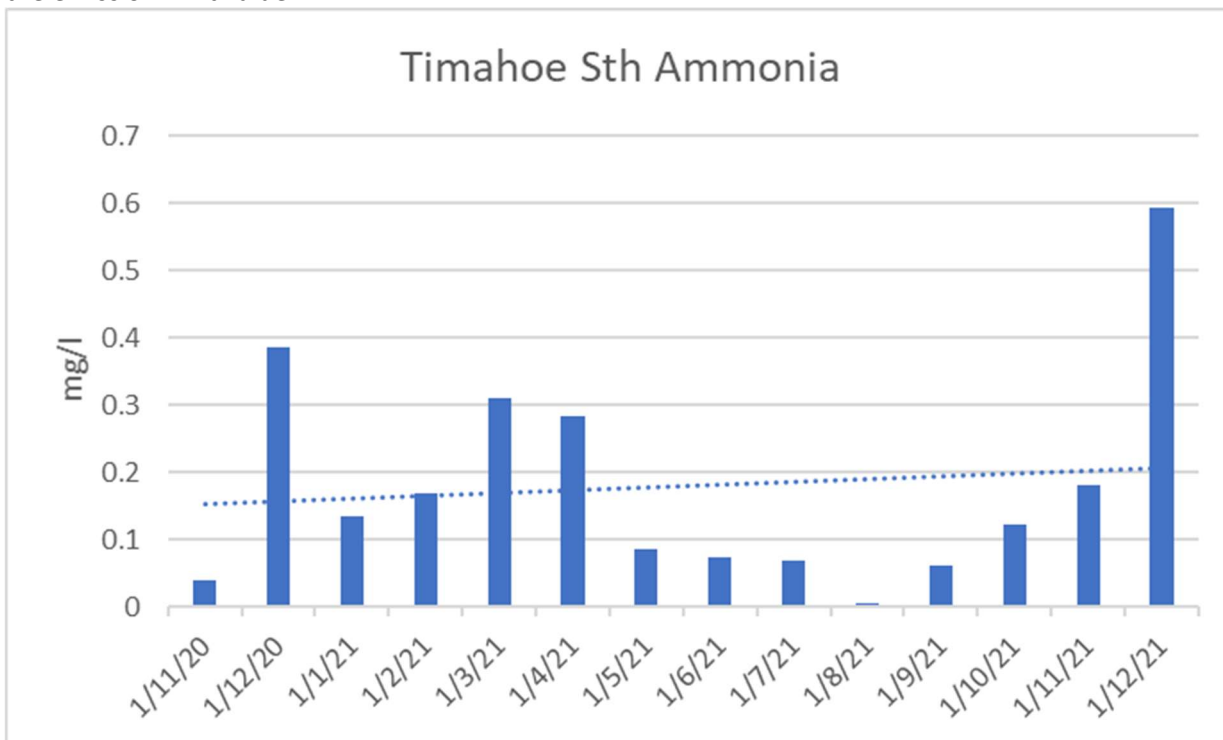
Figure AP13.2. Ammonia concentrations in water sampling from Timahoe South from different discharge points. The main trigger level for ammonia is 1.42mg/l for reporting to EPA.
