Bord na Móna

Ballaghurt & Glebe Bogs

**Cutaway Bog Decommissioning and
Rehabilitation Plan**

2023

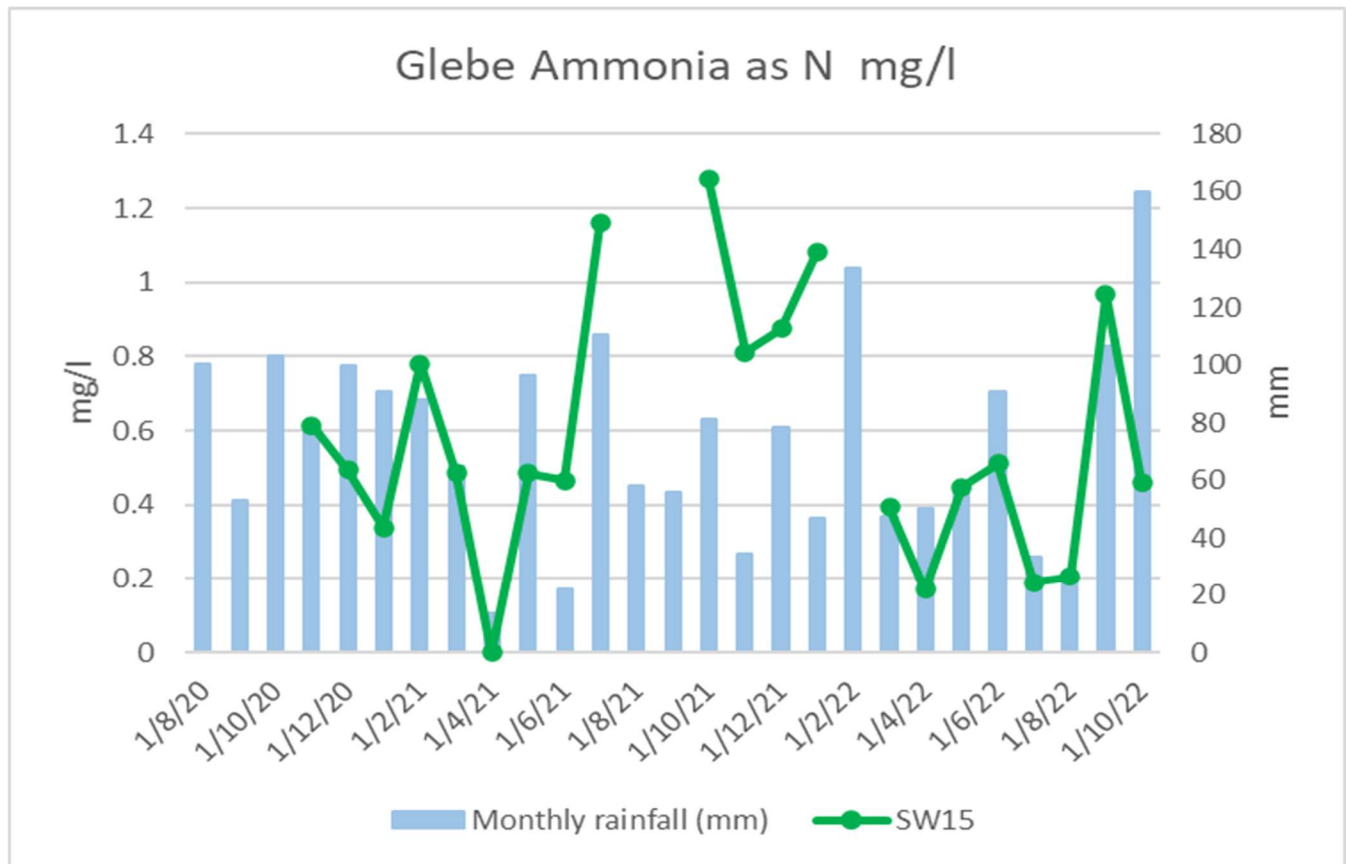
Figure AP13.2. Ammonia concentrations in water sampling from Glebe bog from different discharge points. The main trigger level for ammonia is 1.42mg/l for reporting to EPA.

Some months had no samples due to either no discharge during Summer months or associated Rivers being in flood during Winter months.

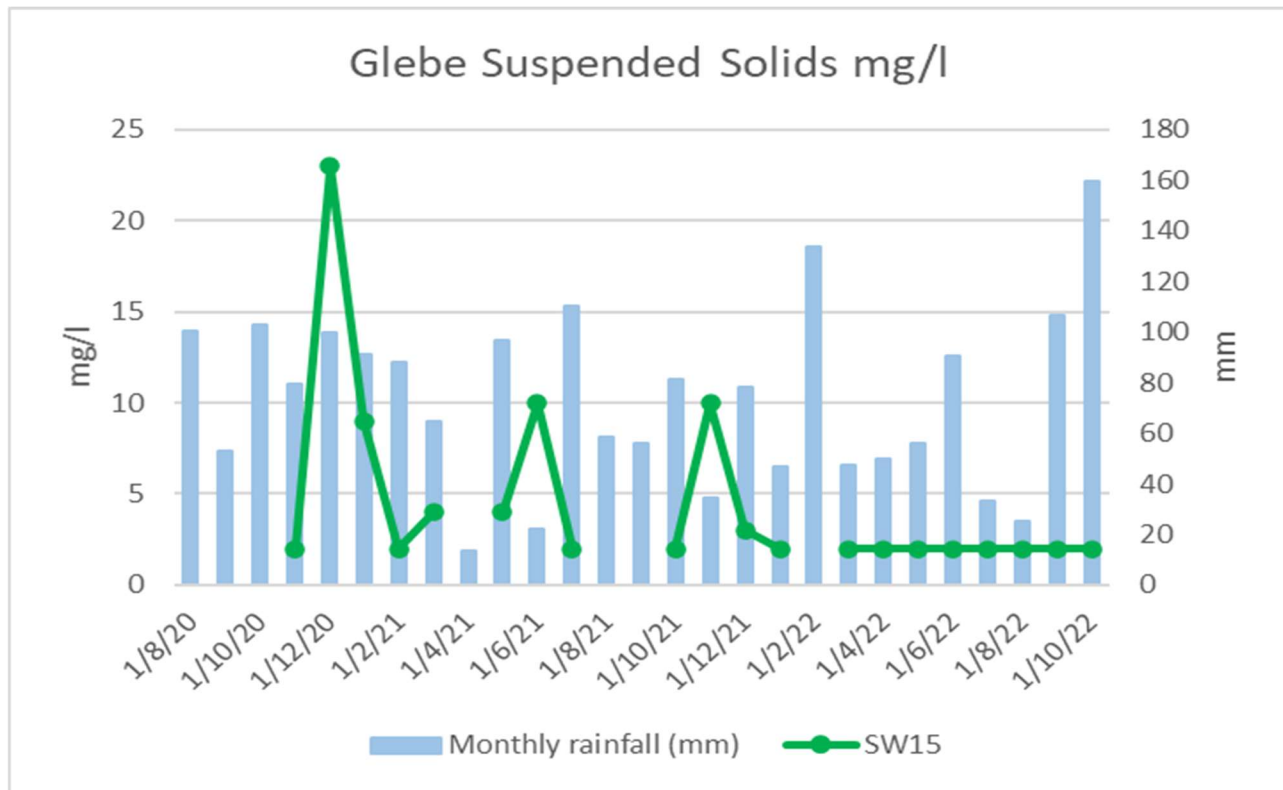
Figure AP13.1. Suspended solids in water sampling at Glebe bog from different discharge points. 35 mg/l is the emission limit value.

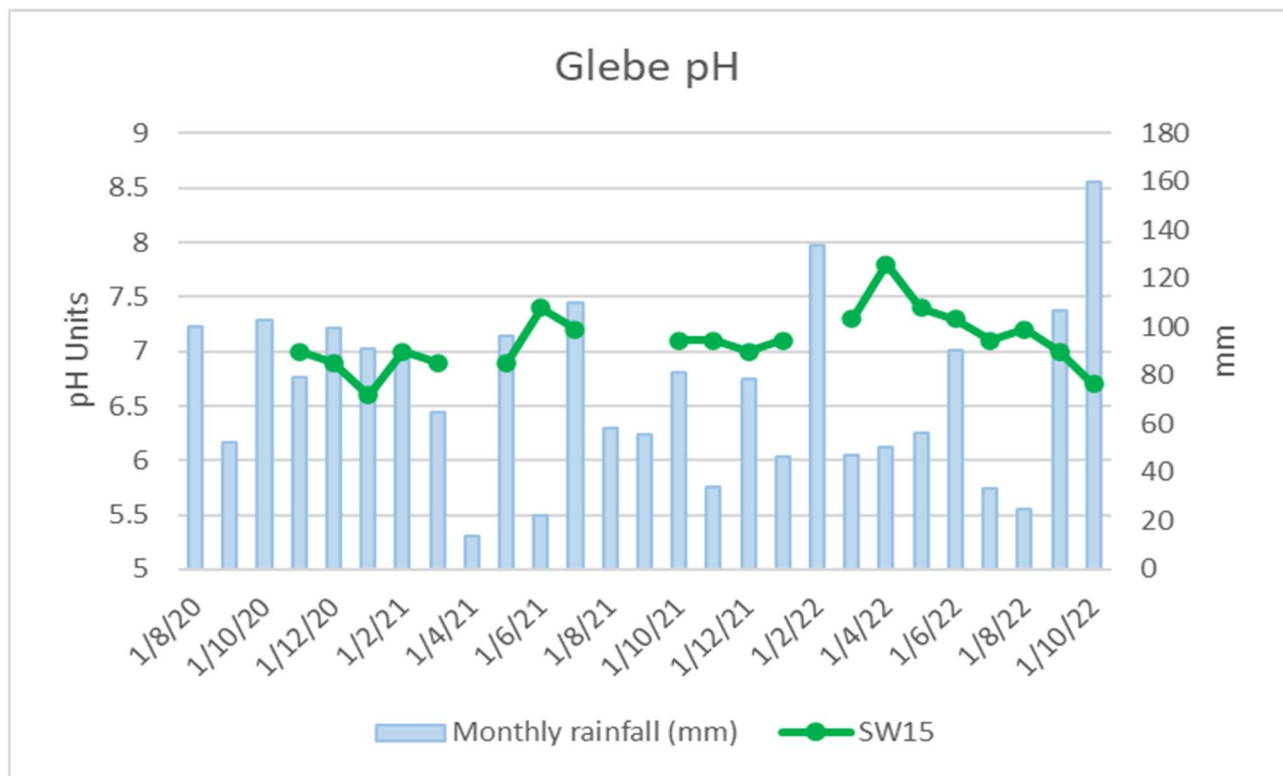
Figure AP13.1. pH in water sampling at Glebe bog from different discharge points.
